## 16.0 Shiprock, New Mexico, Disposal Site

### 16.1 Compliance Summary

The Shiprock, New Mexico, Uranium Mill Tailings Radiation Control Act (UMTRCA) Title I Disposal Site was inspected on May 29, 2009. The disposal cell and all associated surface water diversion and drainage structures remained in good condition and were functioning as designed.

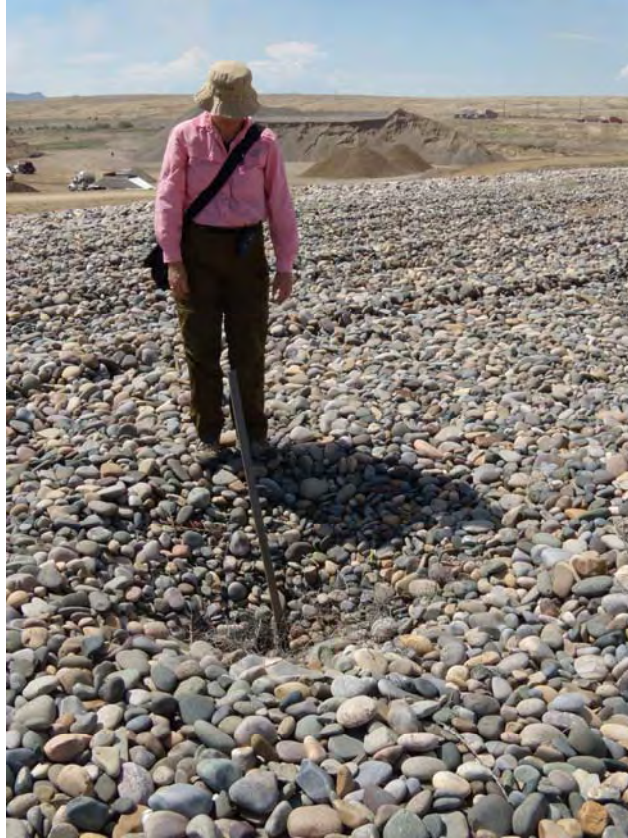
**Disposal Cell, Diversion Channels, and Outflow Channel**—The riprap-covered top and side slopes of the cell are in good condition; no evidence of settling or slumping was found. A conical depression was identified along the southeast edge of the disposal cell cover (PL–1). Since the inspection, several similar conical depressions have been found, but these appear to be vestiges of test pits dug for initial cell cover studies. Although no displacement of materials is apparent in

these areas, these depressions will be measured and monitored in the future, and follow-up actions will be taken if necessary.

*SHP 5/09. PL-1. Conical depression found on top of the disposal cell.*

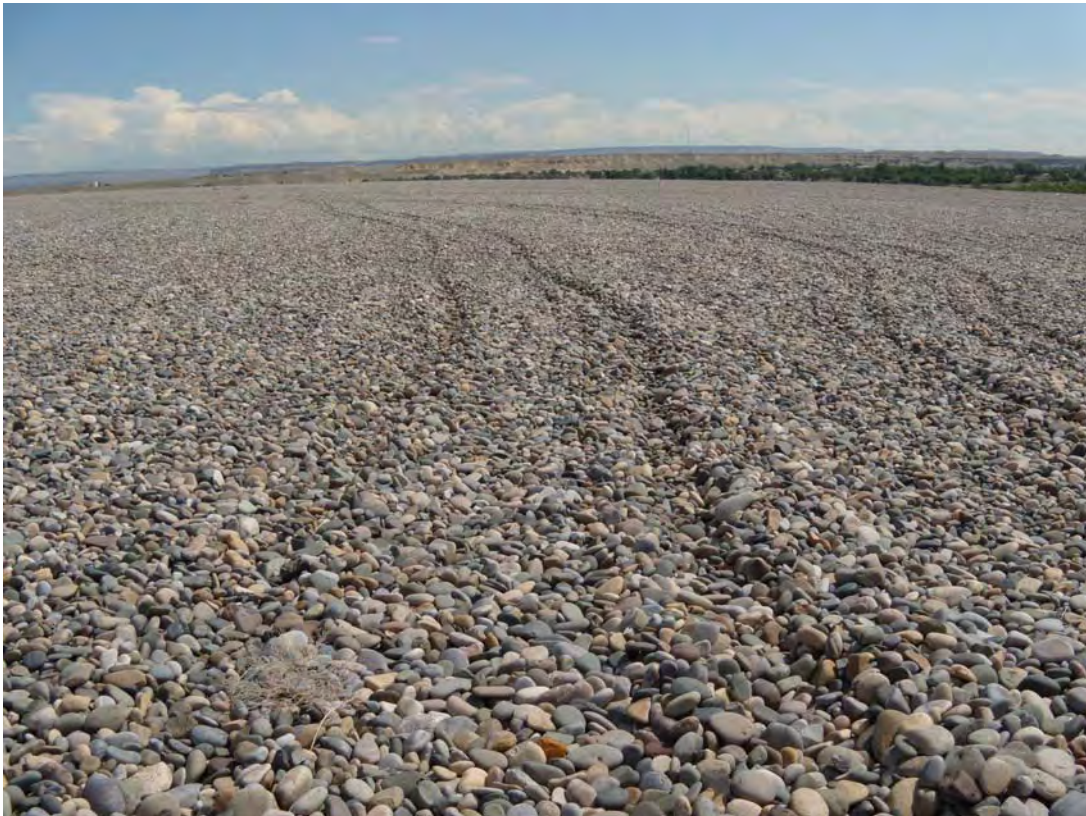
Vehicle ruts are apparent on the surface of the cell (PL-2); these ruts were probably formed in the fall of 2008 during vegetation spraying. This treatment was effective, as all vegetation on the cell cover and in the diversion channels and outflow channel was dead at the time of the 2009 inspection (PL-3).

*SHP 5/09. PL-2. Vehicle ruts on the surface of the disposal cell.*

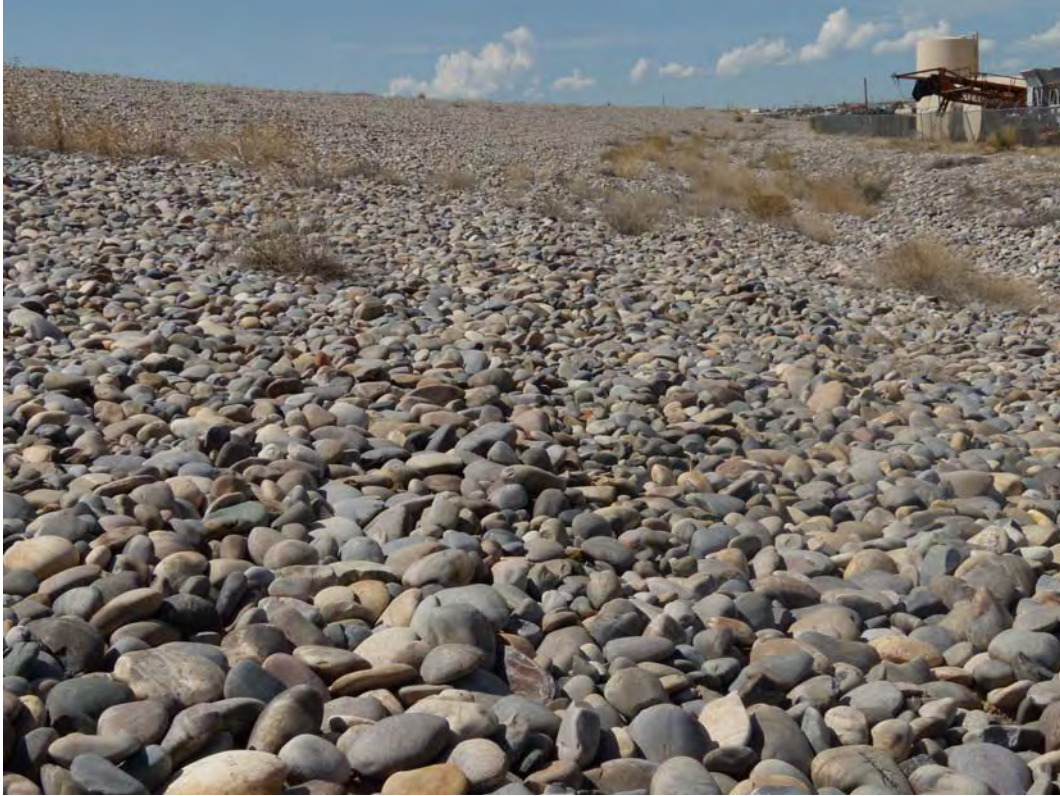
*SHP 5/09. PL-3. Dead vegetation on the disposal cell slopes and drainage channel.*

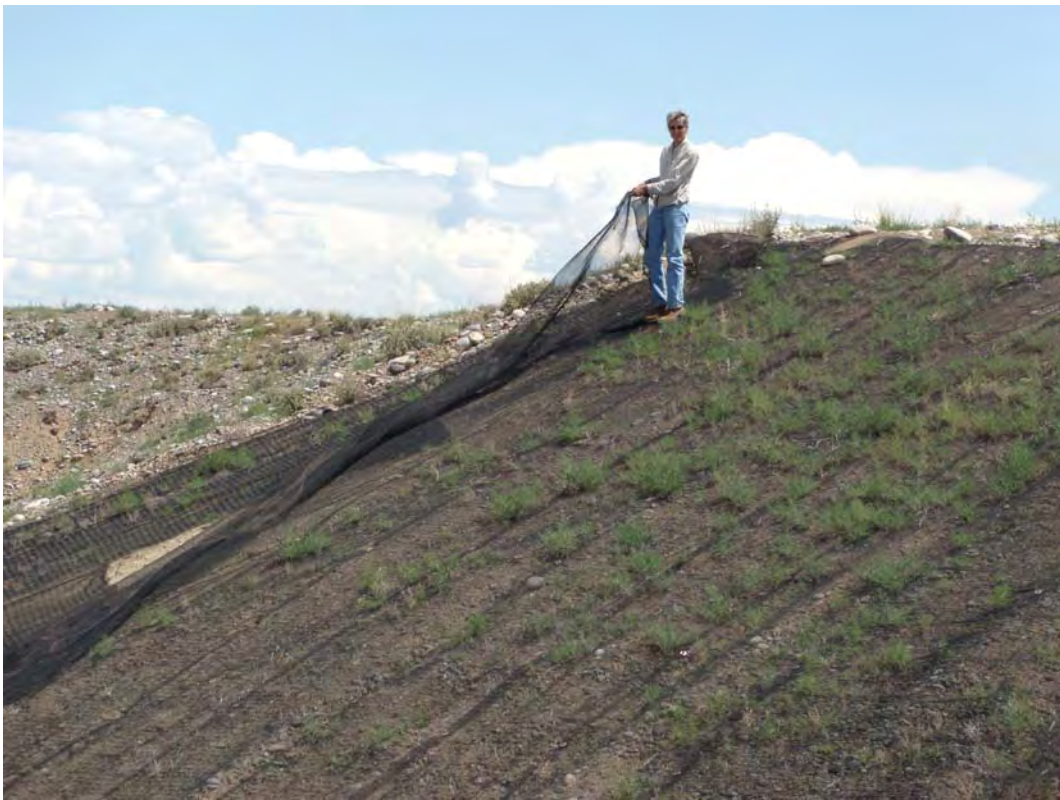
16B Site drainage is ultimately directed toward the outflow channel at the northwest corner of the site. The outflow channel was reconstructed in 2003 to repair damage caused by severe storms in 2001 and 2002, and an energy dissipation basin was constructed immediately above Bob Lee Wash. An erosion area along the southwest bank of the off-site portion of the outflow channel, fully repaired in 2008, was in good condition. The lower, steeper portion of the off-site outflow channel and the energy dissipation structure also remained in good condition. However, erosion control fabric installed on the side slopes of the lower channel had come loose along one edge; this section of fabric requires repair or removal (PL-4).

*SHP 5/09. PL-4. Loose erosion fabric on the slope of the hill above the outflow channel.*

Except for two minor exceptions, all structures, including access roads, gates, entrance signs, fences, monitoring wells, site markers, perimeter signs, survey monuments, and erosion control markers, were in good condition. A section of loose erosion fabric found on a side slope of the lower outflow channel requires removal or repair. Portions of the perimeter fence were bent or damaged but are still functional. No other maintenance needs or cause for a follow-up or contingency inspection was identified.
