16.0 Annual Inspection of the Shiprock, New Mexico, UMTRCA Title I Disposal Site

16.1 Compliance Summary

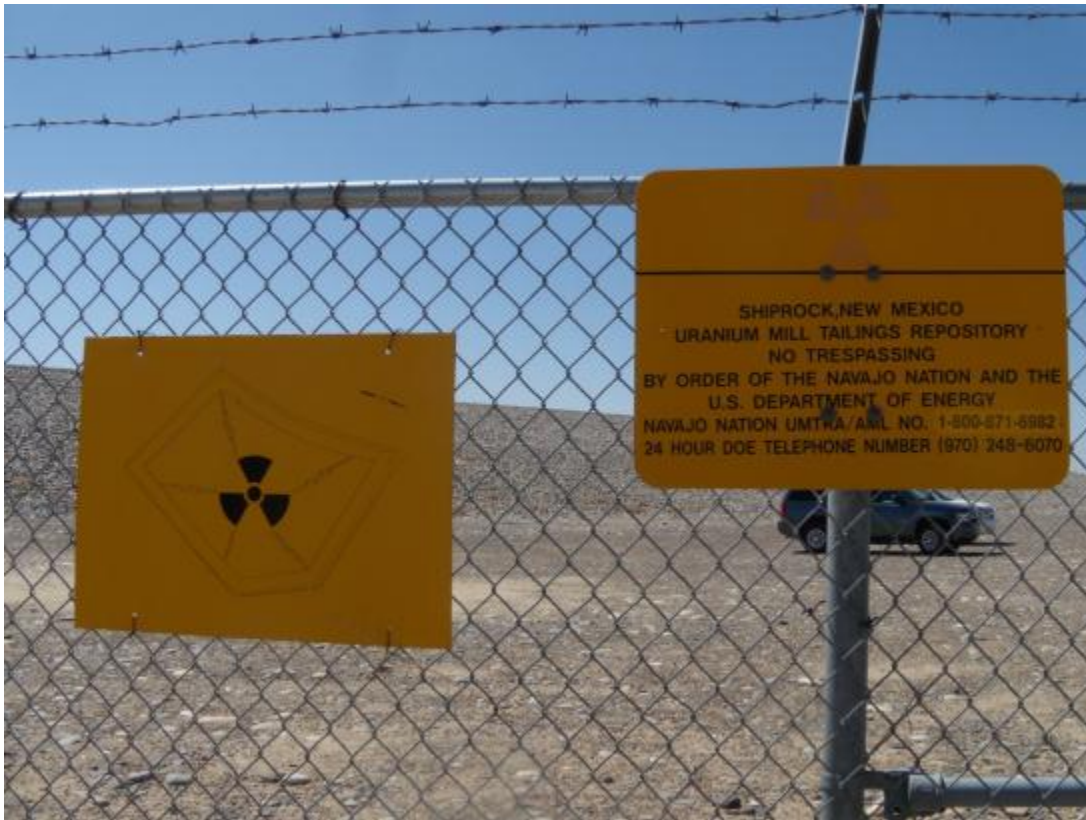
Three gates allow entrance to the site: the east gate (the current main entrance gate near the terrace escarpment), the northwest gate (an auxiliary access gate), and the southwest gate (the former entrance gate). Near each gate, entrance signs are placed in pairs—one text and one pictorial (PL-1). The pictorial sign was missing from the northwest gate. The remaining entrance signs were in good condition; on the signs, contact information for DOE and the Navajo Abandoned Mine Lands/Uranium Mill Tailings Remedial Action Department was correct. The east and northwest gates were intact and functional. Sediment accumulated along the bottom of the southwest gate (PL-2). Access to the main entrance gate is gained by traveling through a gravel pit operated by the Navajo Engineering and Construction Authority (NECA). All access roads were in good condition.

SHP 5/2012. PL-1. New entrance sign at east gate.

- 16C 1. Replace the pictorial sign missing from the northwest entrance gate.

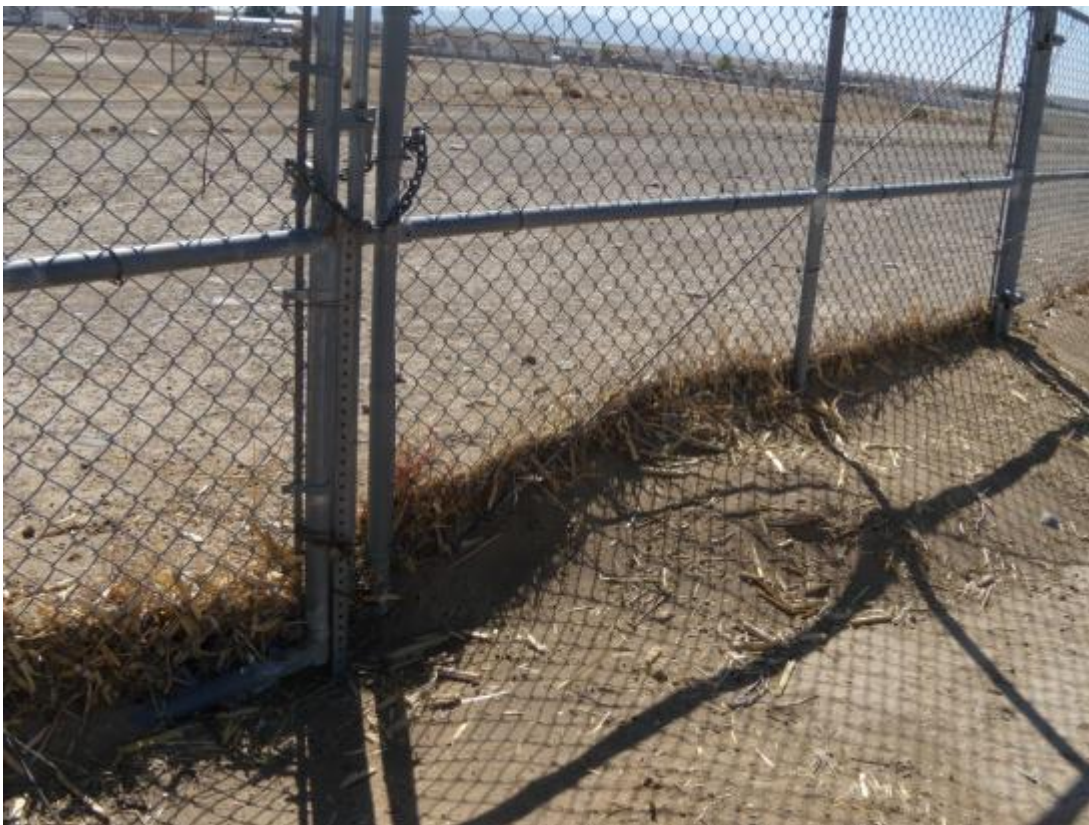
All three of the site's entrance gates remained intact. All perimeter signs were present, legible, and in good condition. One pictorial entrance sign was missing from the northwest gate. Sediment had accumulated under the southwest gate. The perimeter fence, although damaged in places, was intact and functional. Inspectors placed rocks in all significant gaps that formed under the perimeter fence. Boundary monuments BM-2 through BM-6 were not found during the annual inspection; a survey team found and reestablished the missing boundary monuments after the inspection. One erosion control marker was previously damaged by a vehicle but remained functional.

SHP 5/2011. PL-2. Sediment buildup along southwest gate.

1. Remove sediment and debris from under the southwest entrance gate.
2. Remove accumulated tumbleweed and trash from along the disposal site's perimeter fence, the outflow channel, and the fence surrounding the evaporation pond.
- 16A 3. Cover five research pits in the disposal cell cover installed in 2005.
- 16B 4. Reestablish boundary monument BM-1, unbury boundary monuments BM-2 through BM-6, and install reference posts at all boundary monument locations.

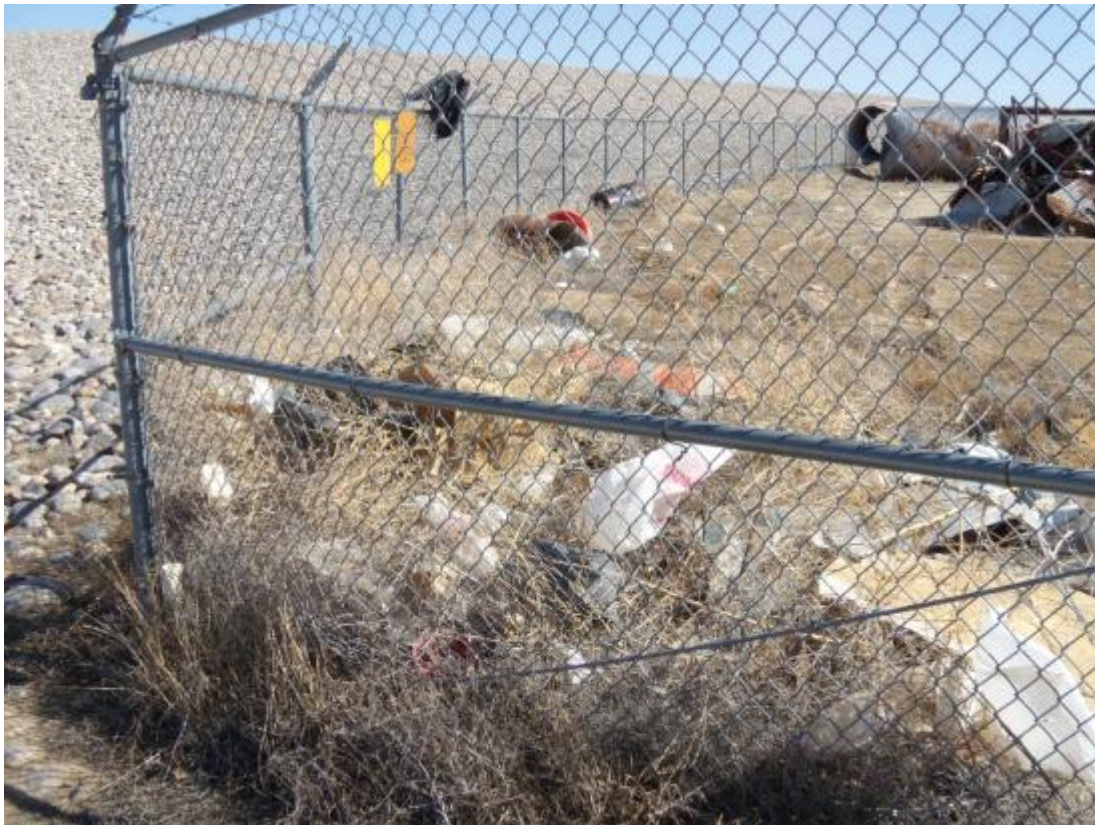
Trash and tumbleweeds have accumulated in many places along the perimeter fence (PL-3 and PL-4), including a section of fence across the outflow channel. These accumulations potentially represent a fire hazard and increase the possibility of damage to the fence, particularly during high winds. To improve the safety and appearance of the site the tumble weeds and trash have been removed.

SHP 5/2012. PL-3. Trash and tumbleweed buildup in fence corner by perimeter sign P14.

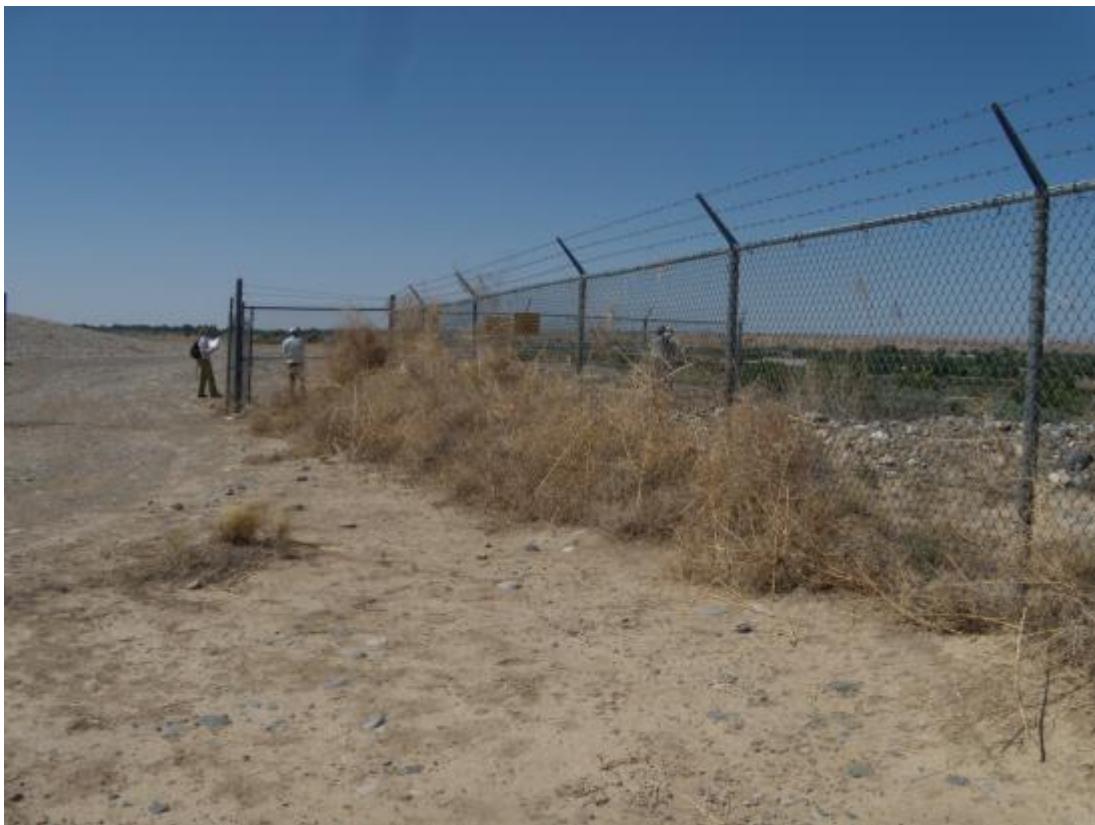
SHP 5/2012. PL-4. Tumbleweed buildup near the east gate.

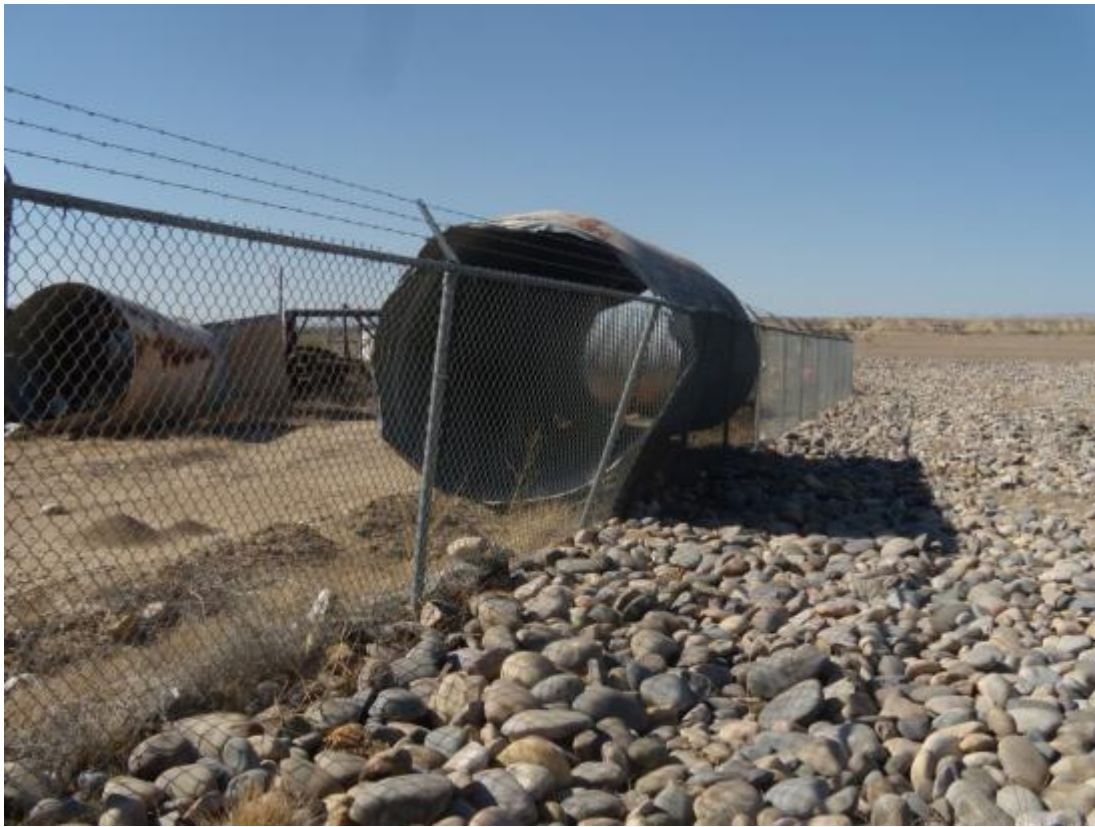
As observed in previous years, the perimeter fence was intact and functional but damaged in a number of areas. Damaged fence sections reported in previous years include bent posts and bent fence fabric between perimeter signs P11 and P12, dirt mounded against the fence near P13, bent posts near P14, a broken fence riser near P15, and fence risers separated from posts between P15 and P16. New damage consists of a section of bent fence near P13; damage resulted from a large culvert placed in the adjoining NECA yard (PL-5). Damaged areas will continue to be monitored.

SHP 5/2012. PL-5. Bent fence (still intact) from large culvert in NECA yard near perimeter sign P13.

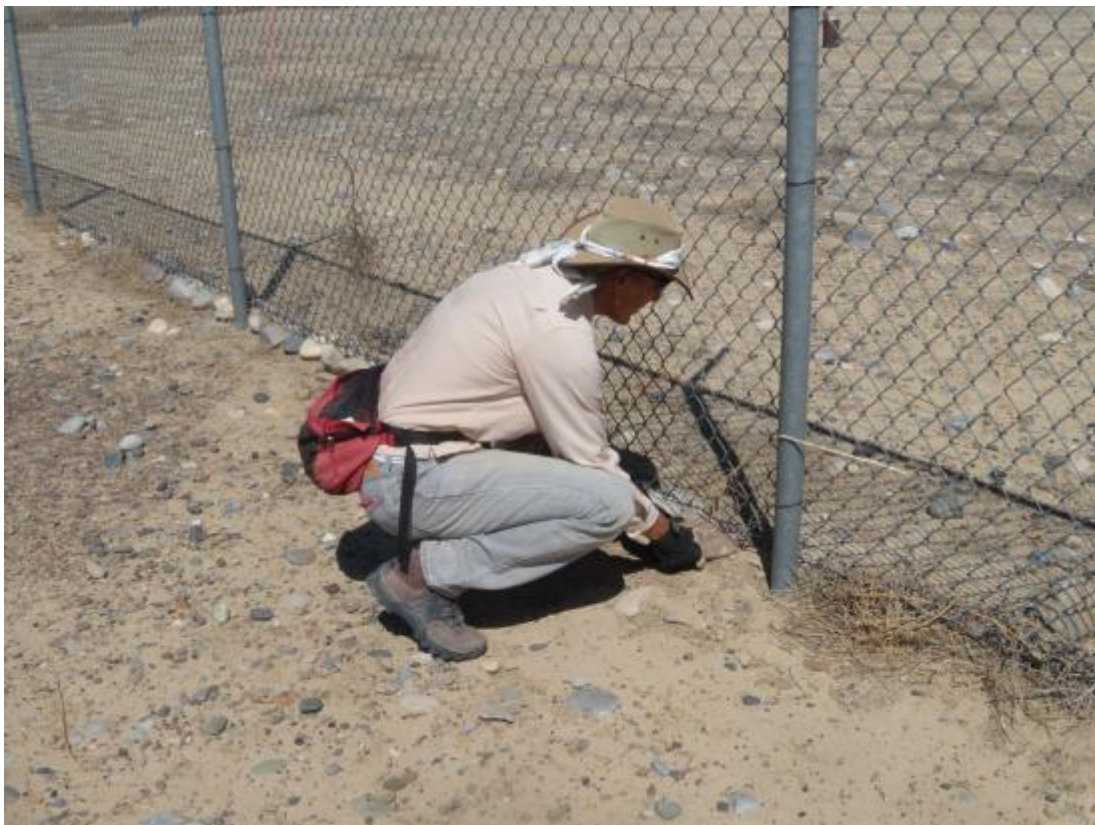
There were small gaps beneath the fence, most formed by animals and wind erosion, along the site perimeter. In 2012, inspectors placed rocks in all significant gaps (PL-6).

SHP 5/2012. PL-6. Placing rocks in hole under perimeter fence.

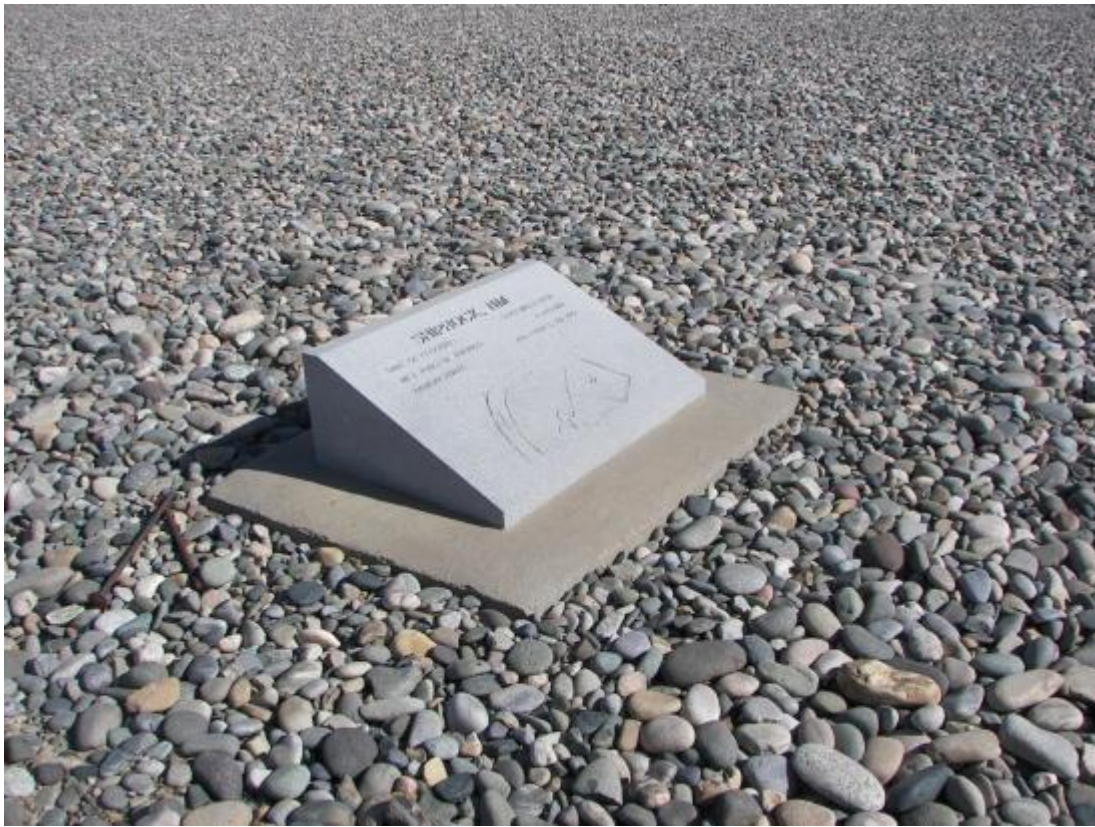
Site marker SMK-1, located just inside the southwest gate, and site marker SMK-2, located on top of the disposal cell (PL-7), were both in good condition. Minor cracks in the concrete base of SMK-1 were sealed in May 2003 and have not changed.

SHP 5/2012. PL-7. Site marker SMK-2.

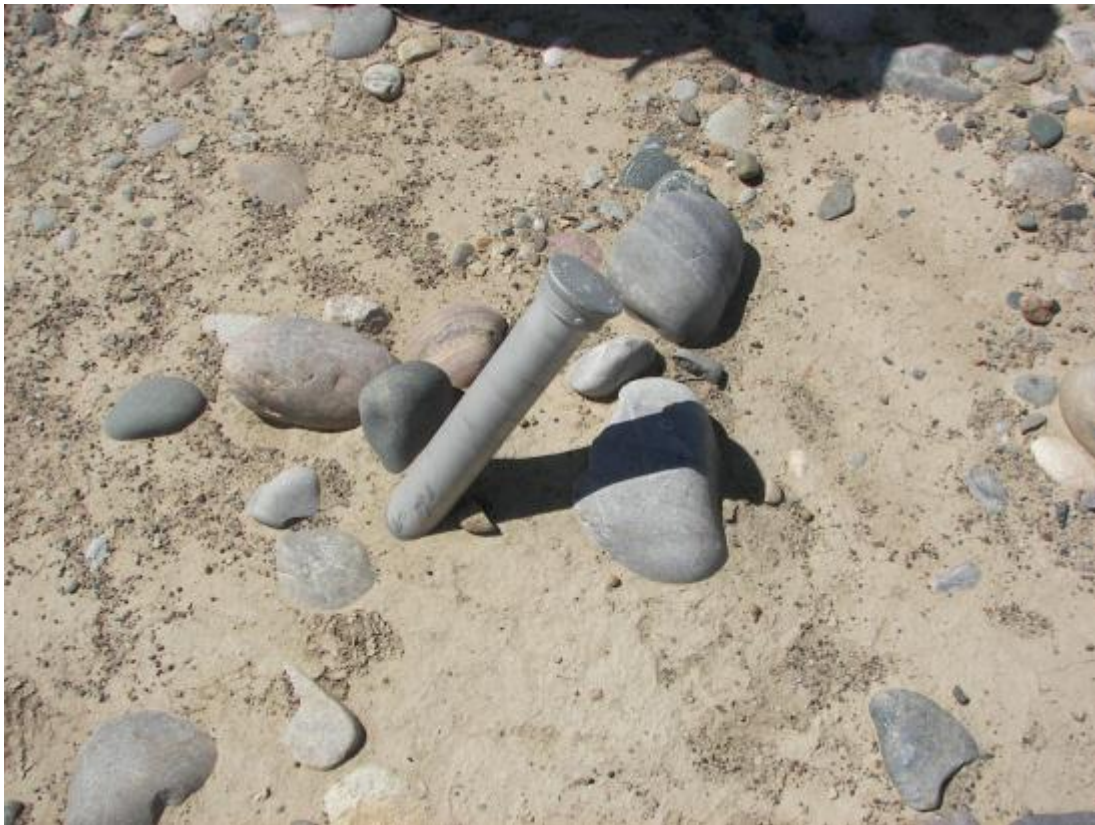
The four pairs of erosion control markers along the edge of the terrace escarpment were in good condition except for the marker near the east entrance gate. This marker was previously damaged by a vehicle (PL-8), but it is still functional and does not require repair at this time.

SHP 5/2012. PL-8. Erosion control marker damaged but functional.

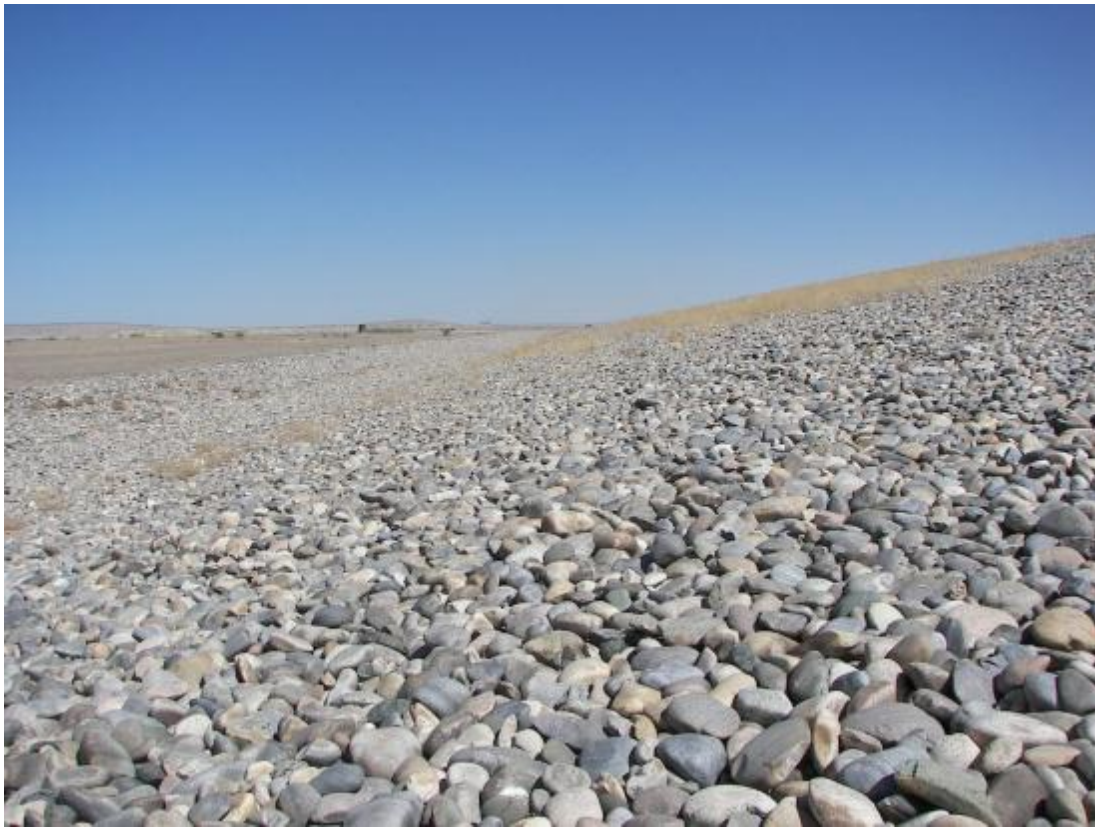
The riprap-covered top and side slopes of the cell were in good condition. No evidence of settling, slumping, erosion, animal intrusion, riprap deterioration, or other disturbance was found (PL-9). Five open research pits, described in previous annual inspection reports, were present on the cell top (PL-10). These research pits, installed in 2005 were filled in after the 2012 inspection. In 2002, Piezocones installed on the cell cover were removed and the associated pits filled in. Since that time, several of these pits have subsided slightly, forming conical depressions in the cover (PL-11). The surface of the cell was also covered with vehicle ruts (PL-12), many of which were formed in 2008 during herbicide treatment. The condition of the depressions and vehicle ruts is monitored annually and had not changed significantly since the 2011 inspection.

SHP 5/2012. PL-9. Side slope of disposal cell, view east.

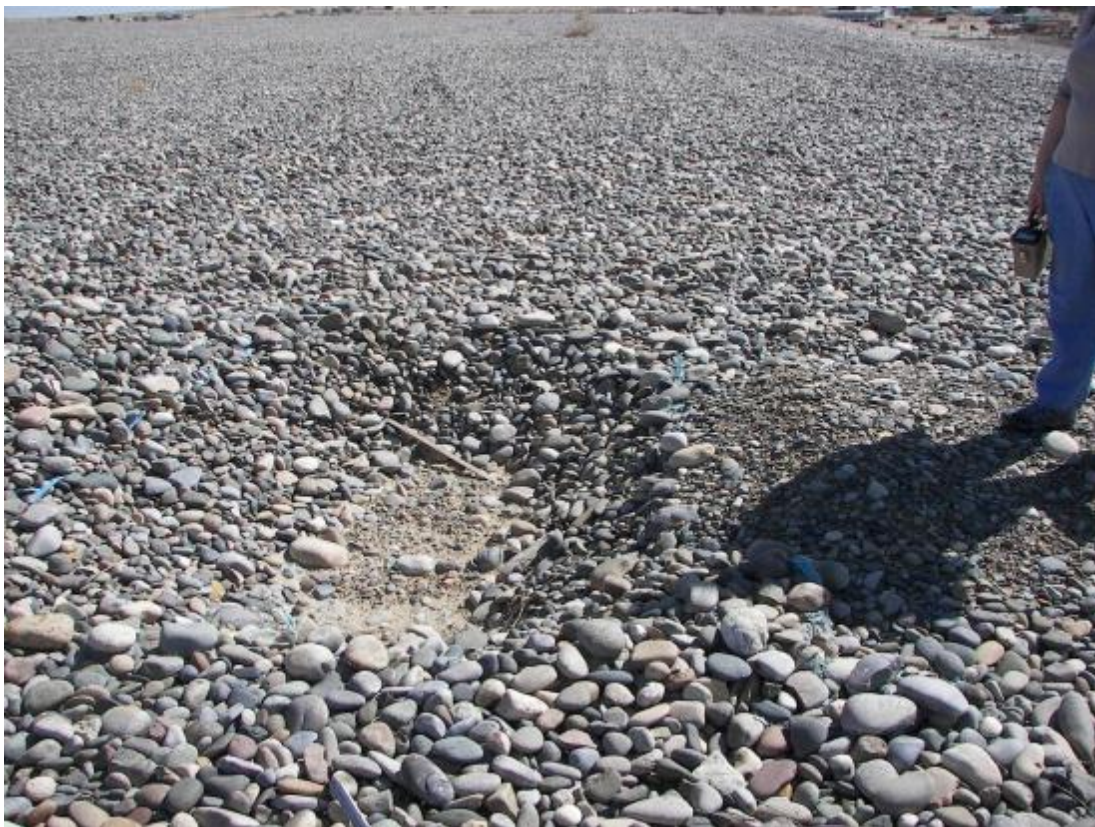
SHP 5/2012. PL-10. Open test pit on western portion of cell.

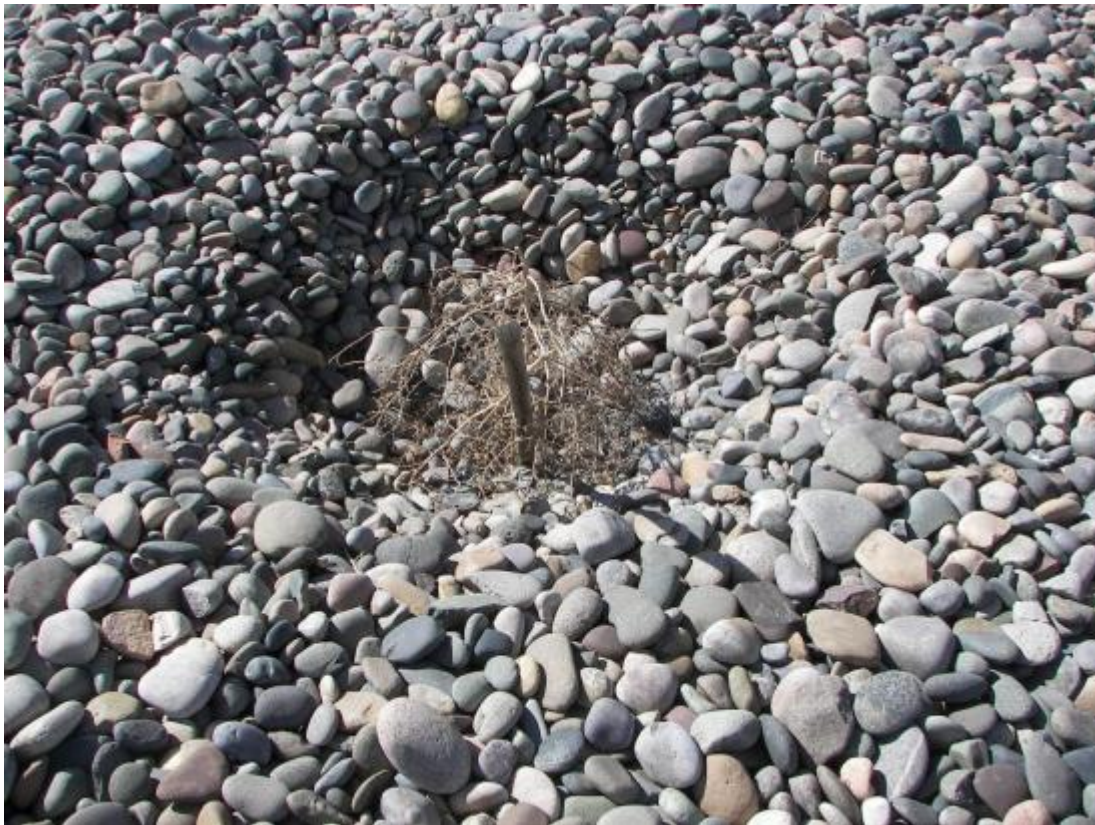
SHP 5/2012. PL-11. Historical test pit on eastern edge of cell.

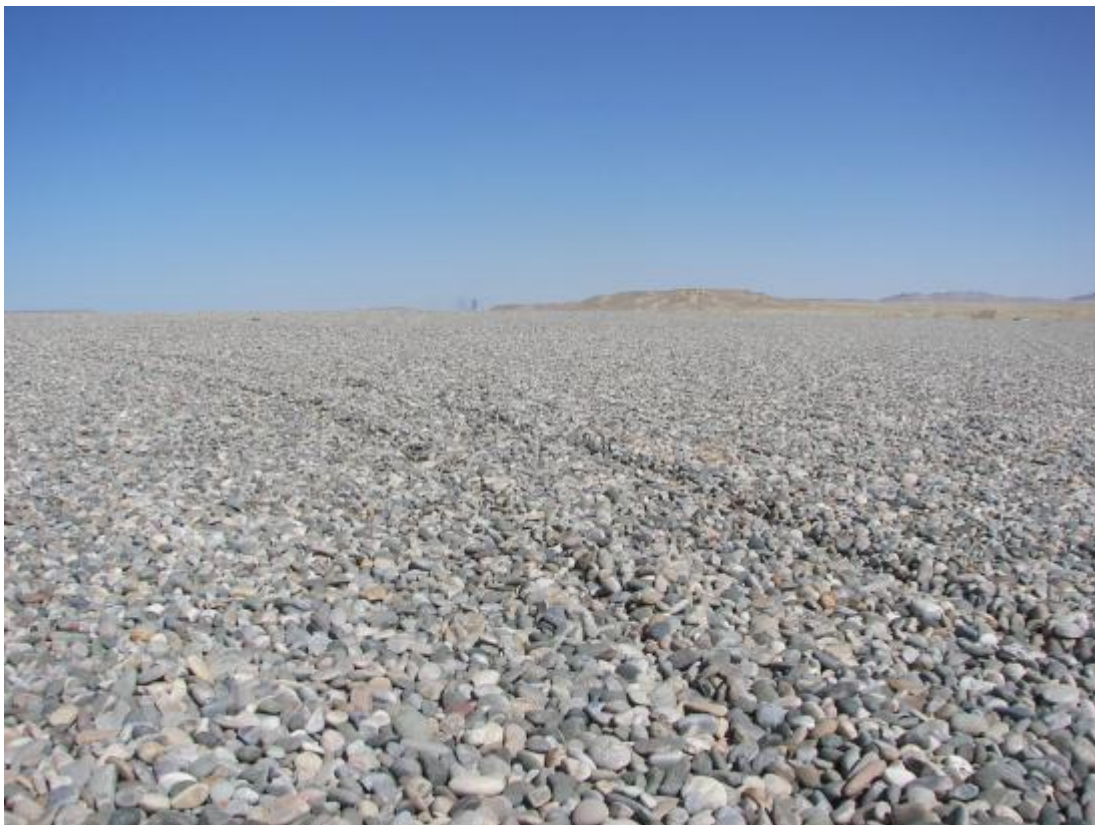
SHP 5/2012. PL-12. Vehicle tracks visible on disposal cell cover, southwest portion of cell.

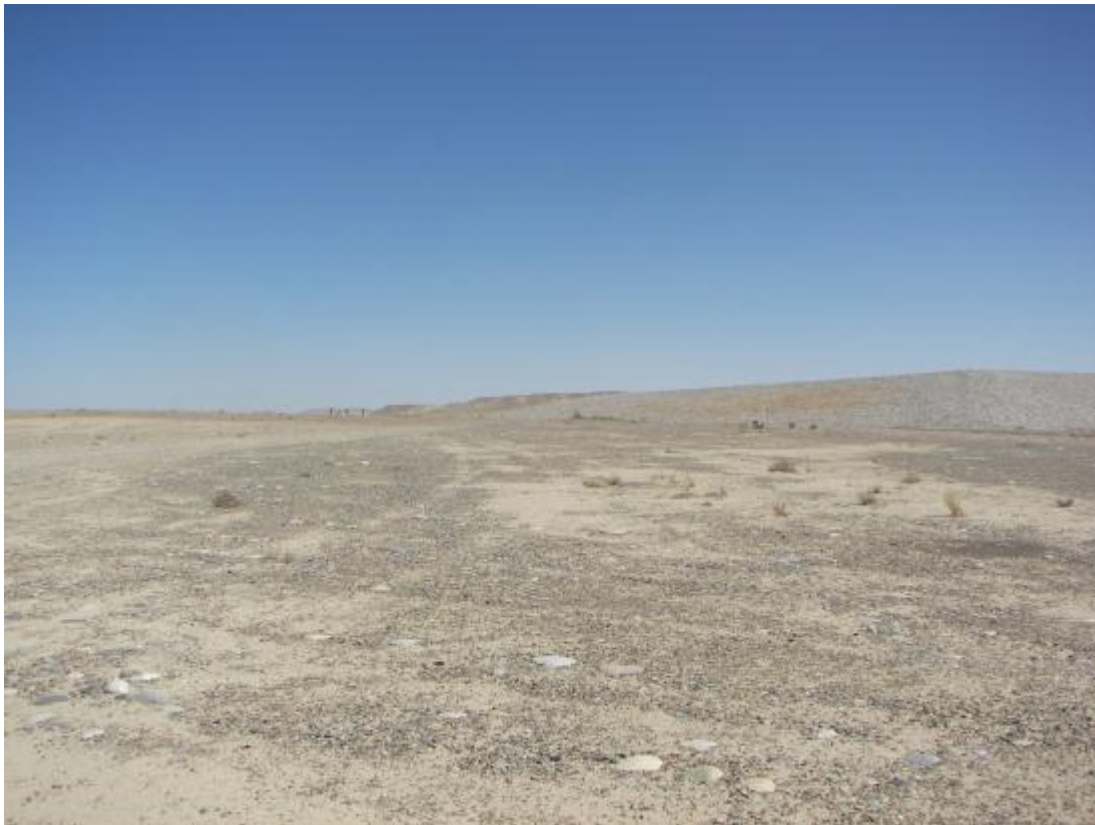
The terrace area is located north and northeast of the disposal cell along the top of a steep escarpment. Very little vegetation grows on the terrace (PL-13). The escarpment, approximately 300 feet from the eastern edge of the disposal cell, is prone to slumping. Fractures and incipient slumps can occur in the Mancos Shale bedrock along the escarpment northwest of erosion control marker 1A. No new erosion was evident in 2012 (PL-14).

SHP 5/2012. PL-13. View of terrace from the northern phytoremediation test plot.

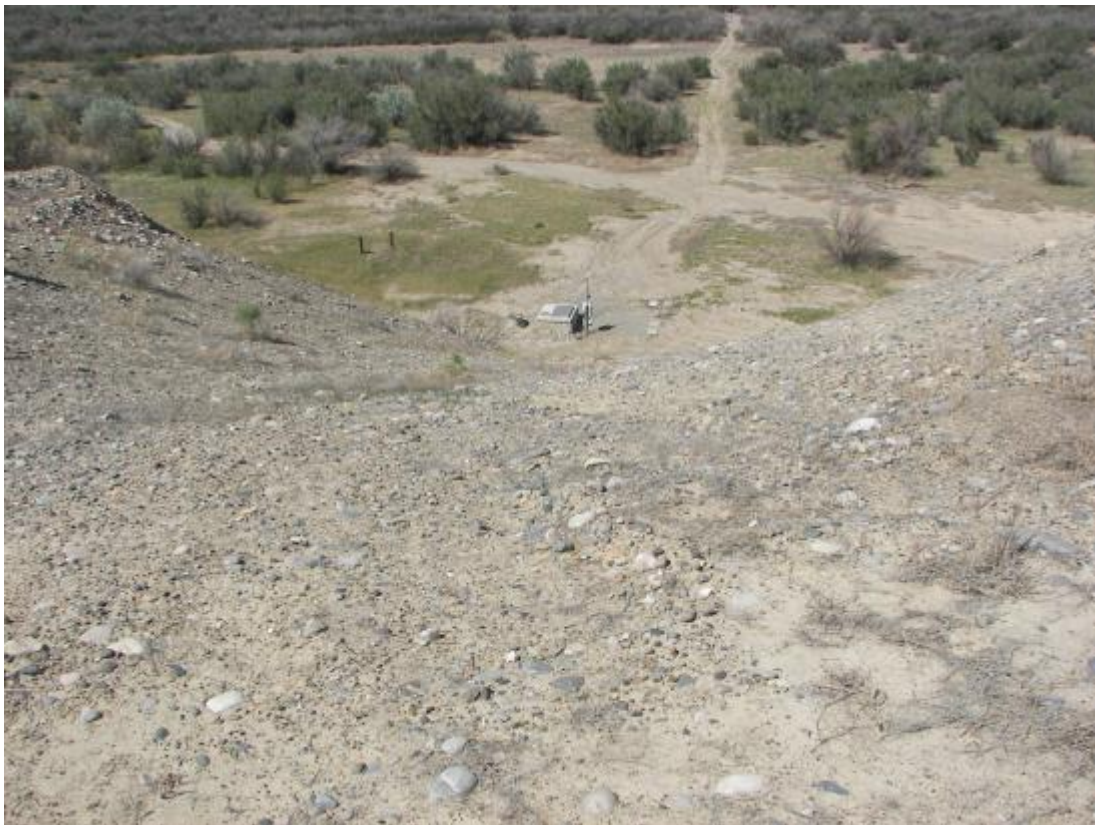
SHP 5/2012. PL-14. Section of escarpment near survey monument SM-1.

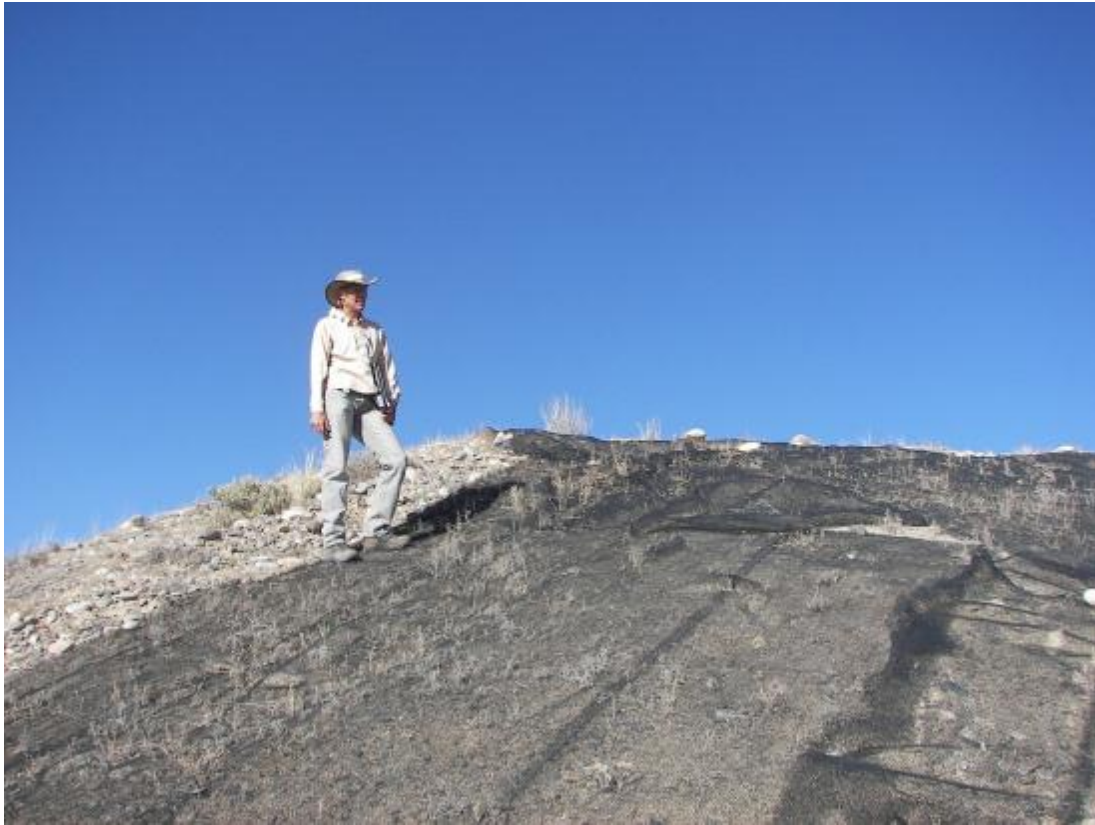
The offsite portion of the outflow channel was functional and in good condition (PL-15).

SHP 5/2012. PL-15. Erosion control fabric along outflow channel.
