# Long-Term Surveillance and Monitoring Program

## Annual Site Inspection and Monitoring Report for Uranium Mill Tailings Radiation Control Act Title I Disposal Sites

Annual Report for the Period  
January 1, 1998, Through December 31, 1998

**1998 Annual Report**

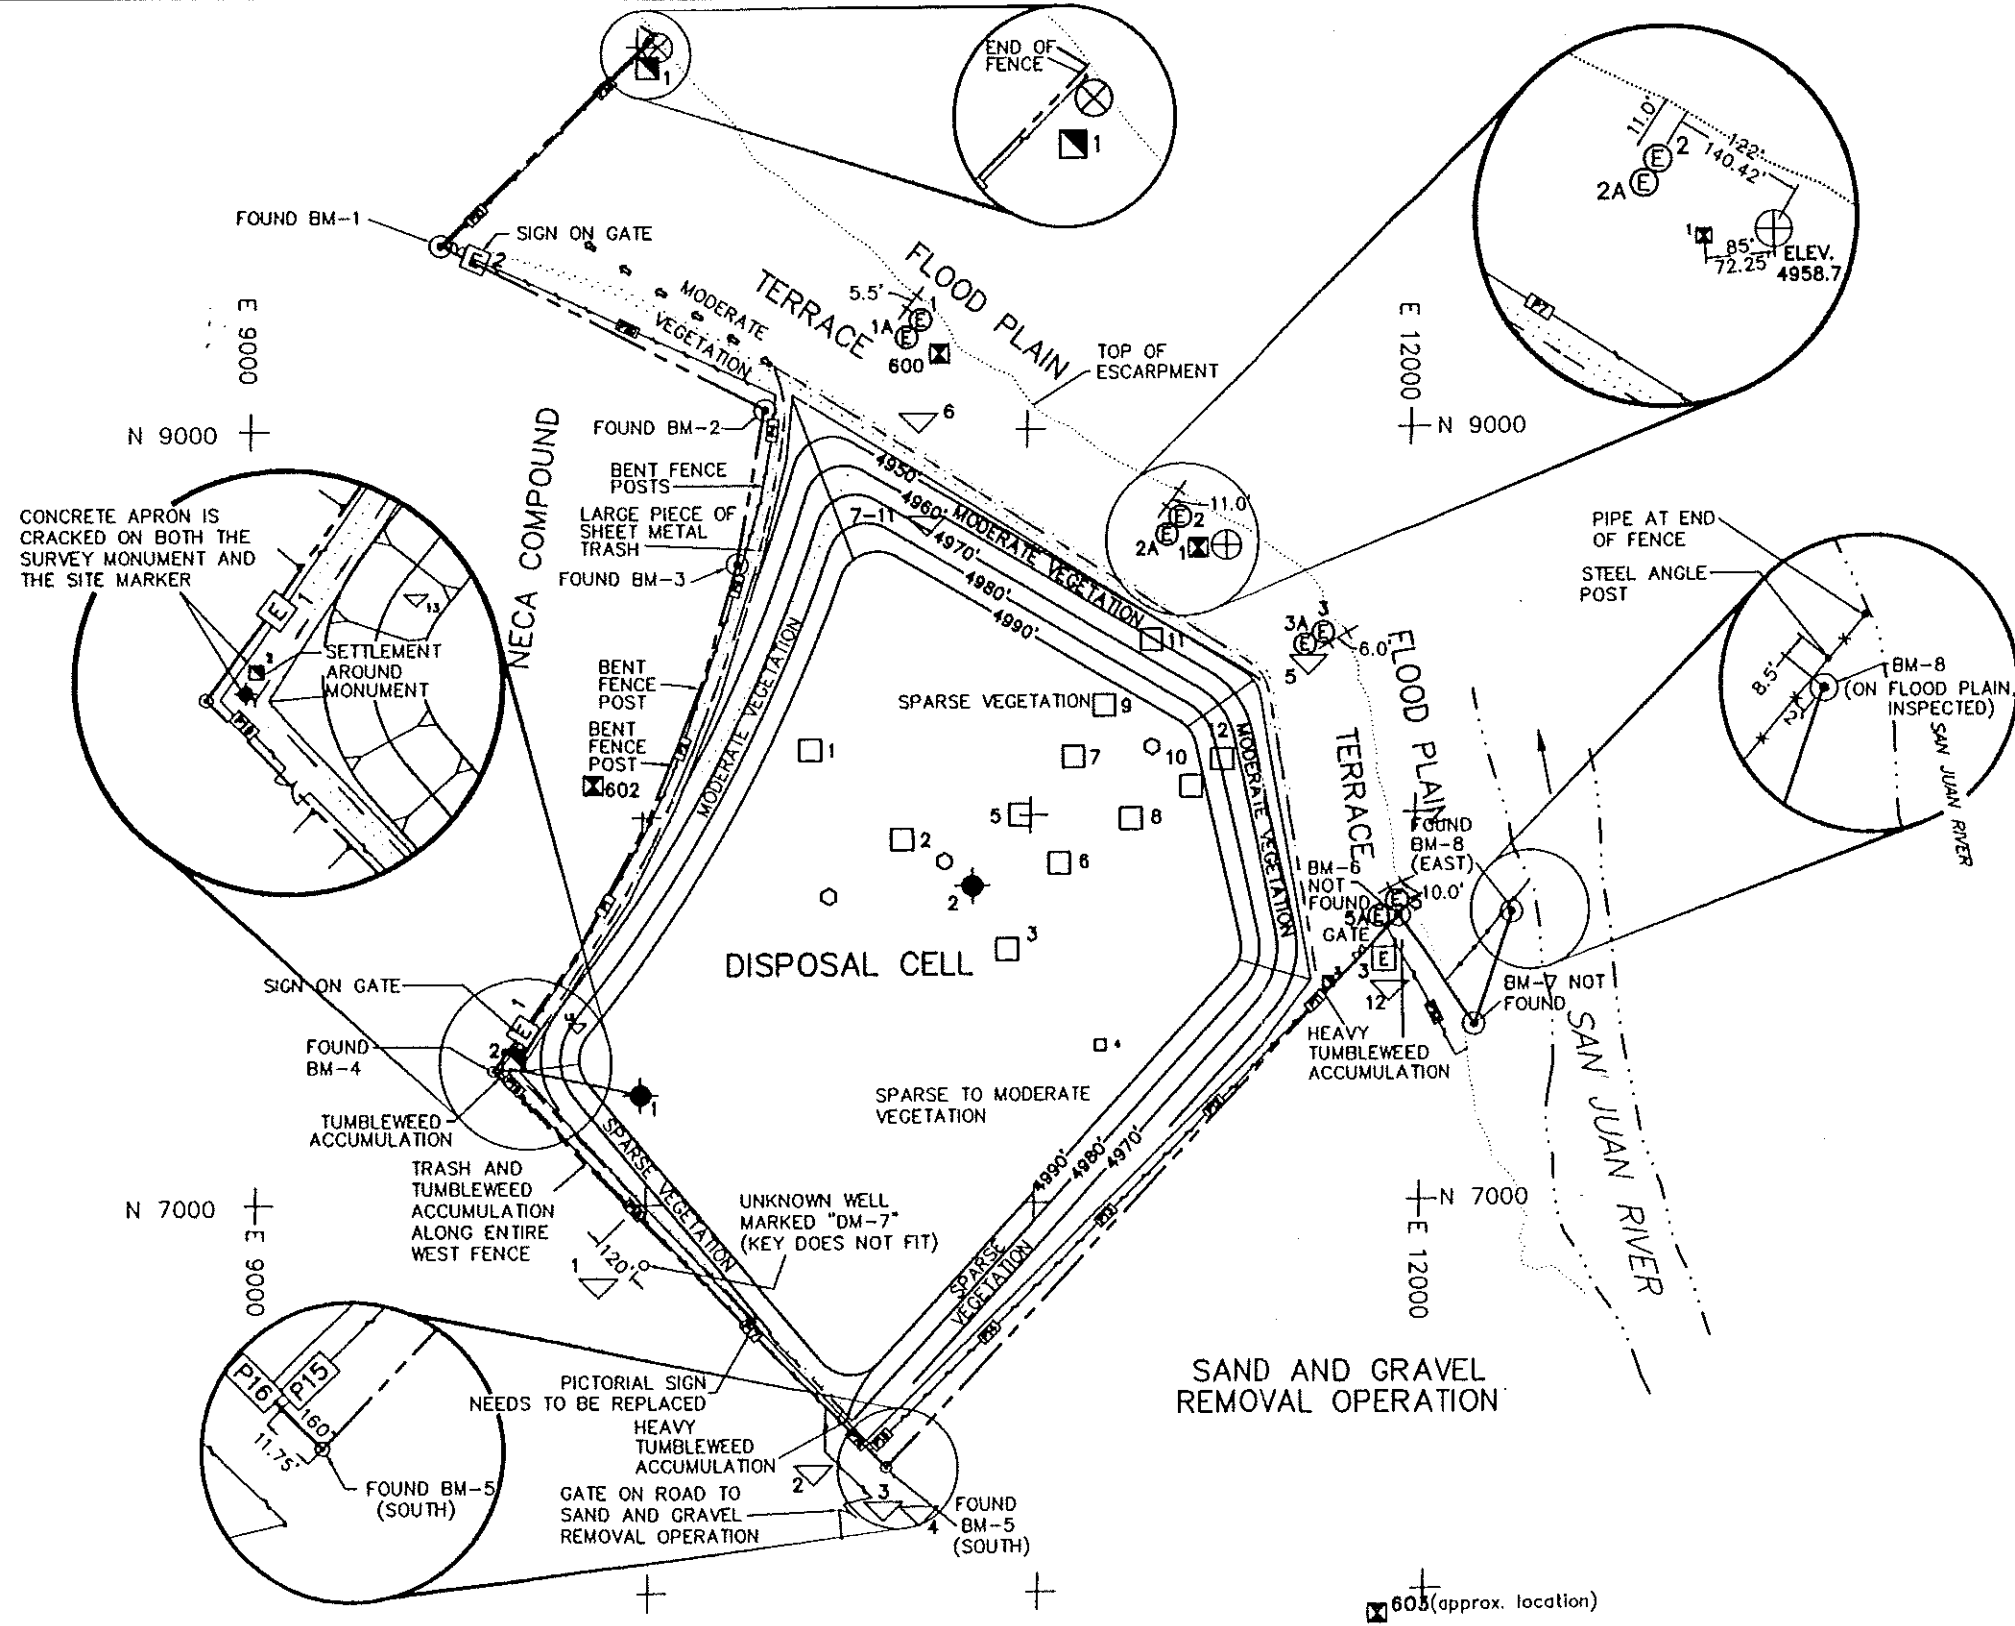
Within each transect, inspectors examined specific site surveillance features, such as survey and boundary monuments, signs, and site markers. Inspectors examined each transect for evidence of erosion, settling, slumping, or other phenomena that might affect site integrity or the long-term performance of the site. Features mentioned in this report are shown on the drawing, Figure SHP-1.

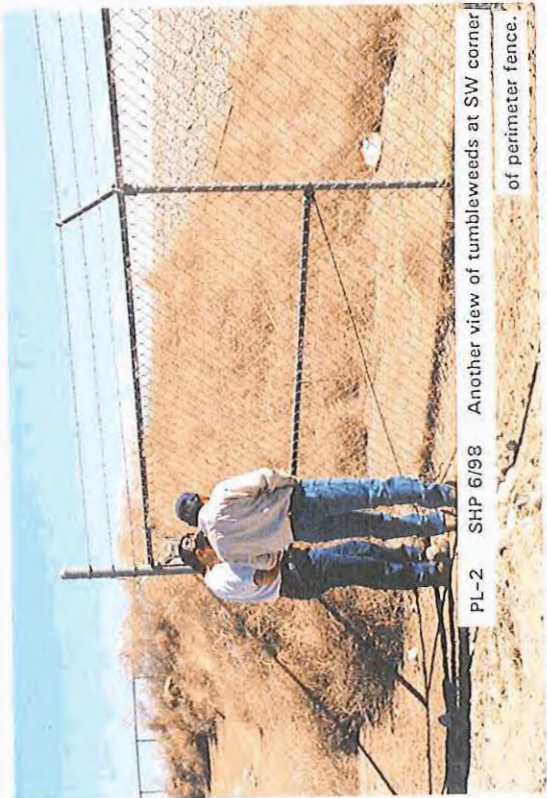
A small to moderate amount of windblown trash is caught in the fence between perimeter signs P1 and P3 and between perimeter signs P19 and P16 (SHP PL-1 through SHP PL-4). Trash will be removed as part of the tumbleweed removal project.

PL-2 SHP 6/98 Another view of tumbleweeds at SW corner of perimeter fence.

In 1996, the security fence along the terrace, north and northeast of the disposal cell, was removed to stop tumbleweeds from accumulating along the fence. Tumbleweeds do, however, continue to accumulate along the fence at other places. At the time of this year's inspection, there were significant tumbleweed accumulations along the west security fence (SHP PL-1, SHP PL-2, and SHP PL-3); in the southeast corner of the fence, near the old entrance gate (SHP PL-4); in the vicinity of perimeter sign P16 (both inside and outside the fence); near entrance sign E3 on the outside of the fence; outside the fence near boundary monument BM-2; and in the vicinity of boundary monument BM-6. The accumulations were so thick at BM-6 that the monument could not be inspected. Tumbleweeds will be removed so that the fence and site surveillance features along the fence can be properly inspected and to improve the appearance of the site.

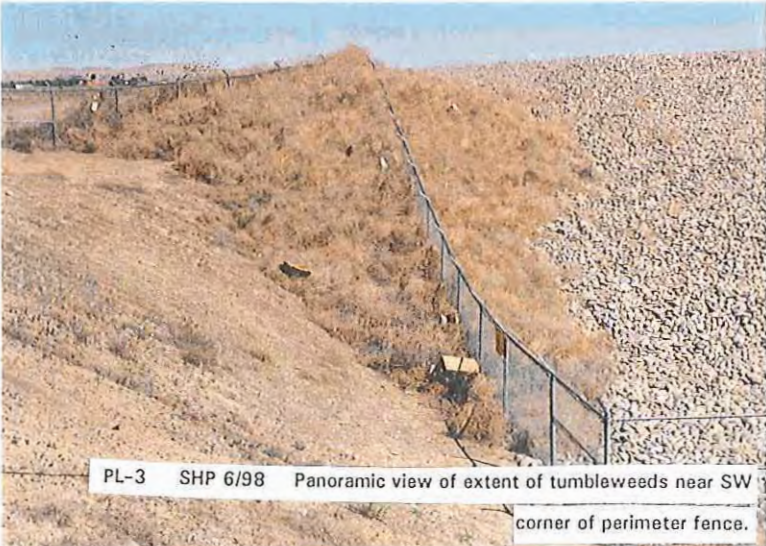
PL-3 SHP 6/98 Panoramic view of extent of tumbleweeds near SW corner of perimeter fence.

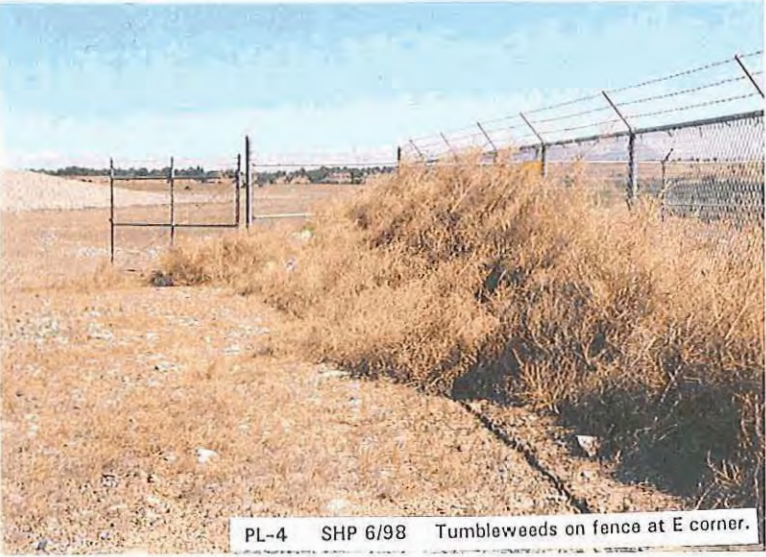
PL-4 SHP 6/98 Tumbleweeds on fence at E corner.

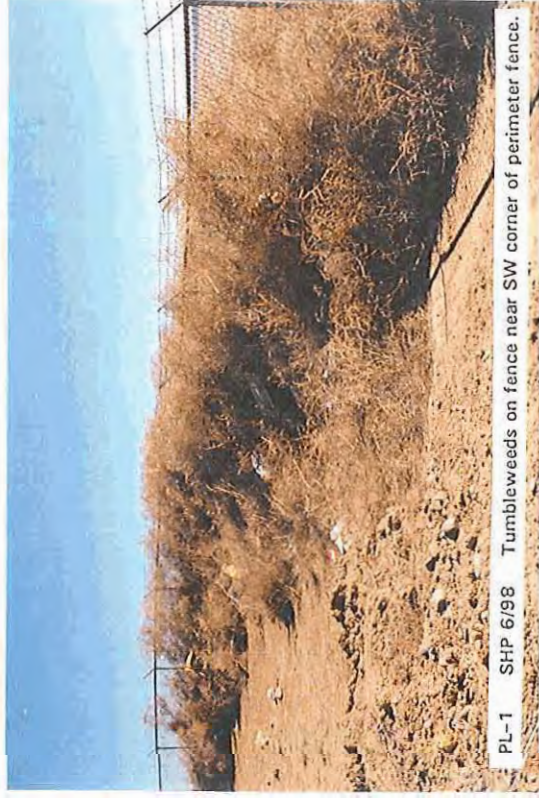
PL-1 SHP 6/98 Tumbleweeds on fence near SW corner of perimeter fence.

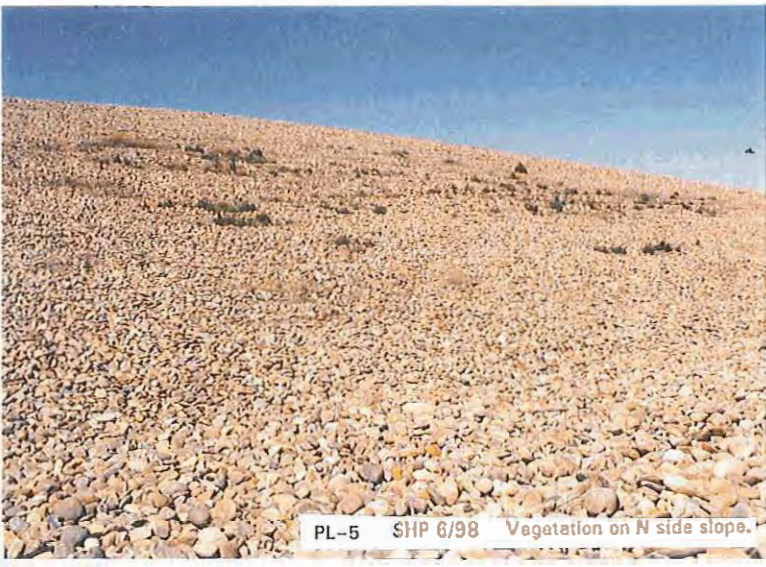
PL-5 SHP 6/98 Vegetation on N side slope.

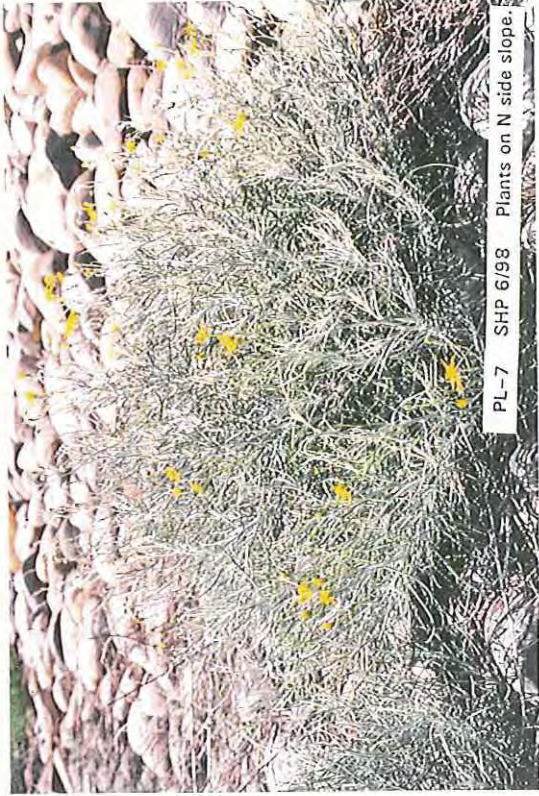
PL-7 SHP 6/98 Plants on N side slope.

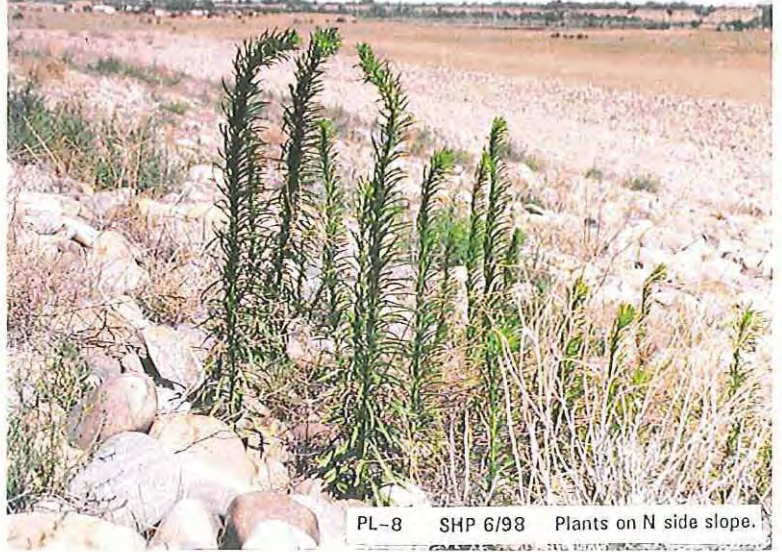
PL-8 SHP 6/98 Plants on N side slope.

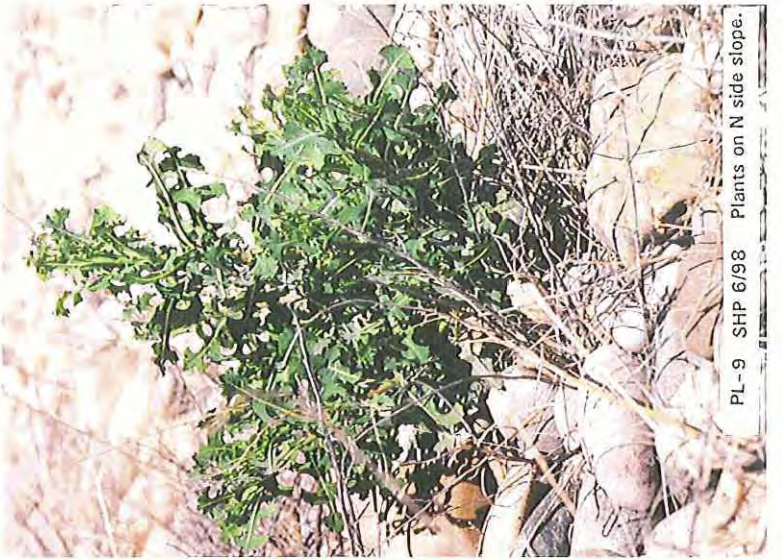
PL-9 SHP 6/98 Plants on N side slope.

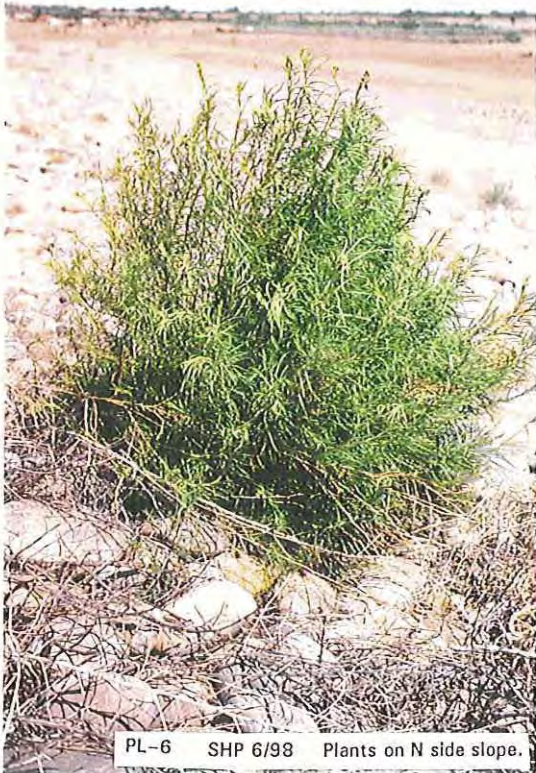
PL-6 SHP 6/98 Plants on N side slope.

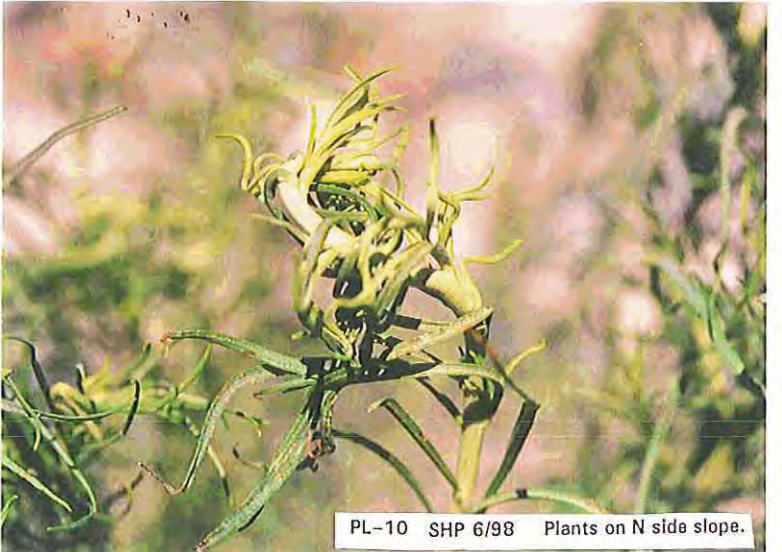
PL-10 SHP 6/98 Plants on N side slope.

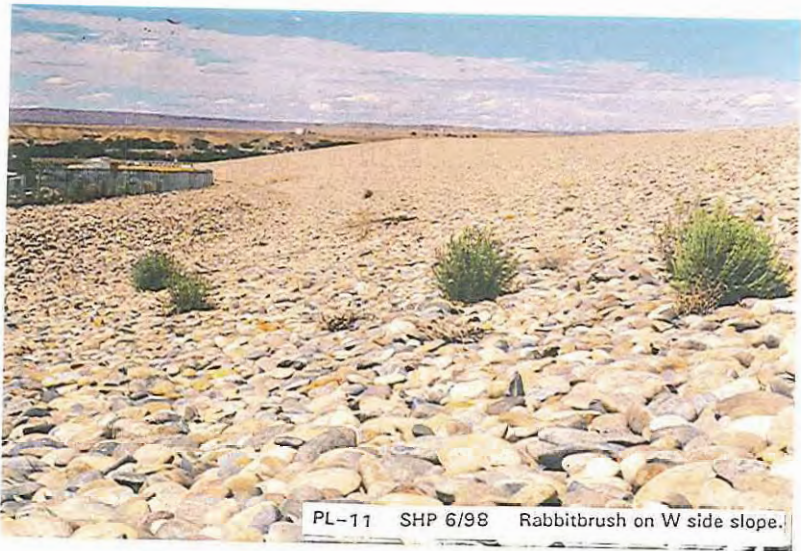
A preemergent herbicide was applied to the ground in November 1997 with some expectation that the preemergent might be effective over more than one growing season. The intention was for the preemergent herbicide to wash off the riprap and impregnate the underlying soil layer. This apparently happened. During this year's inspection only a few small patches of weeds were present. These included kochia, Russian thistle, prickly lettuce, Jim Hill mustard, grey horsebrush, and rabbitbrush (SHP PL-5 through SHP PL-11). Several specimens of rabbitbrush showed injury from the preemergent herbicide, but the plants were still alive (SHP PL-11).

PL-11 SHP 6/98 Rabbitbrush on W side slope.

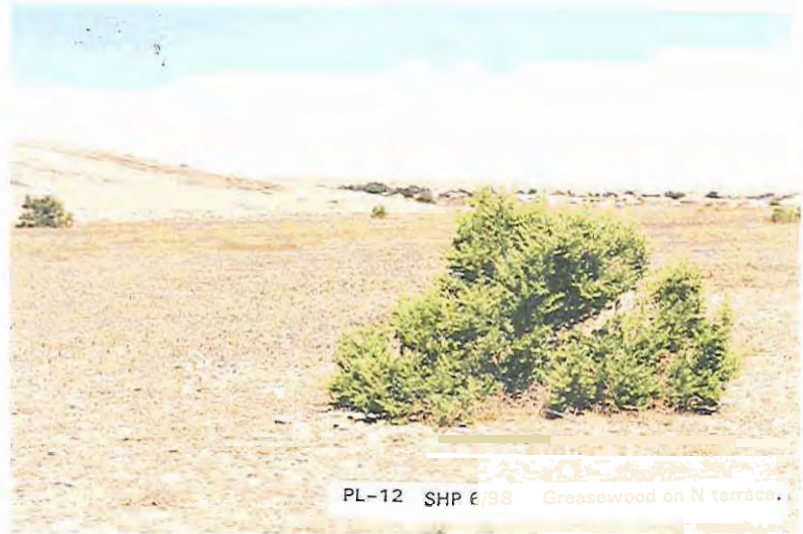
A small stand of greasewood was noted on the northeast terrace near monitor well MW-1 (PL-12). Greasewood is a phreatophyte. Its survival depends upon a supply of water relatively near the surface. It is unlikely that these plants rely on ground water as deep as the floodplain that lies 70 feet (ft) in elevation below the disposal cell.

PL-12 SHP 6/98 Greasewood on N terrace.
