2000 Annual Site Inspection and Monitoring Report for Uranium Mill Tailings Radiation Control Act Title I Disposal Sites

Work Performed Under DOE Contract Number DE-AC13-96GJ87335
Task Order Number MAC 01-06
Document Number S00510

2000 Annual Compliance Report Shiprock, New Mexico, Disposal Site

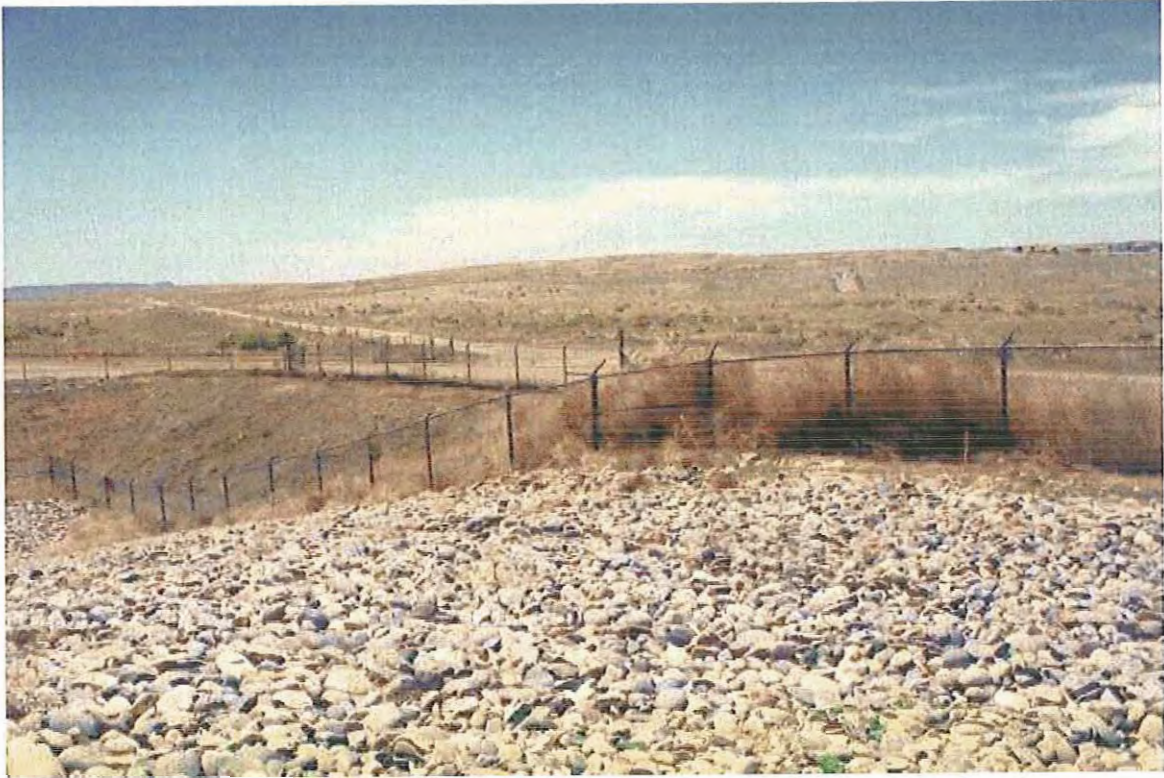
In the past, tumbleweed and trash accumulations along the security fence have warranted removal. Problem areas include the west fenceline and the east corner of the fence near the new entrance gate. Tumbleweeds were removed from these locations in 1999, but tumbleweed accumulation is beginning to build again along the west fenceline near the southwest corner (PL-1). No other accumulation was noted. Removal on an every 2-to-3 year basis is anticipated.

PL-1. Tumbleweed Accumulation Along West Fence Line

No maintenance was required in 2000. Control of tumbleweeds and tamarisk, and removal of tumbleweeds from the fenceline, may be required in 2001.
