# 2001 Annual Site Inspection and Monitoring Report for Uranium Mill Tailings Radiation Control Act Title I Disposal Sites

January 2002

# 2001 Annual Compliance Report Shiprock, New Mexico, Disposal Site

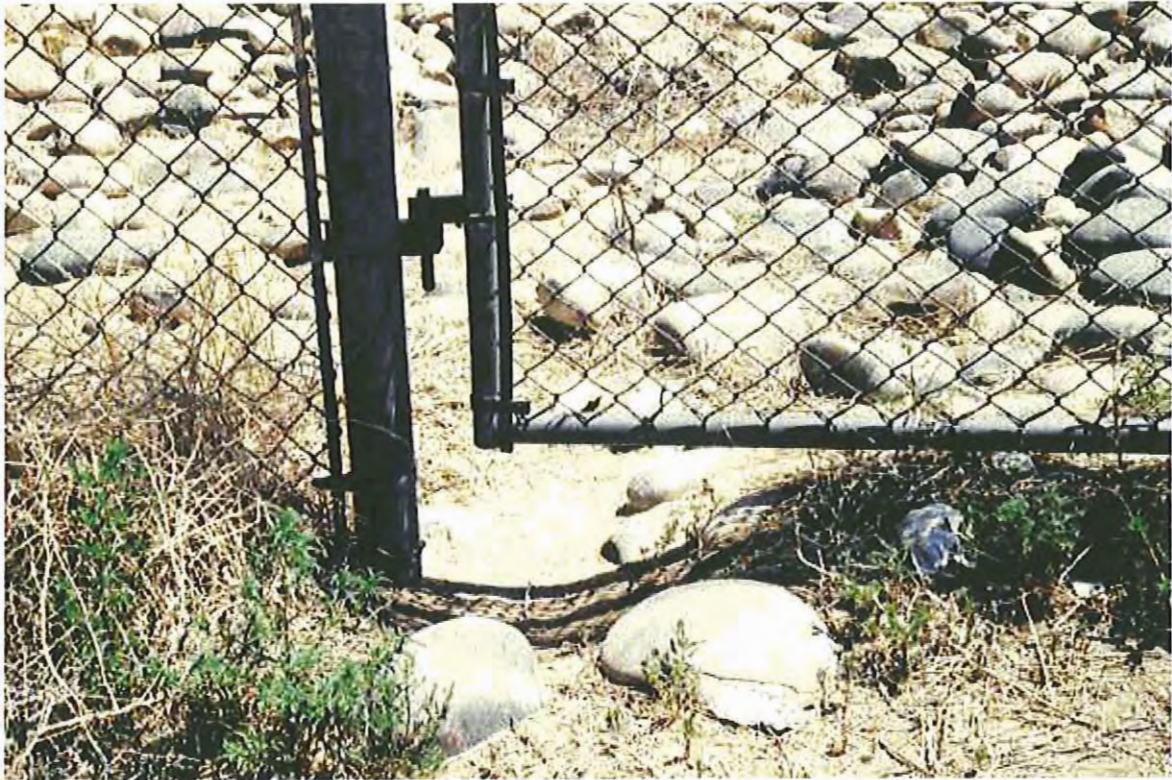
Inspectors noted several locations around the perimeter fence where animals (most likely dogs and coyotes) have crawled beneath the chain link fence fabric or underneath the access gates (PL-1). The openings are sufficiently large to allow access by a small child. Although there is currently no evidence of unauthorized trespass, future inspections should continue to monitor these potential access points for signs of human entry.

*PL-1. Potential Site Entry Point beneath the Access Gate*
