# Annual Performance Report April 2005 Through March 2006 for the Shiprock, New Mexico, Site

July 2006

## Office of Legacy Management

Work Performed by S.M. Stoller Corporation under DOE Contract No. DE-AC01-02GJ79491  
for the U.S. Department of Energy Office of Legacy Management, Grand Junction, Colorado

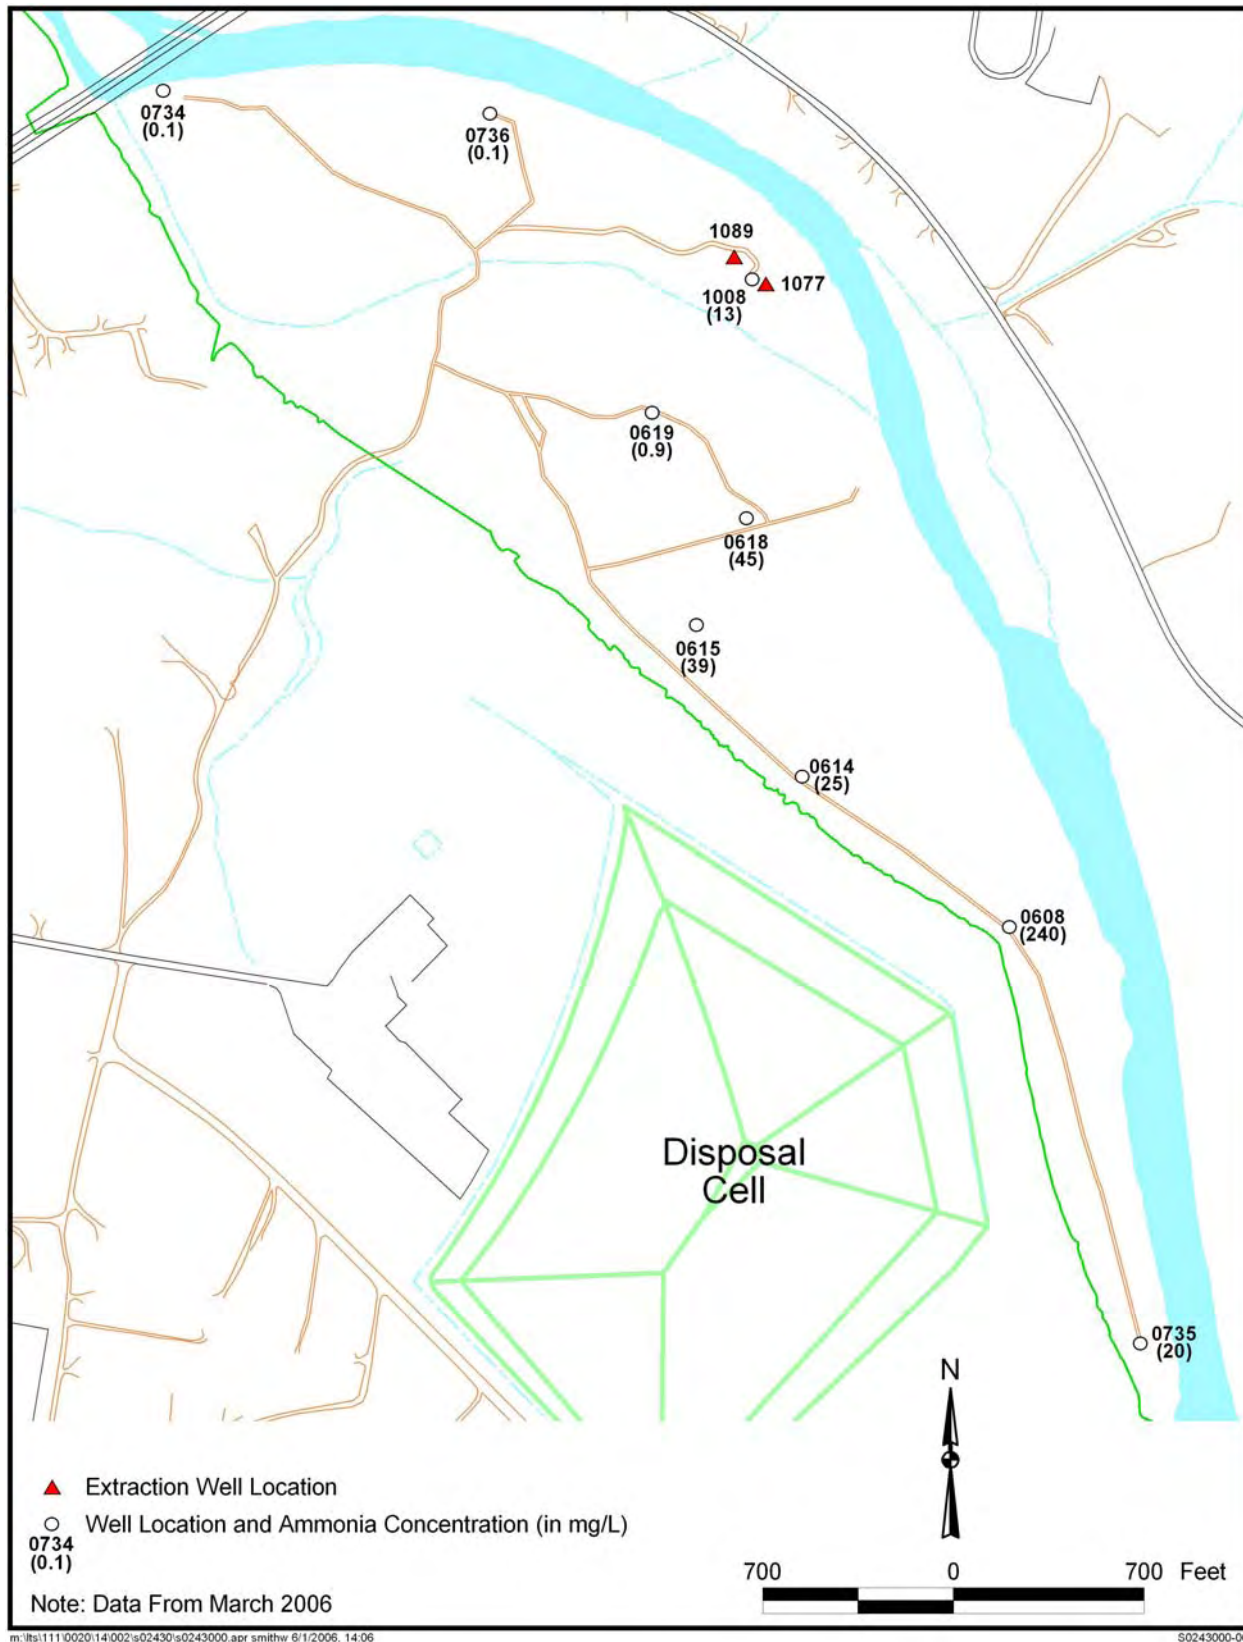
Figure 2-5. Floodplain Ammonia (total as N) Ground Water Concentrations

Ammonium concentrations in ground water have generally decreased over the past 3 years (Figure 2–5). The maximum concentration in monitor well 0608 adjacent to the disposal cell has gone from 420 mg/L to 240 mg/L over the past year; this compares with 303 mg/L in March 2003 (Figure 2–12). Concentrations in all other wells are less than 50 mg/L and generally stable.

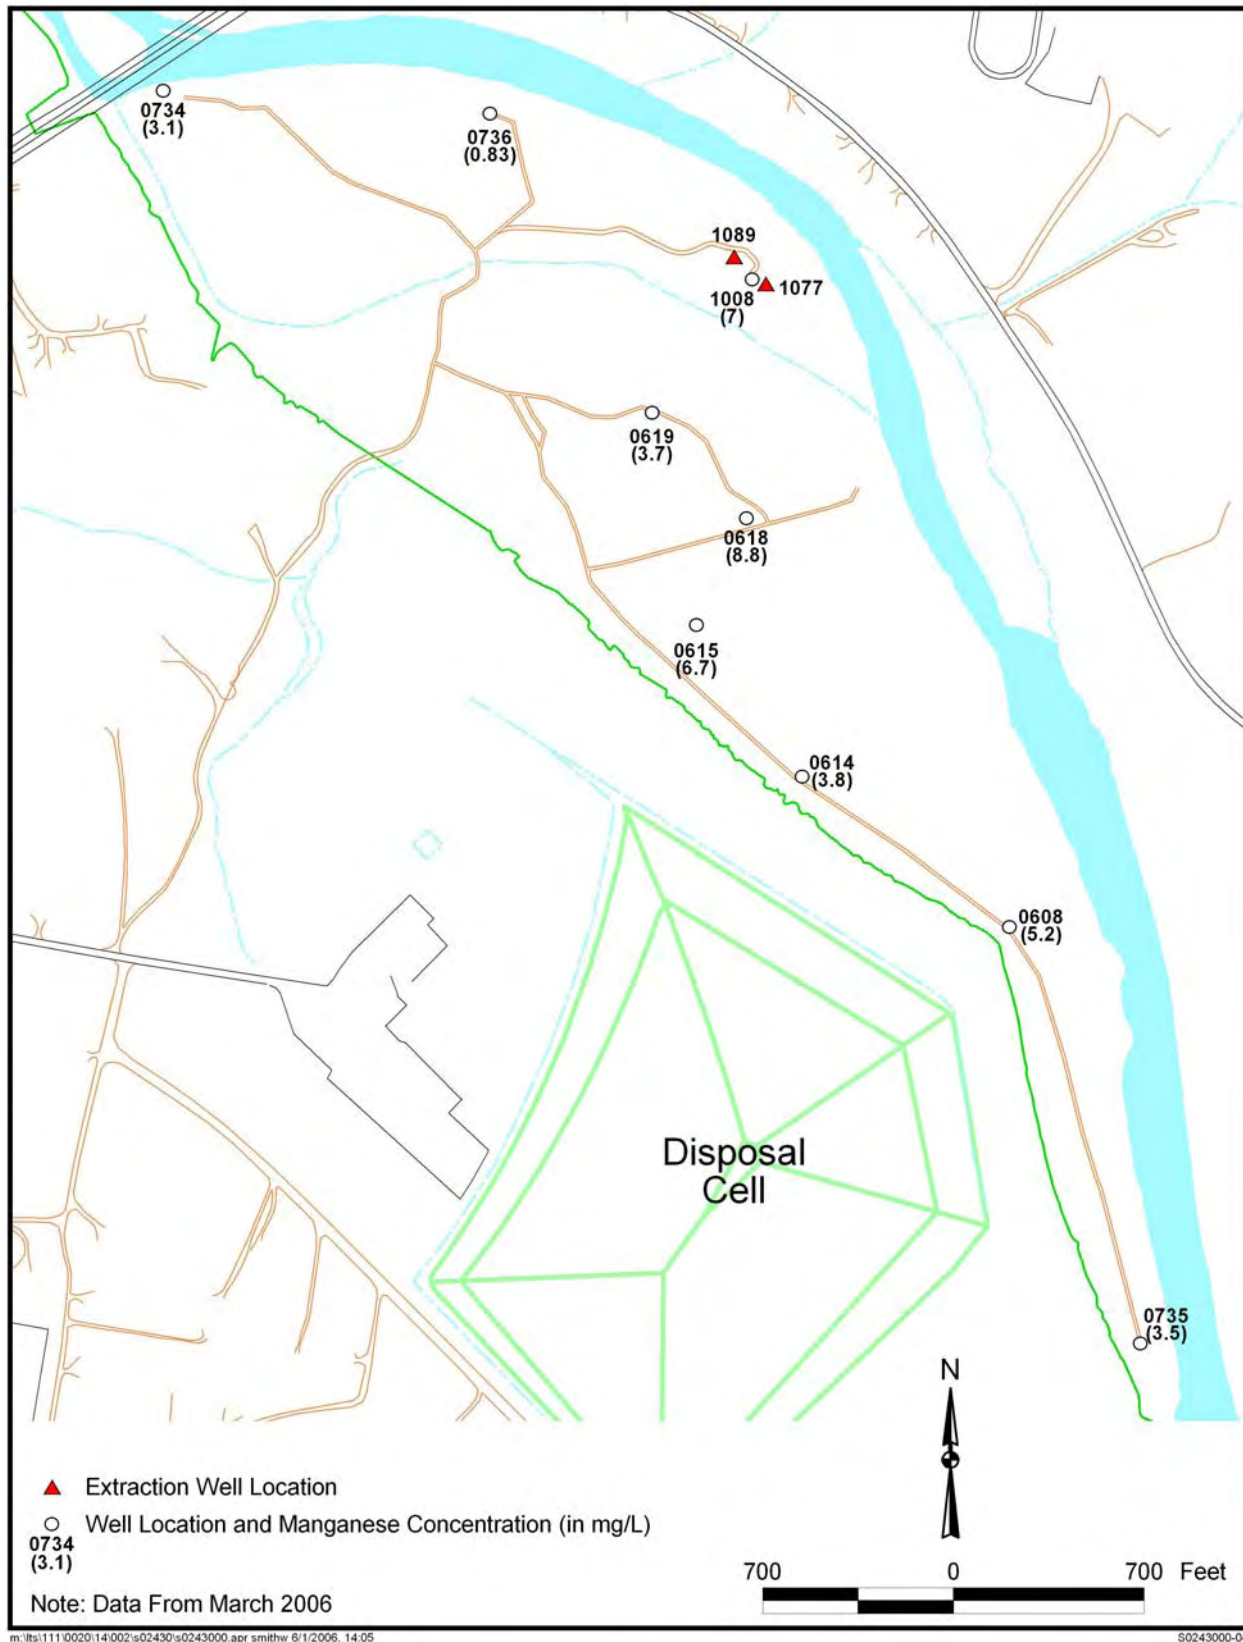
Figure 2-6. Floodplain Manganese Ground Water Concentrations

Concentrations of manganese have been variable over the past 3 years, ranging from 0.83 mg/L to 8.80 mg/L during the March 2006 sampling event (Figure 2–6). There is noticeable but inconsistent variation on a seasonal basis in some of the wells. Over the past 3 years there has been a downward trend in manganese concentrations in ground water in four of the nine wells (Figure 2–13).

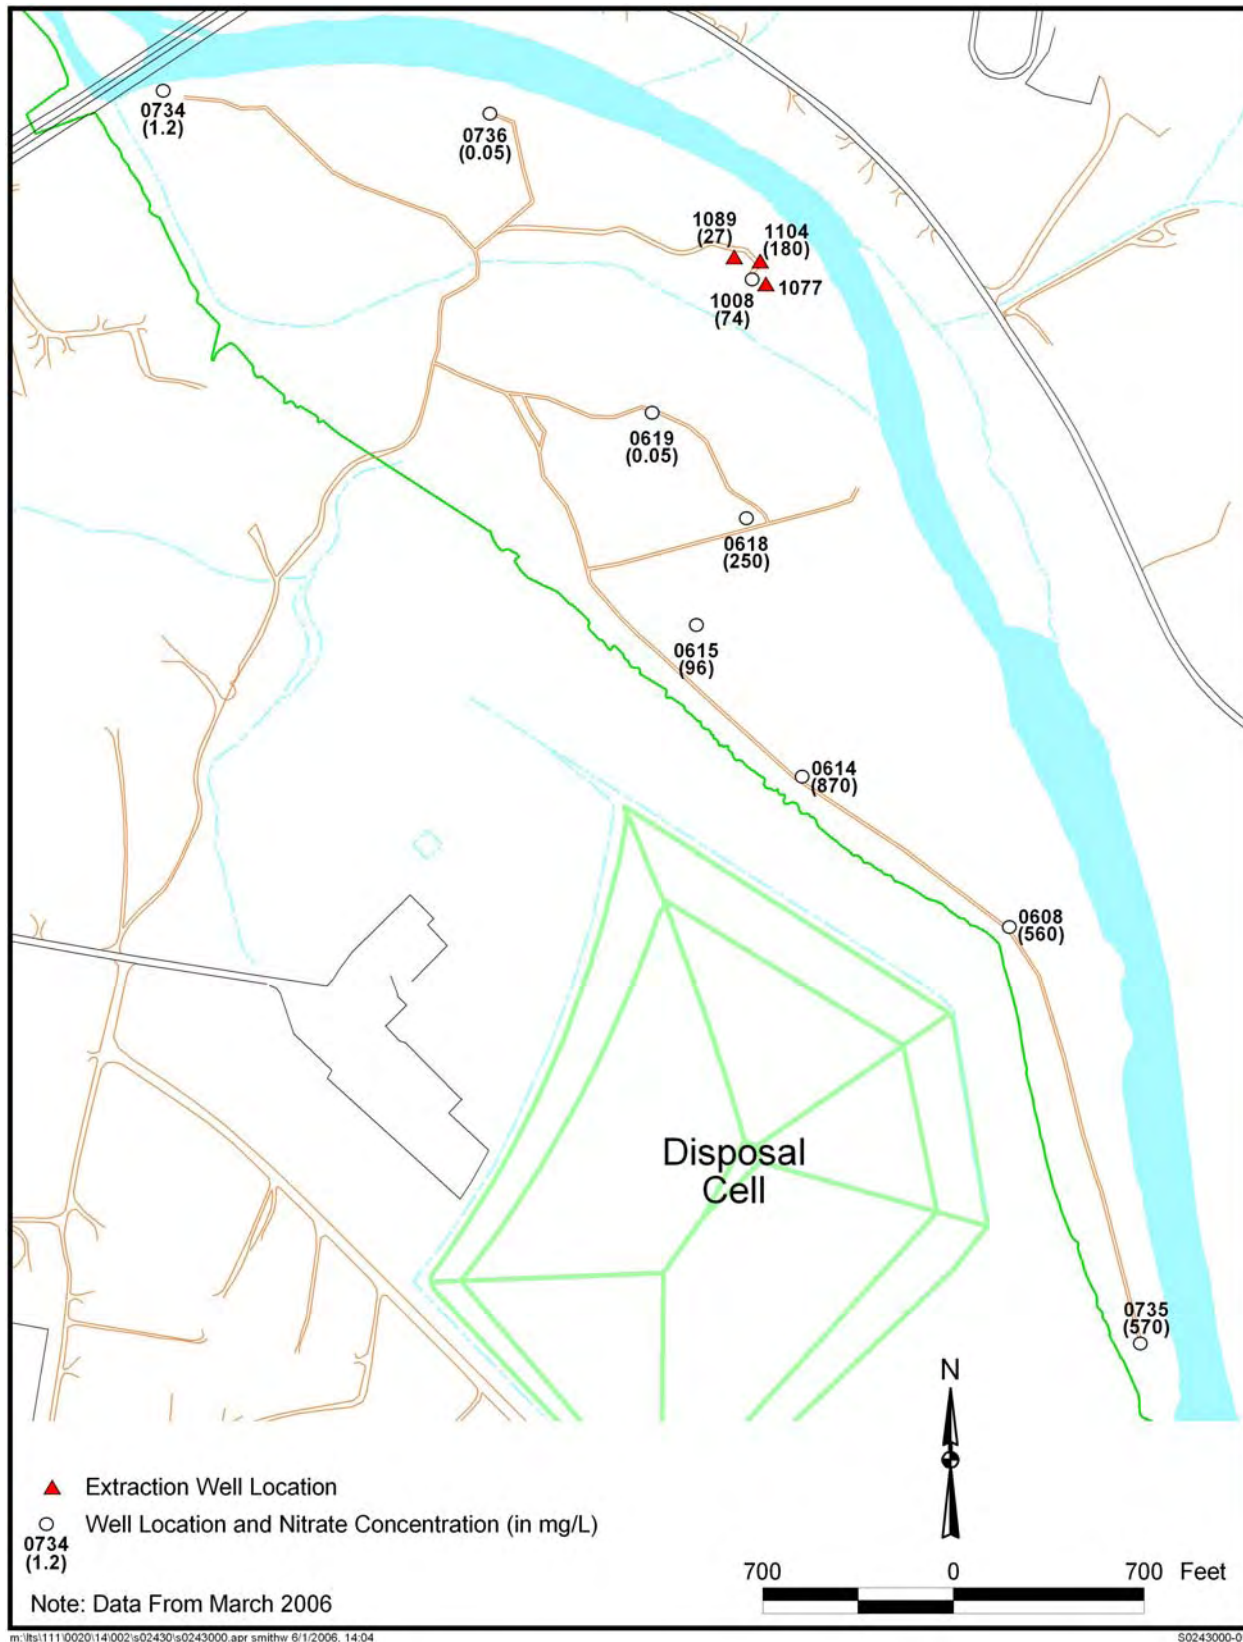
Figure 2-7. Floodplain Nitrate Ground Water Concentrations

Nitrate concentrations in ground water ranged from less than 1 mg/L to 870 mg/L and have increased in four of the nine monitor wells over the past 3 years (Figure 2–7). Again, there has been seasonal variation in some of the wells contrary to the longer-term trends (Figure 2–14).

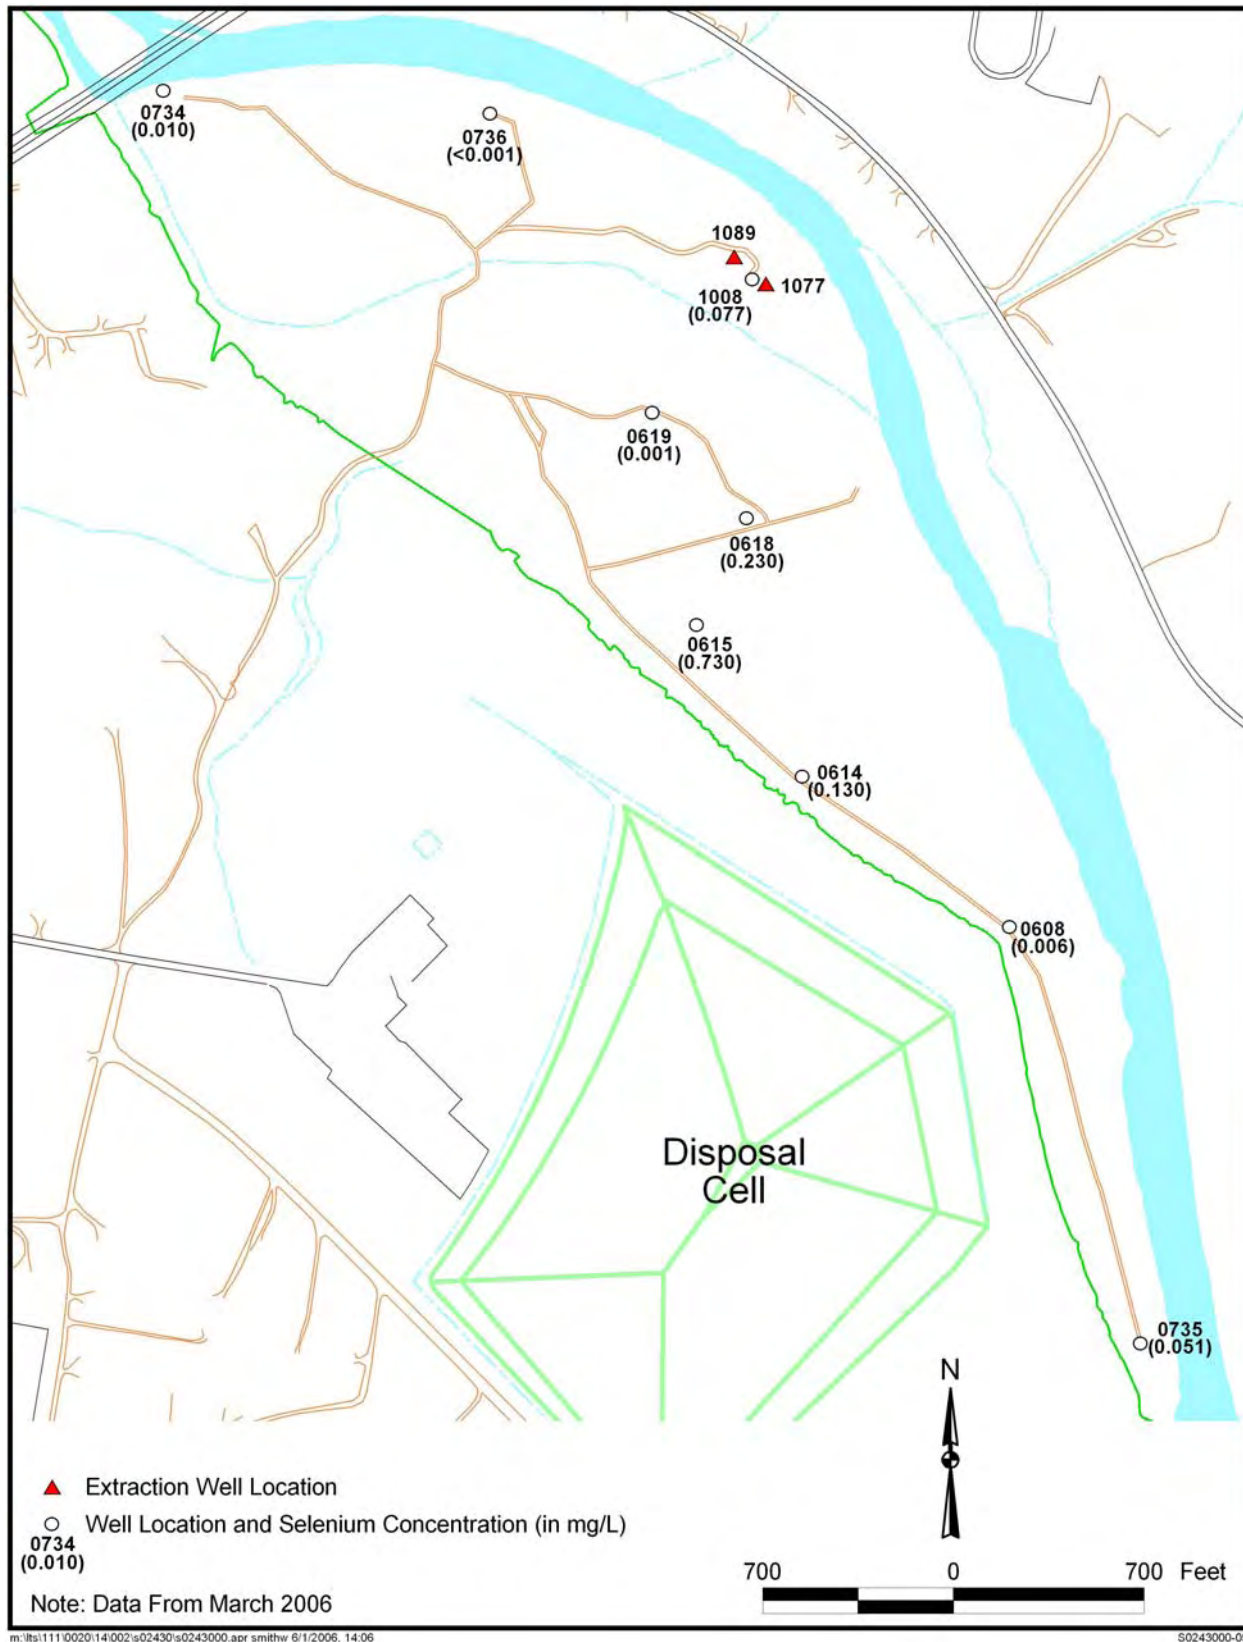
Figure 2-8. Floodplain Selenium Ground Water Concentrations

Concentrations of selenium in ground water have generally been decreasing over the past 3 years (Figure 2-8). The maximum concentration during the March 2006 sampling event was 0.73 mg/L; levels were greater than 0.05 mg/L in five of the nine monitor wells (Figure 2-15).

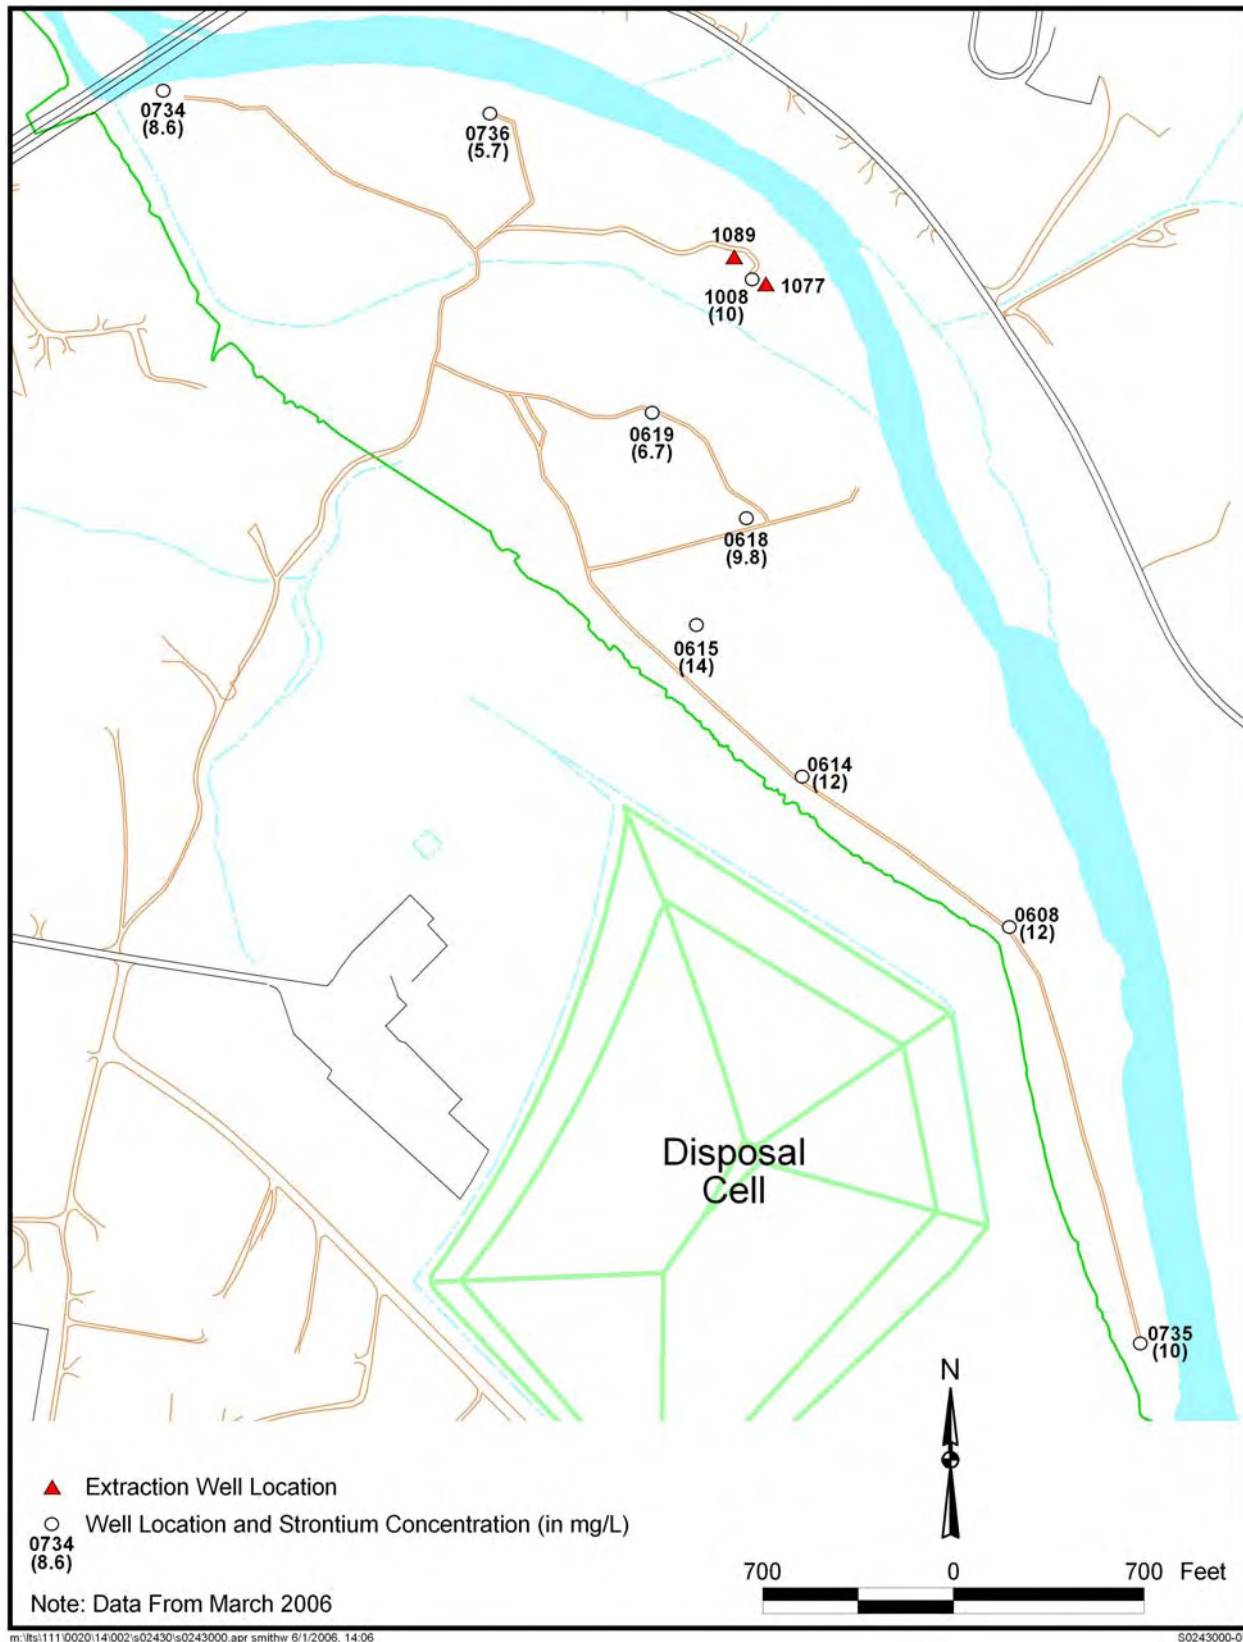
Figure 2-9. Floodplain Strontium Ground Water Concentrations

Concentrations of strontium have generally decreased over the past 3 years (Figure 2-9). Concentrations decreased or were stable in seven of the nine monitor wells and ranged from 5.7 mg/L to 14 mg/L during the March 2006 sampling event (Figure 2-16).

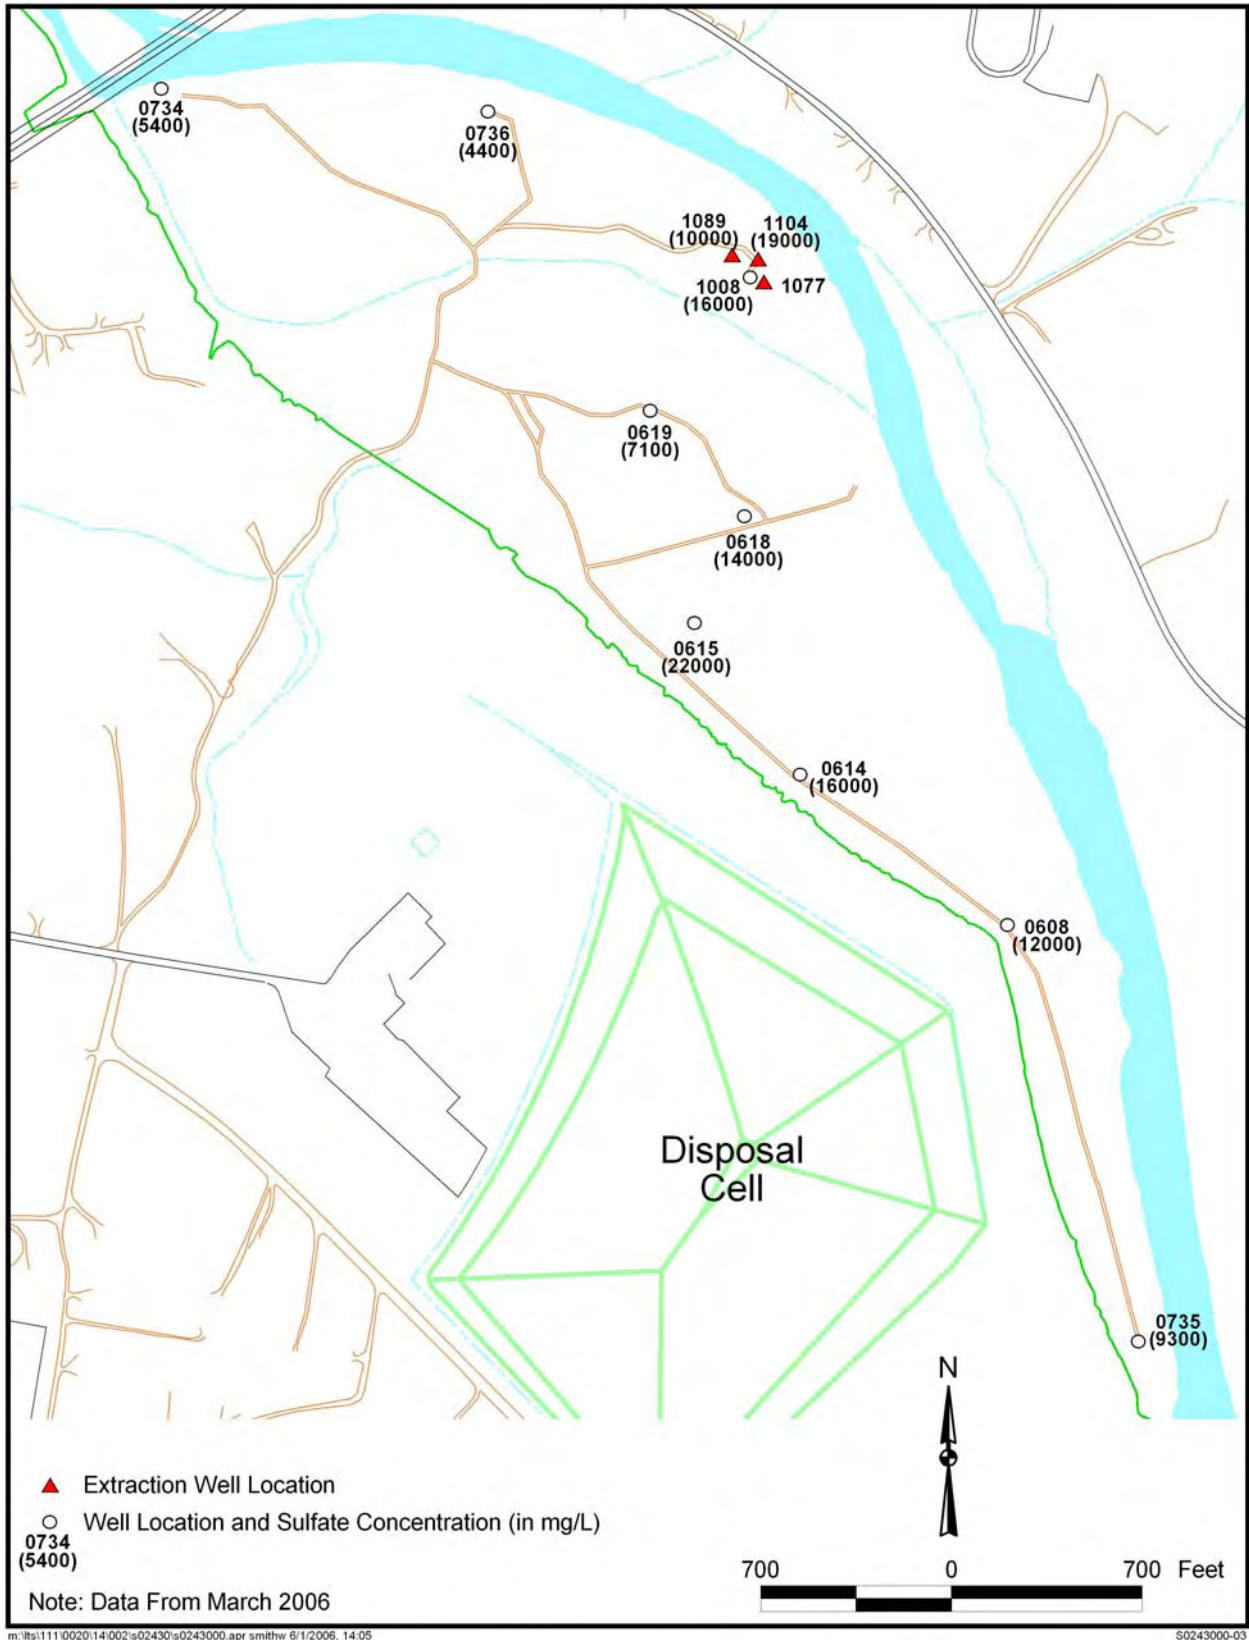
Figure 2-10. Floodplain Sulfate Ground Water Concentrations

Sulfate concentrations in ground water have generally increased over the past 3 years (Figure 2-10). Again, variability is noted in some wells with recent decreases but overall upward trends, which may be the effect of seasonal variation and interaction with surface water from the San Juan River (Figure 2-17).

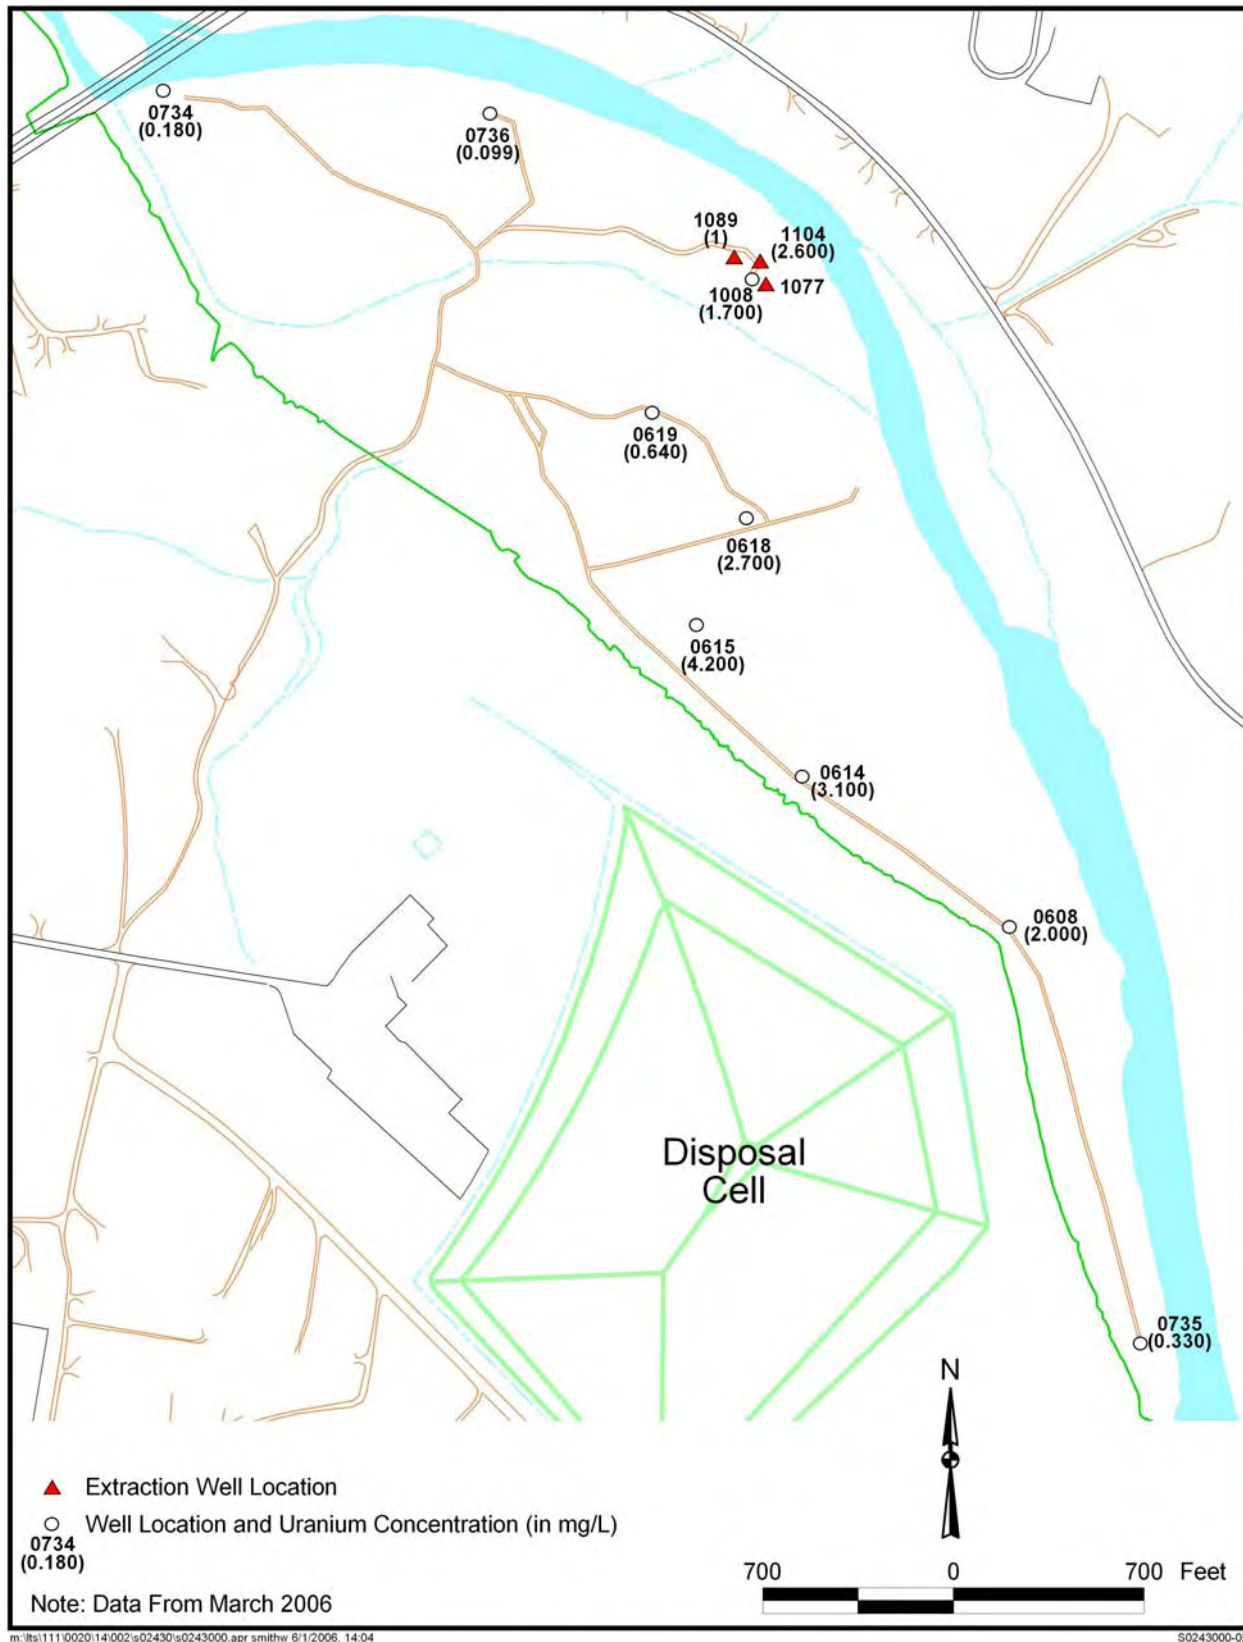
Figure 2-11. Floodplain Uranium Ground Water Concentrations

Uranium concentrations in ground water ranged from 0.099 mg/L to 4.200 mg/L during the March 2006 sampling event (Figure 2-11). Trends over the past 3 years have been variable; concentrations increased in some wells and decreased in others. Again, seasonal variations may be contrary to longer-term trends (Figure 2-18).

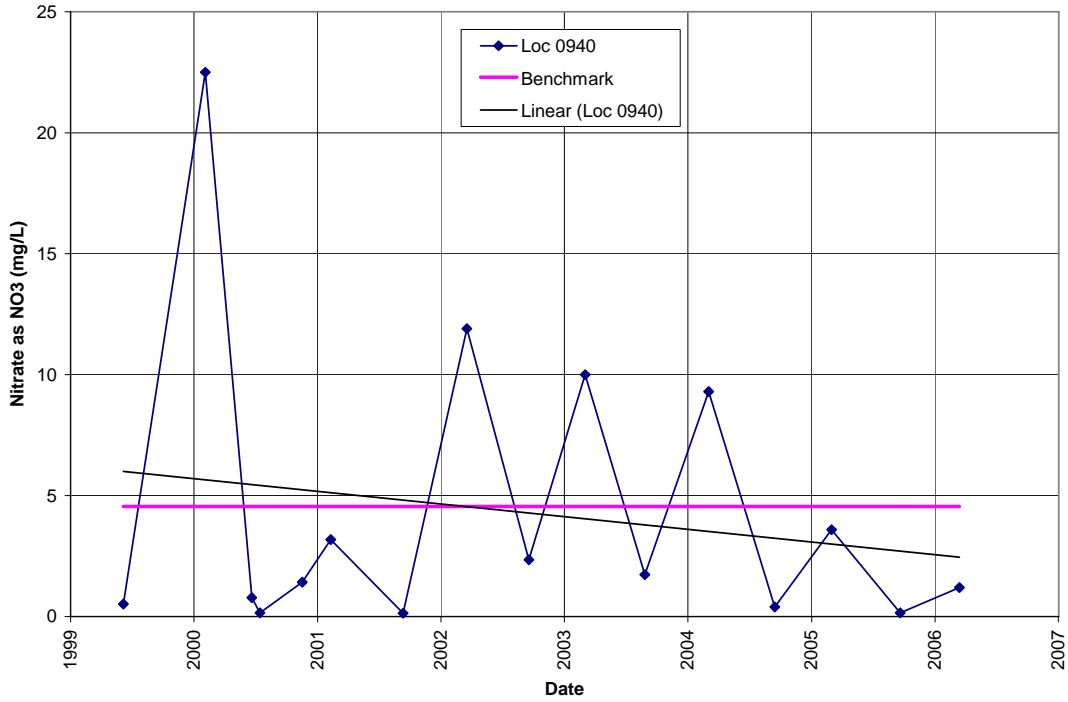
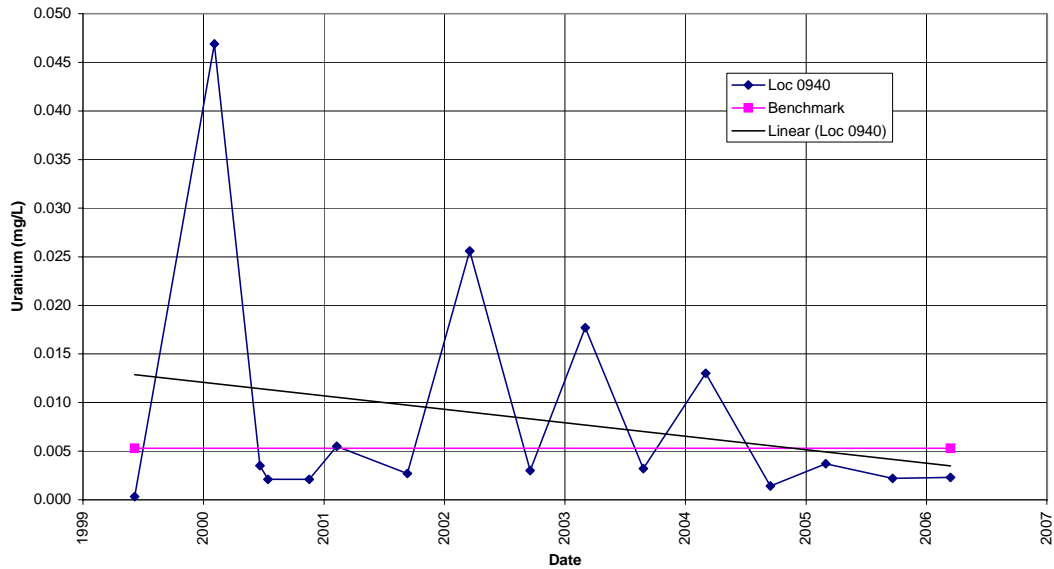
Another indication that pumping of ground water from the floodplain system is having an apparent effect is the fact that concentrations of nitrate (as  $\text{NO}_3$ ) and uranium in surface water in the San Juan River (location 0940) have remained below the upgradient background benchmark values (statistically derived), even during low flow periods, since 2004 (Figure 2-19 and Figure 2-20).

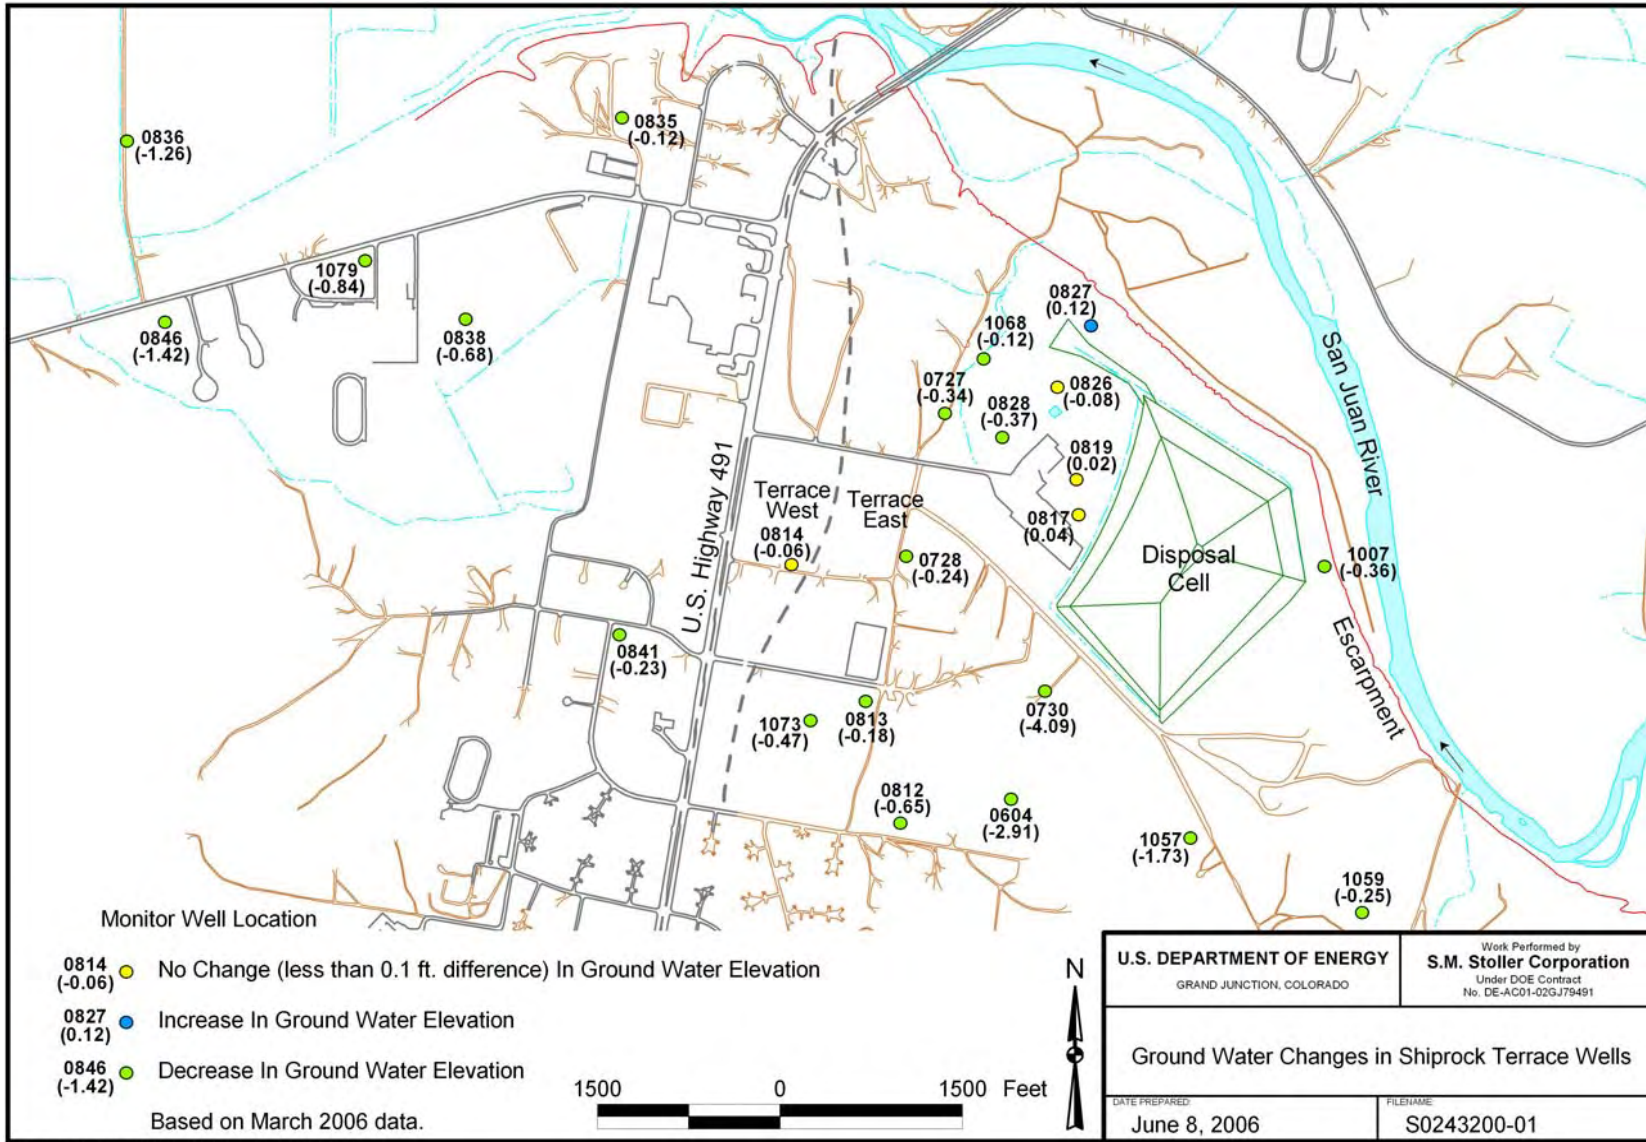
Figure 2-21. Terrace Ground Water Elevation Changes from Baseline to Current Conditions

Ground water level data from the terrace collected during the March 2006 sampling event were compared to baseline ground water elevations presented in the Baseline Performance Report (DOE 2003). Figure 2–21 presents a qualitative map view of some of the ground water elevation increases and decreases. Ground water elevations appear to be declining slightly across the entire terrace ground water system. Of the 23 measurements of ground water levels taken in March 2006, 18 results showed declines relative to the baseline period of March 2003, and only one well showed a very minimal increase. The greatest ground water level decrease was 4.09 ft at well 0730. This well is just southeast of the evaporation pond. The maximum increase in water level elevation (0.12 ft) occurred in well 0827, which is just west of the disposal cell.

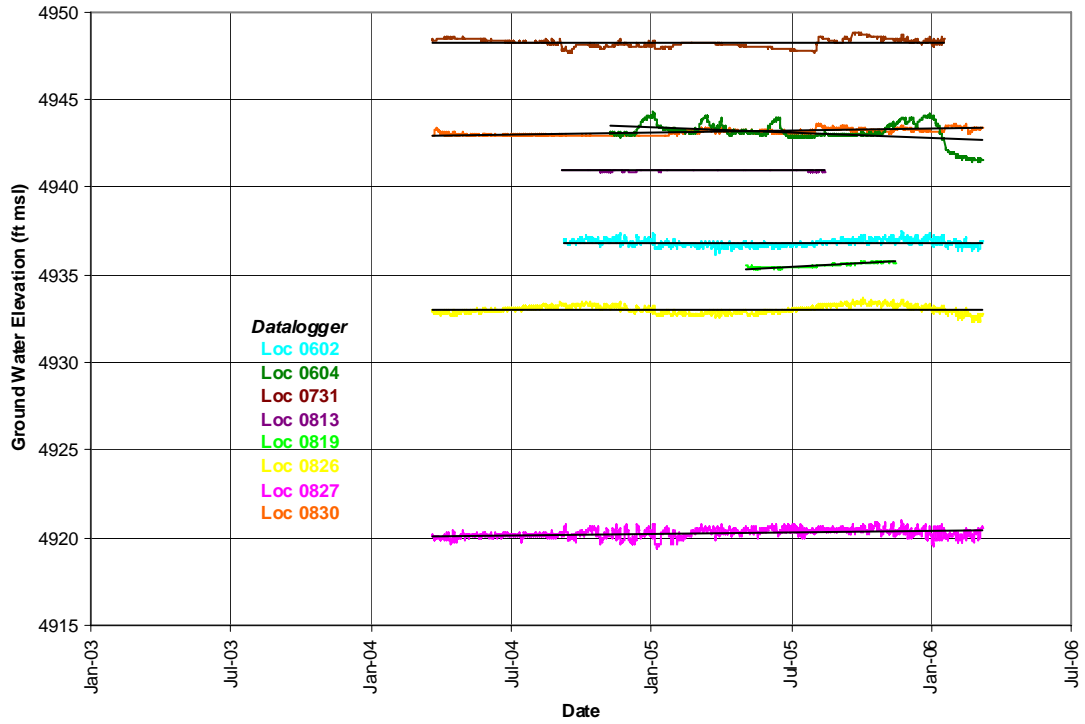
Figure 2-22. Terrace East Datalogger Ground Water Elevations

Water levels have also been monitored using pressure transducers that were installed in selected wells on the terrace prior to treatment system startup. Plots of ground water elevation data collected from pressure transducers connected to dataloggers in terrace east wells 0602, 0604, 0731, 0813, 0819, 0826, 0827, and 0830 are shown on Figure 2–22. With the exception of wells 0813 and 0819, water level changes in these wells are not presented on Figure 2–21; consequently, the plots provide additional means to evaluate trends in the terrace east ground water flow system. The datalogger in well 0604 indicates how the pumping at well 0818 apparently affected neighboring ground water elevations during 2005 and 2006. The average pumping rate for this well for the period was 0.69 gpm, with a notable increase during the last 3 months. Also, initiation of pumping of extraction wells 1095 and 1096 in January 2006, with an average pumping rate of approximately 1.36 gpm, is noted by the decrease in water level measured in well 0604 by approximately 2.5 ft. The decline in water levels at the remaining terrace east locations has been less impressive, perhaps as a consequence of higher-than-normal precipitation during this performance period. Continuous water level monitoring records for terrace east wells 0731, 0813, and 0826 show that water levels in these wells remained about the same as those published in the previous performance report (DOE 2005). It is possible that the overall extraction volume from terrace east needs to increase before the effects of pumping become discernible at the remaining wells.

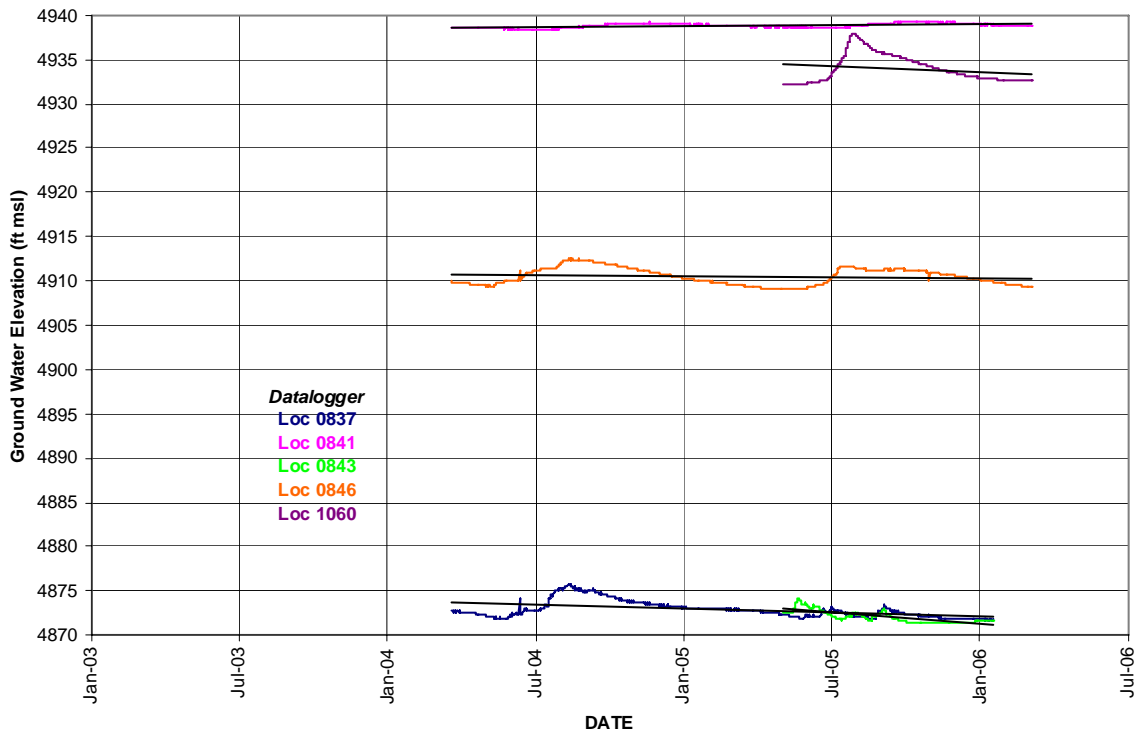
Figure 2-23. Terrace West Datalogger Ground Water Elevations

Plots of ground water elevation data collected by dataloggers in terrace west wells 0837, 0841, 0843, 0846, and 1060 are shown on Figure 2–23. The graphs of wells 0837, 0843, 0846, and 1060 indicate that ground water elevations are influenced by irrigation practices in the terrace west area. Evidence of irrigation is absent in well 0841 because it is approximately 1,200 ft upgradient of the Helium Lateral Canal (Figure 2–1). Therefore, information from these dataloggers does not appear to be relevant to assessing performance of the remediation system at the Shiprock site.

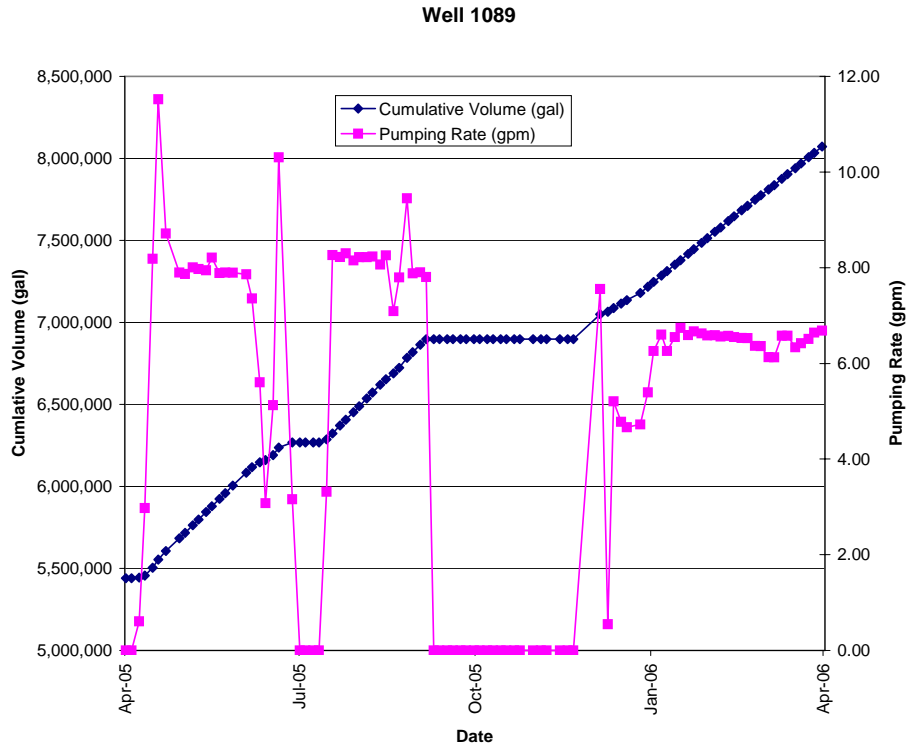
Figure 3–1. Well 1089 Pumping Rate and Cumulative Ground Water Volume Extracted

Figure 3–1 presents measured pumping rates and the cumulative volume of extracted ground water at well 1089 from April 2005 to March 2006. Elevated pumping rates during early spring 2005 are attributed to the higher river stage of the San Juan River at that time. The higher river stage during the spring produces an increased saturated thickness and, consequently, more available drawdown in the pumping well. By the end of March 2006, well 1089 had removed just over 8,000,000 gallons of water from the floodplain ground water system since the start of operations in March 2003. Approximately 2,600,000 gallons of water were removed during this performance period at an average pumping rate of 4.68 gpm.

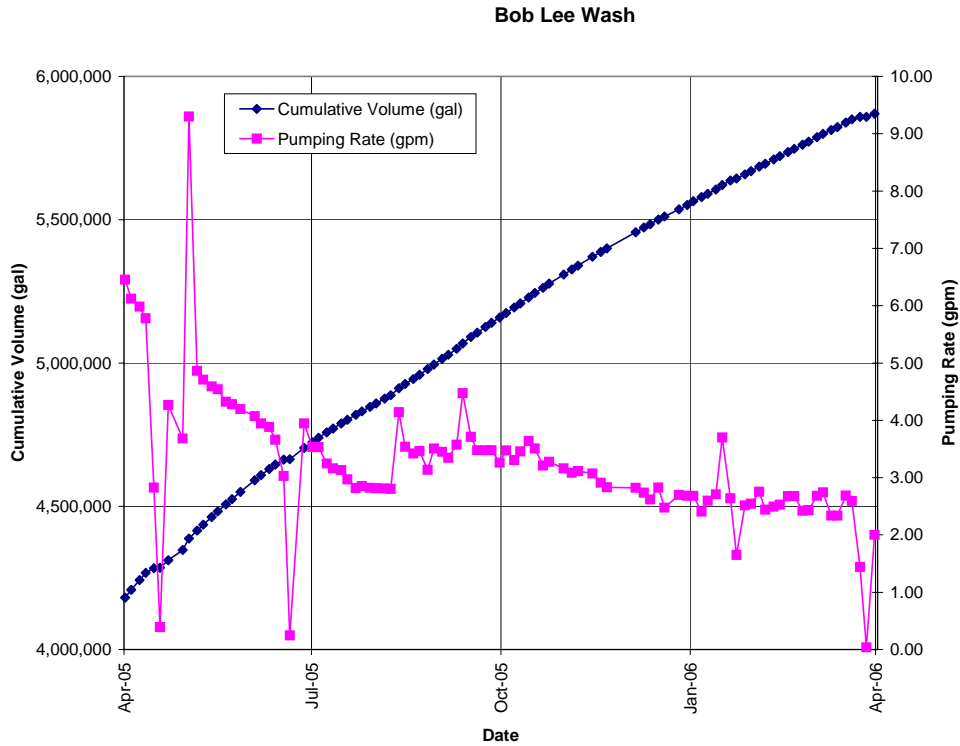
Figure 3–13. Bob Lee Wash Pumping Rate and Cumulative Ground Water Volume Extracted

Extraction rates and cumulative flow volumes for the pump installed in the Bob Lee Wash (location 1087) drain are presented in Figure 3–13. During the current performance period, the average pumping rate from Bob Lee Wash was 3.34 gpm, and approximately 1,690,000 gallons of water were removed by the ground water interceptor drain.
