16.0 Shiprock, New Mexico, Disposal Site

16.1 Compliance Summary

The Shiprock, New Mexico, Uranium Mill Tailings Radiation Control Act (UMTRCA) Title I Disposal Site was inspected on May 29, 2008. The disposal cell and all associated surface water diversion and drainage structures remained in good condition and were functioning as designed. Erosion along the southwest bank of the outflow channel was repaired and in good condition. Scattered deep-rooted shrubs on the top and side slopes of the cell, along with tamarisk in the outflow channel, were treated with herbicide. Halogeton, a noxious weed present on the terrace and along site access roads, was also treated. Tumbleweeds and trash continue to accumulate along the perimeter fence and in the outflow channel area; these accumulations were removed in 2008.

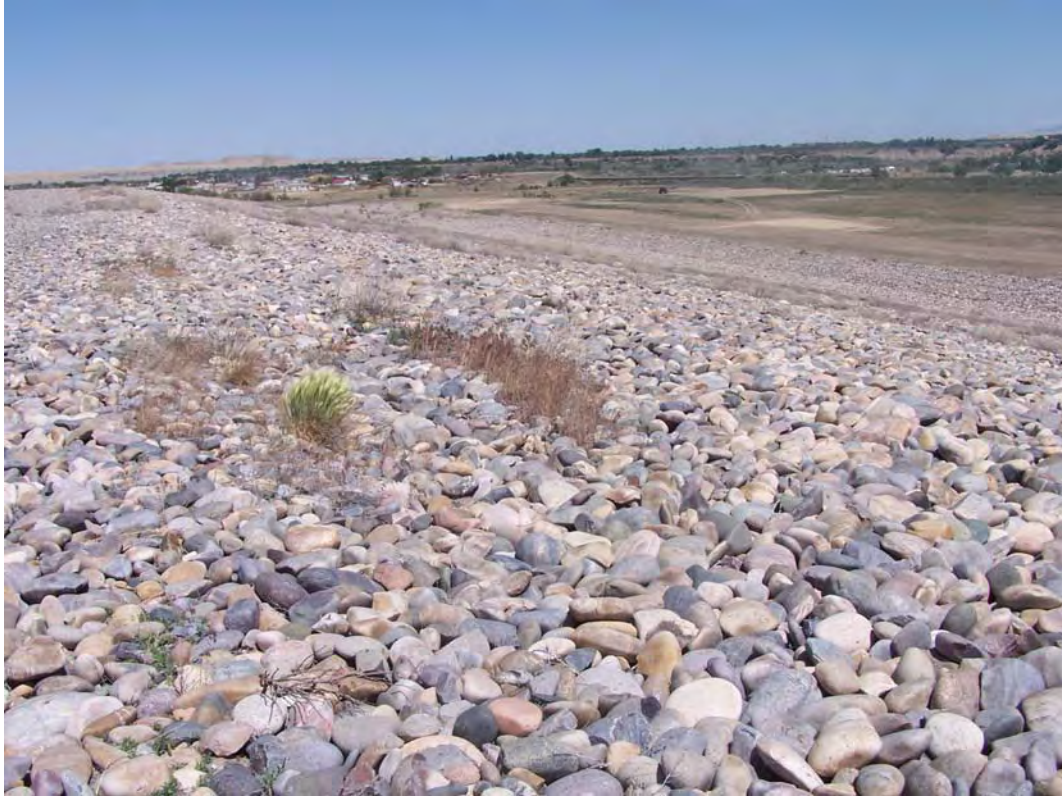
16C DOE is continuing to study the effects of plant encroachment on the disposal cell to evaluate the need for ongoing vegetation control. Saturated hydraulic conductivity measurements continue to be collected at five locations on the cell to evaluate cover performance. Shallow pits exposing the freeze-protection layer at these five locations have been left uncovered for additional measurements and do not affect the performance of the cell cover. These research pits, along

with nearby depressions caused by vehicle access to the research area, are filling with vegetation (PL-1). These areas will continue to be monitored to ensure that cover performance is not affected.

SHP 5/08. PL-1. Depressions in cell side slope rock cover that contain vegetation.

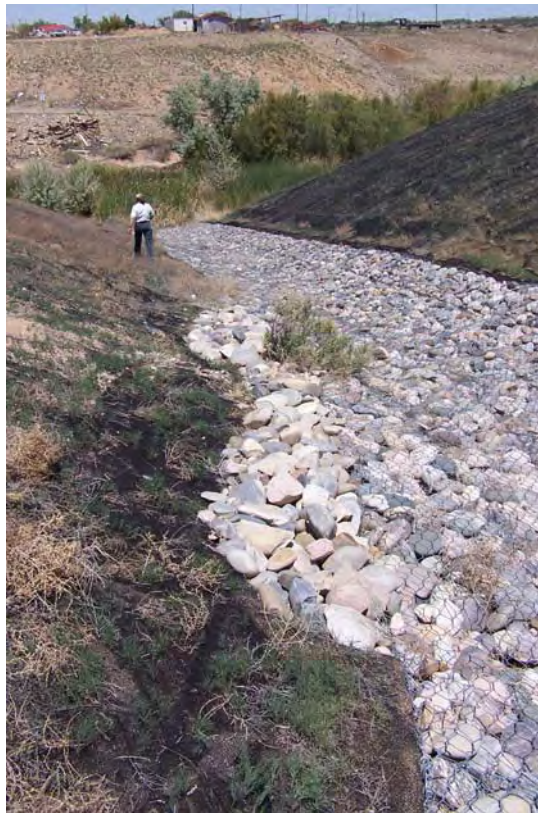
16D Site drainage is ultimately directed toward the outflow channel at the northwest corner of the site. The outflow channel was reconstructed in 2003 to repair damage caused by severe storms in 2001 and 2002, and an energy dissipation basin was constructed immediately above Bob Lee Wash. An erosion area along the southwest bank of the off-site portion of the outflow channel was repaired and in good condition (PL-2). The lower, steeper portion of the outflow channel and the energy dissipation structure remained in excellent condition. Rock cover in the outflow channel was also in good condition.

SHP 5/08. PL-2. Repaired area of outflow channel.

In 2008, several gaps found at the base of the perimeter fence were filled with rock, erosion along the southwest bank of the off-site portion of the outflow channel was repaired, deep-rooted plants on the cell top were controlled, and noxious and undesirable plants were treated with herbicide. No other maintenance or repairs occurred at the site in 2008.

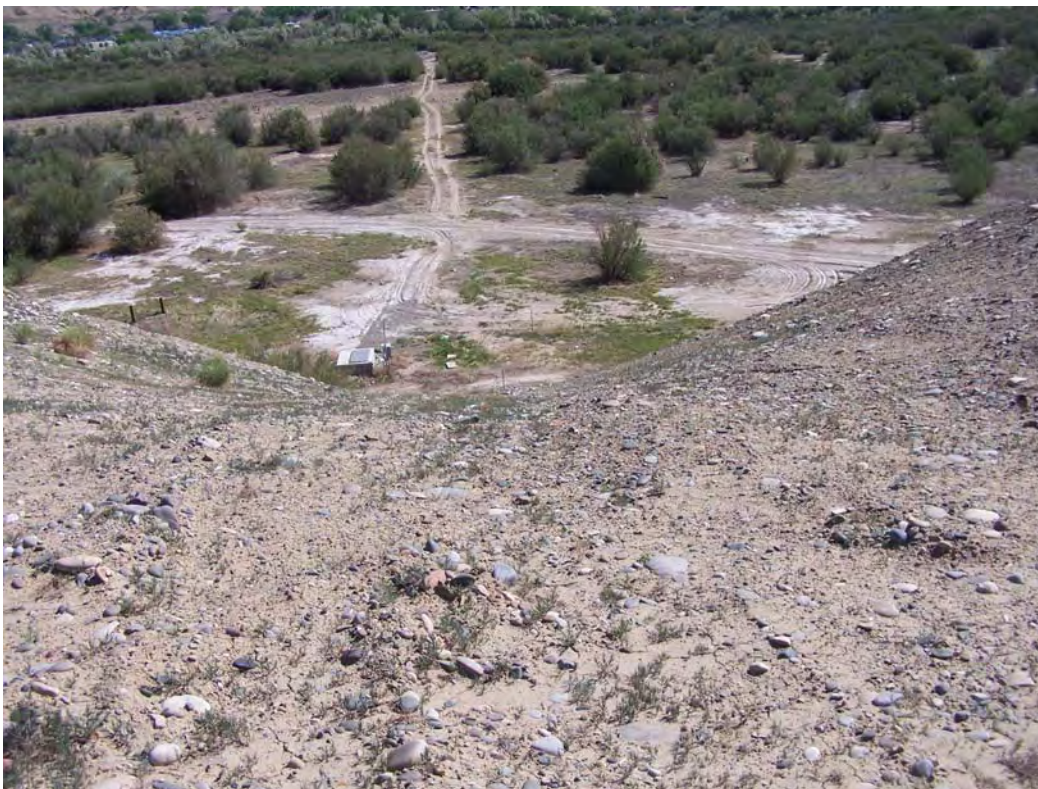
Terrace Area and Site Perimeter—The terrace area is north and east of the disposal cell between the cell and the escarpment. The escarpment, more than 300 feet from the eastern edge of the disposal cell, is prone to slumping. Four sets of erosion control markers are placed along the terrace escarpment. Fractures and incipient slumps commonly occur in the Mancos Shale bedrock along the escarpment northwest of erosion control marker ECM-1A. The erosional “pillar” that had separated from the edge of the escarpment, located near survey monument SM-1 and documented previously, showed no new movement in 2008. Erosion in this area continued to remain unchanged (PL-3). Inspectors will continue to monitor the stability of the escarpment.

SHP 5/08. PL-3. View from top of escarpment of erosion area below berm near SM-1; no new erosion is evident.

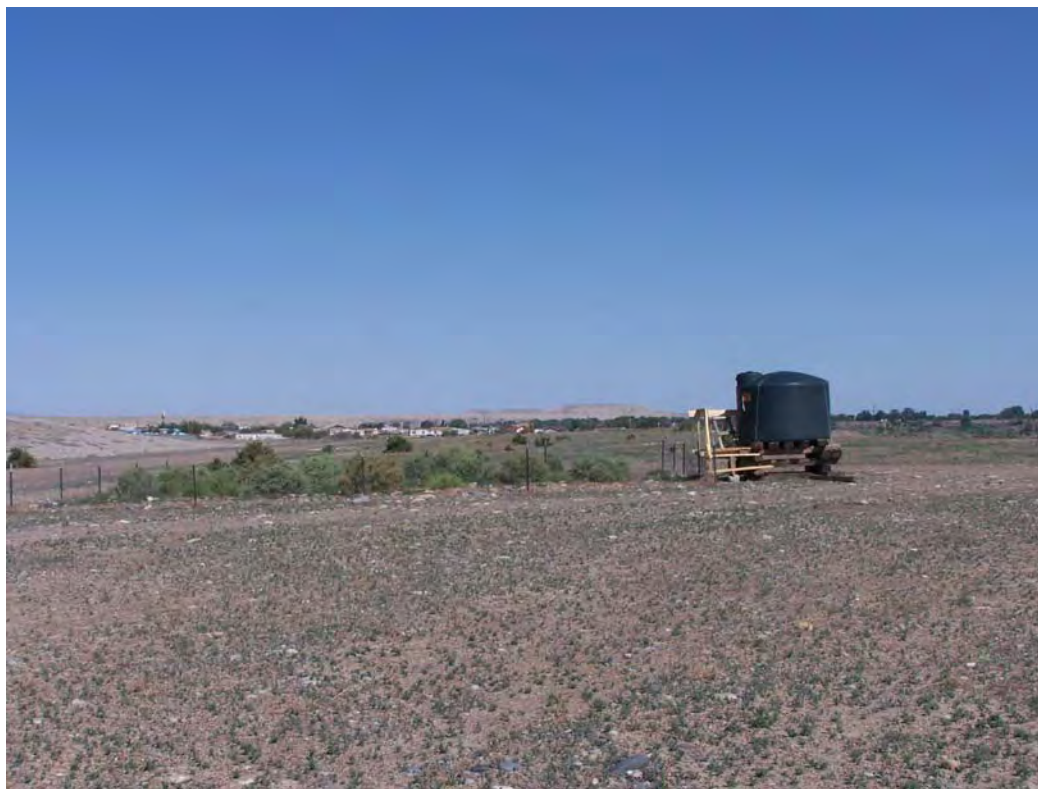
16G Two phytoremediation test plots—the northern and the southern (PL-4) test plots—have been maintained on the northeast side of the terrace since 2006. The purpose of the testing is to demonstrate the effectiveness of using phreatophytes for removing former processing-site legacy groundwater contamination from the terrace. The experiments are projected to continue for another 1 to 3 years.

SHP 5/08. PL-4. Southern phytoremediation test plot.
