| Tab Number | Document Name and Date | Document Type | Author | Recipient | Description |
|---|--|---|---|---|--|
| 1 | Investigation of Mold and Moisture at the FAA Detroit Metropolitan ATCT Facility | Report | OST | FAA | This investigation was performed to determine if mold and moisture issues still affected the DTW ATCT as was alleged by some employees. It determined that fungal growth and water intrusion still affected the building. The report contained a recommendation to perform water damage assessments at other Leo Daly ATCTs. |

**INVESTIGATION OF MOLD AND MOISTURE AT THE
FEDERAL AVIATION ADMINISTRATION
DETROIT METROPOLITAN AIR TRAFFIC CONTROL TOWER FACILITY**

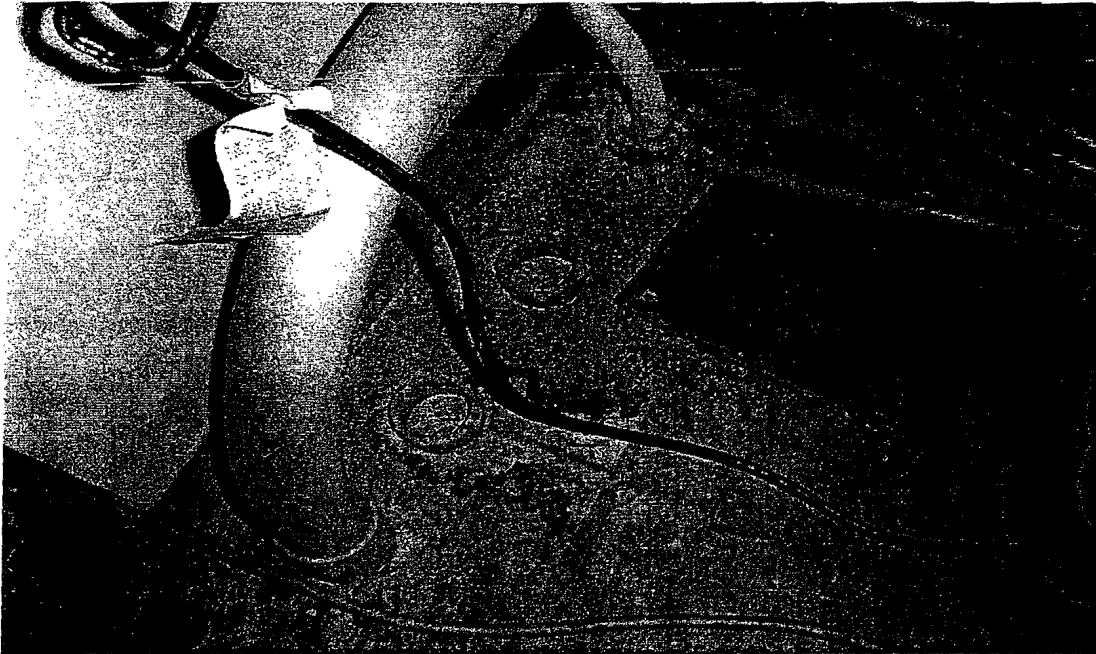
Photo 3: ASDE Penthouse, East Wall, South of Door.

The white residue shown on the floor of the ASDE Penthouse appears to be caused by condensation on the insulated metal panel and uninsulated steel beam and sections of roof deck.

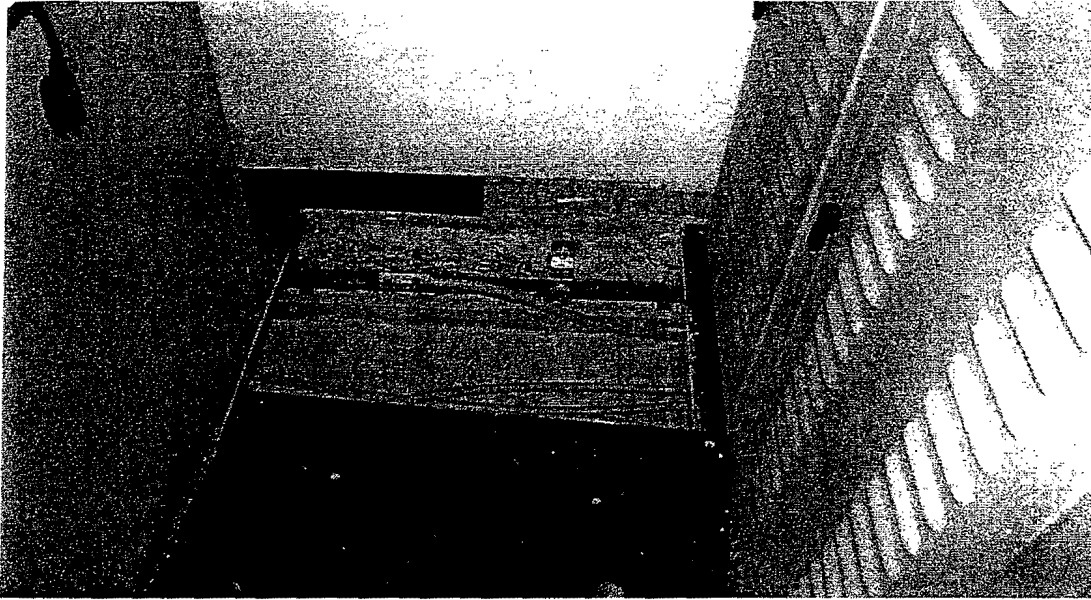
Photo 25: Sub Junction Level, Room SJ1, West Wall.

Inspection of the gypsum board walls below the raised access floor in the Equipment Room SJ1 revealed heavy concentrations of black mold as shown above. It can be attributed to the water from the humidifier and plugged floor drain in the southwest corner of this room.

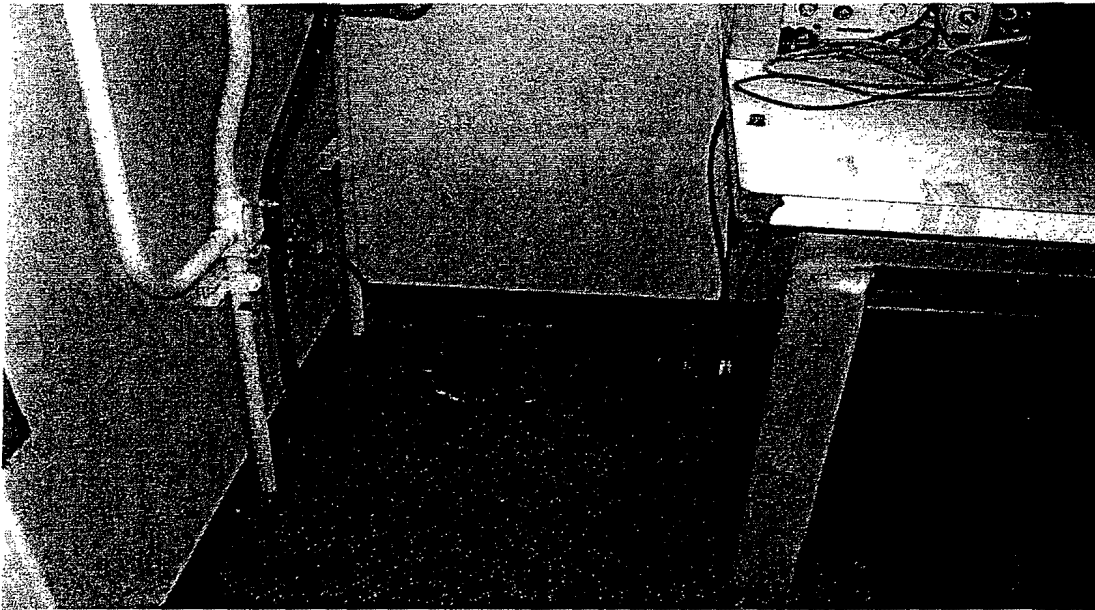
Photo 26: Sub Junction Level, Room SJ1, Southwest Corner.

Areas of yellow discoloration in the painted finish as shown above and visible mold were found up to three feet above the raised access floor.

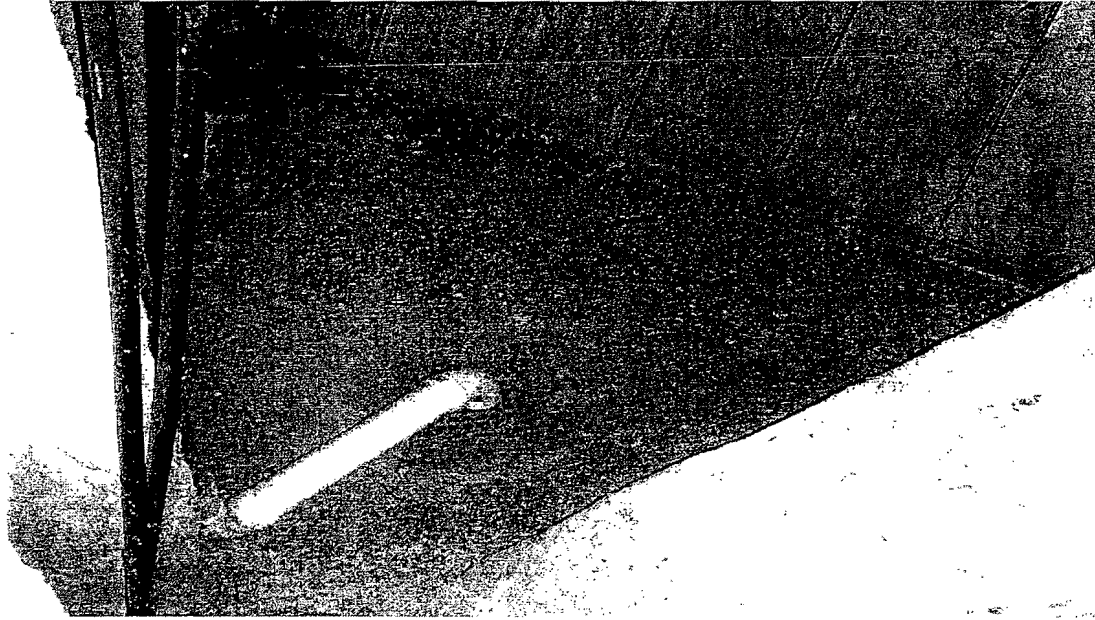
Photo 29: Sub Junction Level, Room SJ6.

Fireproofing debris and pigeon staining and droppings were observed in the bottom of air shaft SJ6. No pathogenic compounds were detected from the sample collected from this location.

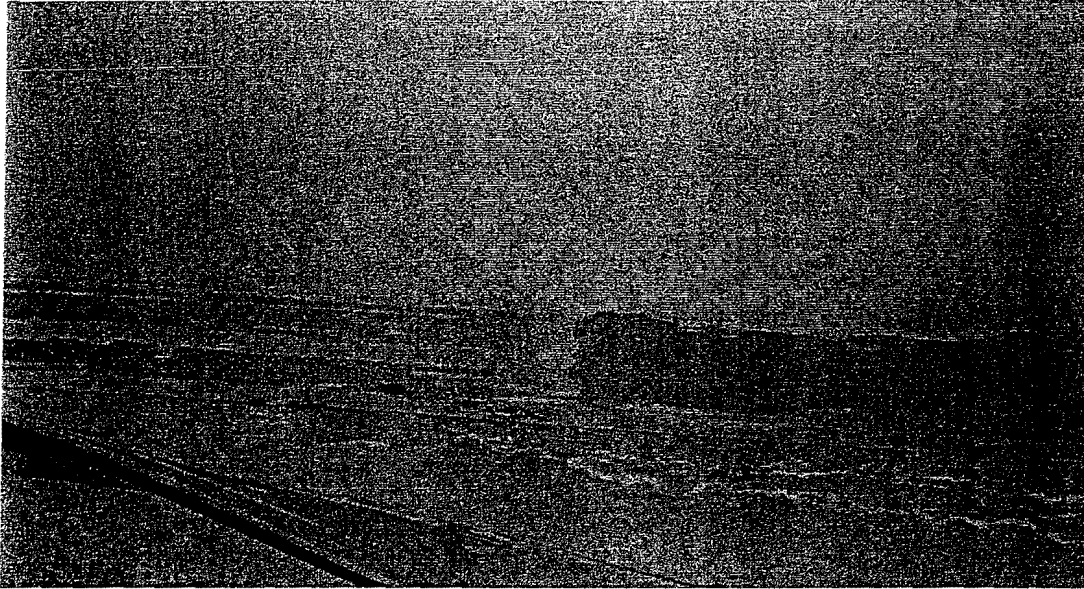
Photo 53: 3TS5, North Wall.

Mold is shown behind the base on the north wall of Room 3TS5.

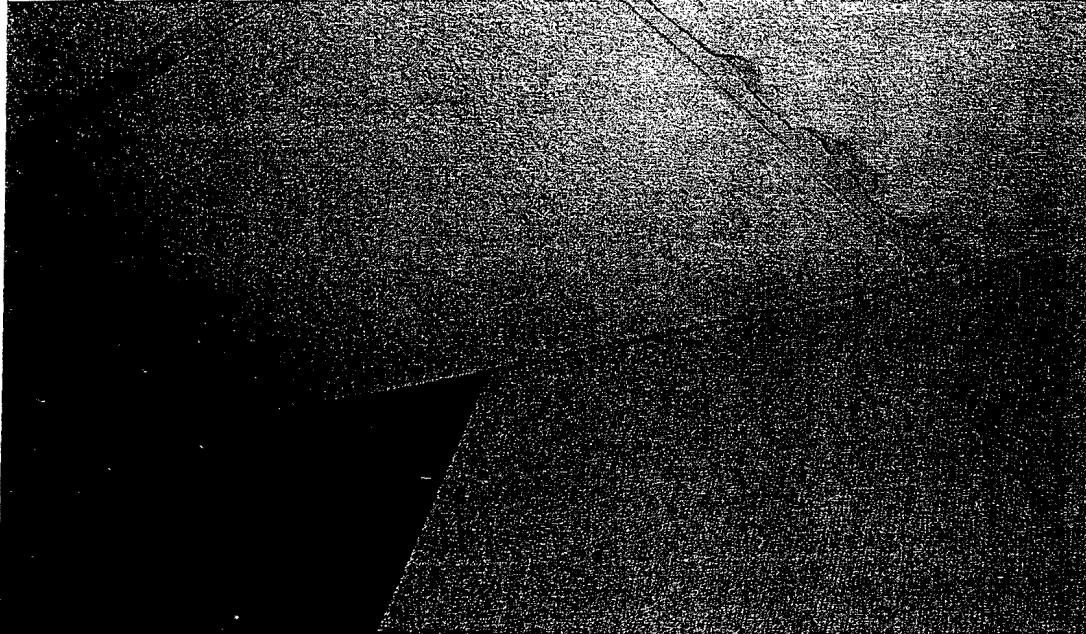
Photo 54: 2TS1, Stained Ceiling Tile.

A water stain was found on the tile adjacent to the wall outside of 2TS5 as the result of condensation from an uninsulated section of cold water return piping as shown above. The pipe is routed through the wall between two metal studs framing the door opening and there was no room to install the pipe insulation used throughout the rest of the facility.

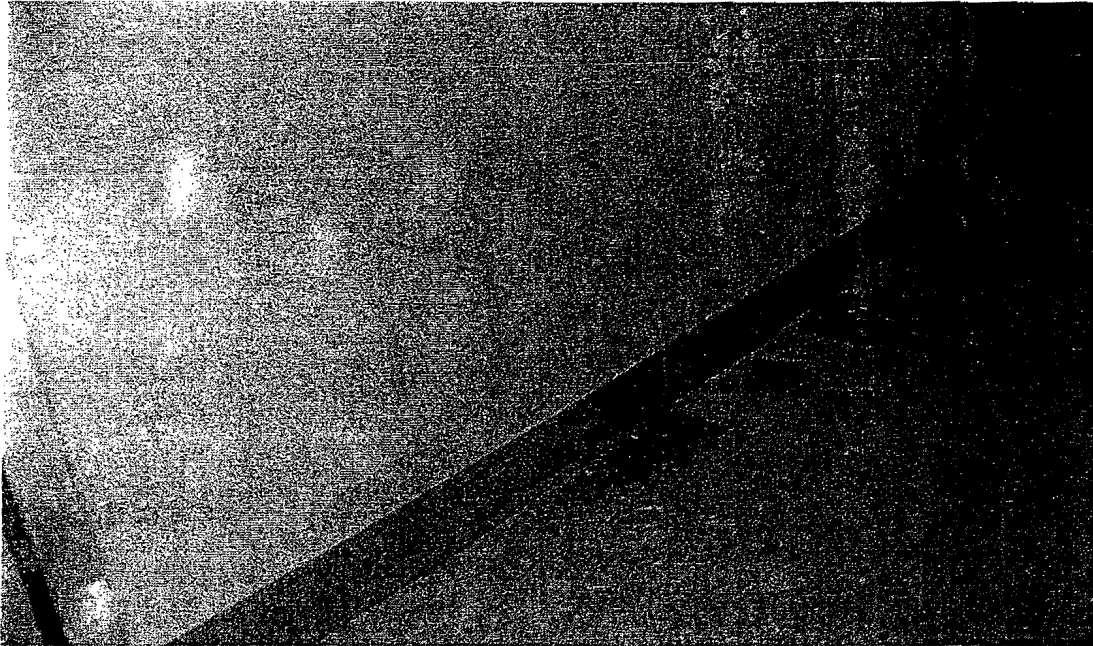
Photo 63: 8TS4, West Wall.

Condensation and frosting are shown on the west wall of Room 8TS4, on January 18, 2007.

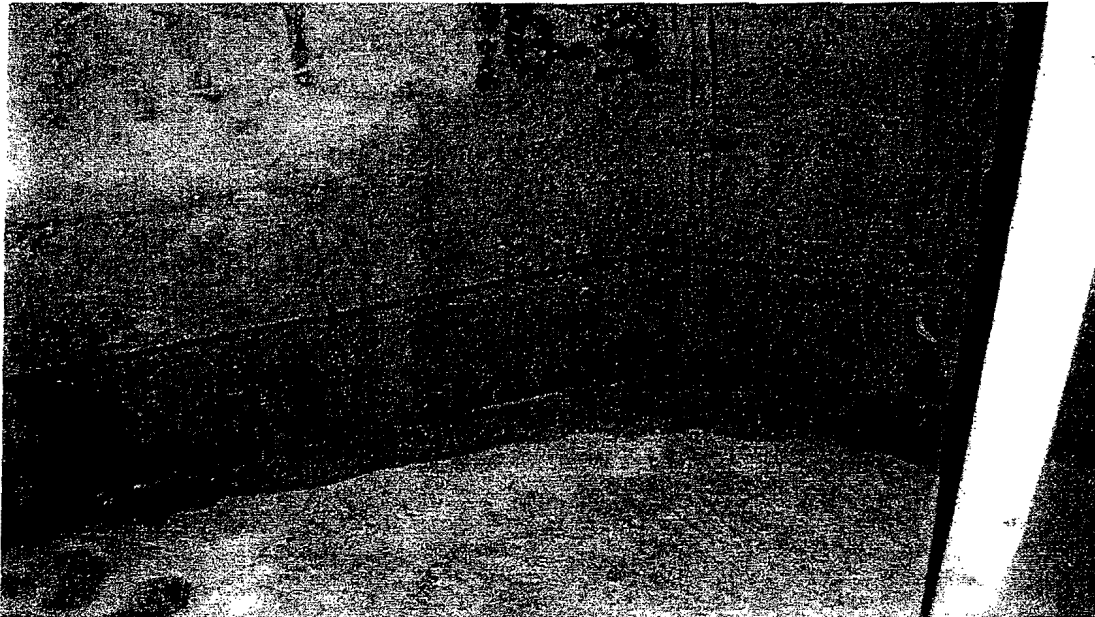
Photo 64: 8TS4, Northeast Wall.

Water and condensation is seen on the northeast wall of Room 8TS4. After a period of warmer outside temperatures, frost has melted and water is seen accumulating on the floor on January 19, 2007.

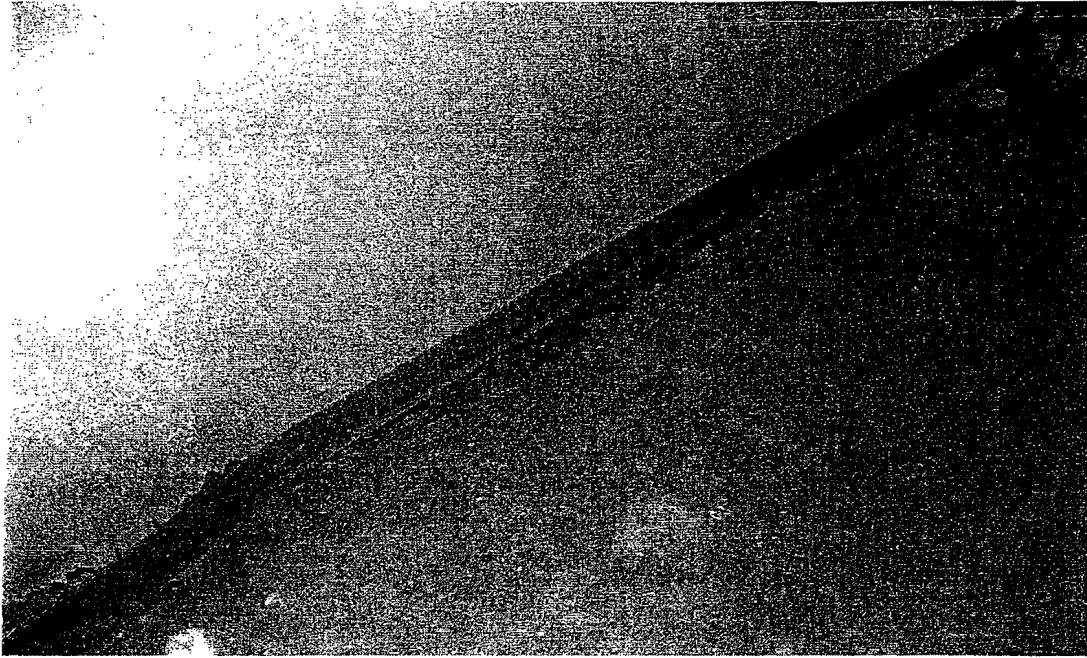
Photo 65: 10TS5, West Wall.

Standing water is seen along the base of the west wall in Room 10TS5, on January 18, 2007.

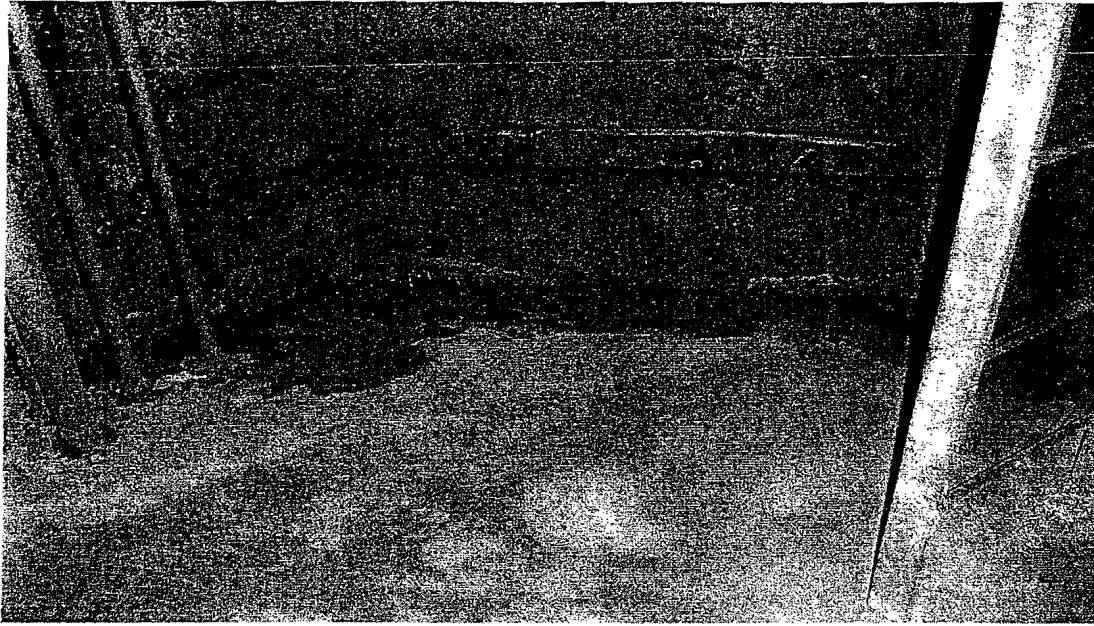
Photo 67: 9TS4, North Wall.

Melting frost and condensation are shown by the north wall of Room 9TS4, on January 18, 2007.

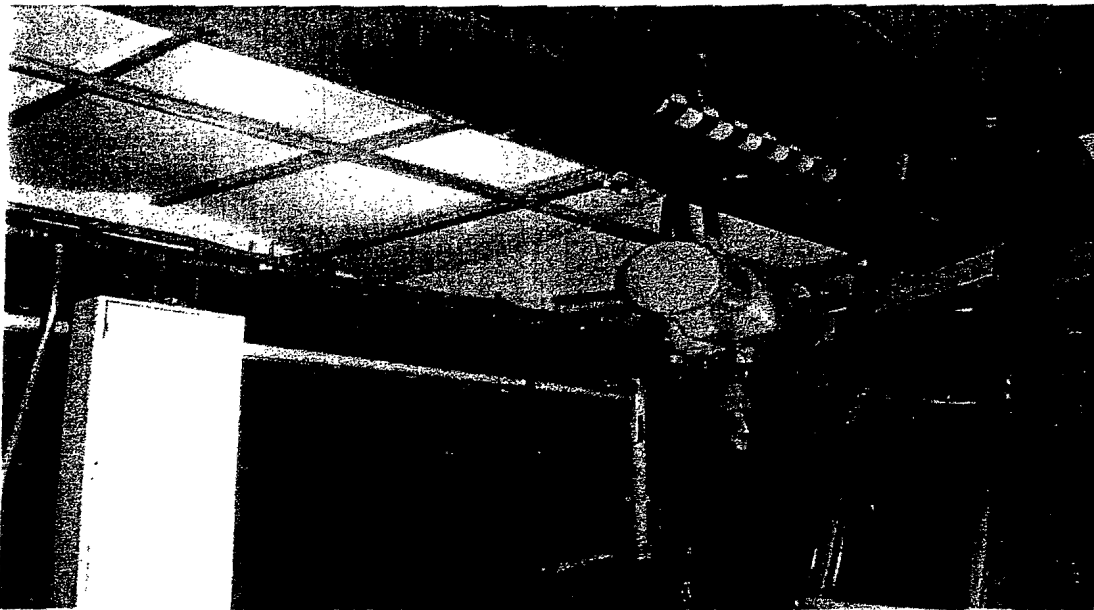
This photo shows the insulated roof deck with the fiberglass panels (thermal barrier) coming loose at many locations. Items to be protected from overspray such as a light fixture, conduit body cover, and heater can be seen in the background.

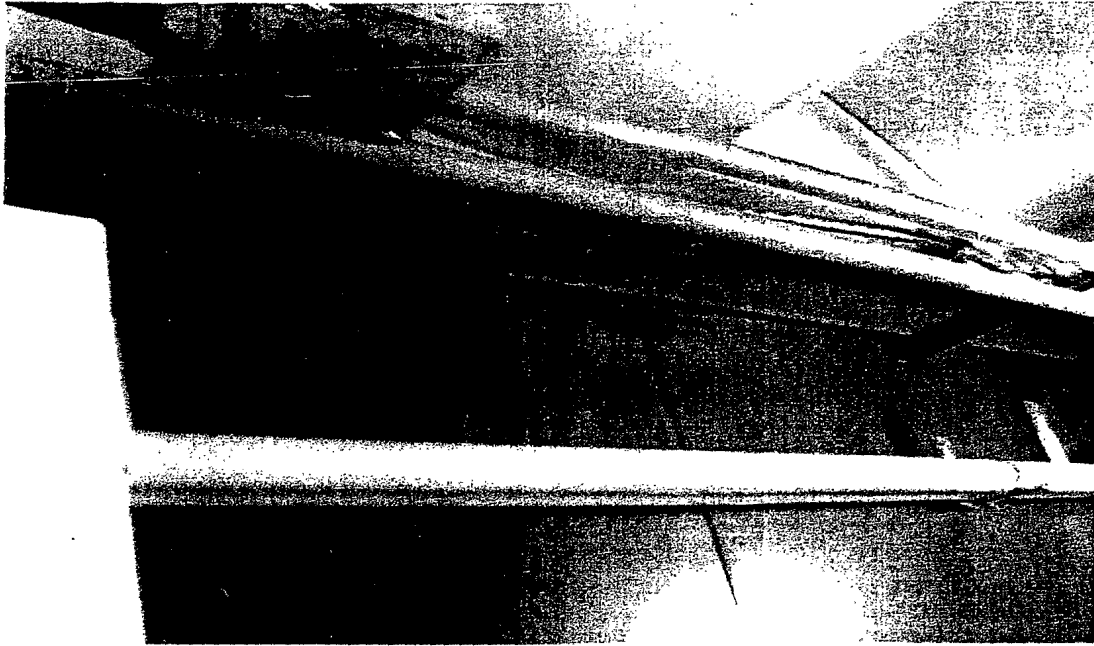
This photo shows the uninsulated pocket formed between the beam, insulated metal siding panel and the steel plate roof deck.
