**REPORT ON FAA'S ACTIONS TO ADDRESS
MOLD AT THE DETROIT METROPOLITAN AIR
TRAFFIC CONTROL TOWER FACILITY**

Report Number: AV-2006-055

Date Issued: July 11, 2006

Subject: ACTION: Report on FAA's Actions To Address
Mold at the Detroit Metropolitan Air Traffic
Control Tower Facility
Federal Aviation Administration
AV-2006-055

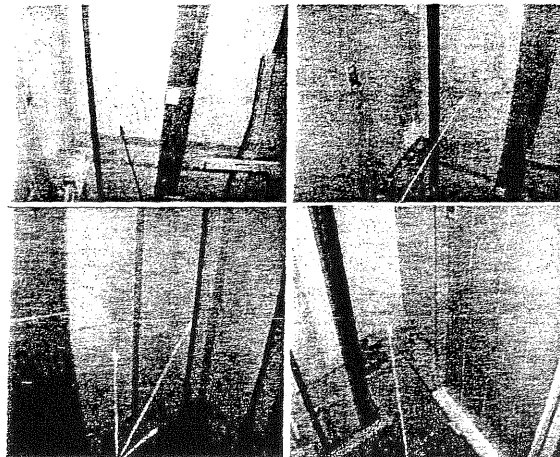
What did the mold in the elevator shaft look like?

- **Top Left:** Spots of visible mold growth on east wall of shaft of the third floor.
- **Top Right:** Visible mold growth on shaft on west wall of seventh floor.
- **Bottom Left:** Visible mold growth on shaft on west wall of eighth floor.
- **Bottom Right:** Visible mold growth on east wall of shaft of sixth floor.

- May 2006 – Mold in the elevator shaft was remediated by HEPA vacuuming and damp wipe-down with detergent and water. FAA continues to conduct monthly moisture inspections of the facility (including the elevator shaft) to identify mold or moisture issues.

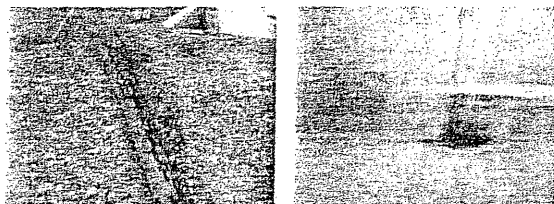
Pictured:
Near right - Exterior caulking failure.
Far right - Moisture seeping into unoccupied space in the tower from the exterior wall.

- July - October 2006 - Exterior sealing and caulking to eliminate water infiltration.
- August - September 2006 - Interior work that may include removal of walls/wallboard and changes to accommodate HVAC duct modifications if needed.
- August - November 2006 - Mechanical/electrical work including HVAC (Heating/Ventilation/Air Conditioning) work to control and manage humidity within the tower and elevator shafts.
