# Report on Exterior Building Envelope

## And HVAC Conditions

Airport Traffic Control Tower

2006  
April 24, 2005 MK

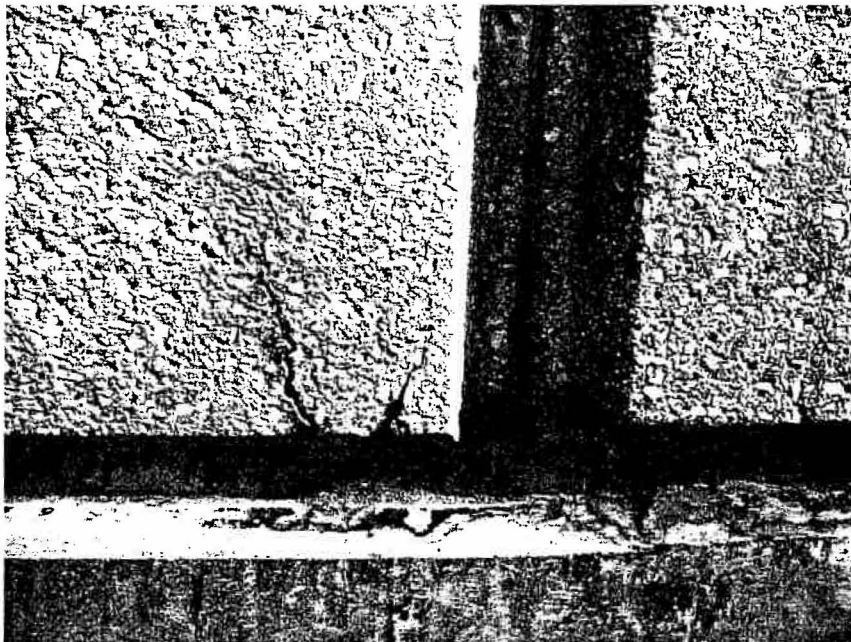
Photo 4.1-4  
ATCT Ground Level

During a walk around the exterior of the Ground Floor, DMJMH+N observed multiple cracks on the surface of exposed aggregate concrete panels and mismatched color finish (See Photos 4.1-4, 4.1-5 and 4.1-6).

It is apparent that many panels are subject to deterioration, most likely caused by freeze-thaw action during the winter season. There are also hairline cracks in the grouted joints between concrete panels, which may also allow moisture and wind driven rain water to seep through and into the interior of the building envelope (See Photo 4.1-5). This observation and conclusion was subsequently confirmed through the inspection of the interior face of unfinished concrete walls, where at some levels there were visible water stains and some efflorescence along the grouted joints.

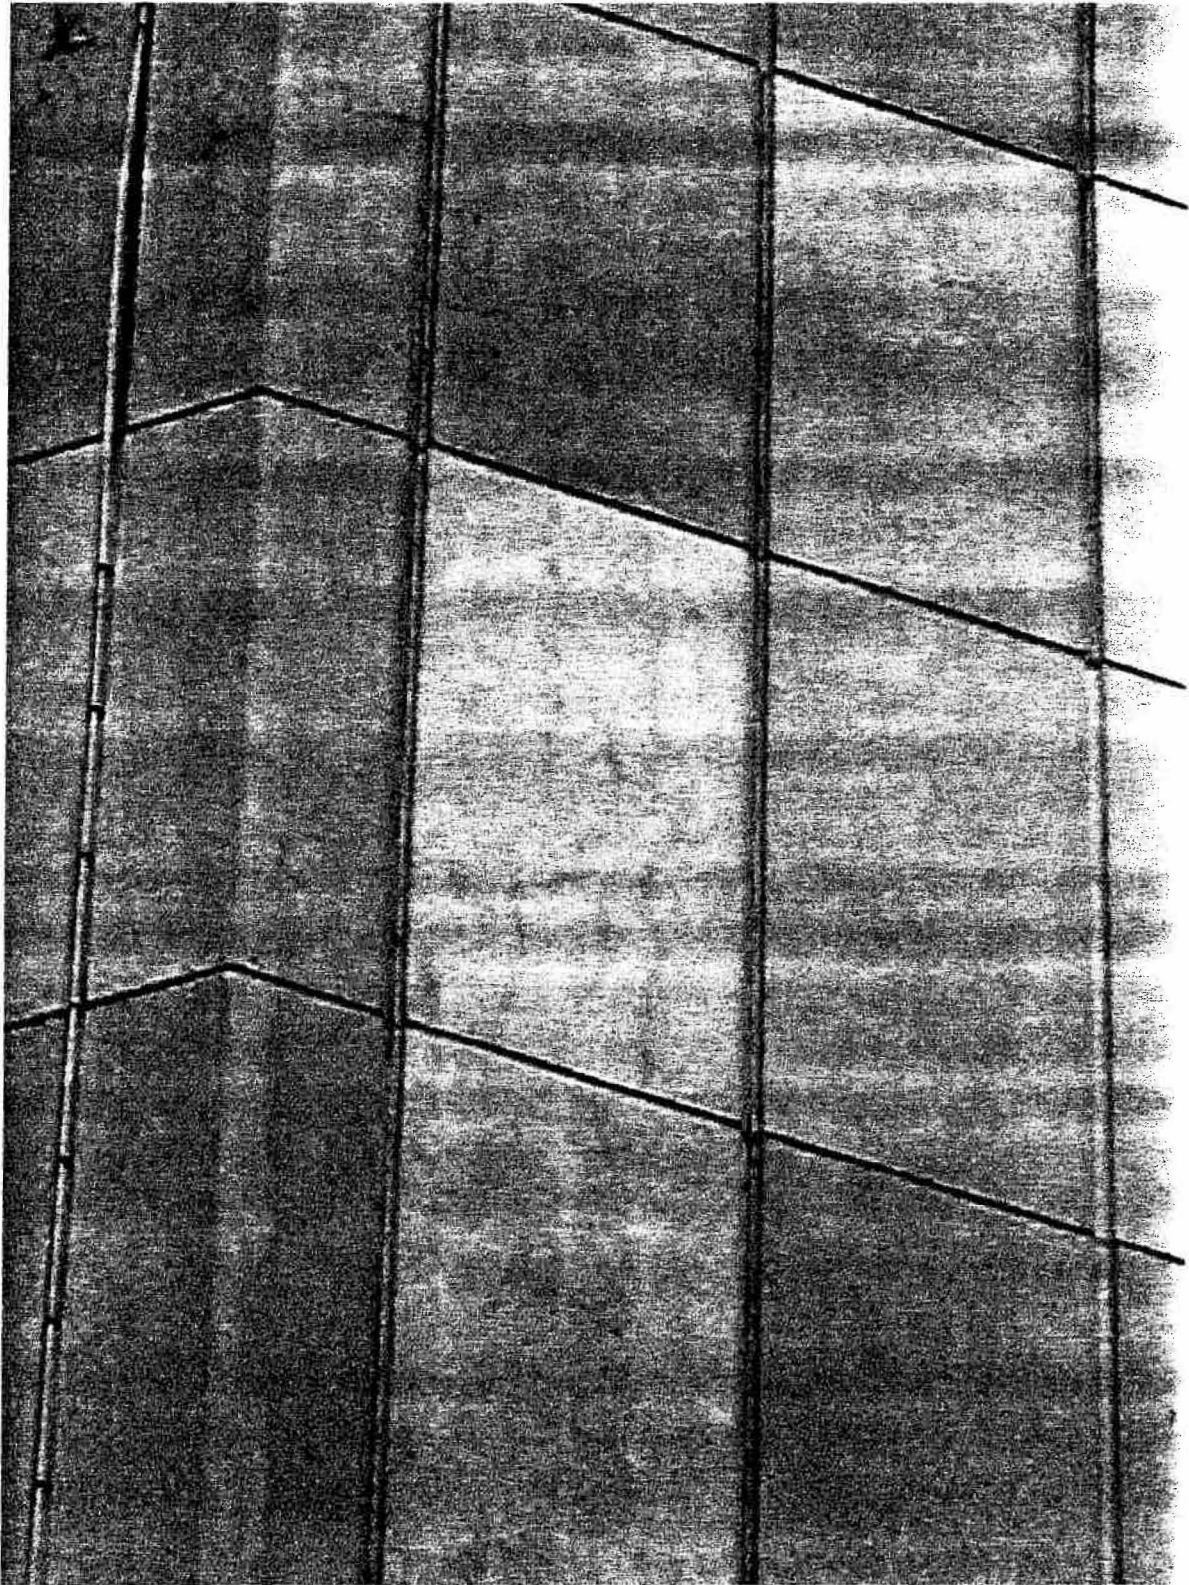
Photo 4.1-6  
Cracking & Mismatch of Color in ATCT Structural Precast Panels

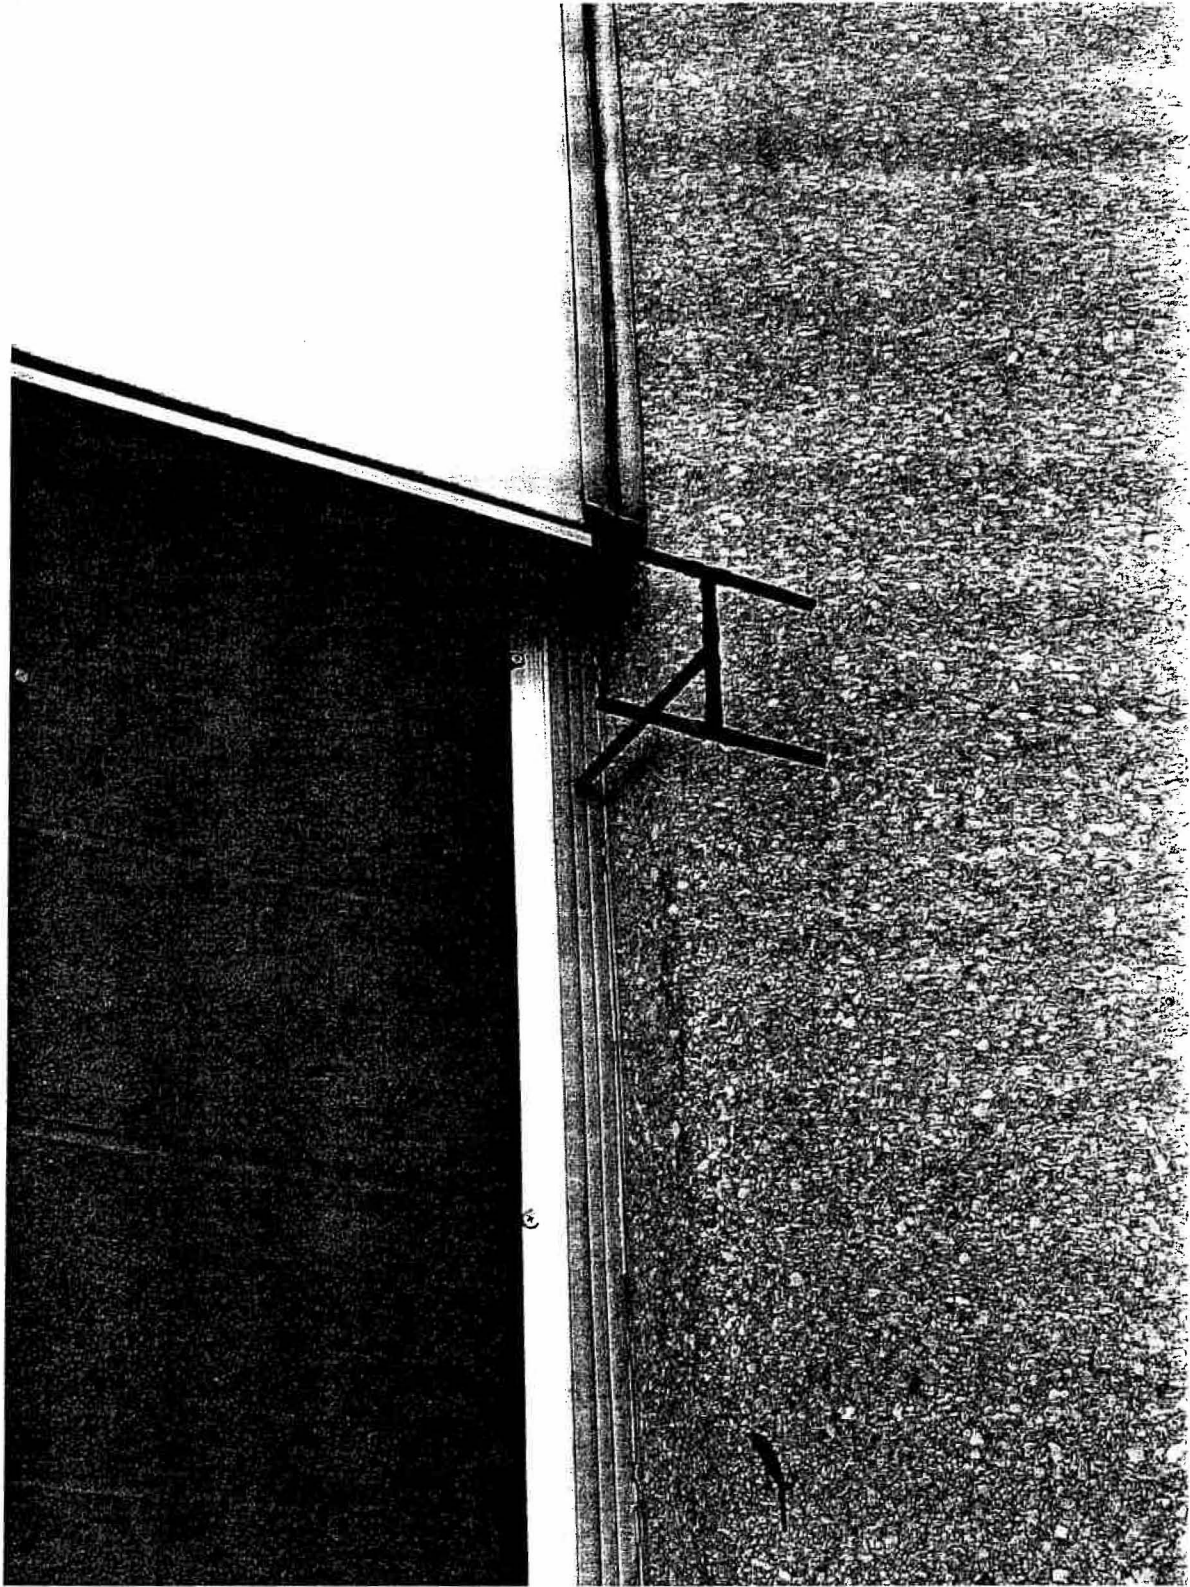
Photo 4.1-7  
Penetration Through Elastomeric Seal @ Link to ATCT Shaft

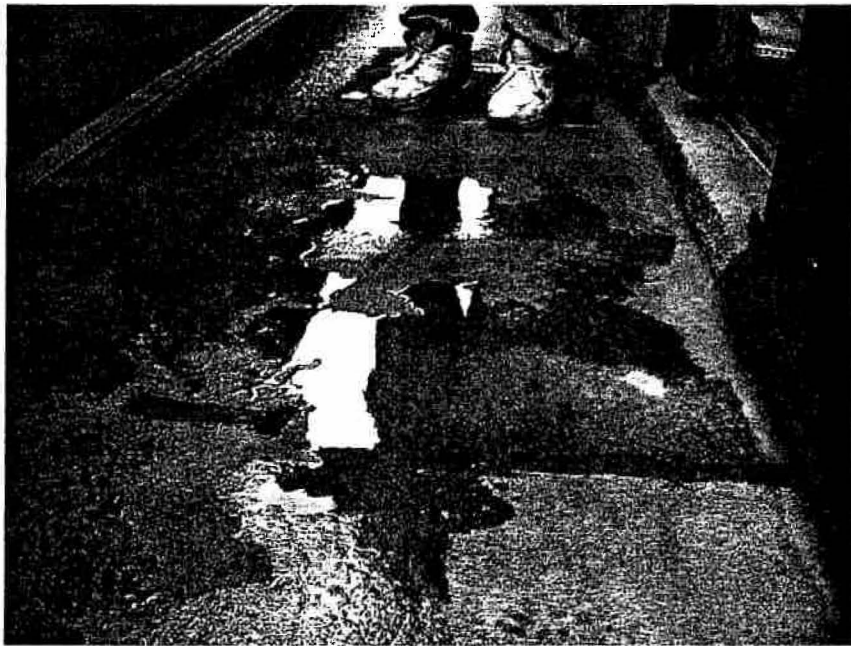
Photo 4.2.2-1  
Cab Walkway

Inspection of the Cab Walkway revealed the concrete slab surfaced with waterproof coating surrounded by low profile concrete curbs on each side, along entire perimeter of the Cab. There was standing water in several places due to uneven surface and low slope of concrete (See Photo 4.2.2-1). There were four area drains set flat with the surface of concrete walkway. There were many cracks in concrete surface with visible epoxy sealer patches (See Photo 4.2.2-2). The Cab Walkway floor appears to be constructed in accordance with design documents as a double slab with waterproofing membrane sandwiched between them and covered on the surface with a waterproof coating.
