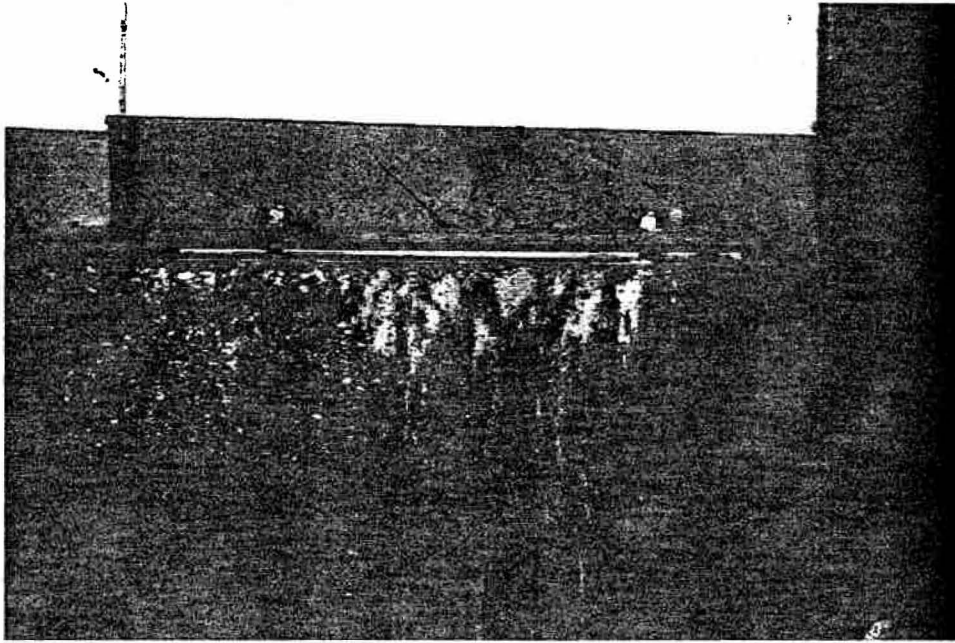
Photo 4.2.3-1
Sill Angle at Bottom of Exterior Wall of Cab Walkway

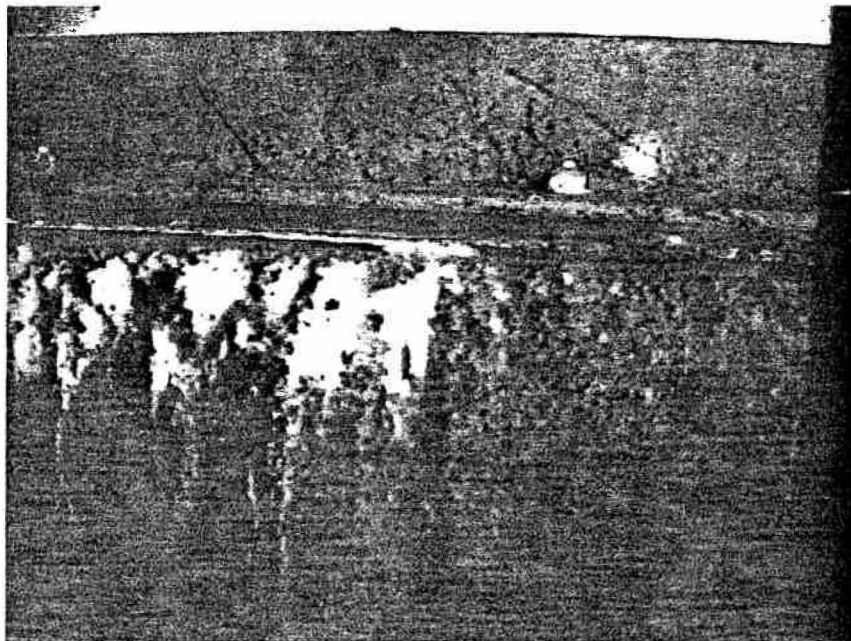
Photo 4.2.3-2
Sill Angle at Bottom of Exterior Wall of Cab Walkway

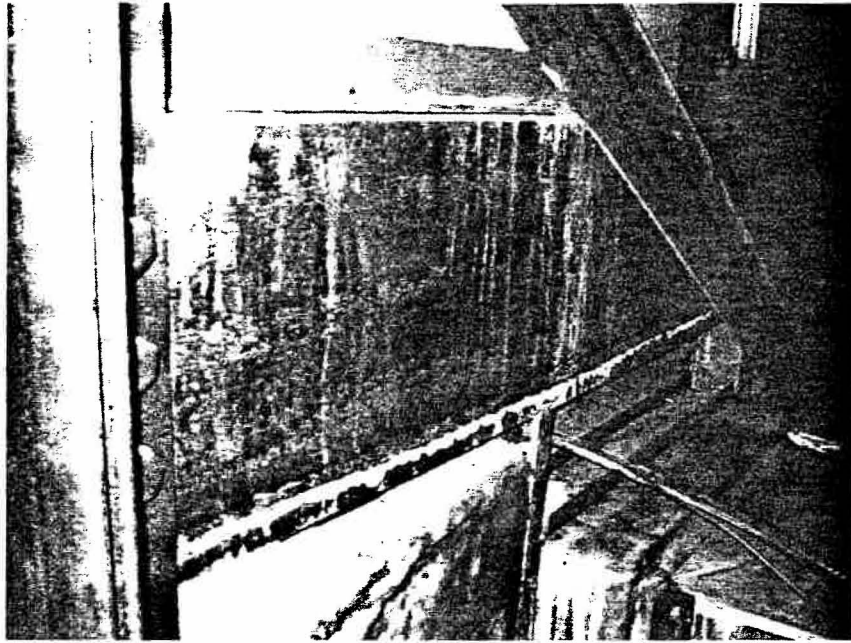
Photo 4.2.3-3
Sill Angle at Bottom of Exterior Wall of Cab Walkway

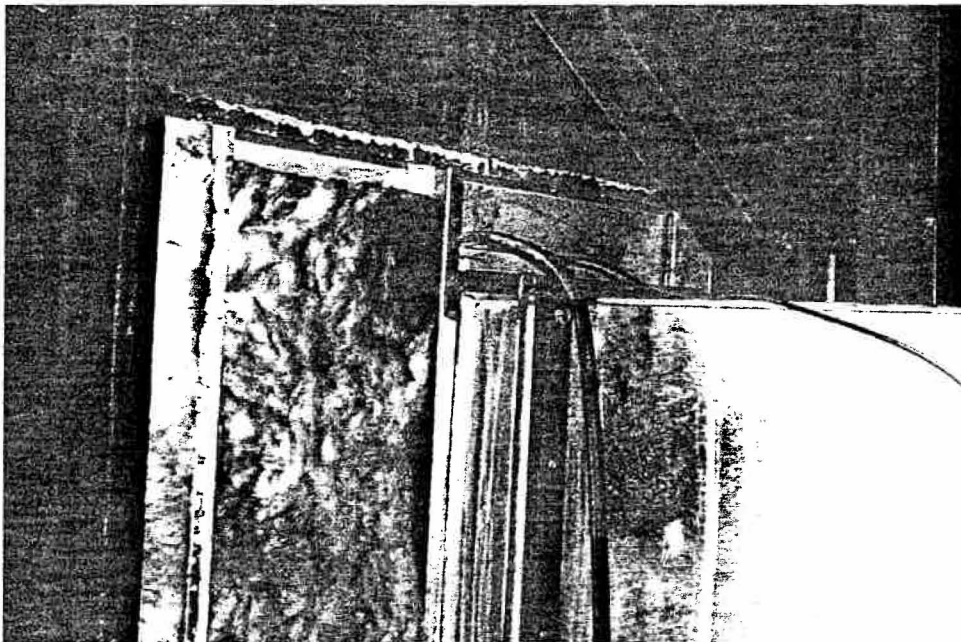
Photo 4.2.3-4
Metal Studs and Tracks Below Cab Walkway

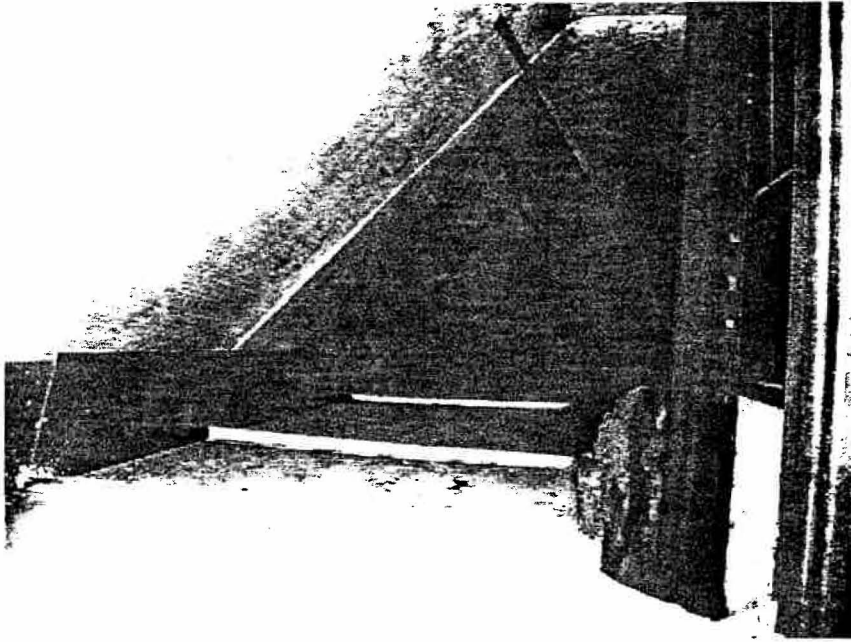
Photo 4.2.3-5
Cable Access Level Below and Outside of Cab Walkway

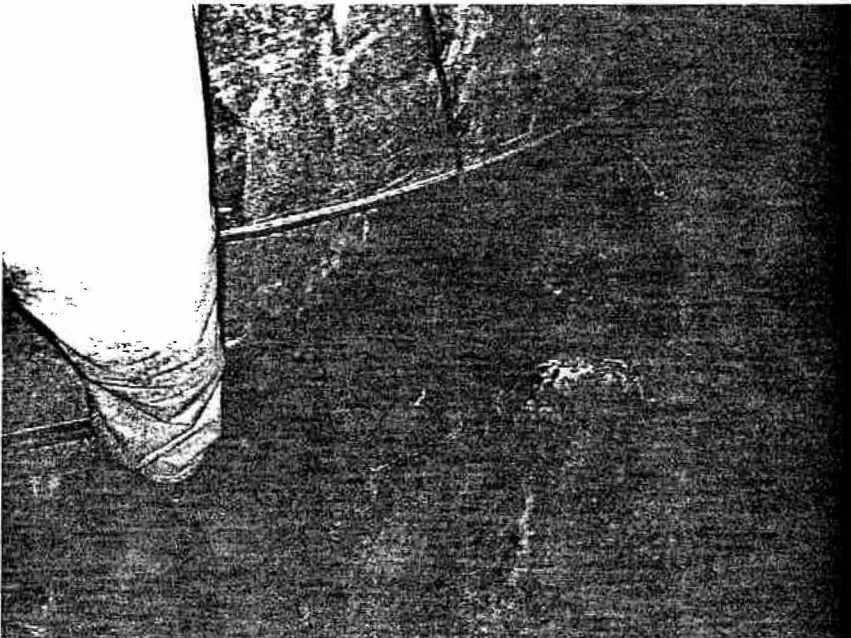
Photo 4.2.3-6
Drain at Cable Access Level Below Cab Walkway

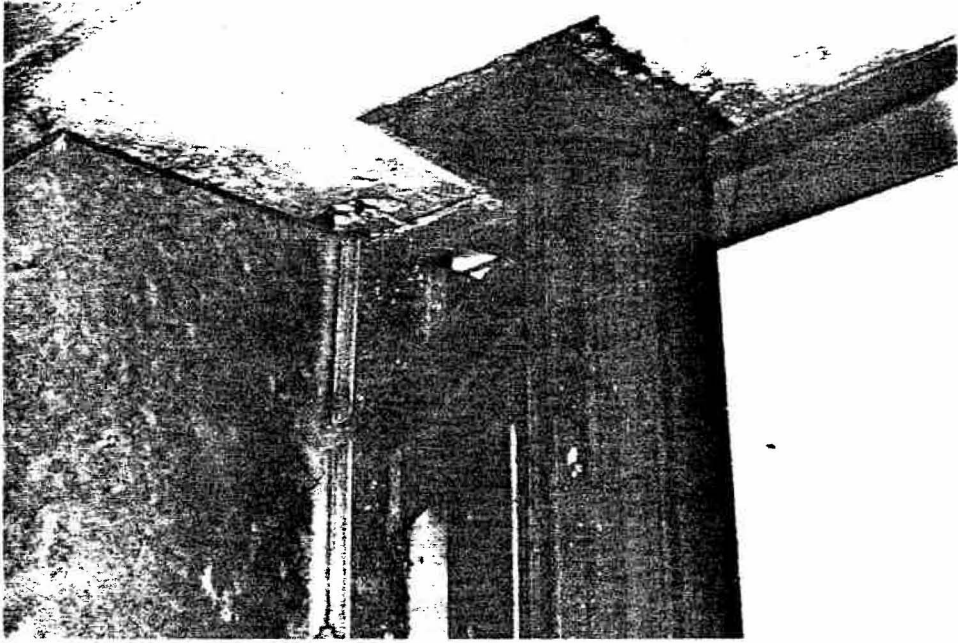
Photo 4.2.3 7
Precast Concrete Support Steel at Cable Access Level

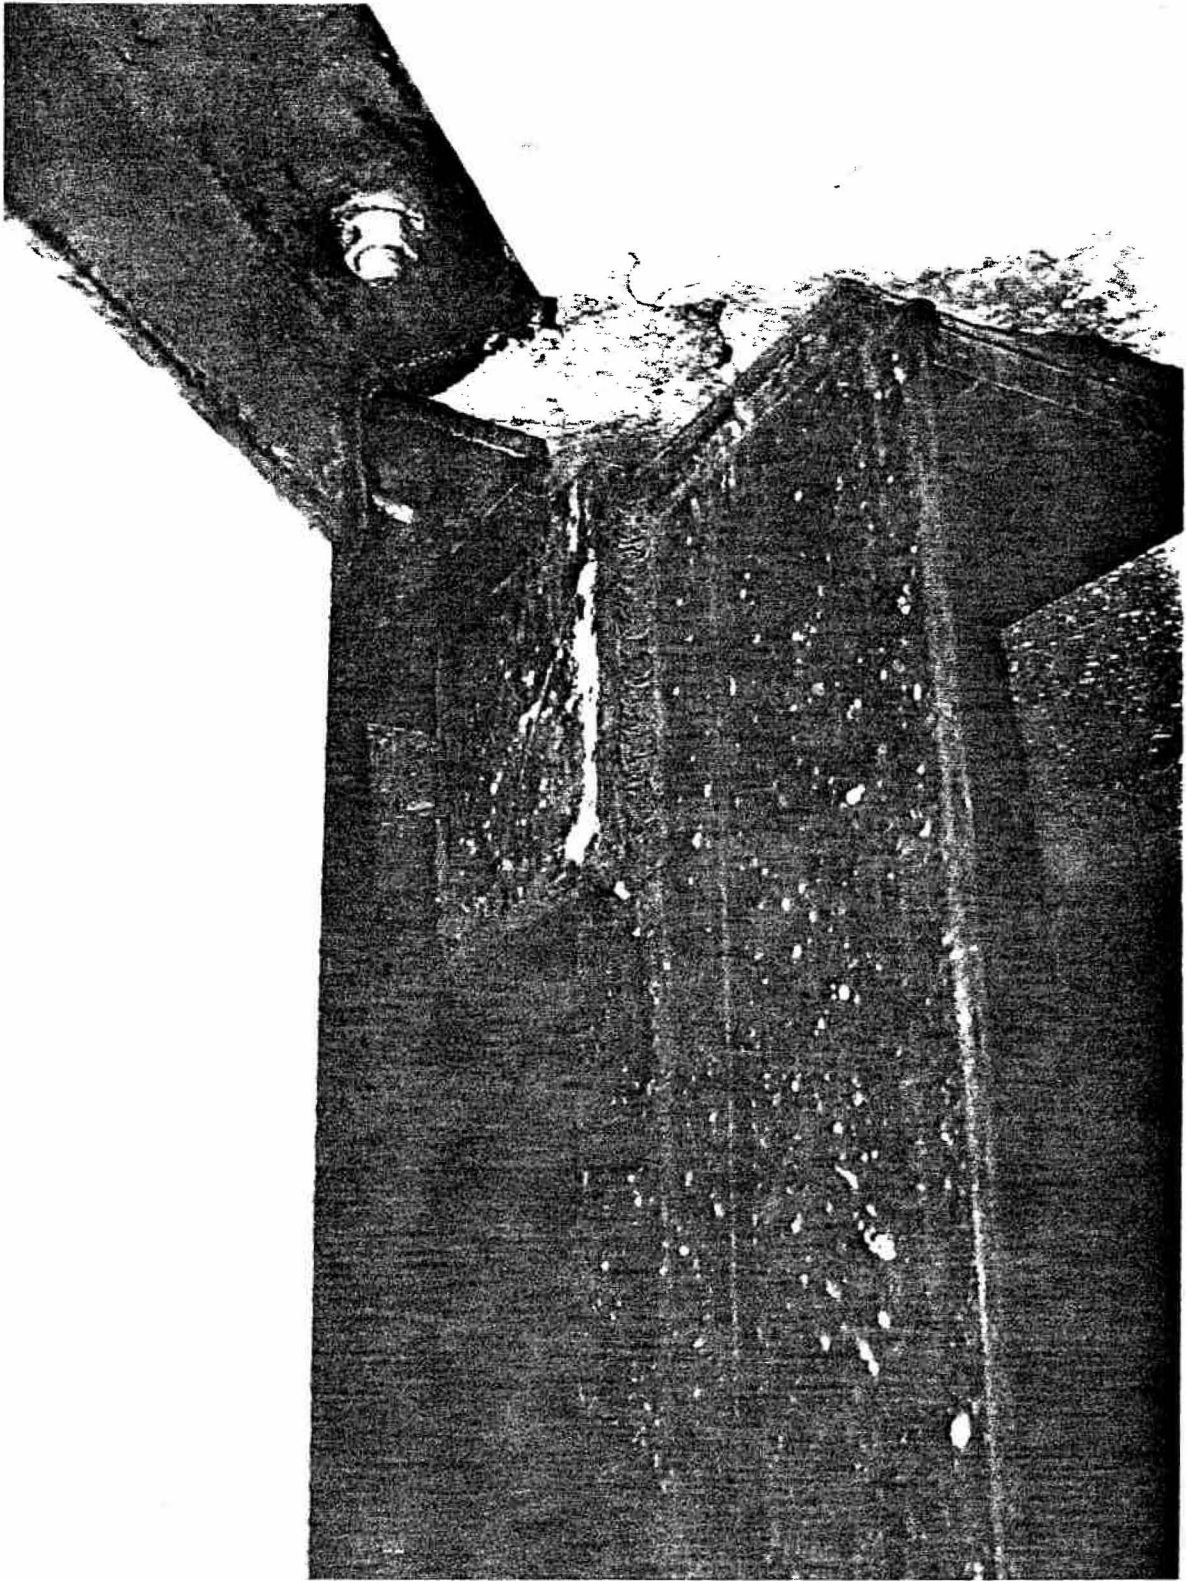
Photo 4.2.3-8
Precast Concrete Support Steel at Cable Access Level

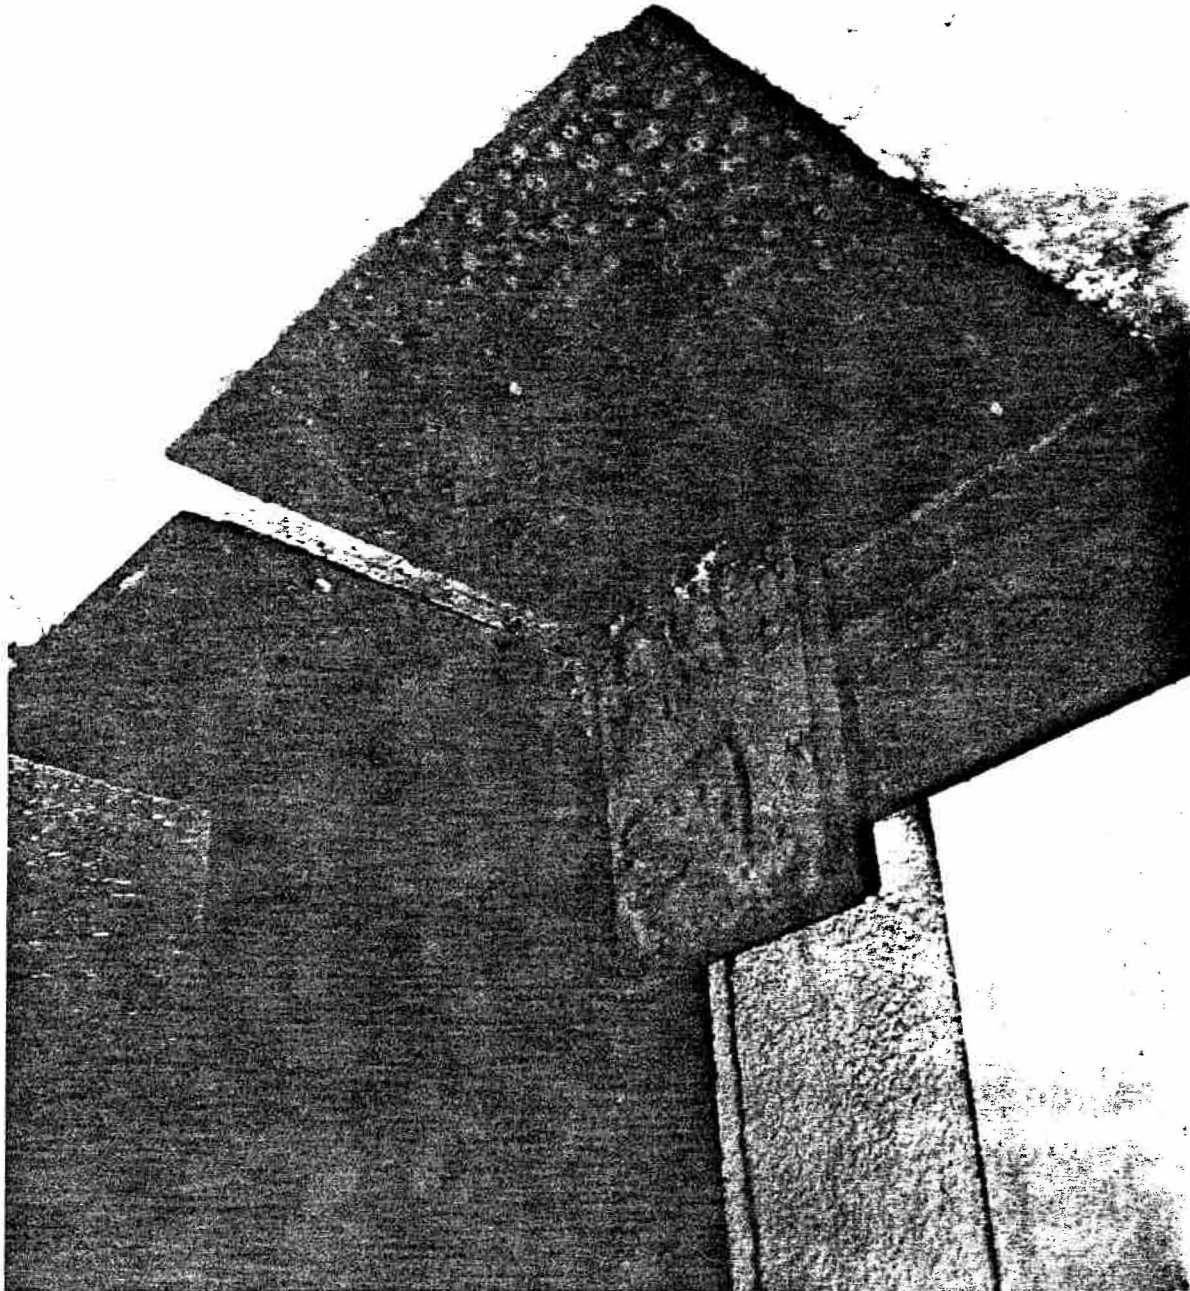
Photo 4.2.3-9
Precast Concrete Support Steel at Cable Access Level

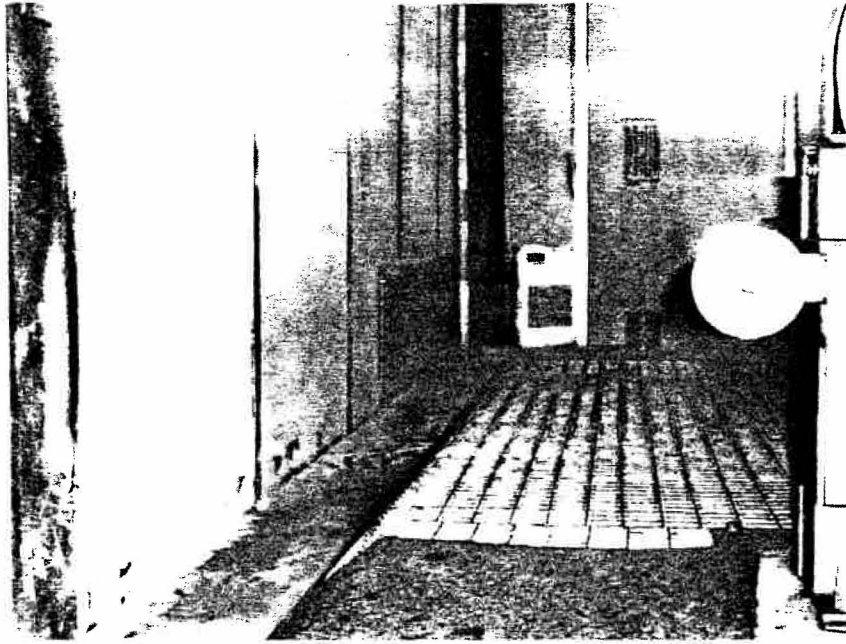
Photo 4.2.4-1
Relief Grille in Elevator Overhead

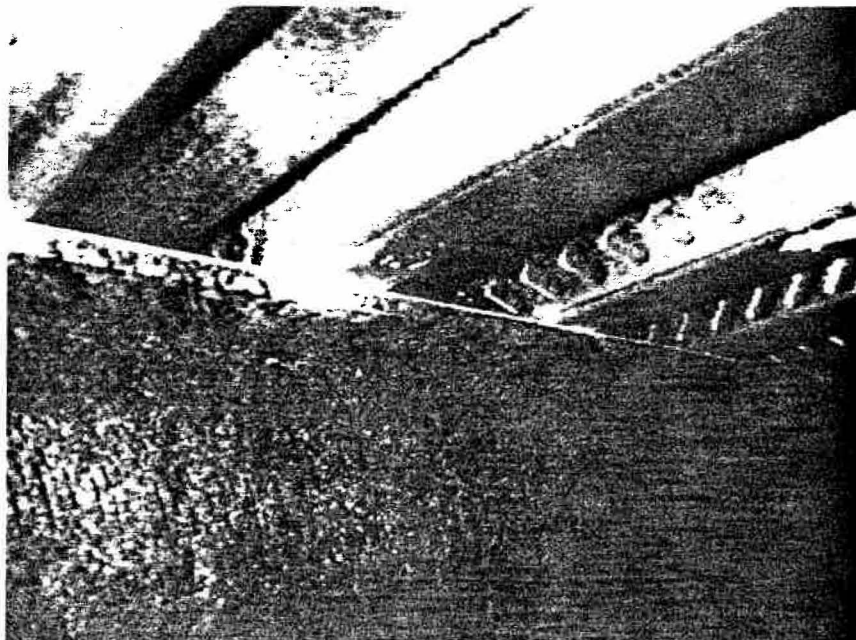
Photo 4.2.4-4
Metal deck at Support Beam in Elevator Overhead

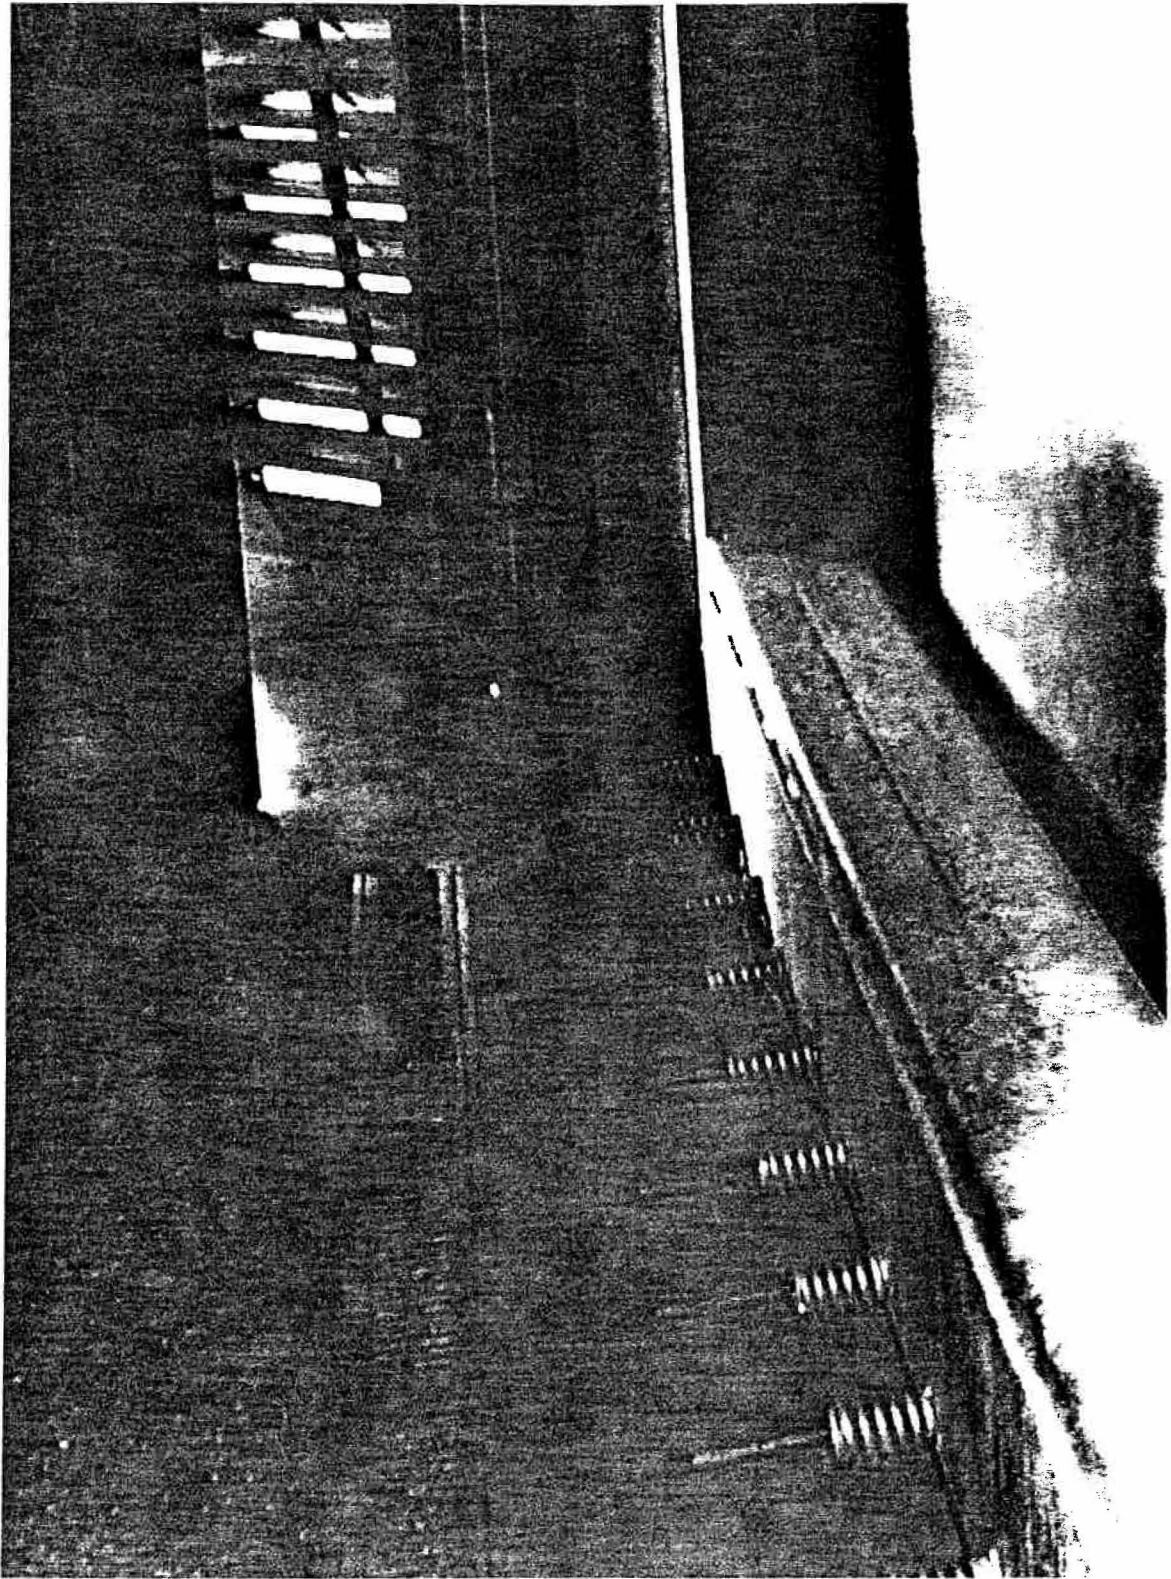
Photo 4.2.5-2
Water Marks at Hinged Louver Door at Microwave Balcony

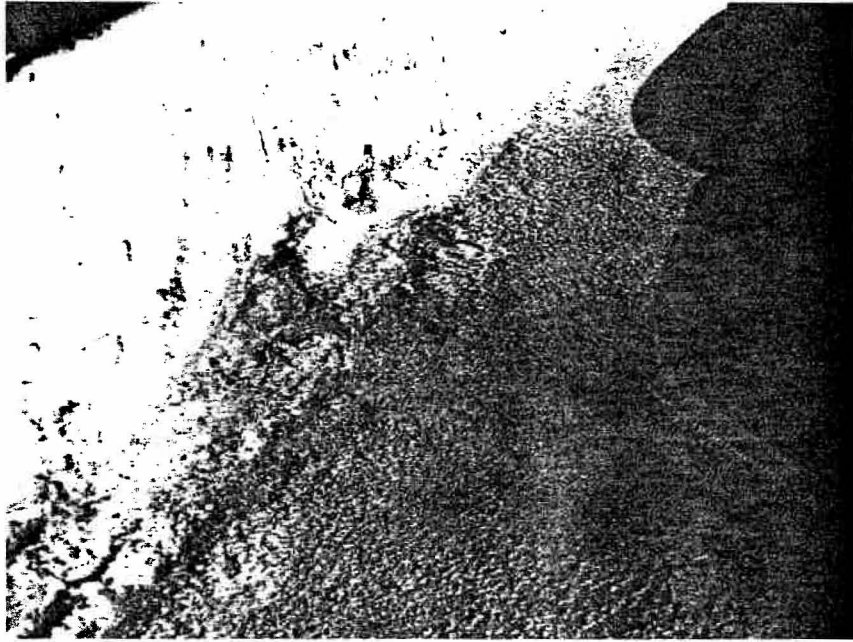
Photo 4.2.5-3
Deteriorated Coating on Exterior Walkway at Junction Level

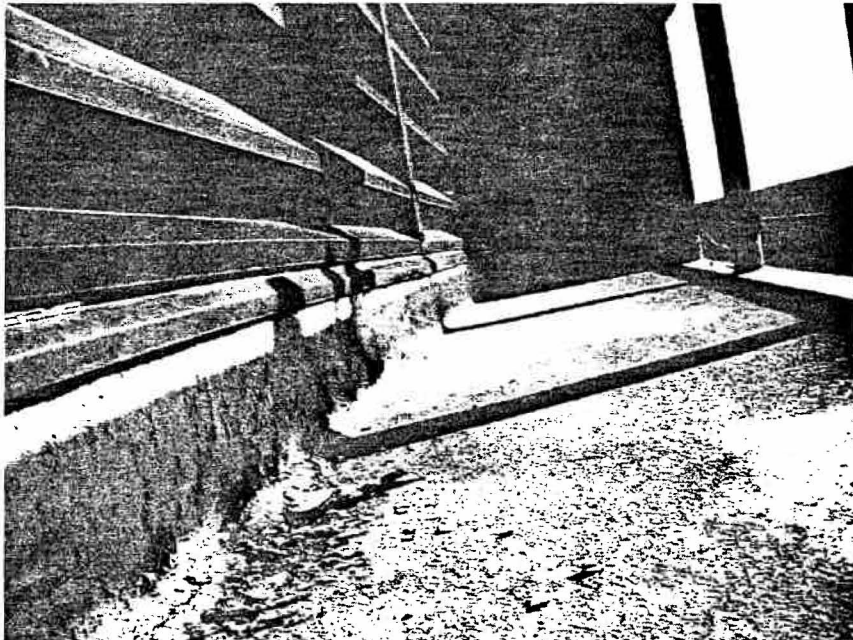
Photo 4.2.5-4
Deteriorated Coating on Exterior Walkway at Junction Level

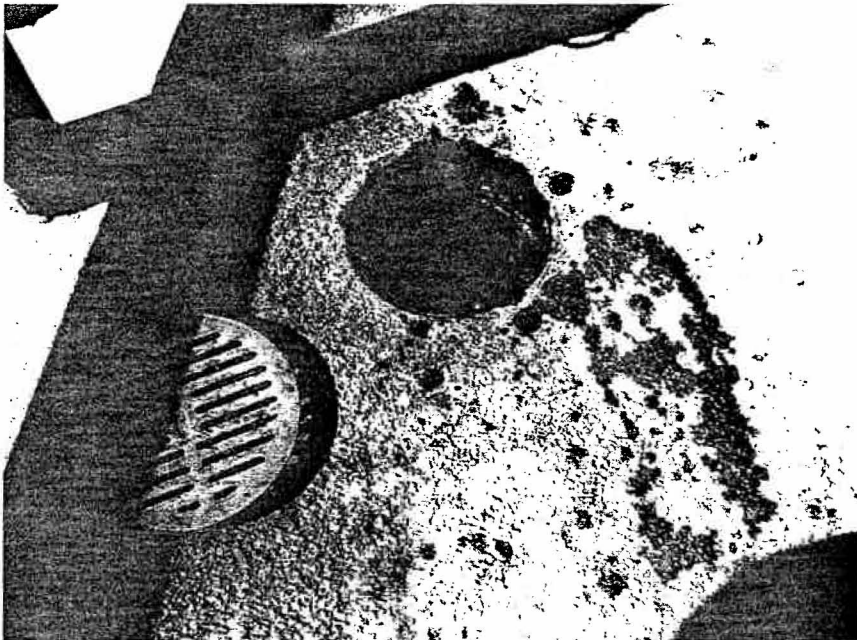
Photo 4.2.5-6
Plugged Drain - Exterior Walkway at Junction Level

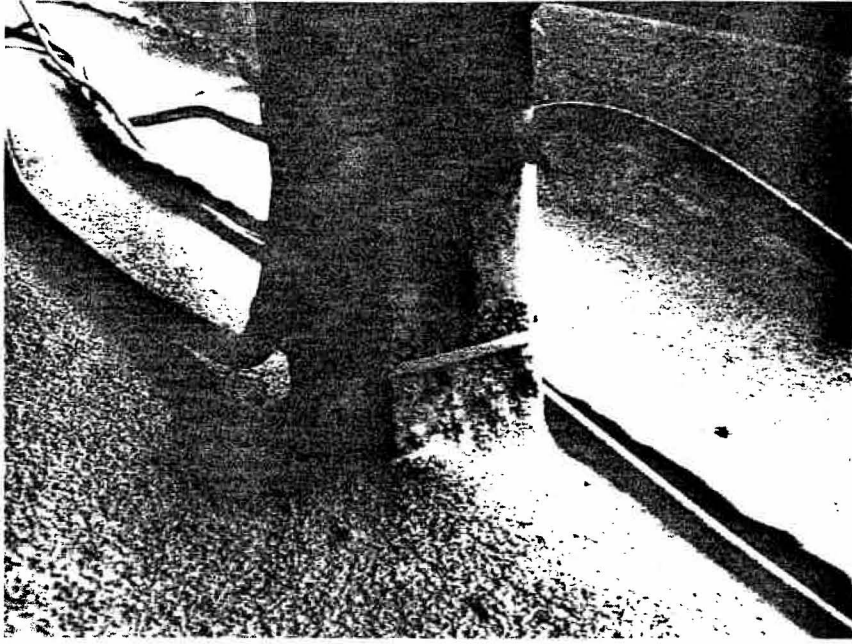
Photo 4.2.5-7
Handrail Post - Exterior Walkway at Junction Level

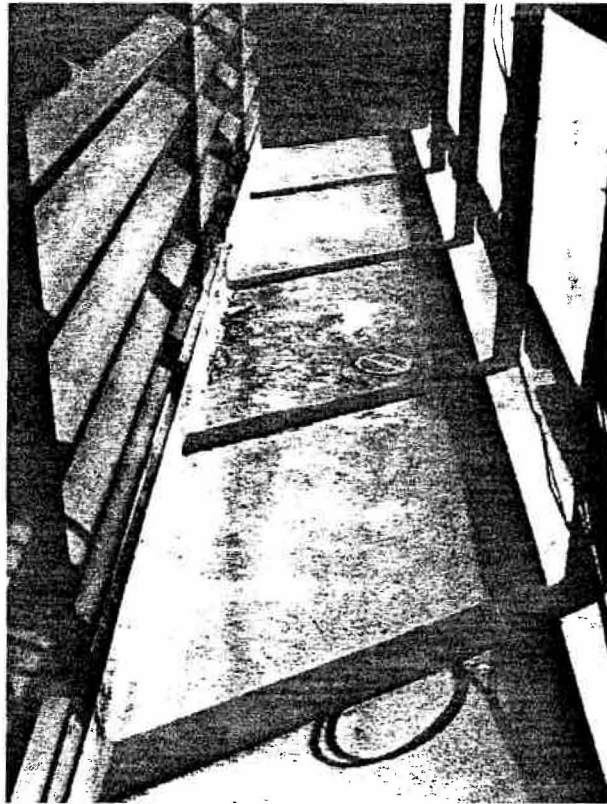
Photo 4.2.5-8
Handrail Post - Exterior Walkway at Junction Level

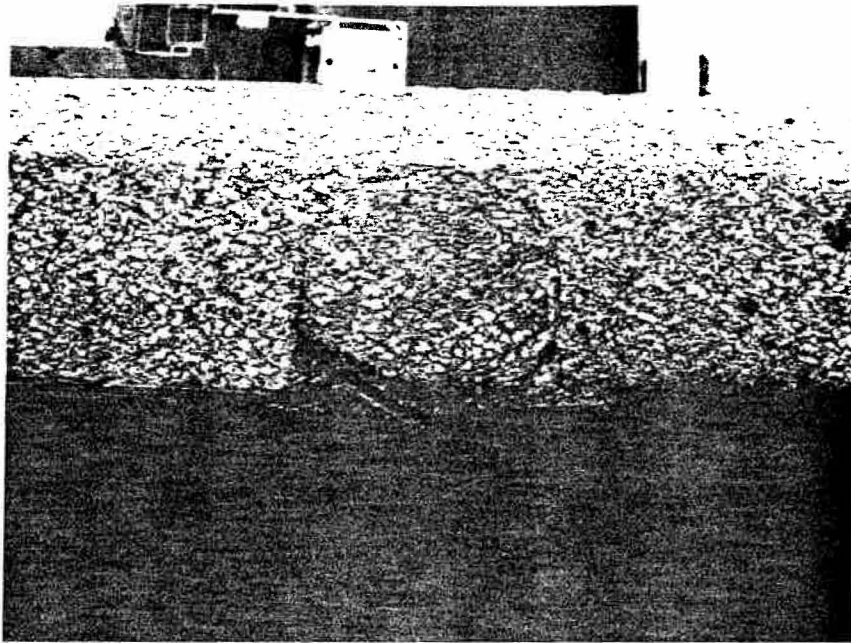
Photo 4.2.5-9
Top of Precast Panel - Exterior Walkway at Junction Level

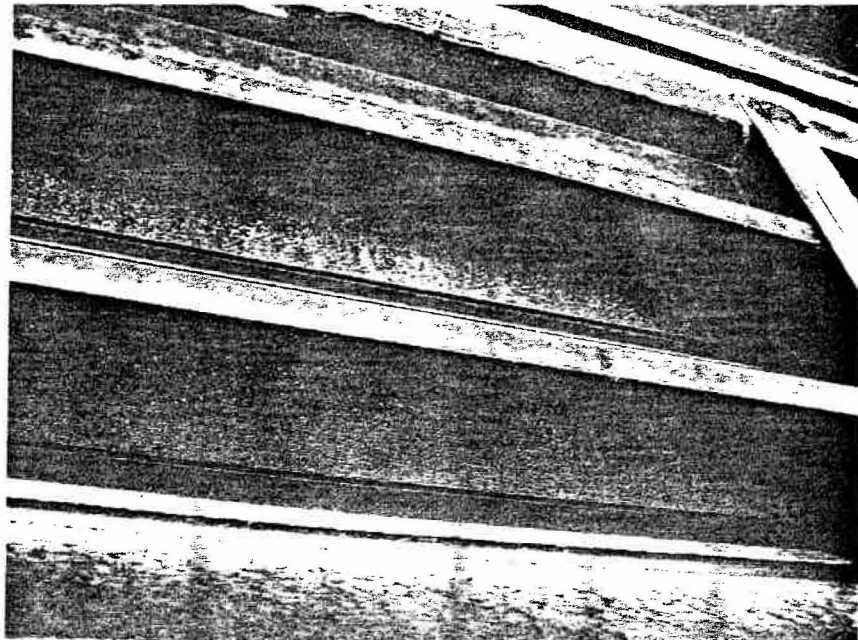
Photo 4.2.5-10
Louver - Exterior Walkway at Junction Level

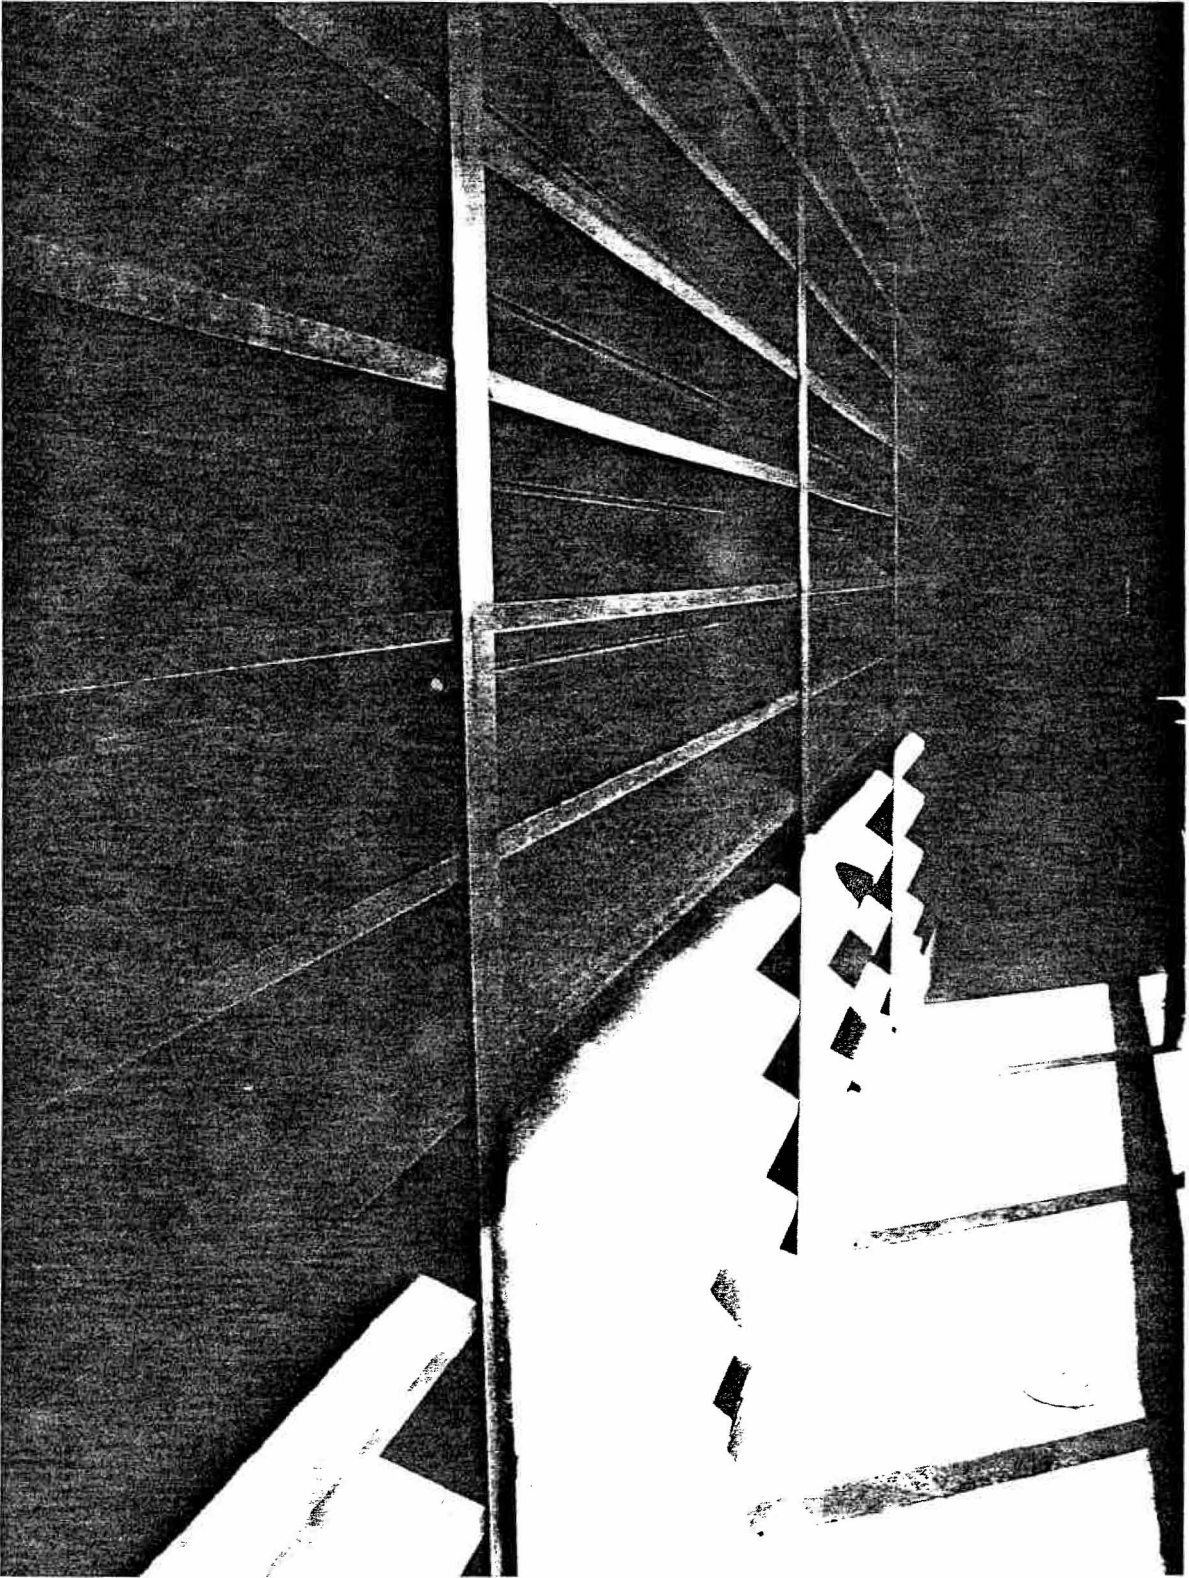
Photo 4.2.5-11
Louver - Exterior Walkway at Junction Level

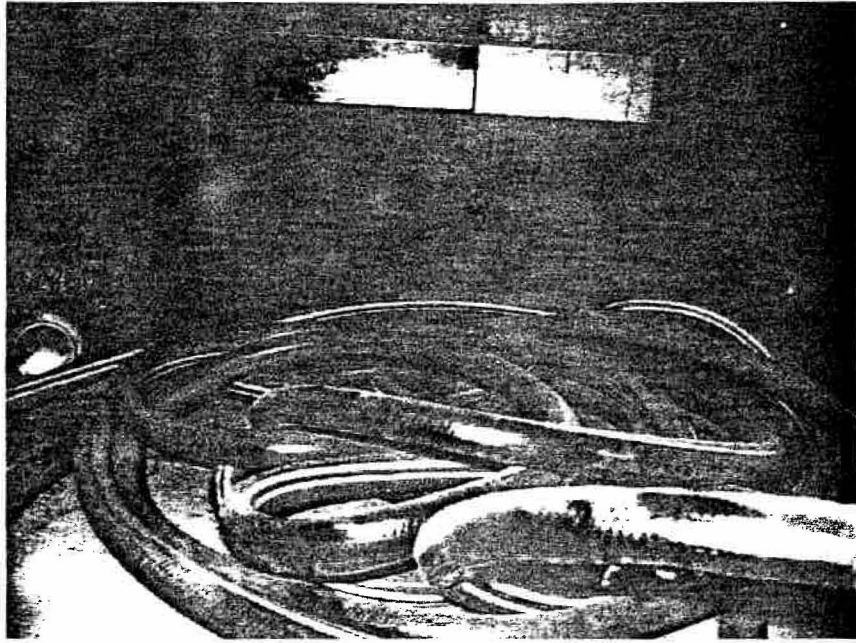
Photo 4.2.5-12
Below Louver - Junction Level Mechanical Room

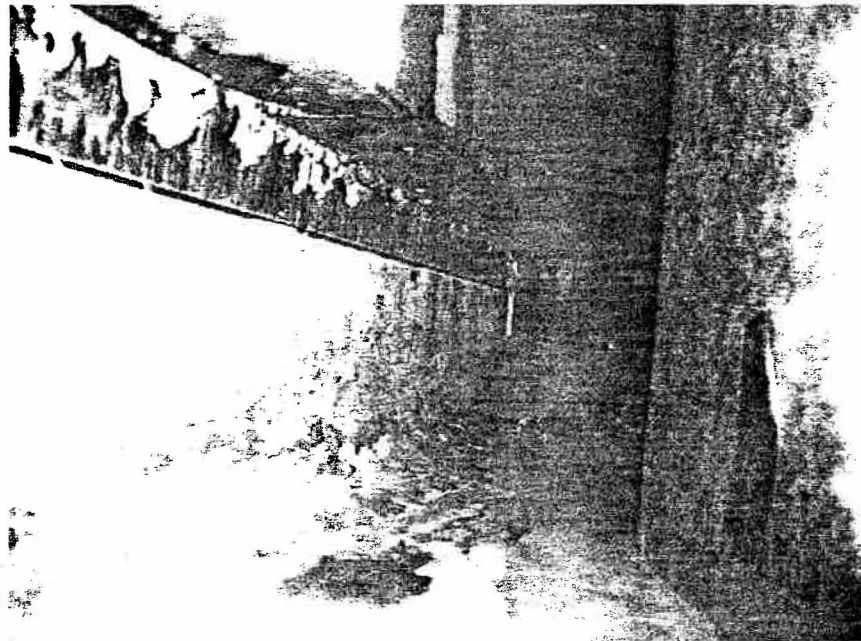
Photo 4.2.5-13
Below Louver - Junction Level Mechanical Room

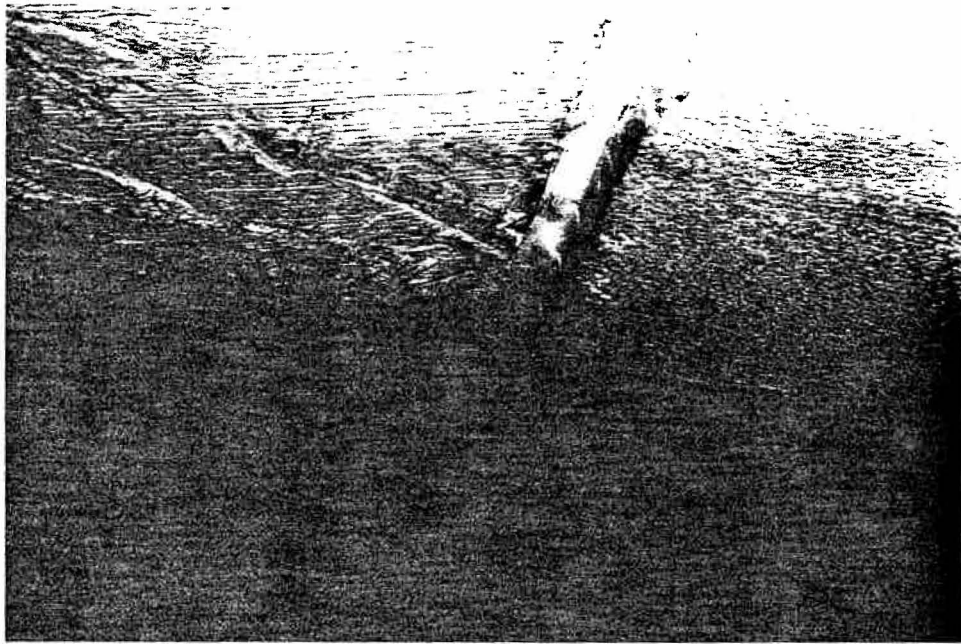
Photo 4.2.5-14
Above Soffit Louver – East Exterior Walkway at Junction Level

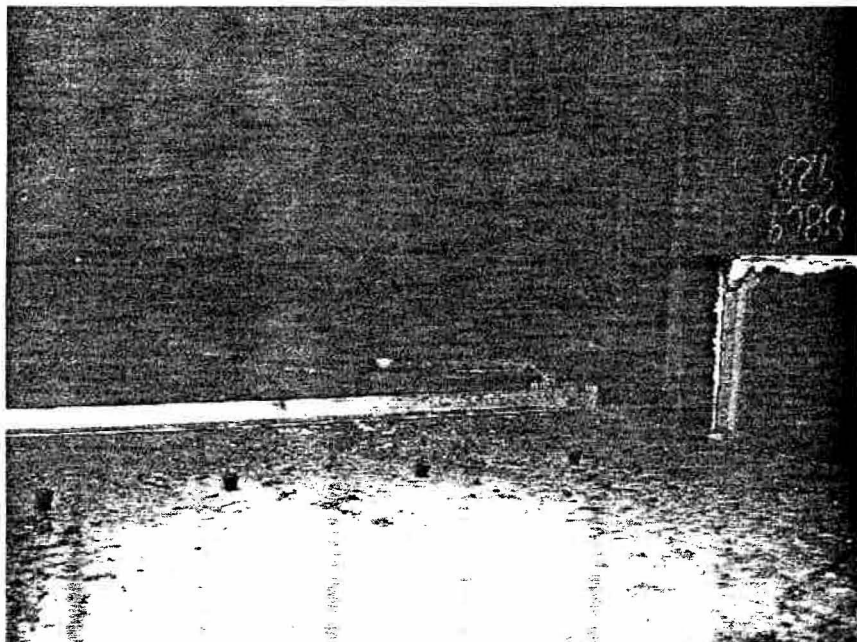
Photo 4.2.5-15
Above Soffit Louver – East Exterior Walkway at Junction Level

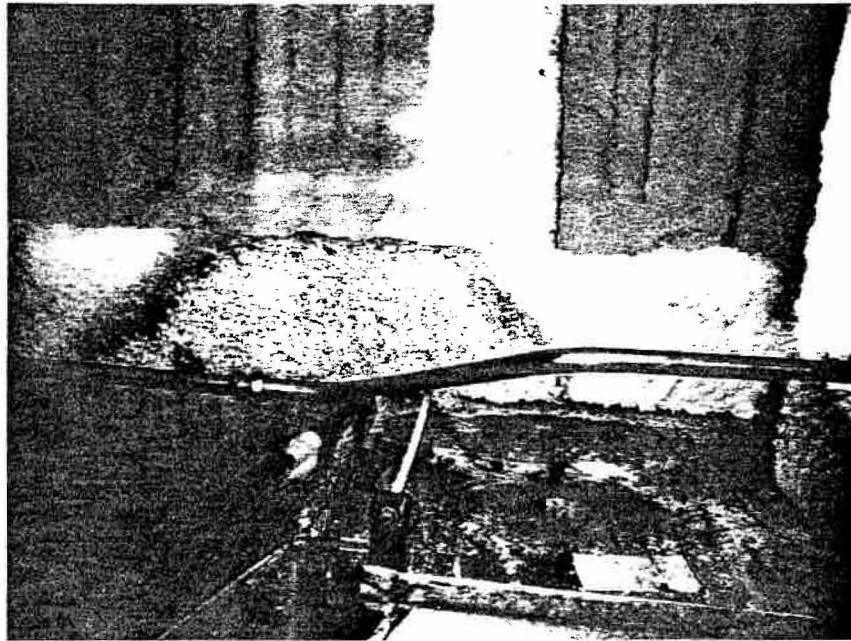
Photo 4.2.6-1
Structural Steel Above Mechanical Room at Sub-Junction Level

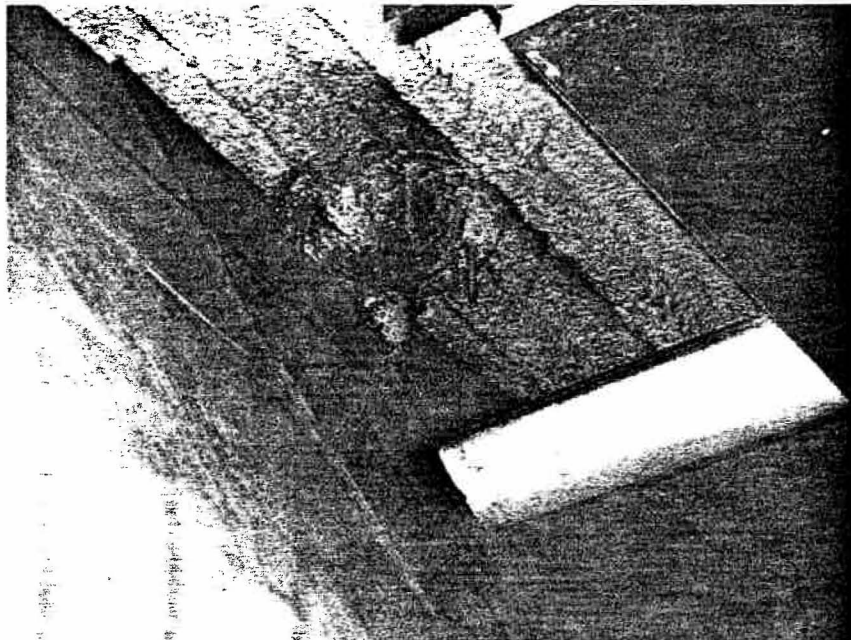
Photo 4.2.6-2
Bottom of Plugged Drain on Exterior Walkway at Junction Level

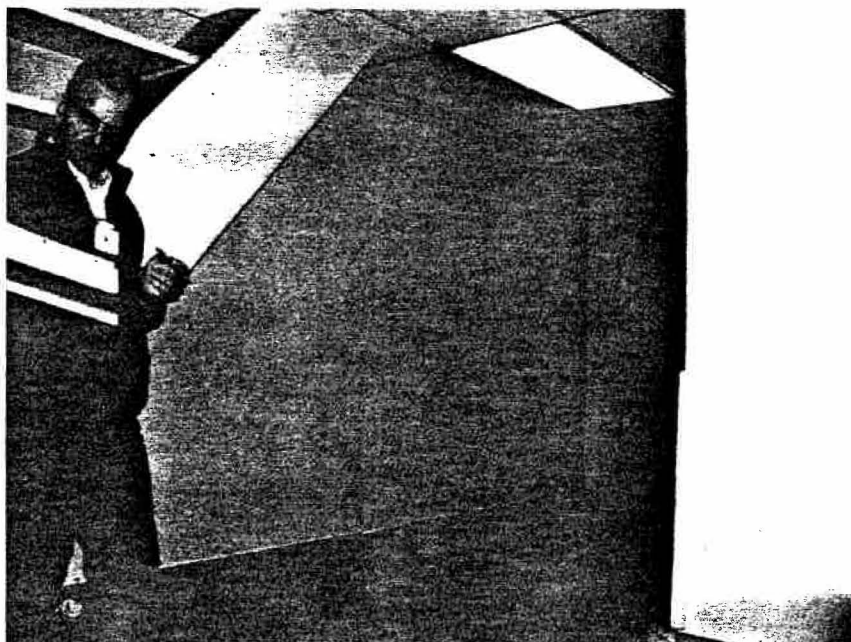
Photo 4.2.7-1
Room #1028 – Plywood Access Panel

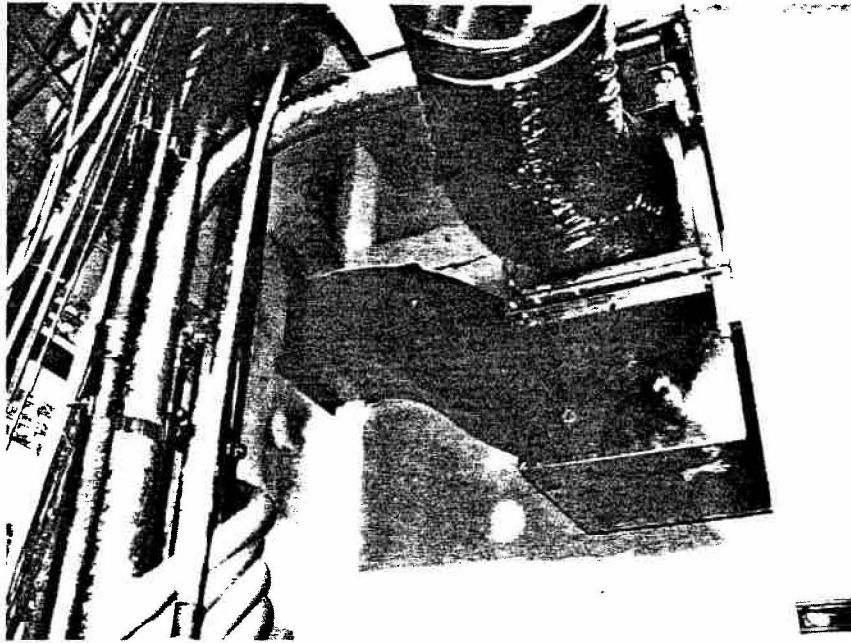
Photo 4.2.7-4
Exhaust Fan in Room 1027A for Room 1028

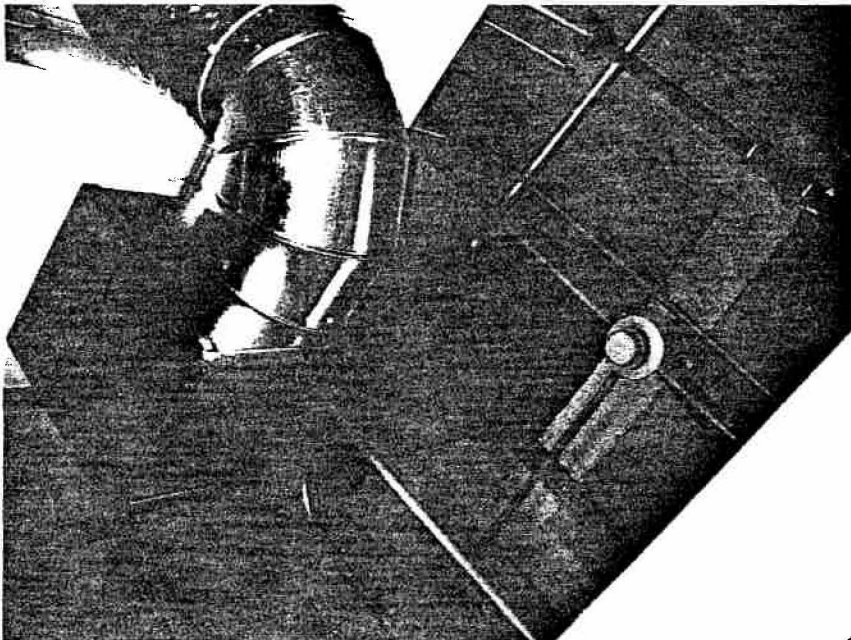
Photo 4.2.7-5
Exhaust Duct From Room 1028 Up Through the 11th Floor Slab

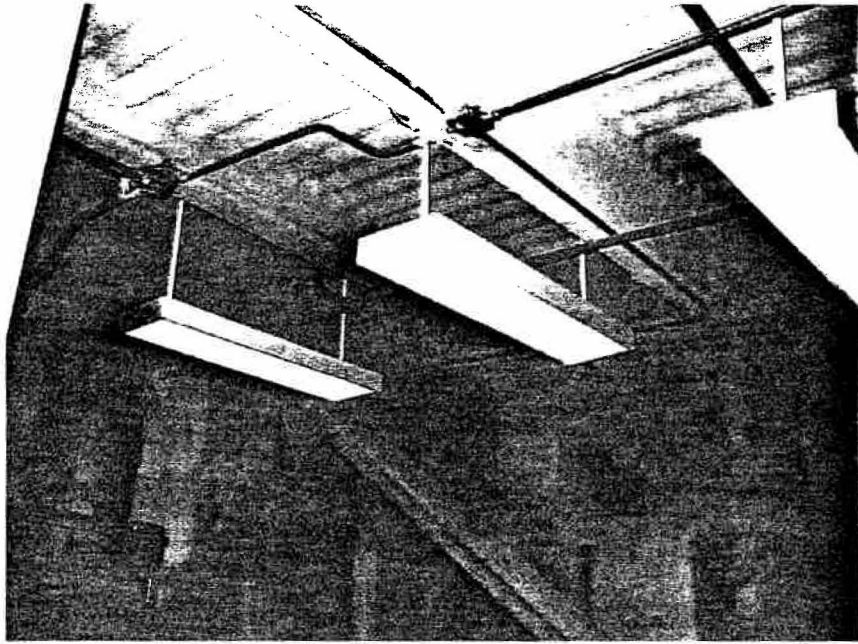
Photo 4.2.8-1
Ceiling in Room #928
