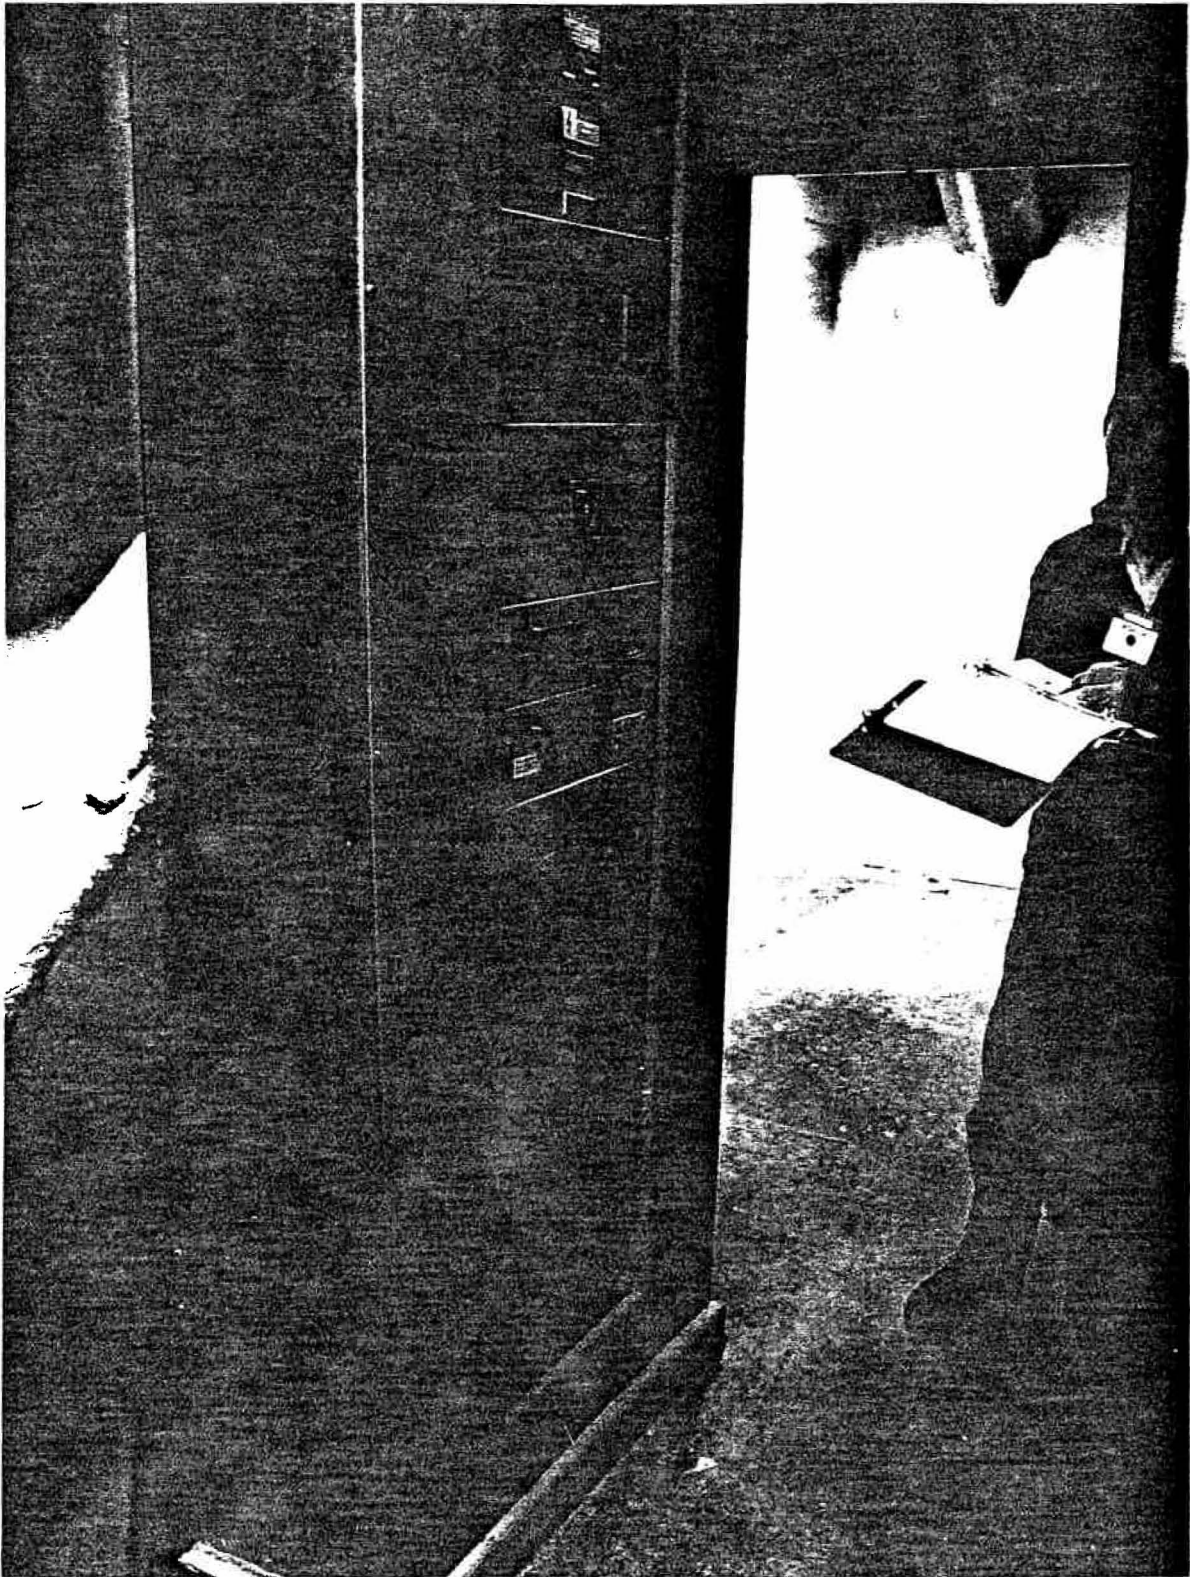
Photo 4.2.8-4
Electrical Equipment in Room #927A

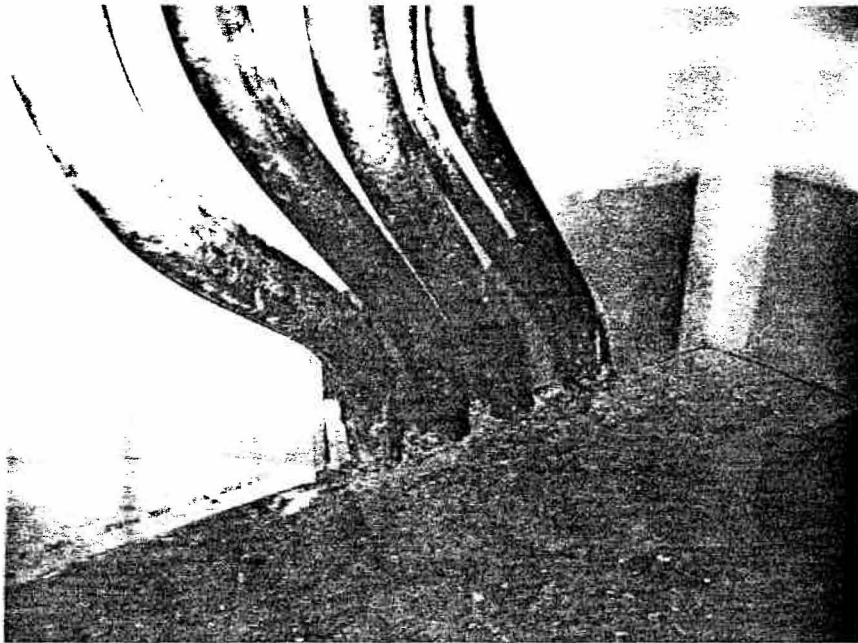
Photo 4.2.8-8
Room #927A - Wall Adjacent to Room 928

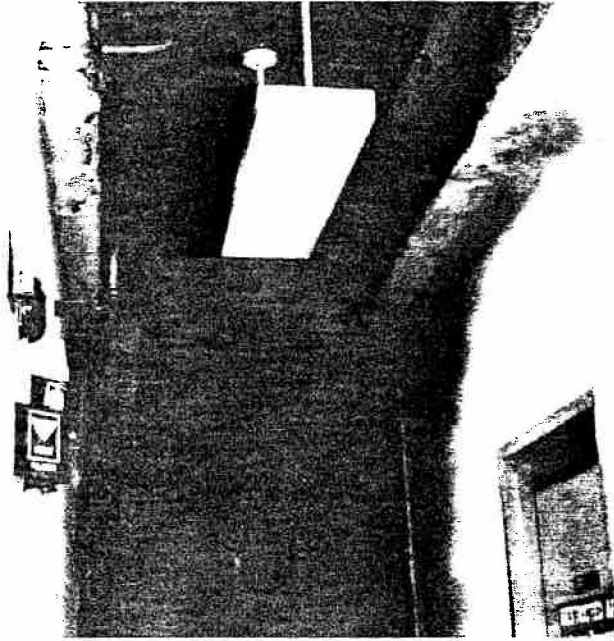
Photo 4.2.9-1
Door to Room 828 on Right – No Rated Wall above Beam Above Door

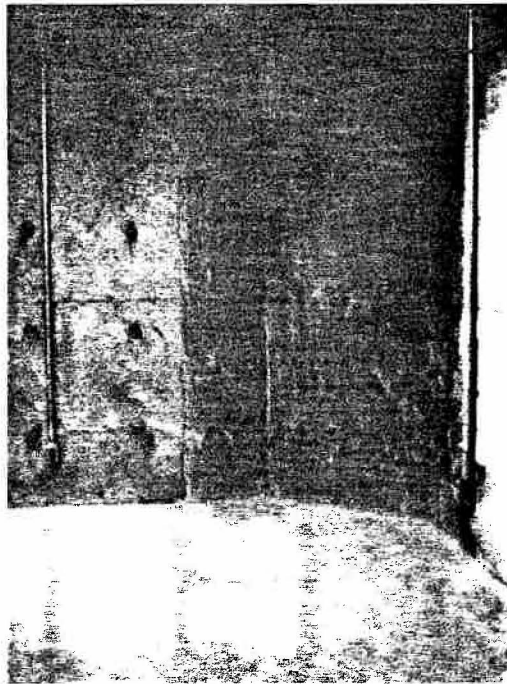
Photo 4.2.9-2
Exterior Wall in Room #828 – Moisture at Horizontal Joint

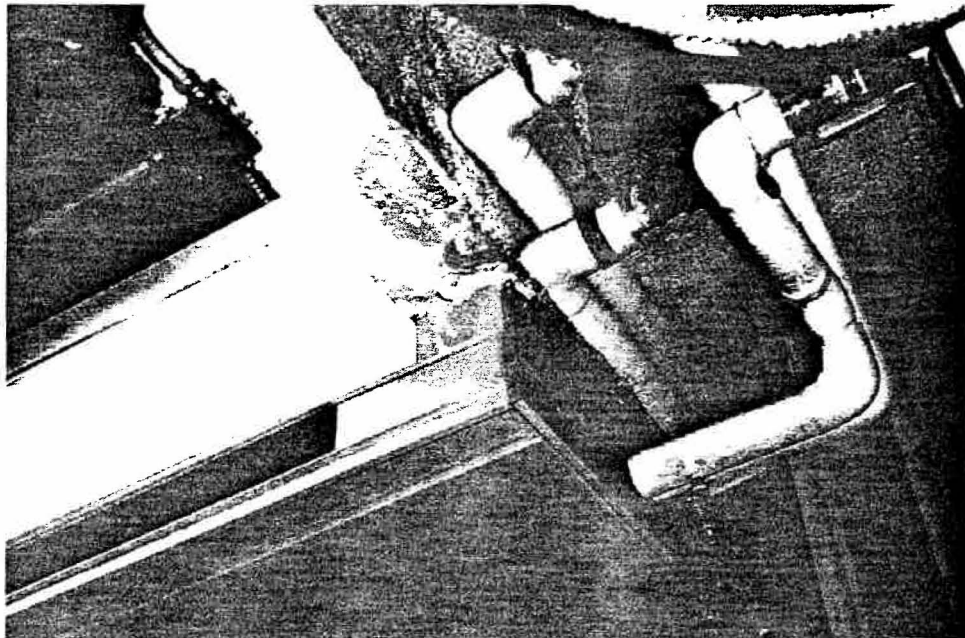
Photo 4.2.9-4
Moisture Stain on Beam in Room #827

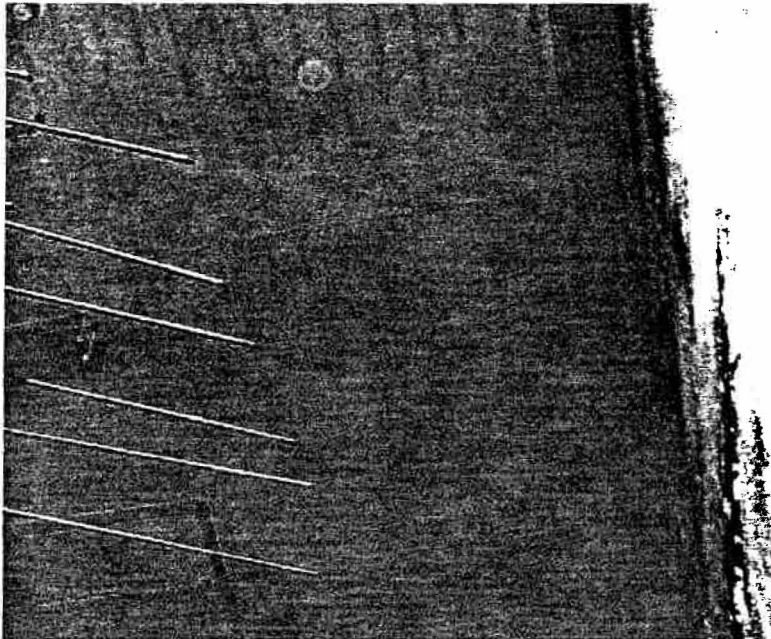
Photo 4.2.10-1
Ceiling/Floor Slab Above Room #728

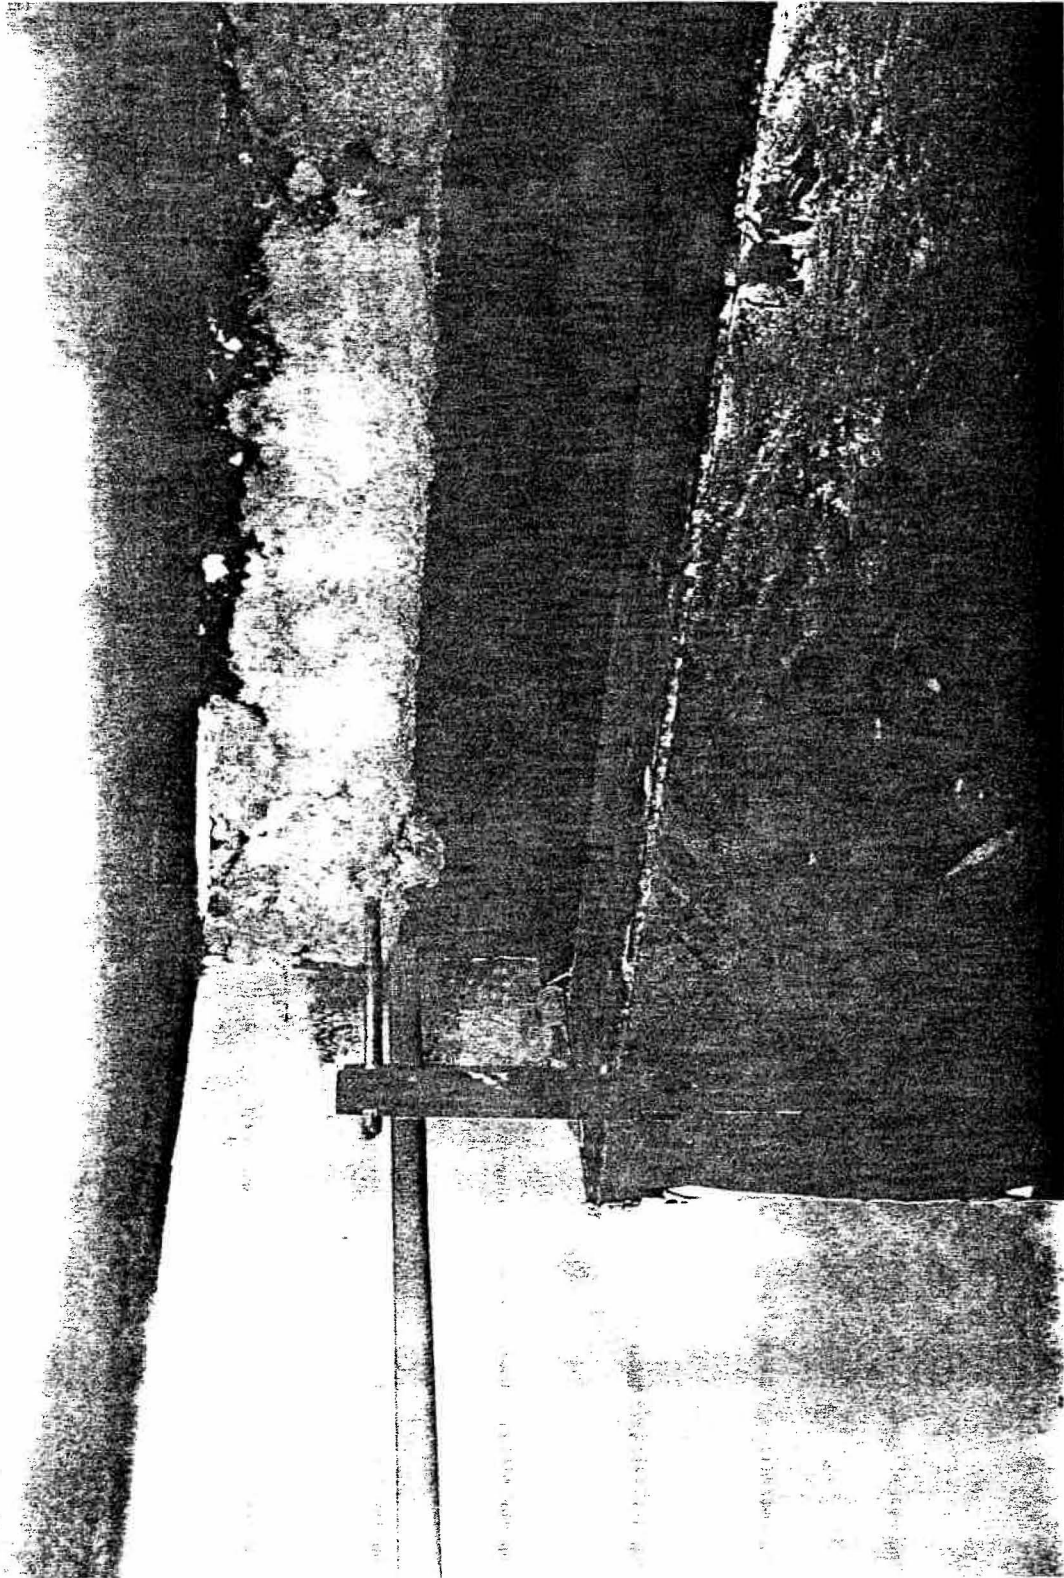
Photo 4.2.12-2
Wall Between Elevator Lobby and Room #527 – Note all Stops Top of Duct

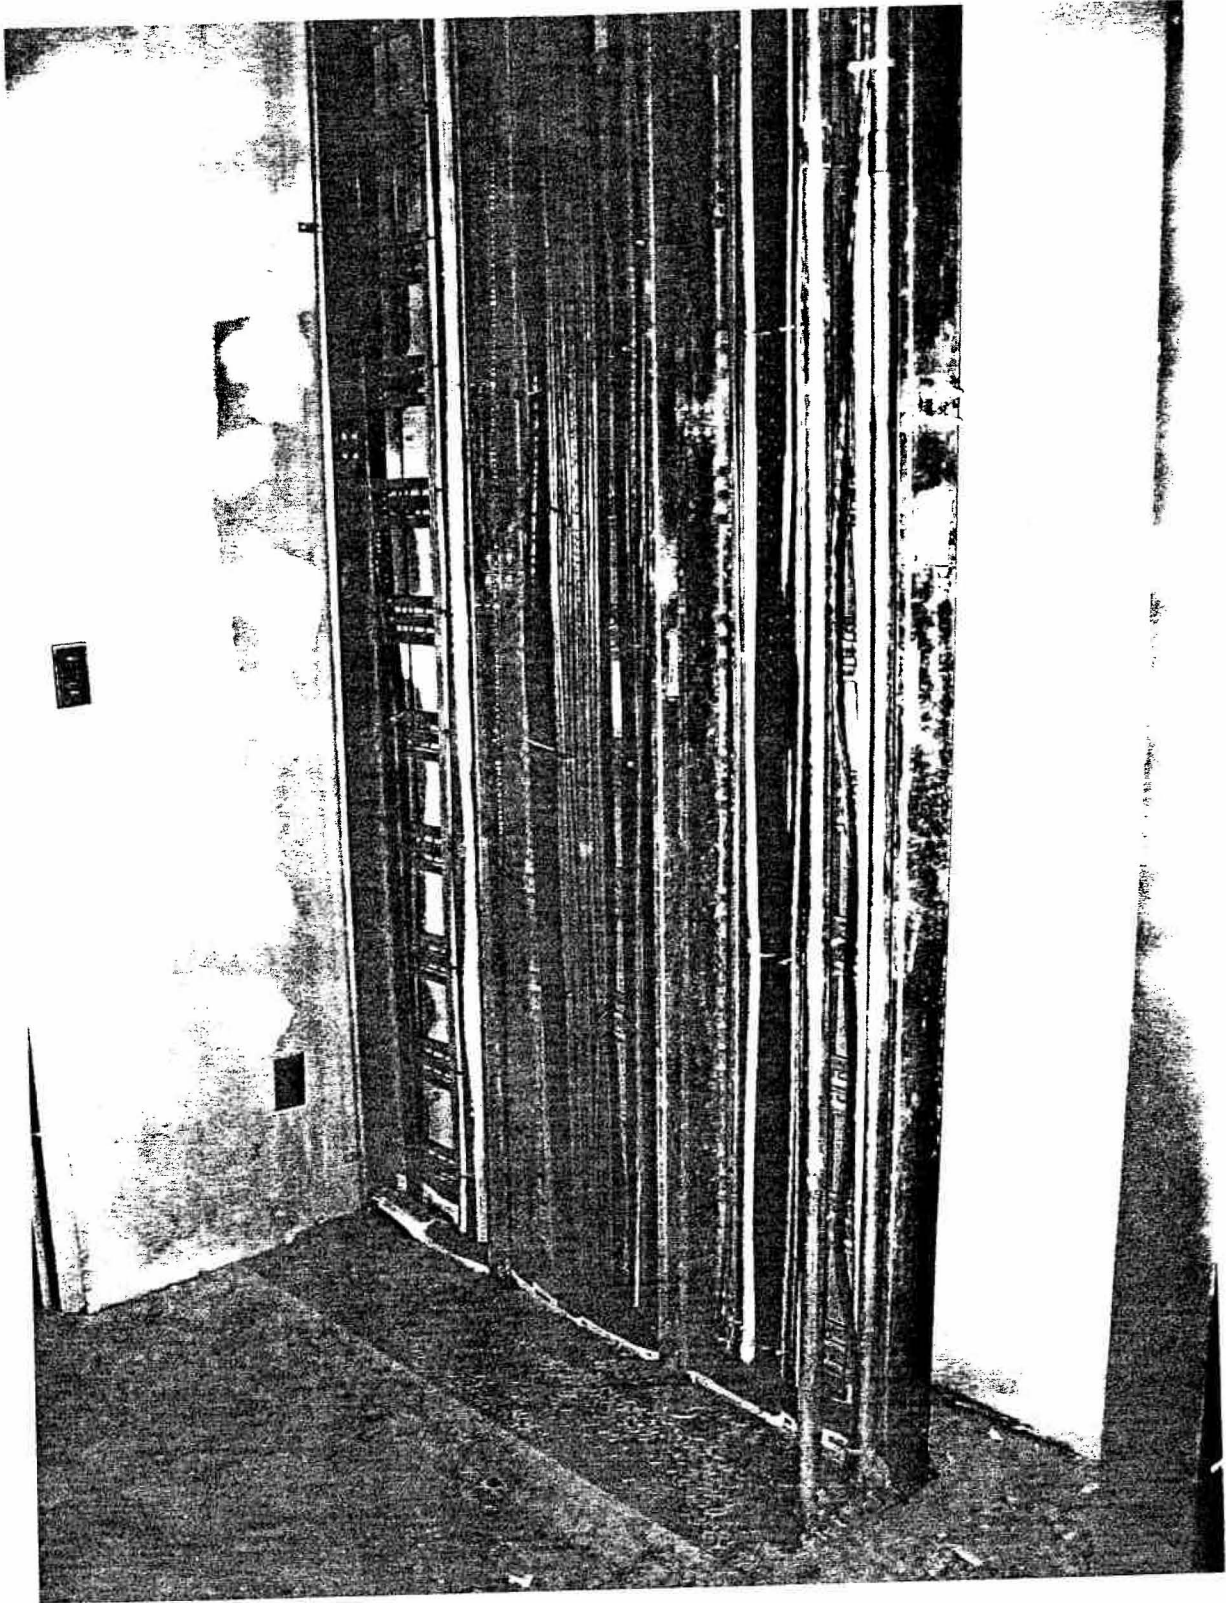
Photo 4.2.12-2
Room #527A – Stains at Bottom of Wall and Up Corner

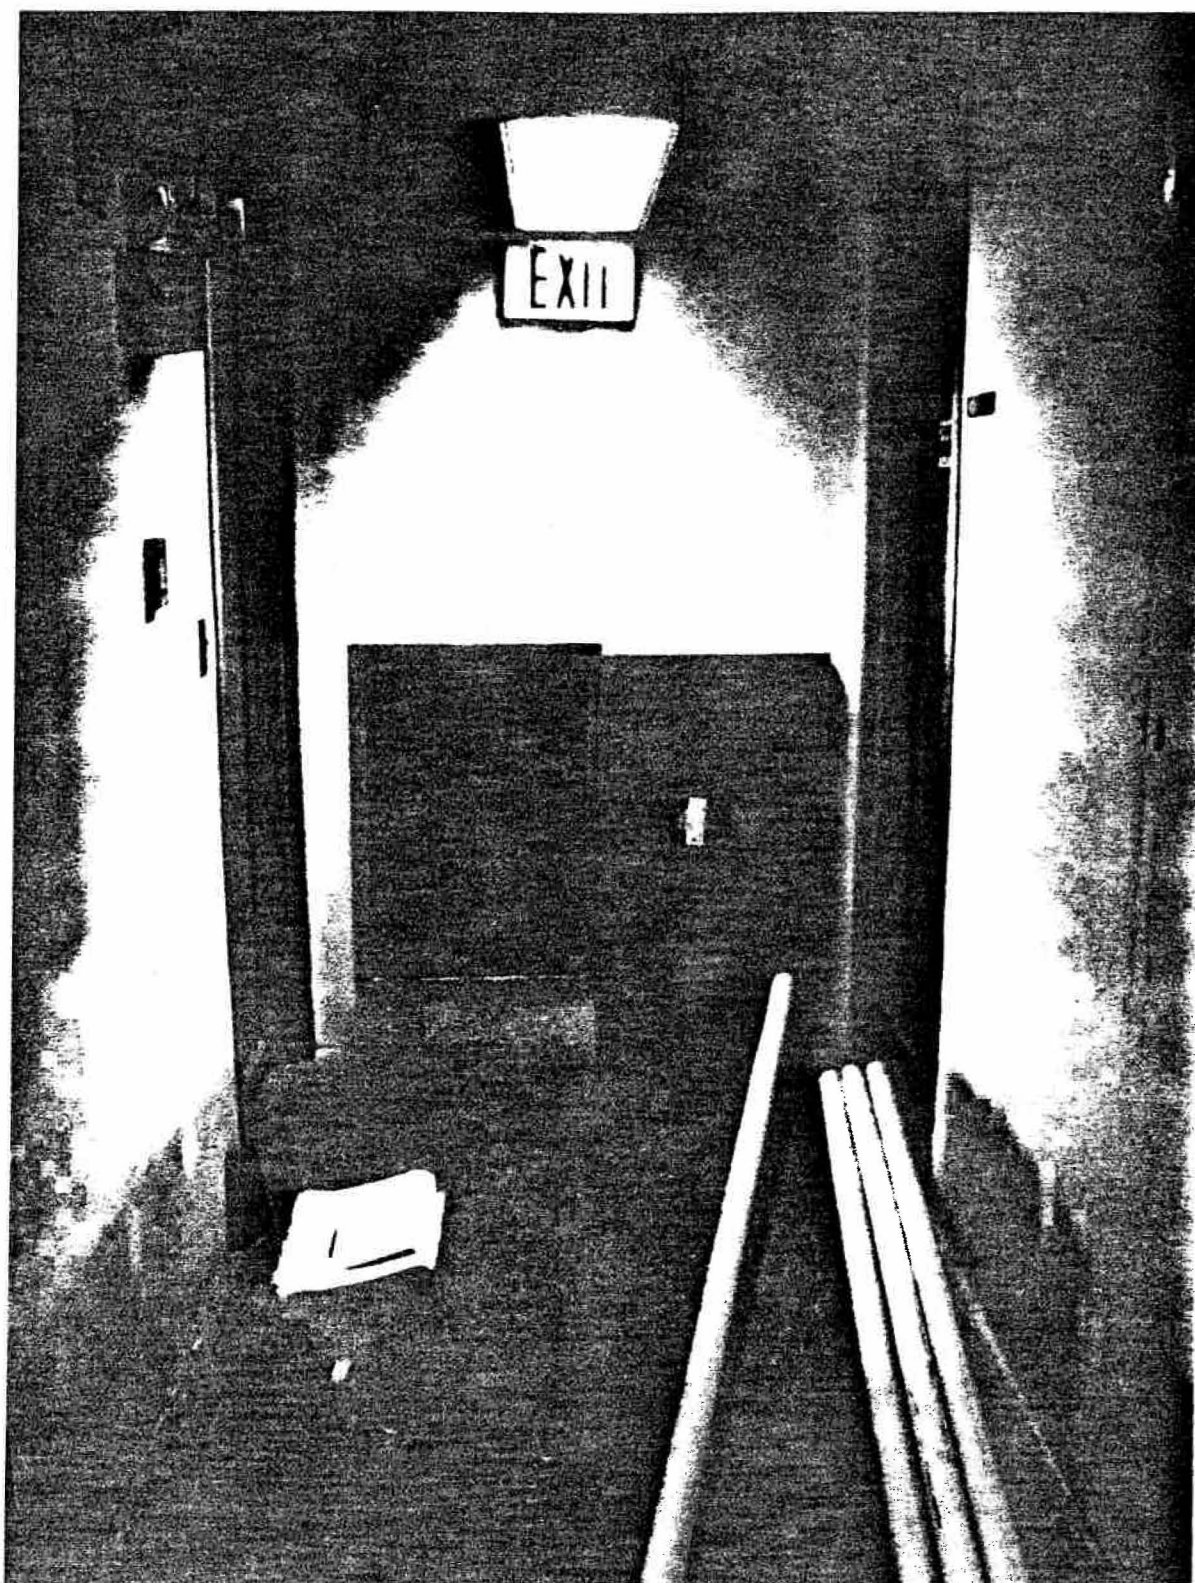
Photo 4.2.13-1
Fourth Floor Elevator Vestibule – Uninsulated Access Door

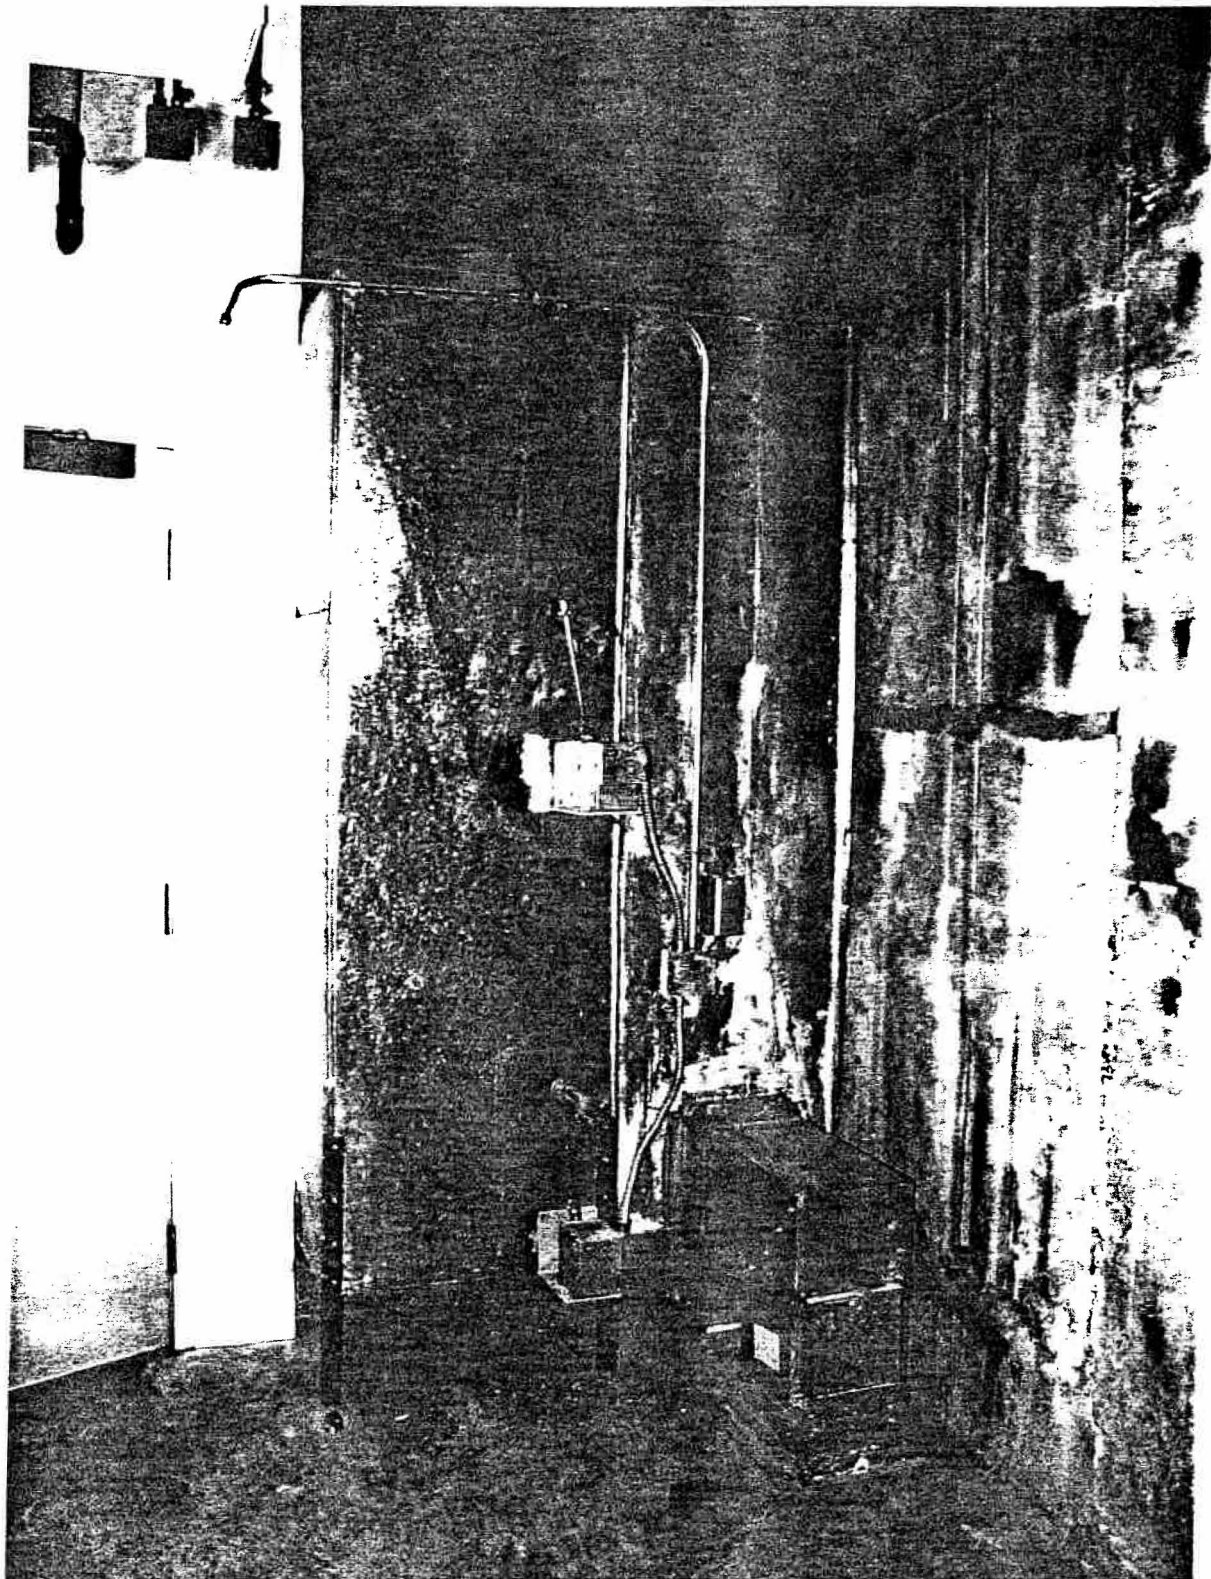
Photo 4.2.13-2
Room #428 Exposed to Ductwork for Stairway Pressurization Intake

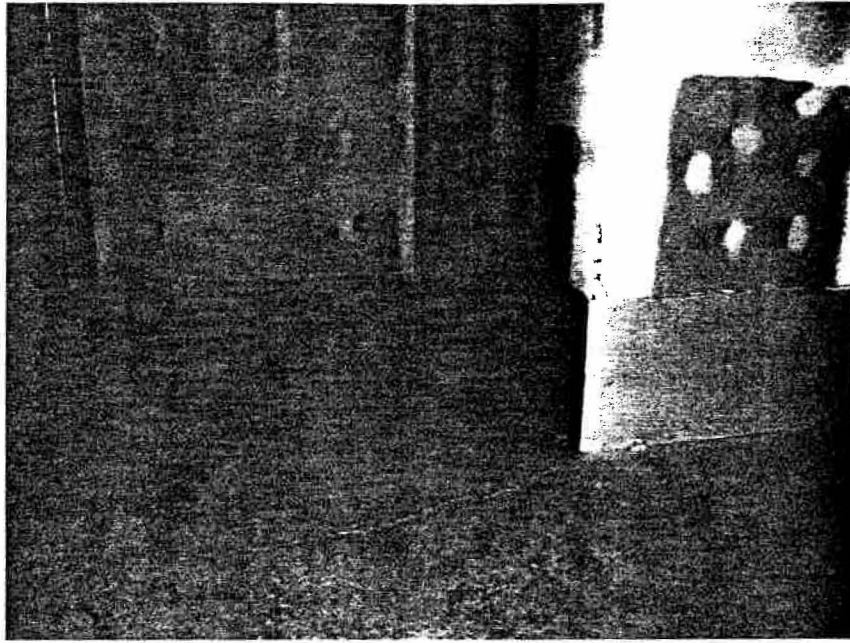
Photo 4.2.13-3
Room #428 – Replaced Gypsum Board

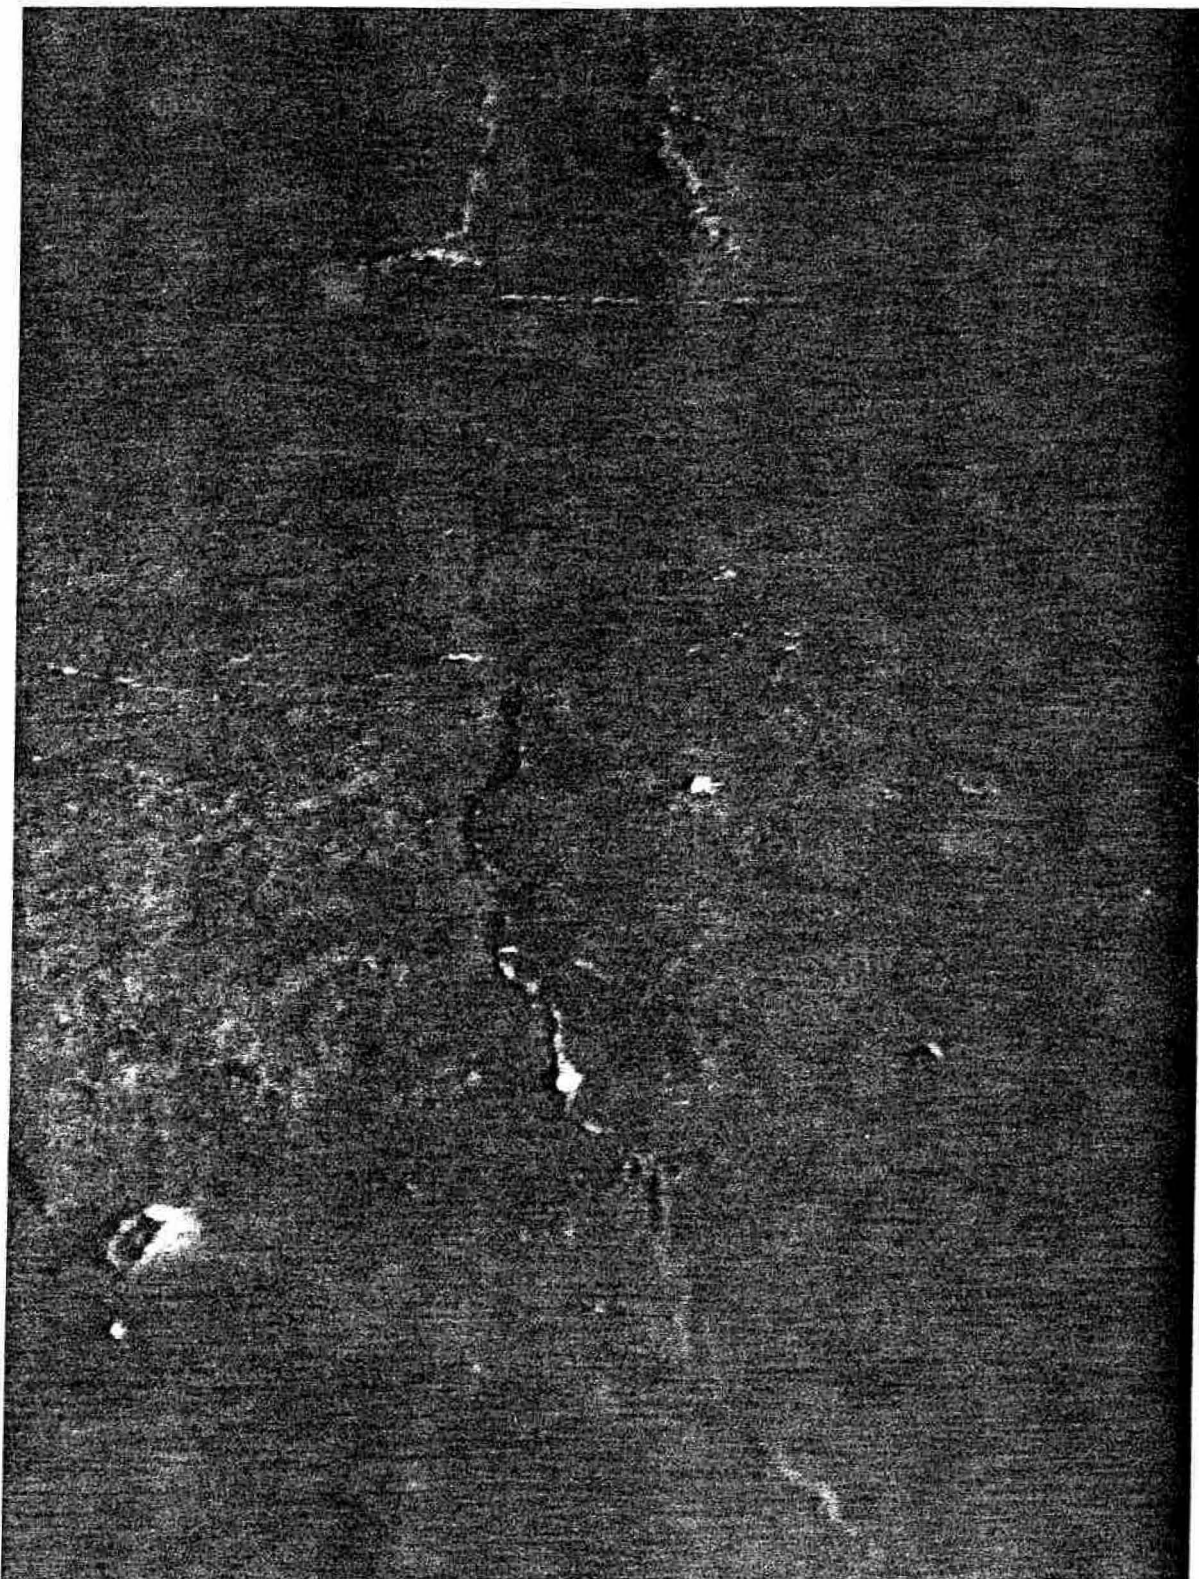
Photo 4.2.13-4
Room #428 – Cracked Floor Slab and Efflorescence on Exterior Wall

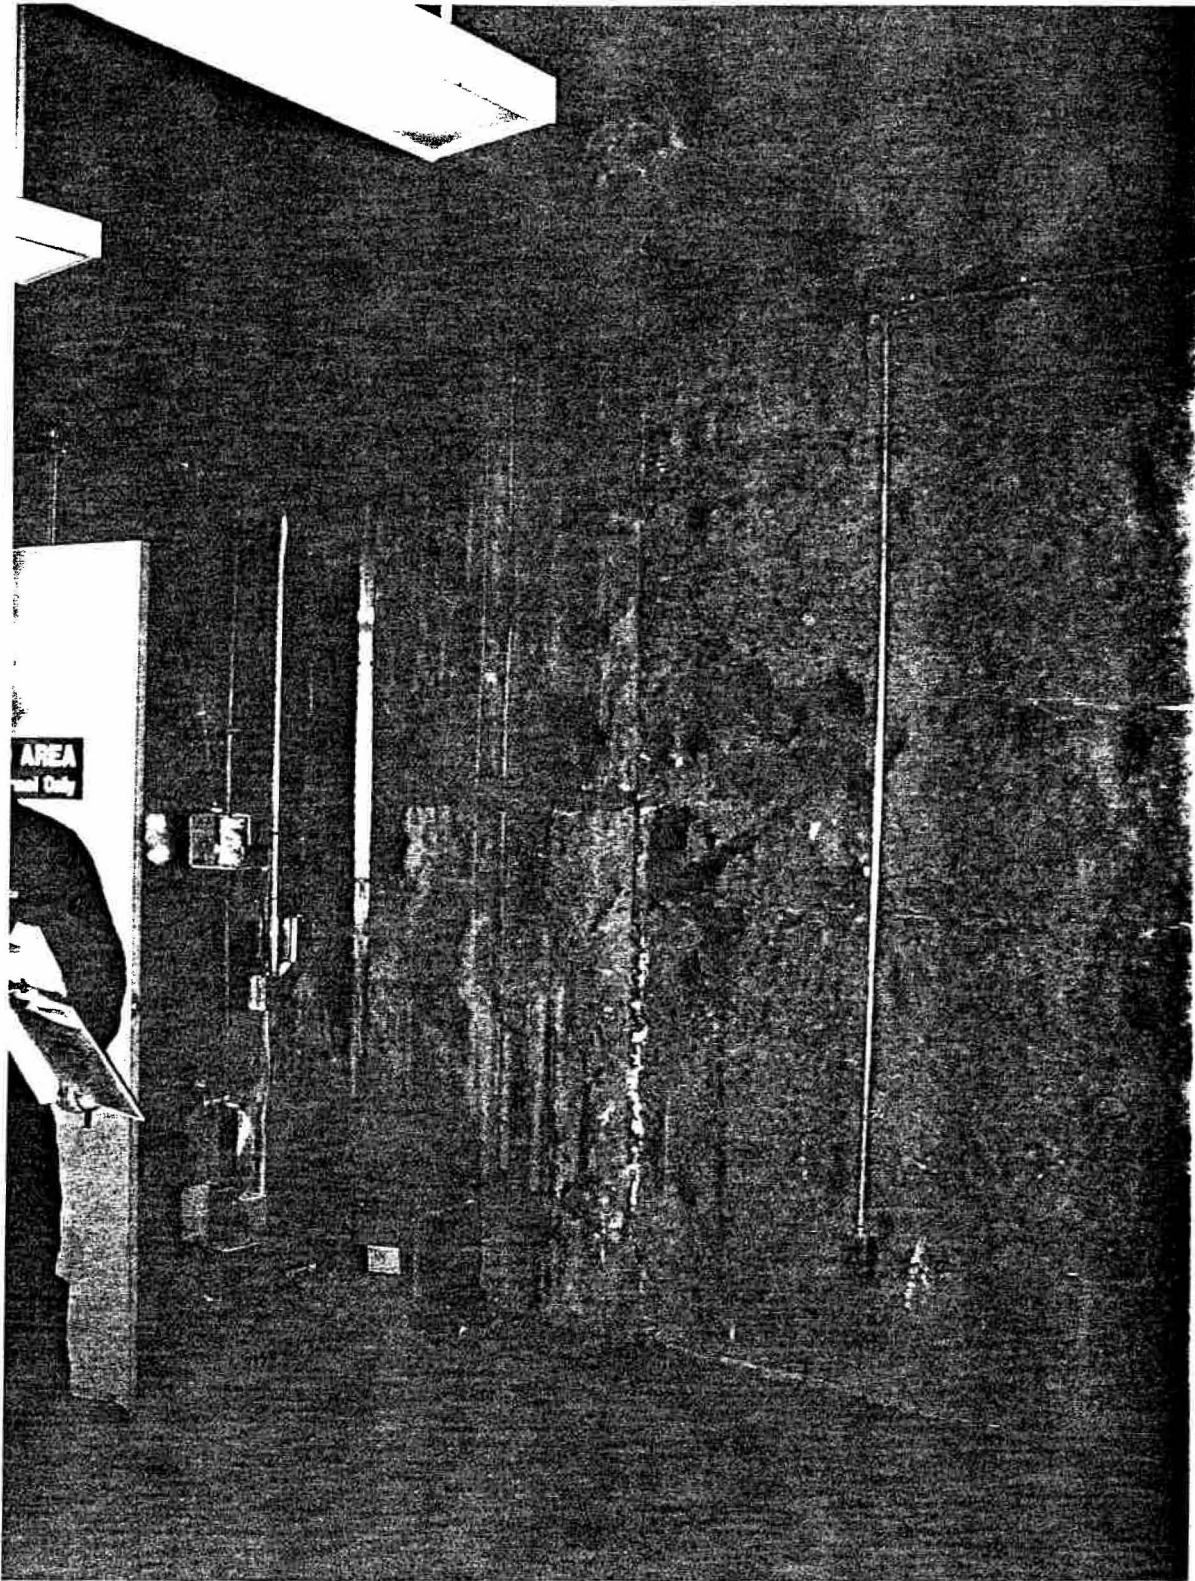
Photo 4.2.13-5
Room #428 – Stains at Joint Between and at Top of Structural Precast and Cast-In-Place Concrete

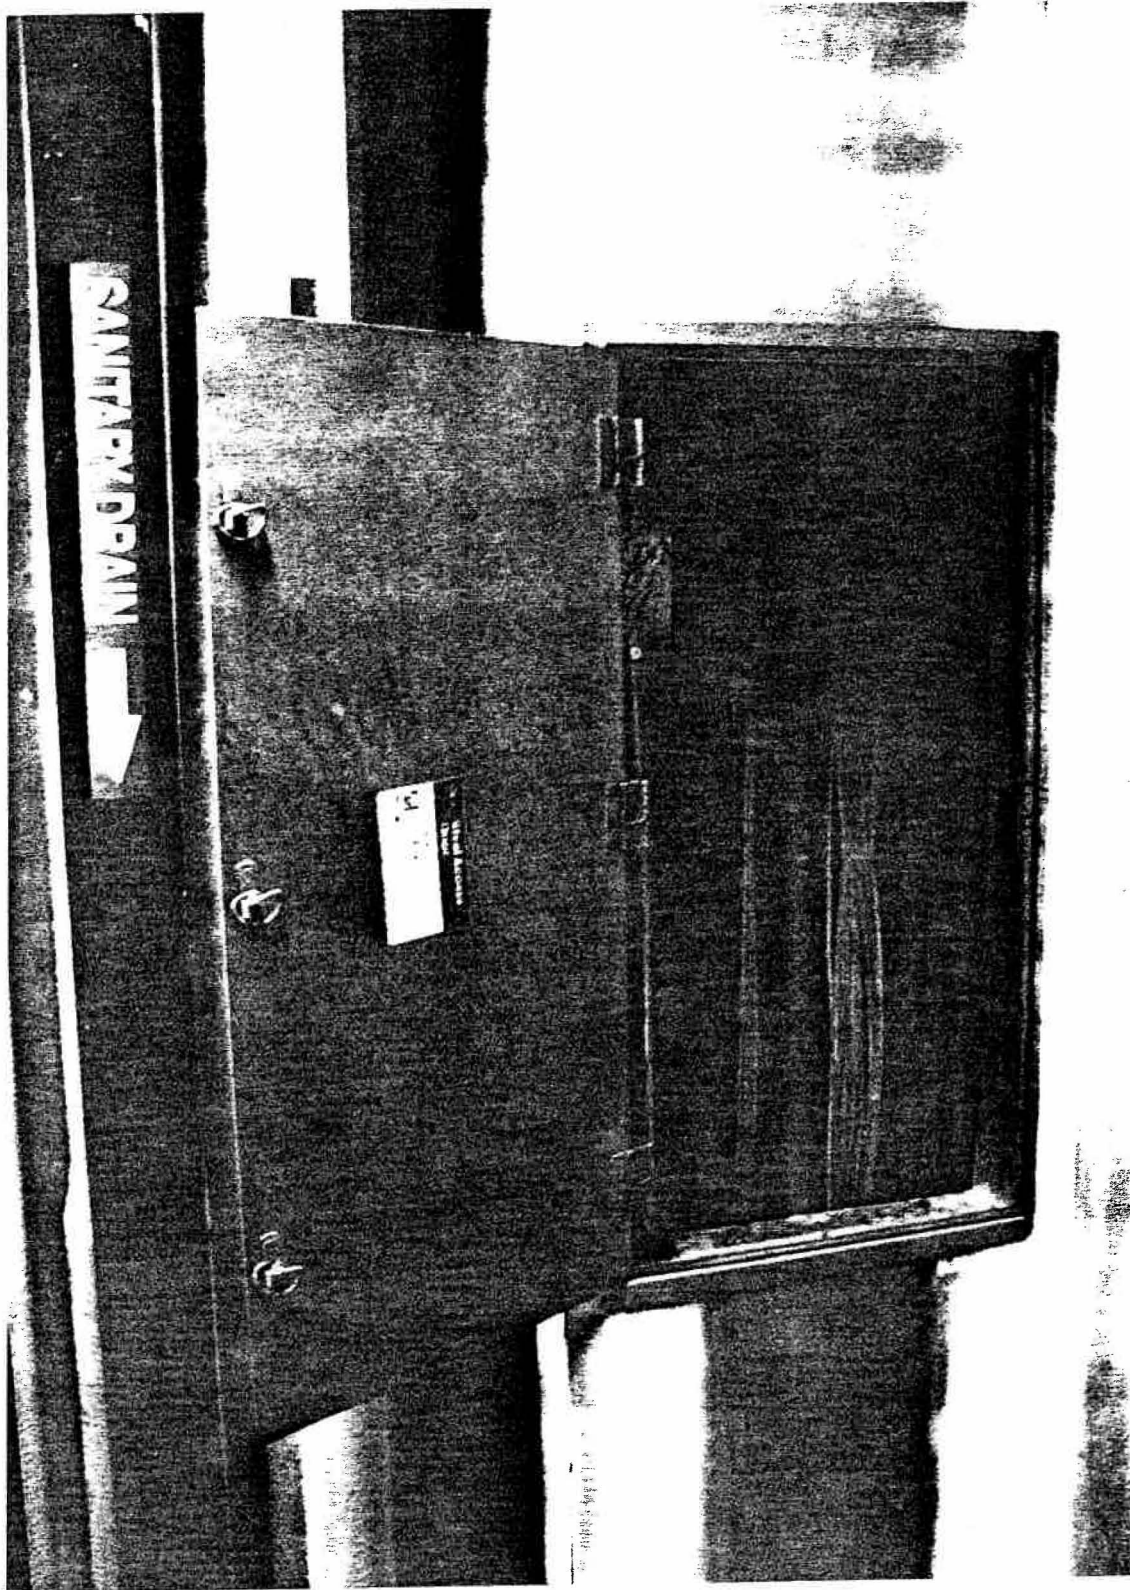
Photo 4.2.13-7
Room #427 - Non-Rated Access Door

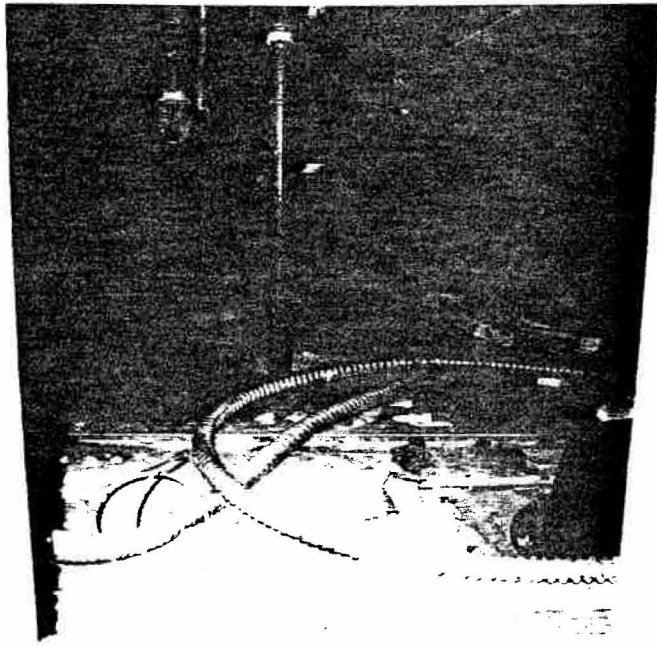
Photo 4.2 13-8
4th Floor Above Elevator Vestibule – Improperly Rated Penetrations

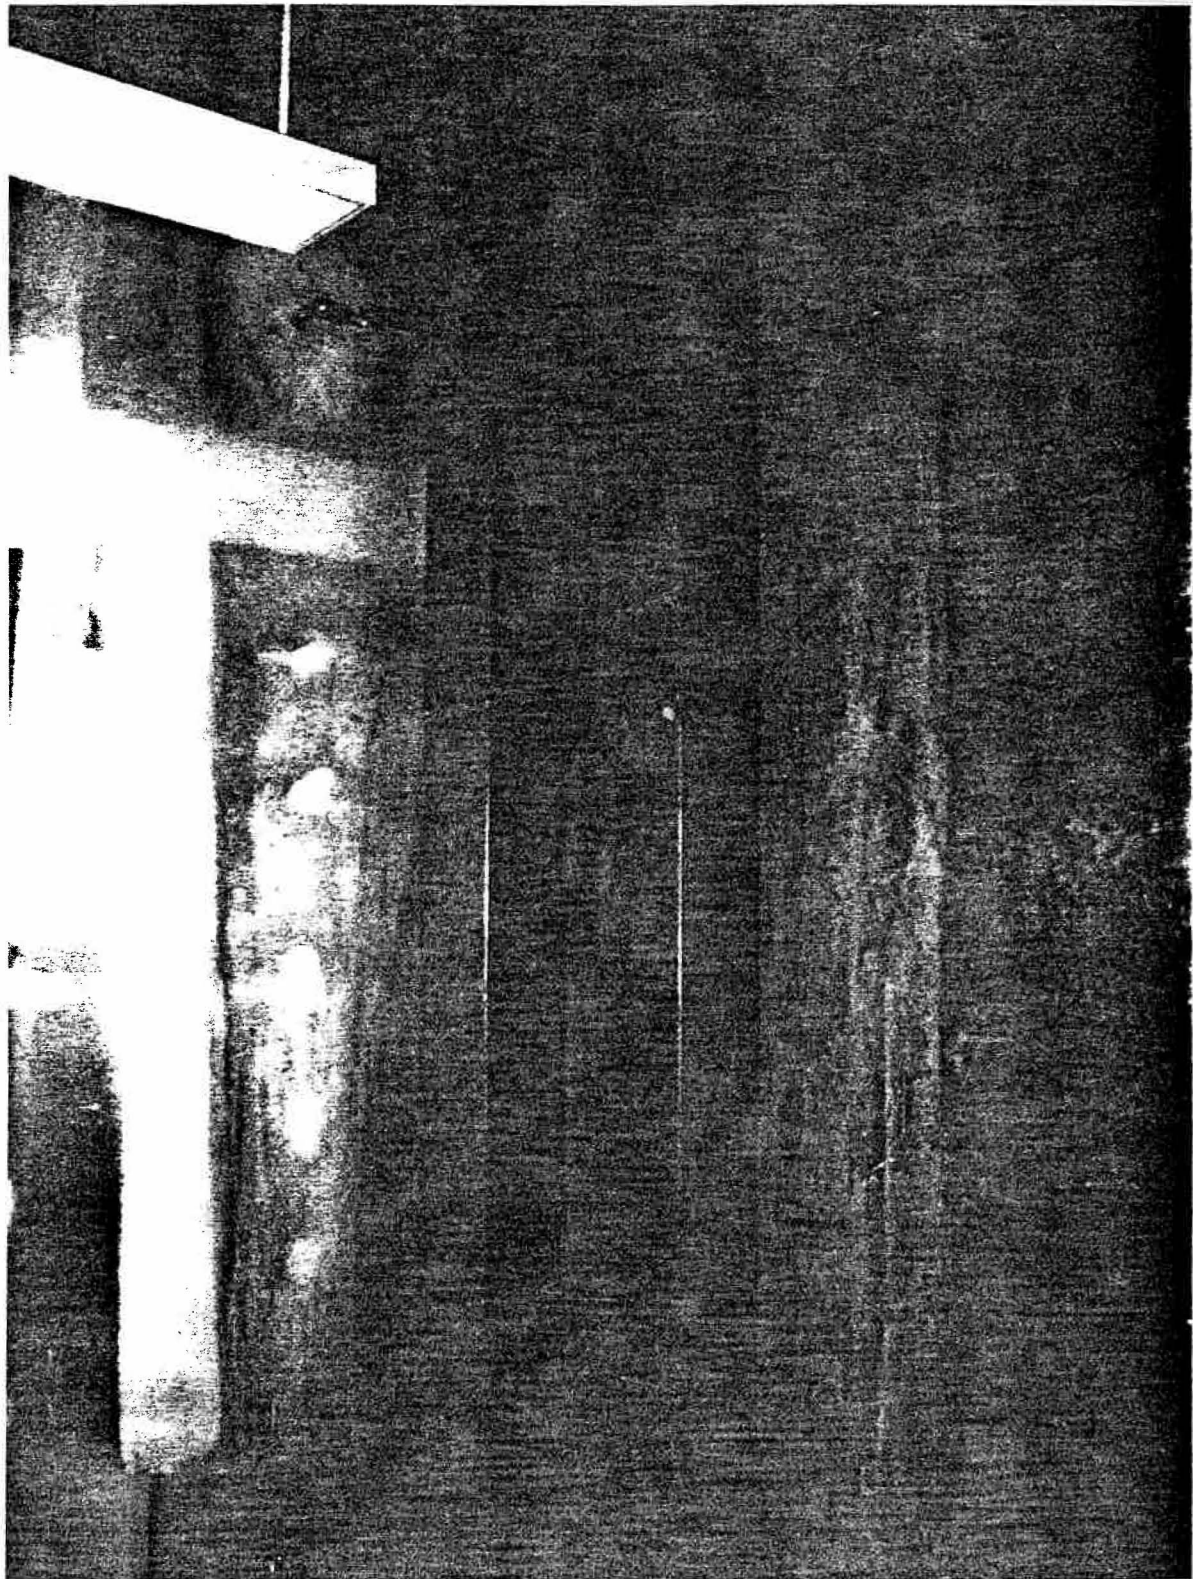
Photo 4.2.14-1
Room #328 – Ducts Without Fire Dampers

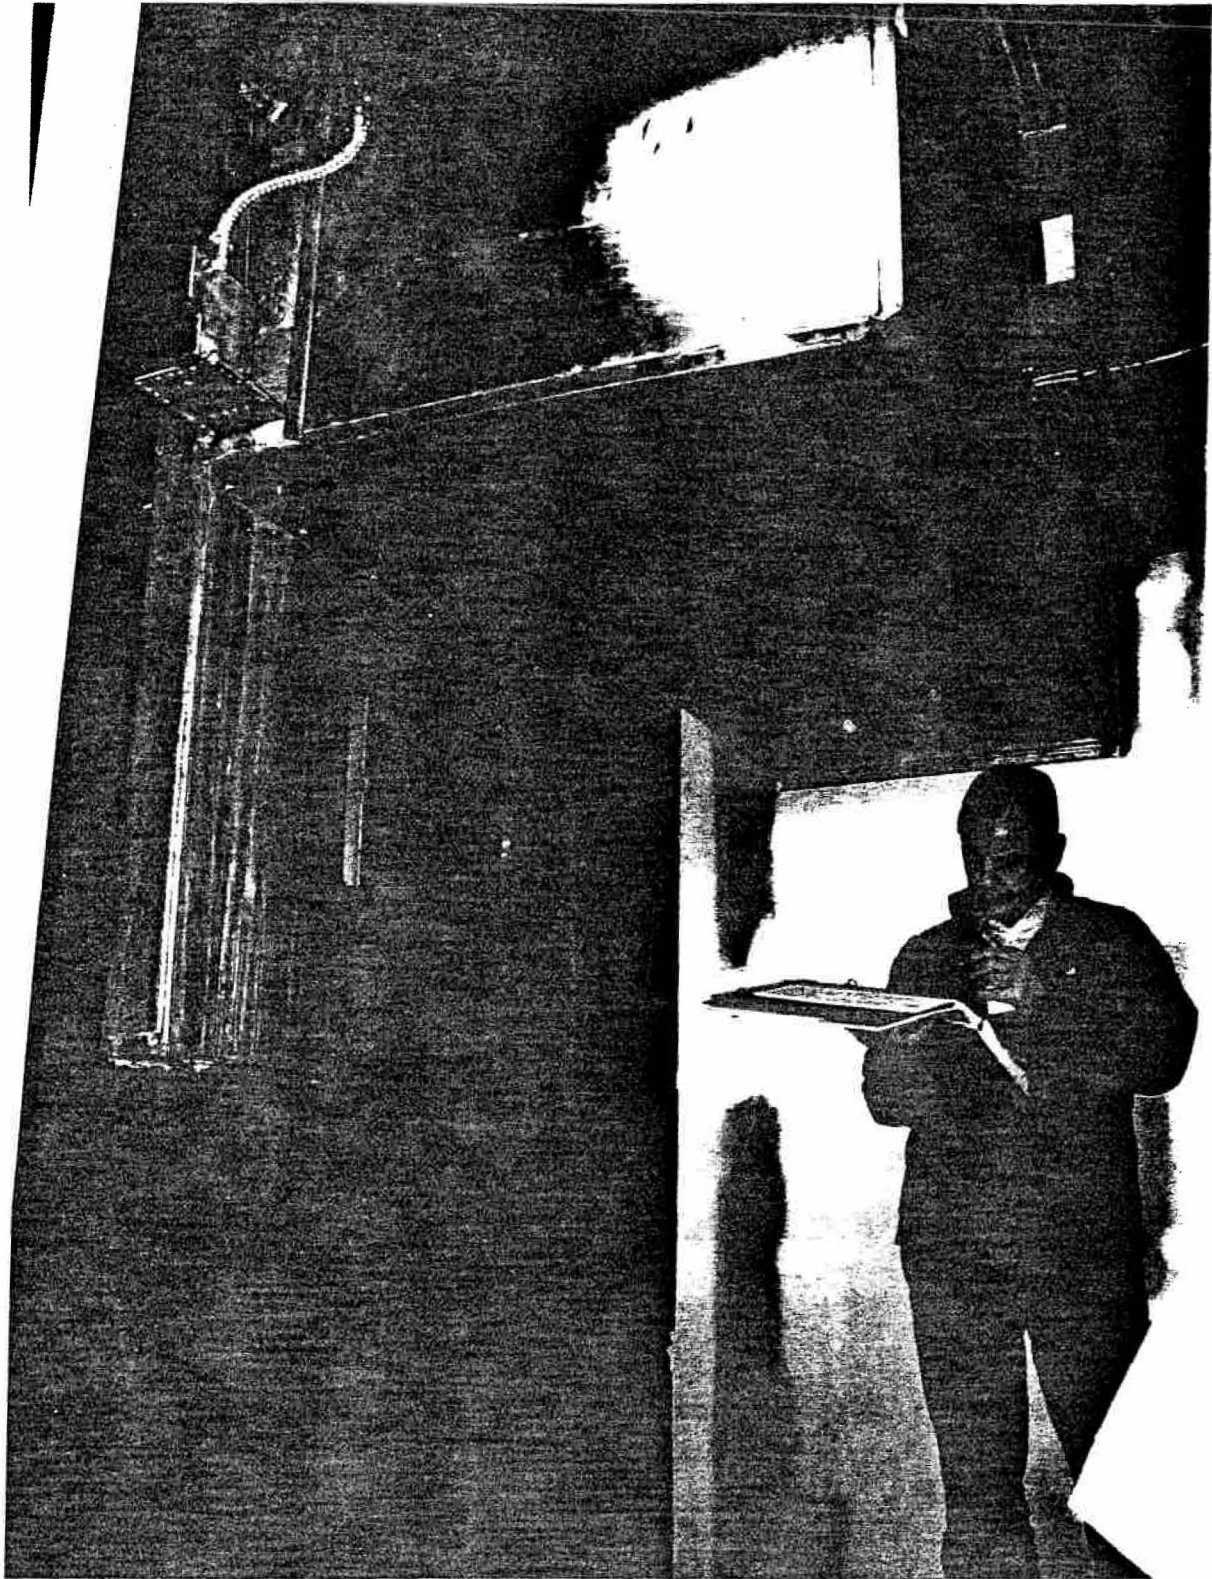
Photo 4.2.14-2
Room #327 – Stains on Blank-off Panel

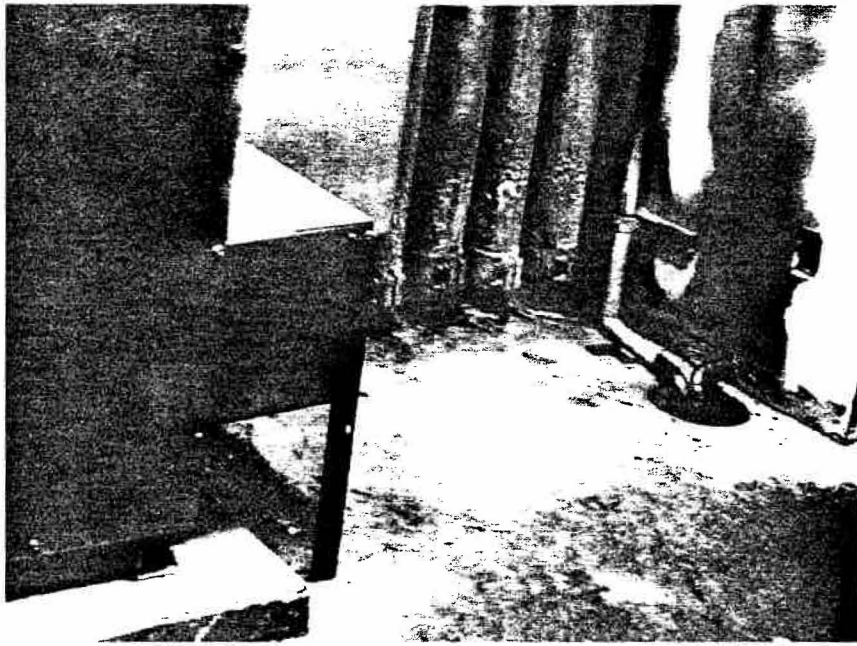
Photo 4.2.16-1
Room #127 – Floor Drain
