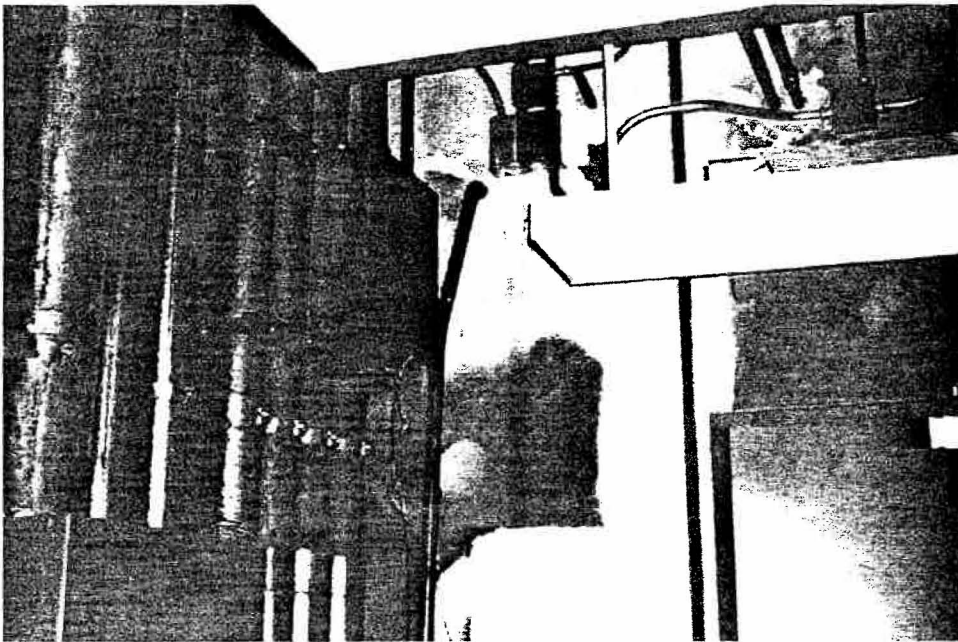
Photo 4.2.16-2
Room #127 – Water Stain on Wall

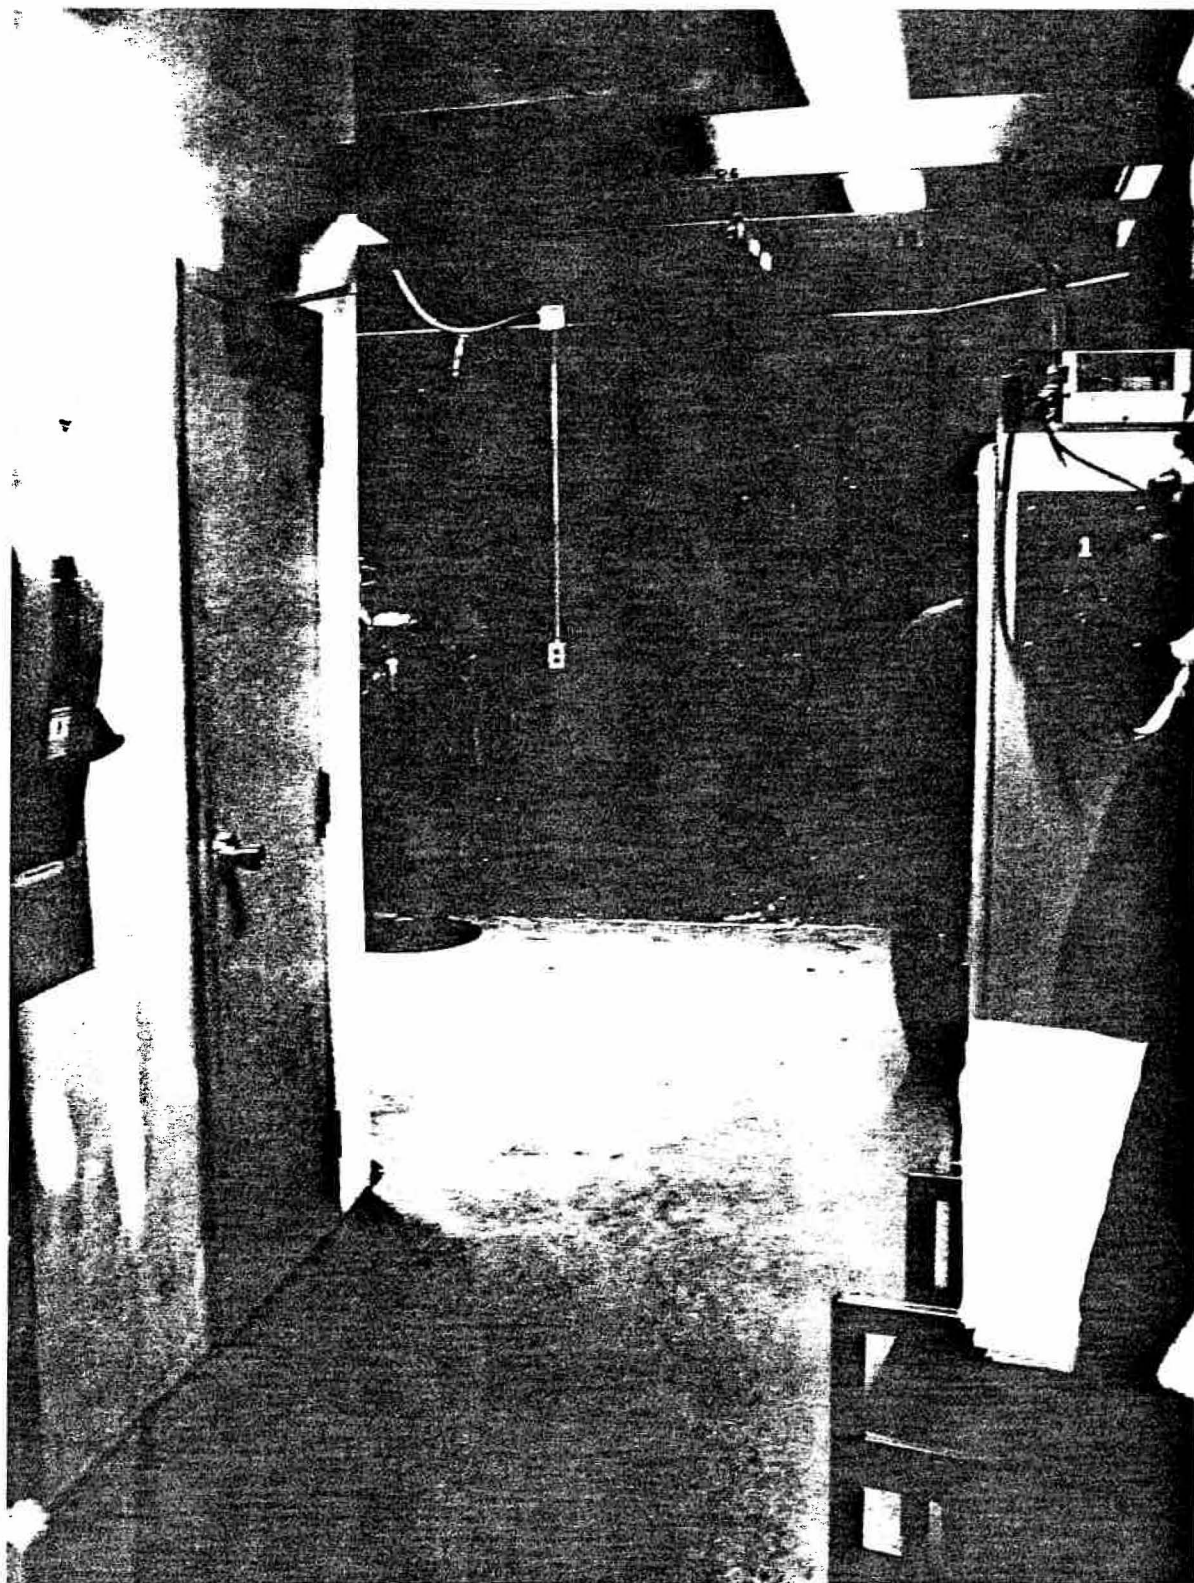
Photo 4.2.16-3
Room #127A – Elevator Machine Room

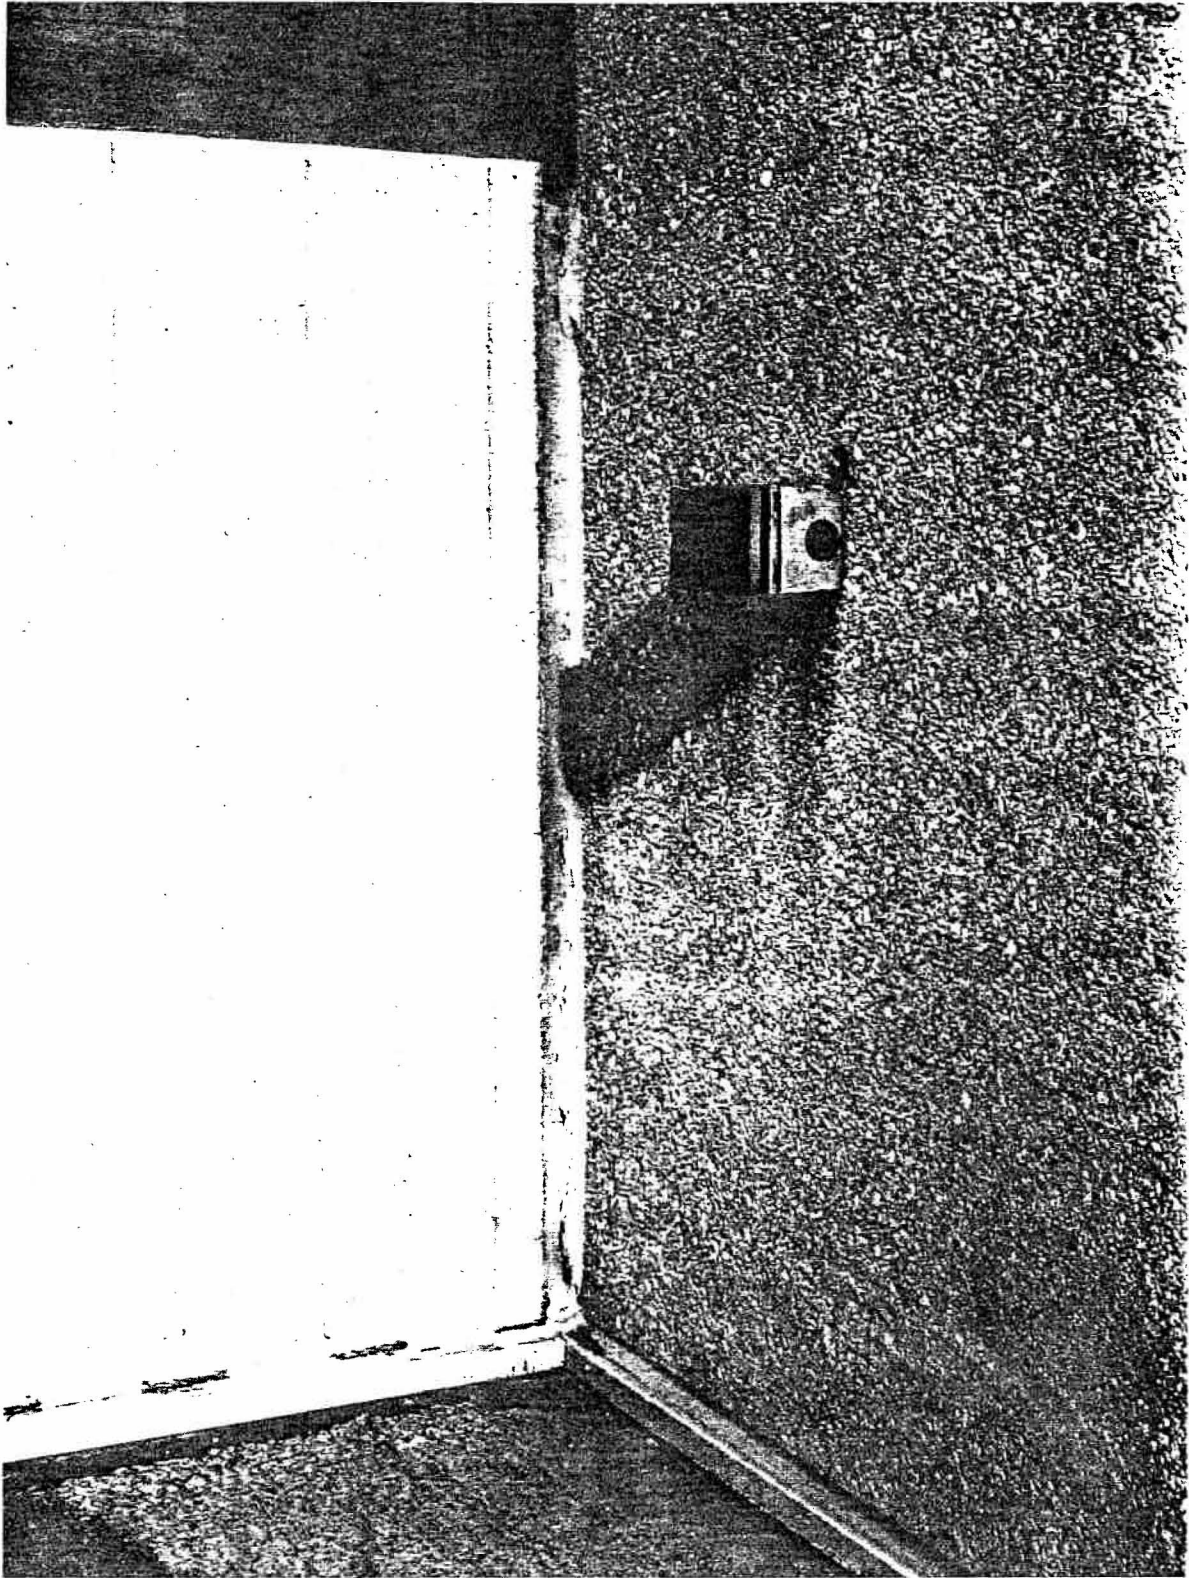
Photo 6.1.12-1
Wide Joint at Link/Base Building
