Upper Big Branch Mine–South Mine ID: 46-08436

April 5, 2010 Accident

Public Briefing

June 29, 2011

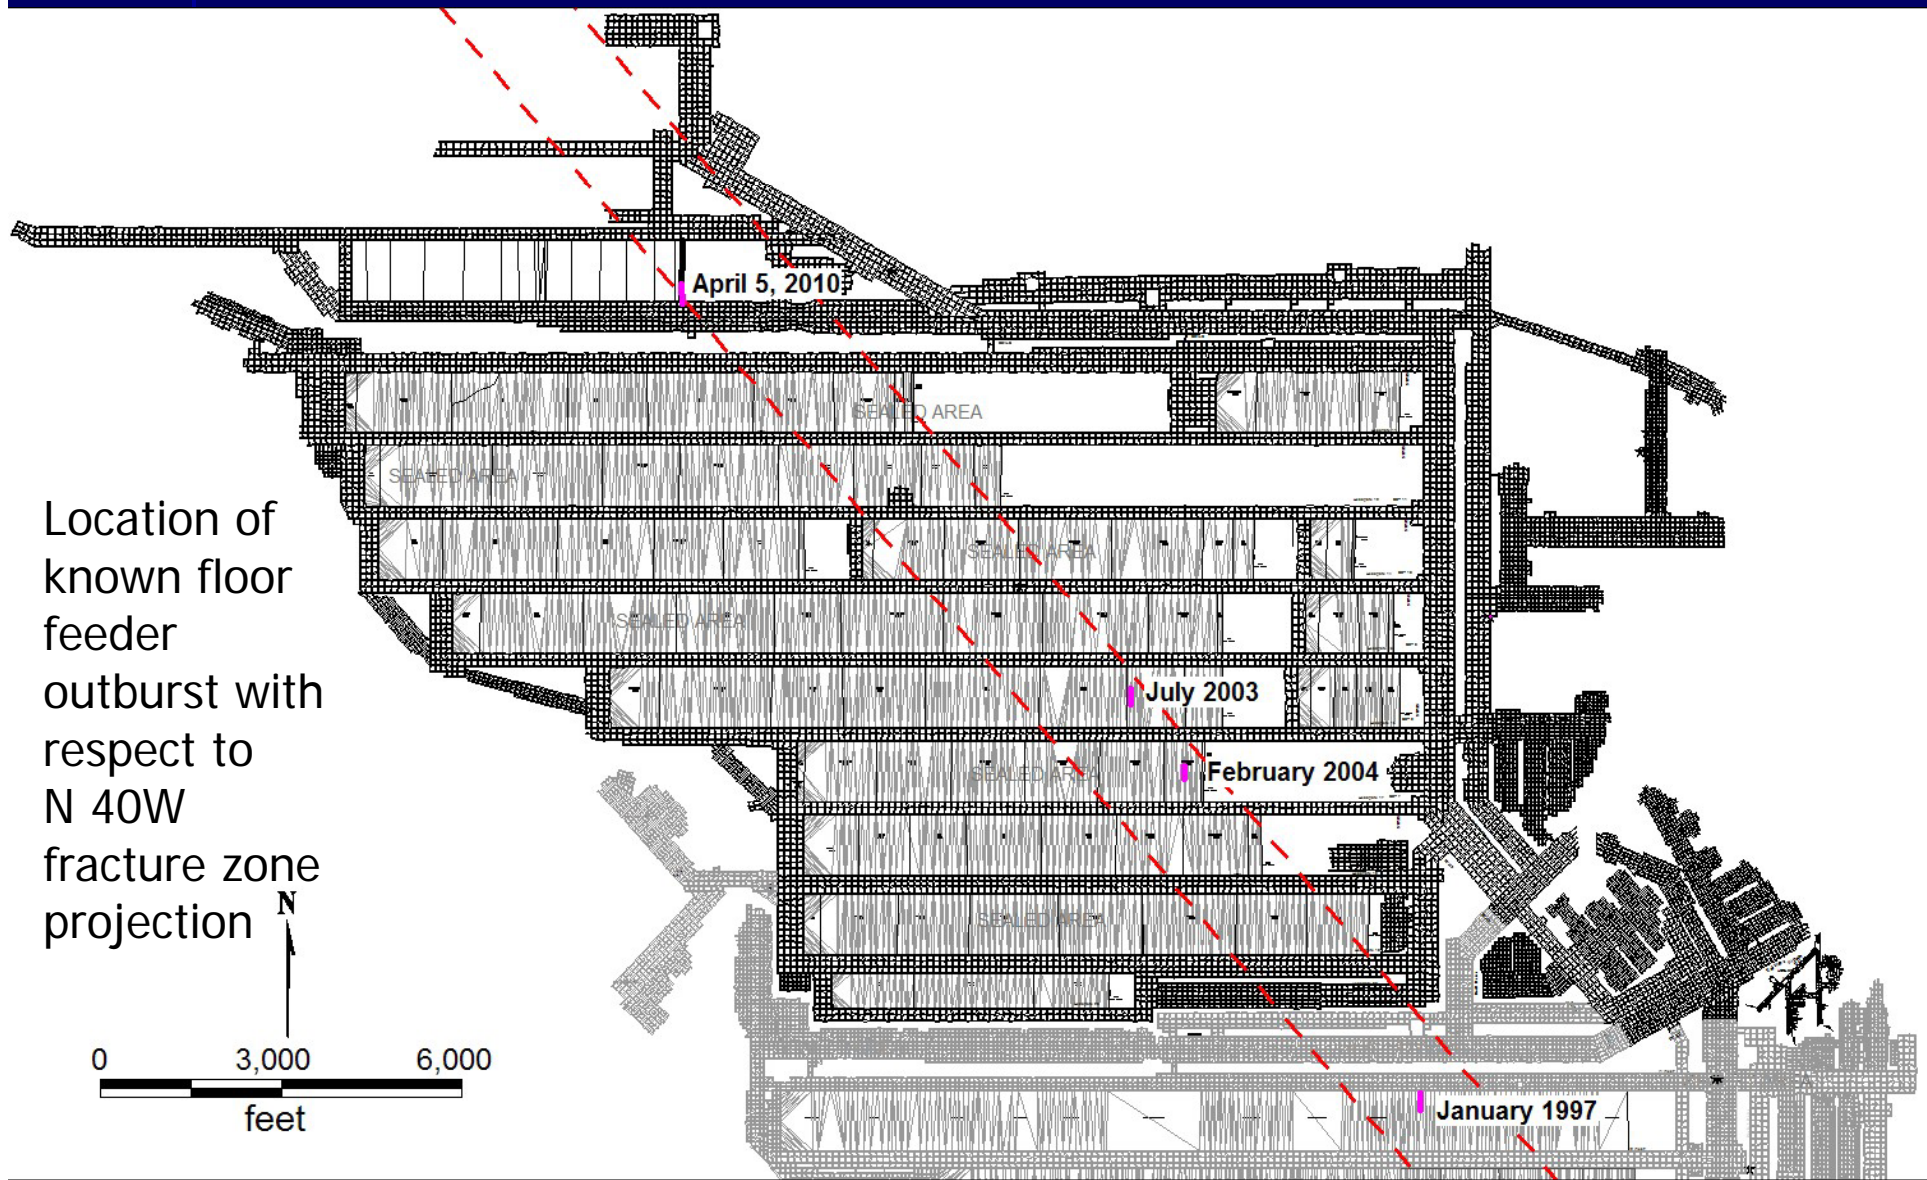
Locations and Dates of Known Gas Outbursts Relative to Fault Zone

- Eagle coal seam
 - Up to 1,200 feet deep
 - Extensive overmining
 - History of floor heaving
 - Long history of inundations
- Explosion in gob of LW 2 West panel in 1997
 - Attributed to roof fall
- UBB inundations in 2003 and 2004
 - Floor cracks, regional faulting
 - MSHA Tech Support investigated
 - Massey was aware of inundations
 - Recommendations given to UBB
 - No evidence of implementation

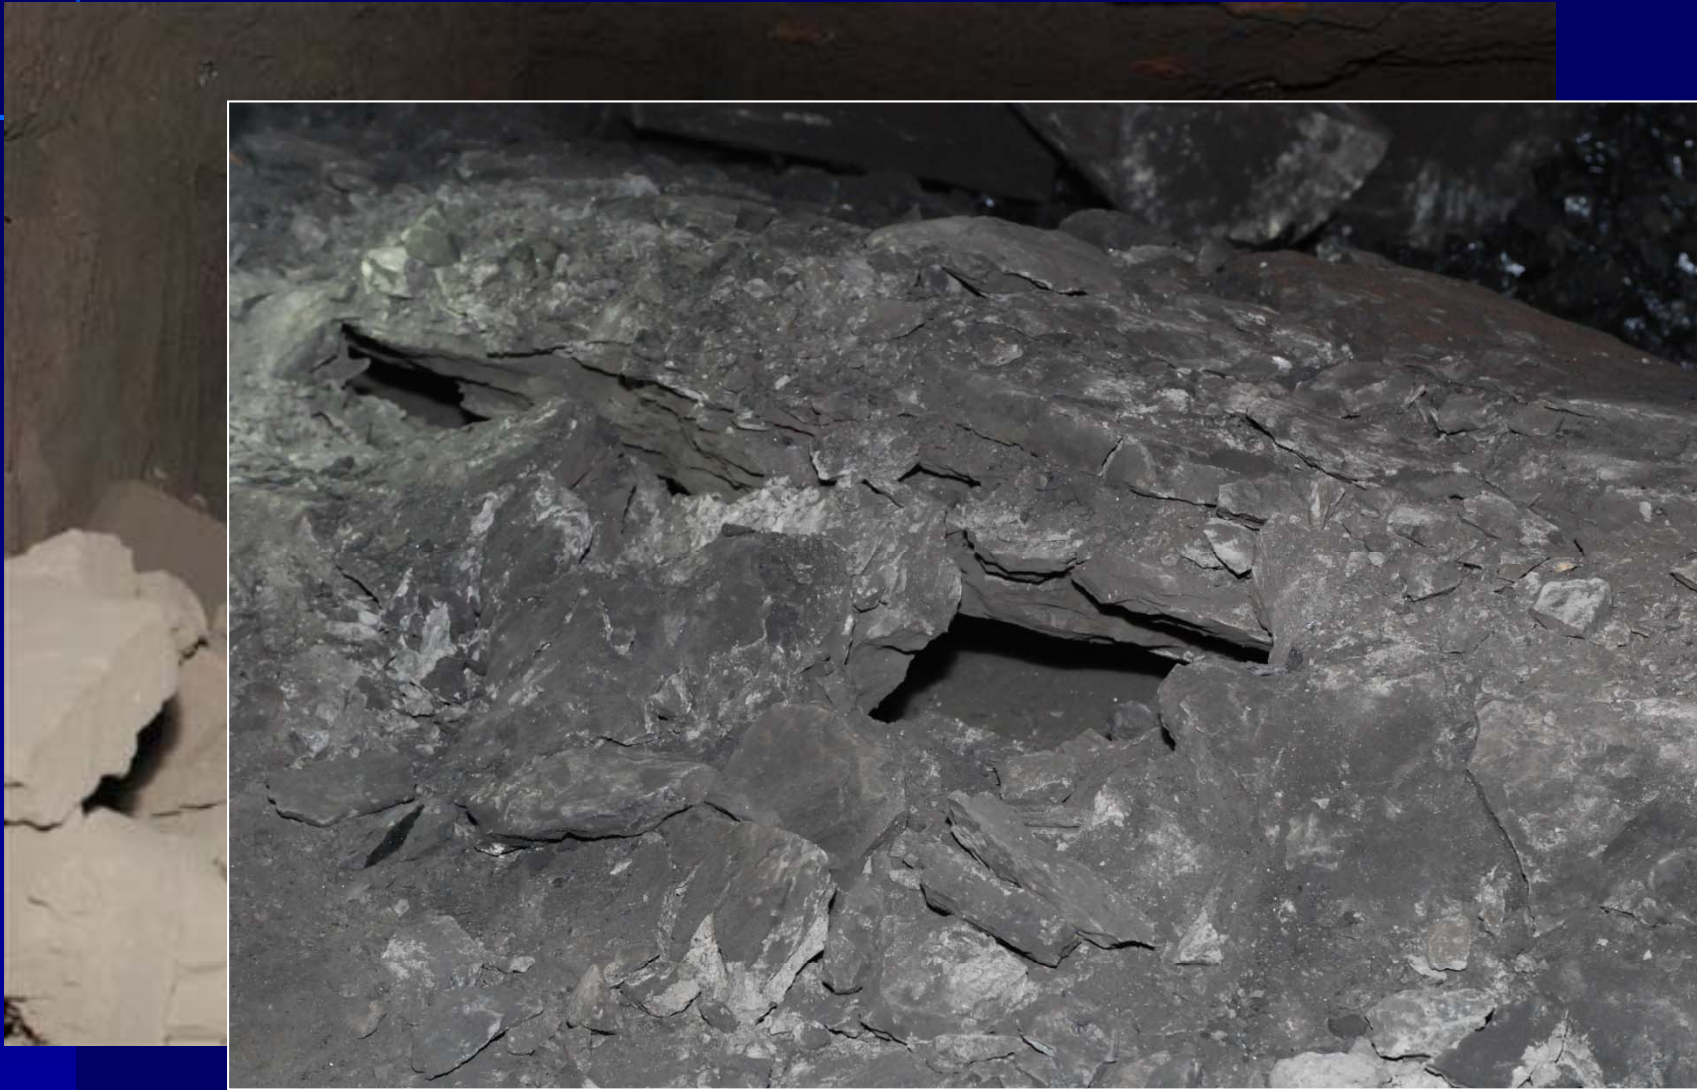
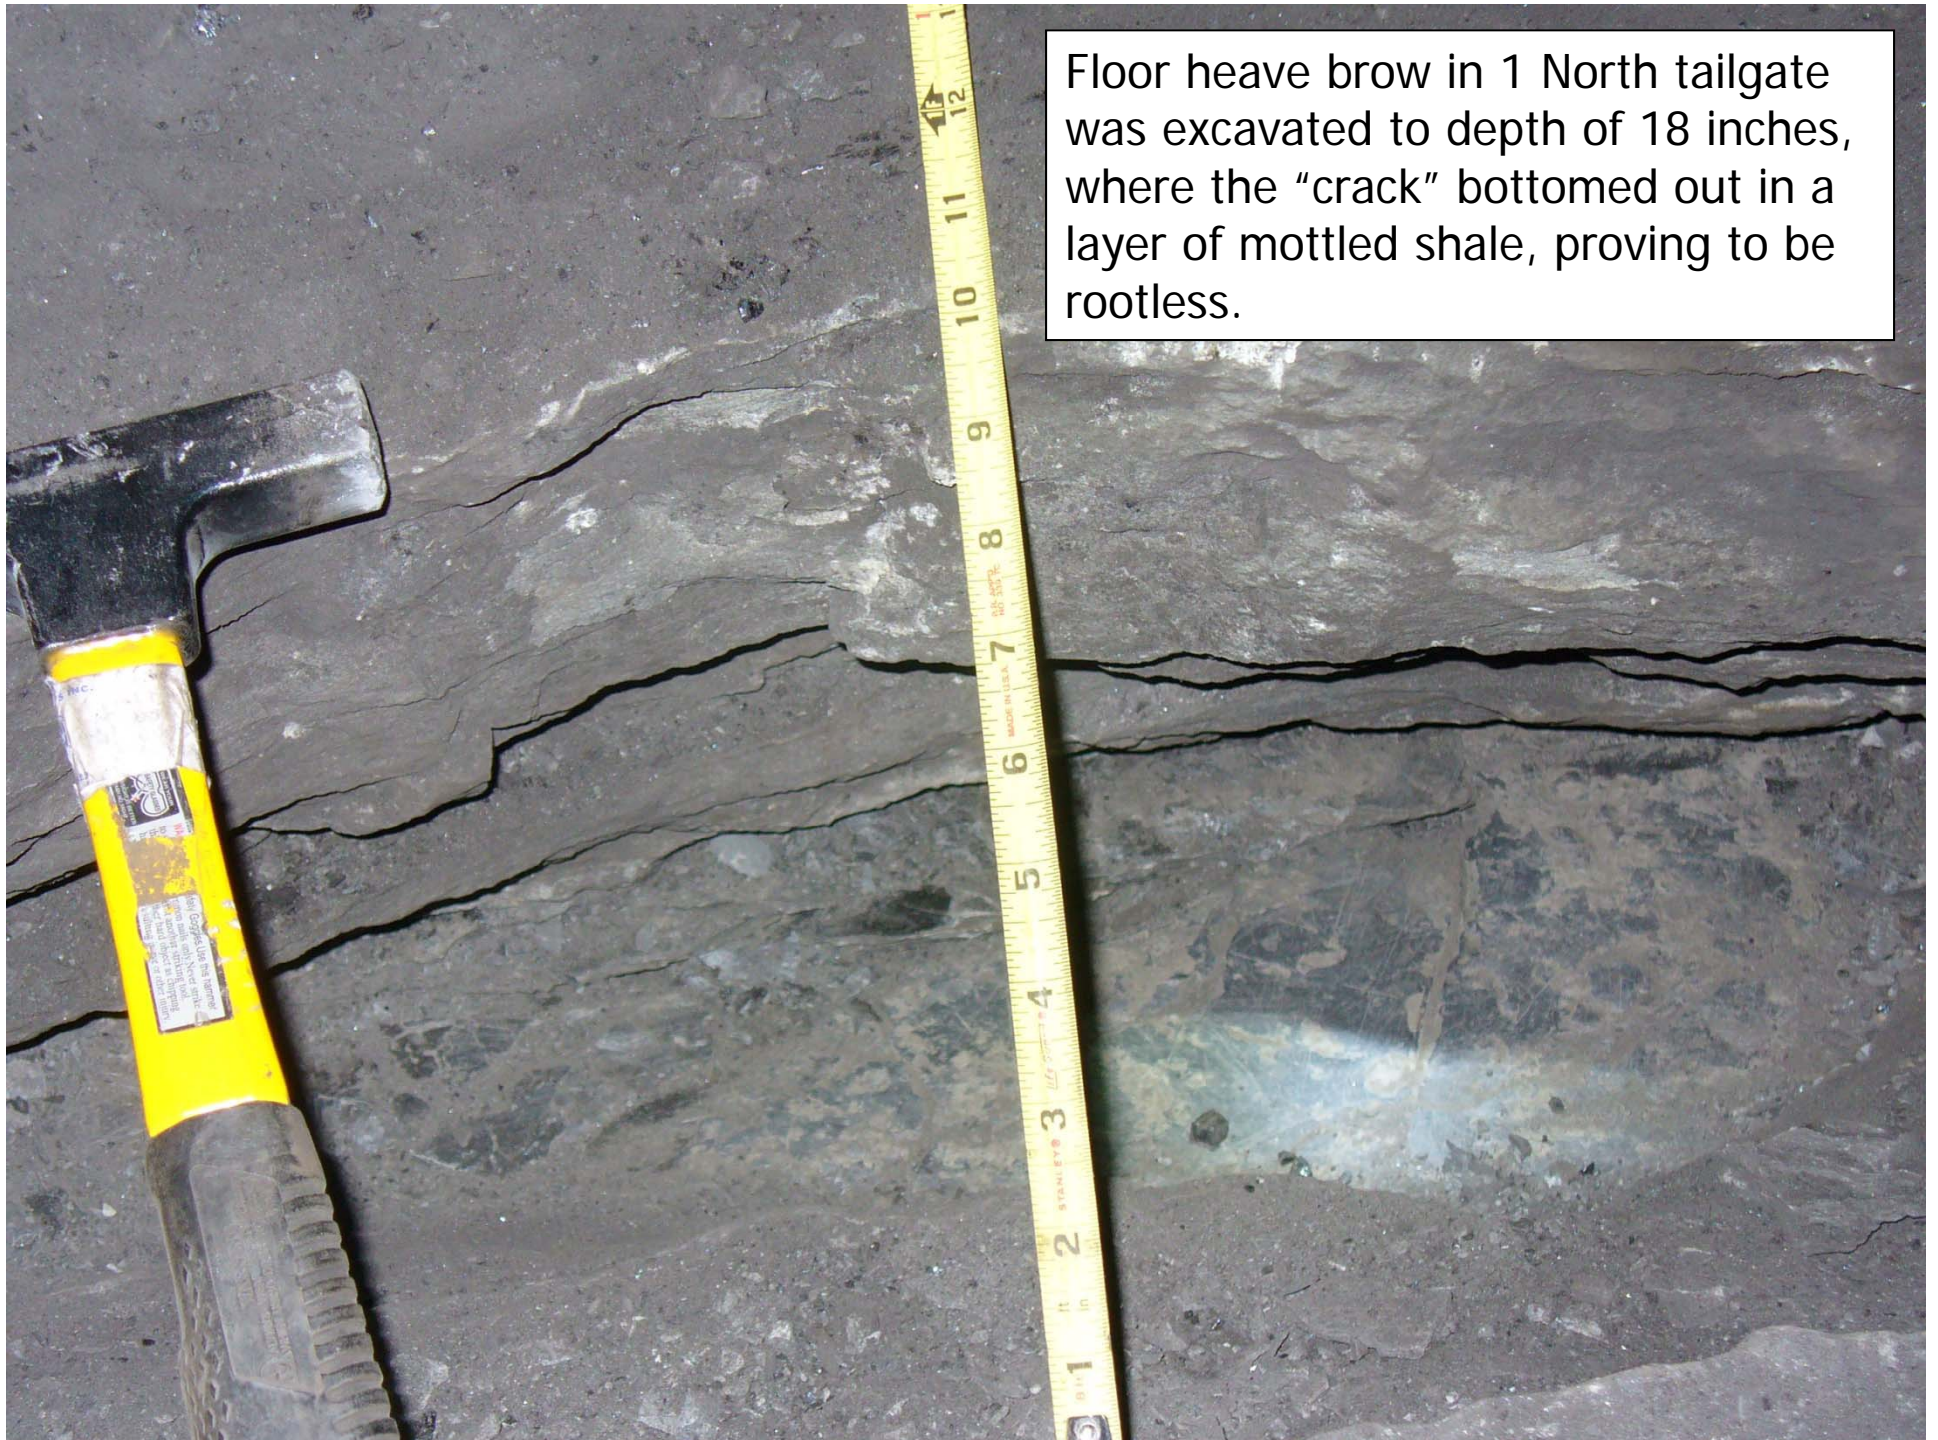
Examples of Floor Heaving

Floor heave brow in 1 North tailgate was excavated to depth of 18 inches, where the "crack" bottomed out in a layer of mottled shale, proving to be rootless.

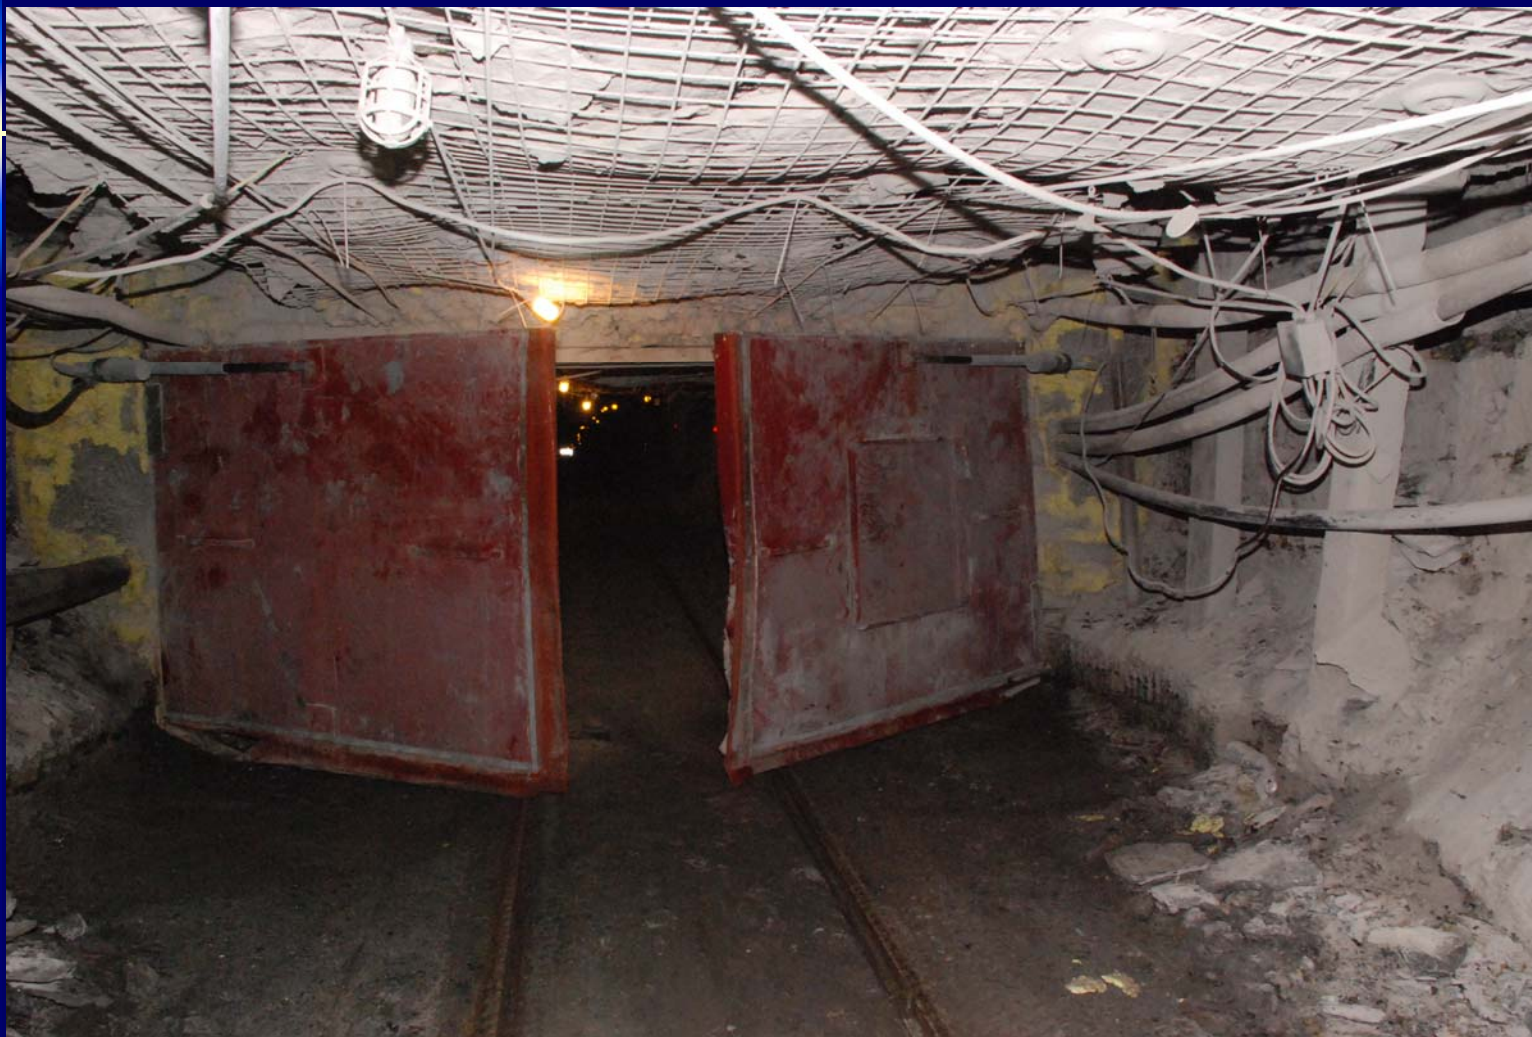
Equipment Door

- Chronic ventilation problems at UBB
 - Number of ventilation-related citations and orders
 - Indicated by testimony of those who provided information to the investigators
- Many equipment doors used in lieu of overcasts
 - Did not reliably separate air courses
 - Often left open
 - Subject to damage and increased leakage

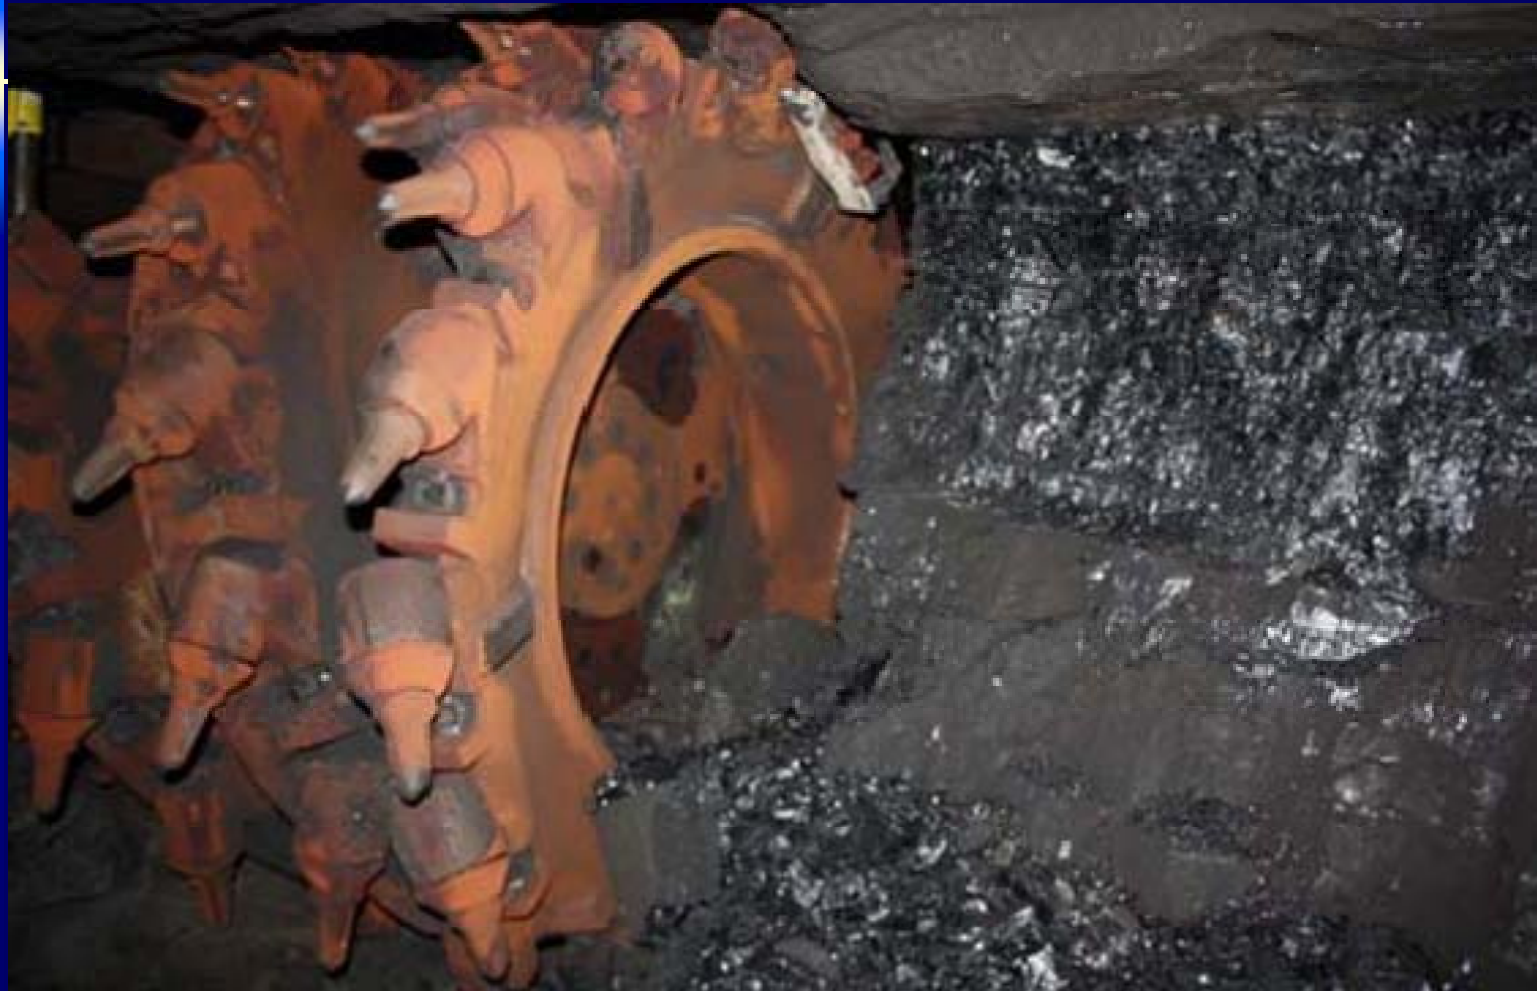
Tail Drum of Longwall Shearer

- Water supply used for dust suppression was inadequate for LW
 - Improperly-filtered river water
- Tailgate drum
 - 7 missing spray nozzles
 - Unapproved spray nozzles
 - Minimum water pressure could not be maintained
- Functioning dust suppression would have reduced float coal dust generation

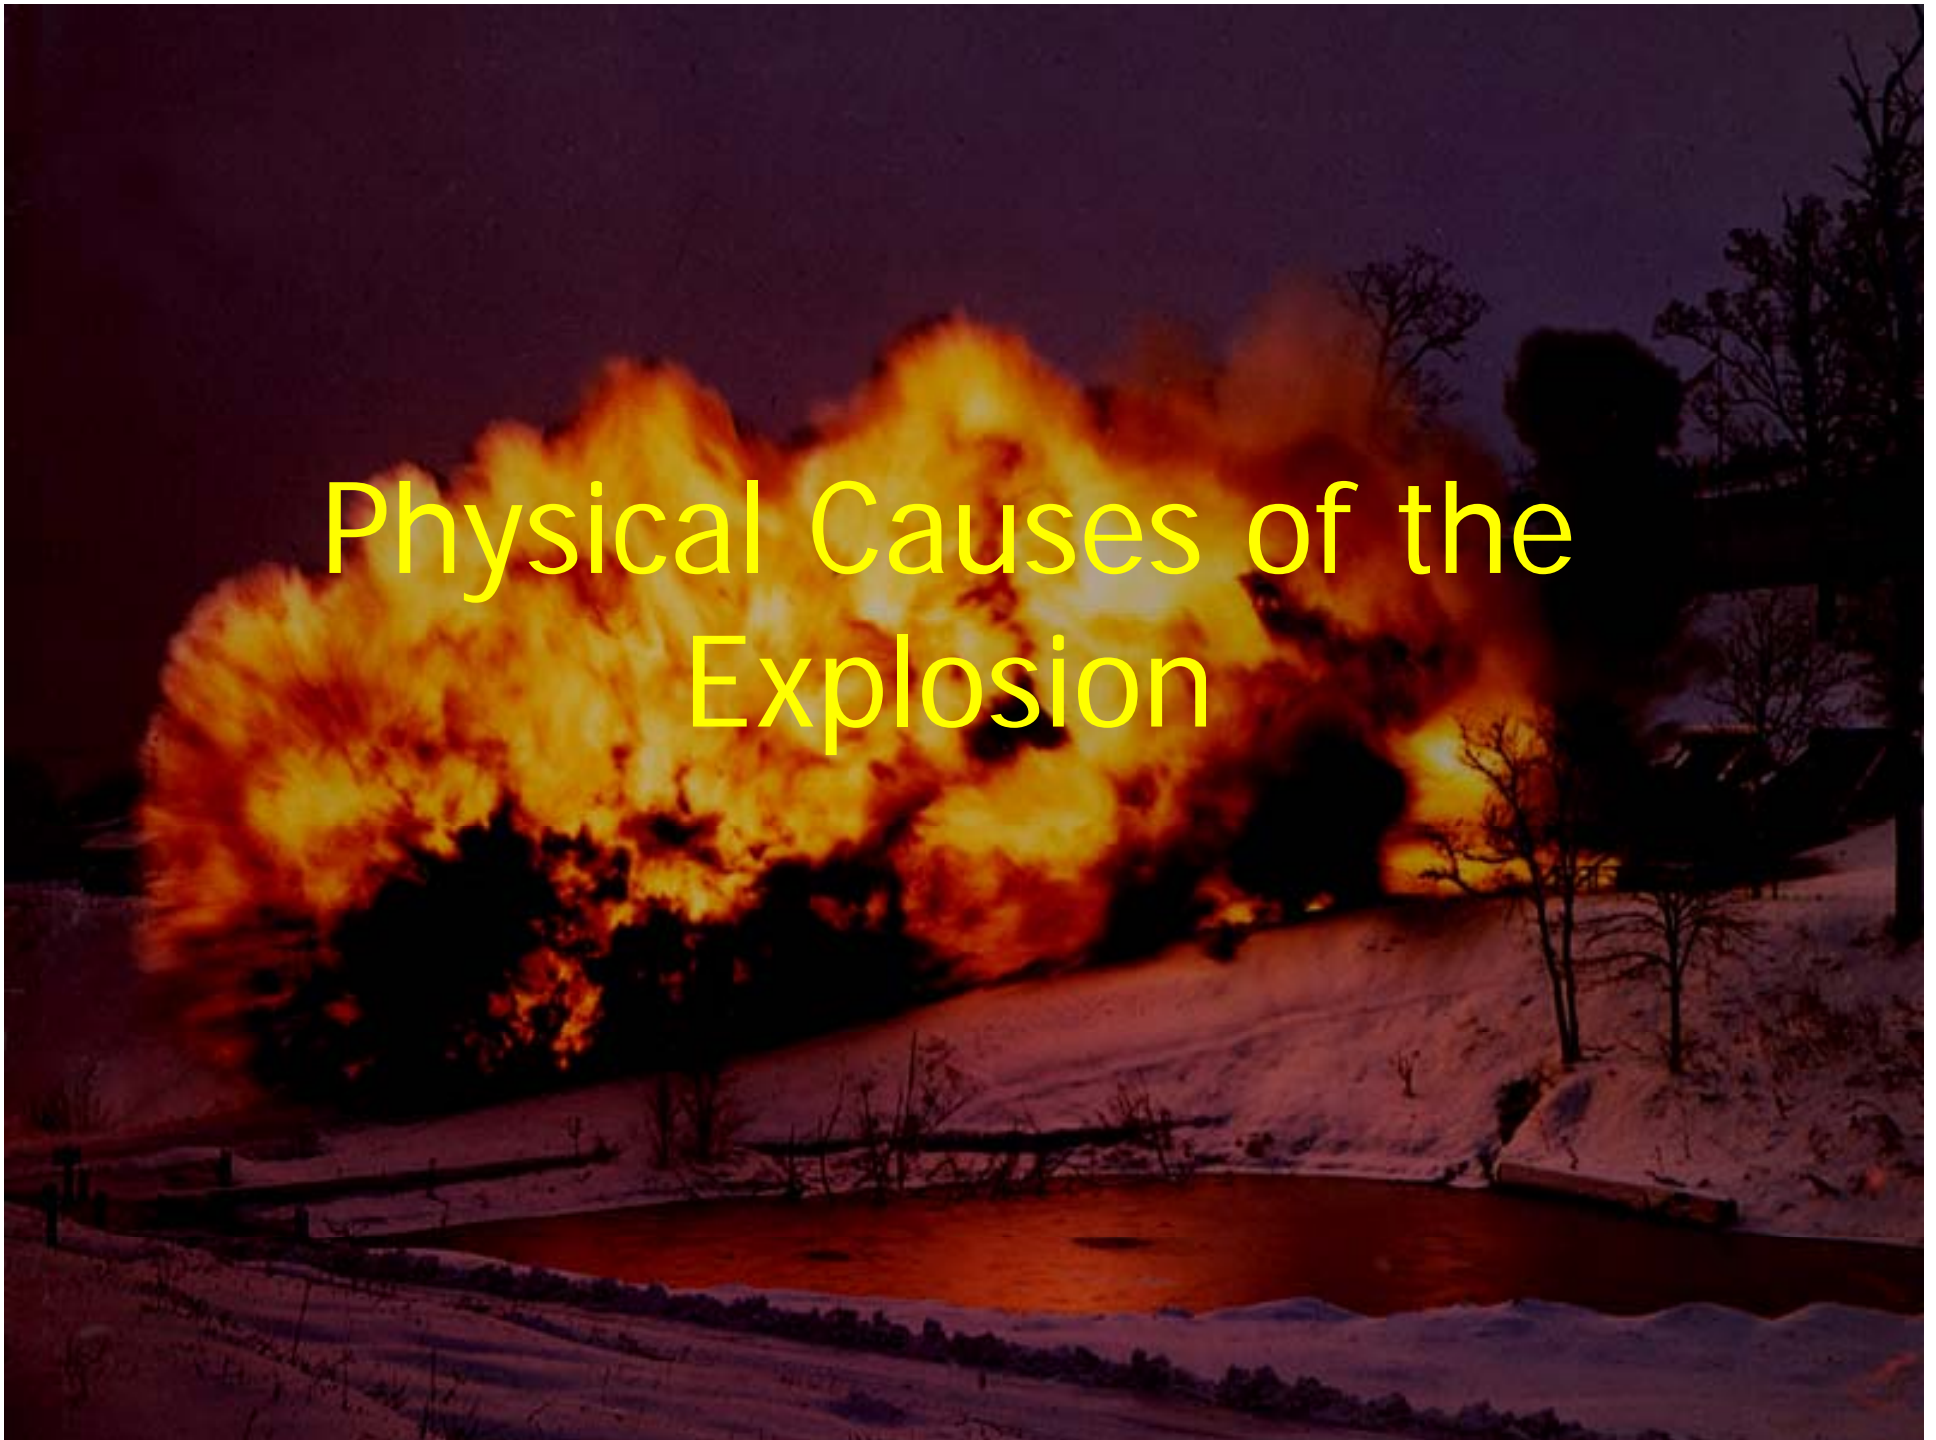
Physical Causes of the Explosion

- The most likely ignition source is from the LW shearer cutting sandstone
 - Worn bits
 - Nonfunctional and missing water sprays
- Other, less likely, sources:
 - Rock fall
 - Pan line
- Nearly all recovered electrical components have been tested and checked for possible ignition sources and none were identified
 - Remaining components will most likely not be identified as possible ignition sources

- Methane liberated from floor cracks
 - Floor cracks with methane liberations identified at Shields 160 and 171
- A limited amount of methane in explosive range occurred at shearer
- Ignited at shearer due to cutting through sandstone
- The crew left the shearer location
- Flame from initial ignition ignited an accumulation of methane
- A localized explosion occurred and traveled through the outby crosscut of the tailgate, suspended coal dust, and propagated into a major coal dust explosion
