REPORT OF INVESTIGATION

Fatal Powered Haulage Accident  
March 29, 2005

Mine #1  
Rockhouse Energy Mining Company  
Sidney, Pike County, Kentucky  
ID No. 15-17651

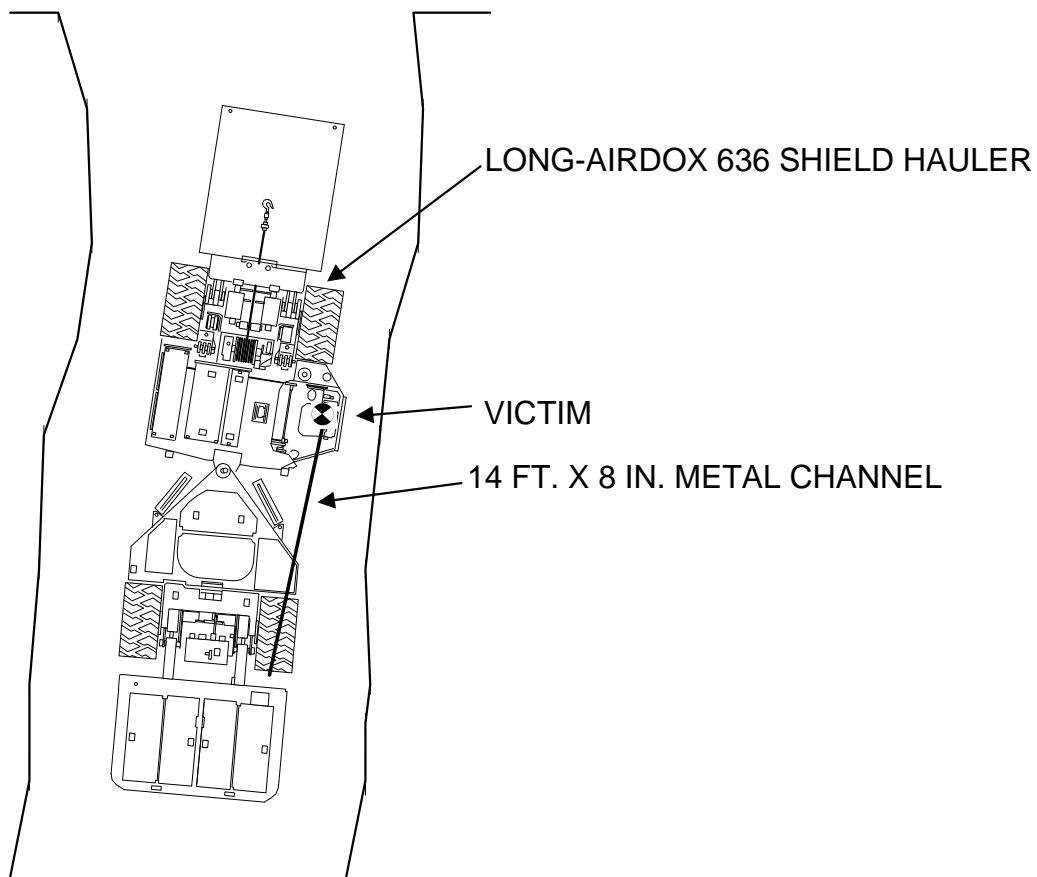
Sketch of Accident Scene  
 Fatal Fall of Roof Accident  
 Mine #1  
 Rockhouse Energy Mining Company  
 Sidney, Pike County, Kentucky  
 I.D. No. 15-17651  
 March 29, 2005

The accident occurred approximately 2.55 miles inby the drift opening in the crosscut between the No. 3 Entry and No. 4 Entry at Crosscut No. 88 on the 005-0 MMU Longwall Section. Measurements taken at the accident scene revealed that the overall mining height ranged from 91 inches to 109 inches, as measured from the mine floor to the mine roof. The width of the roadway at the accident scene measured approximately 17.5 feet. The approved roof control plan limits entry widths to 20 feet. The roadway was wet and muddy with 6 to 10 inches of mud and water on the mine floor. The roadway contained extraneous material including metal track ties, wooden crib blocks, metal channel, metal jacks, and concrete blocks in the vicinity of the accident.

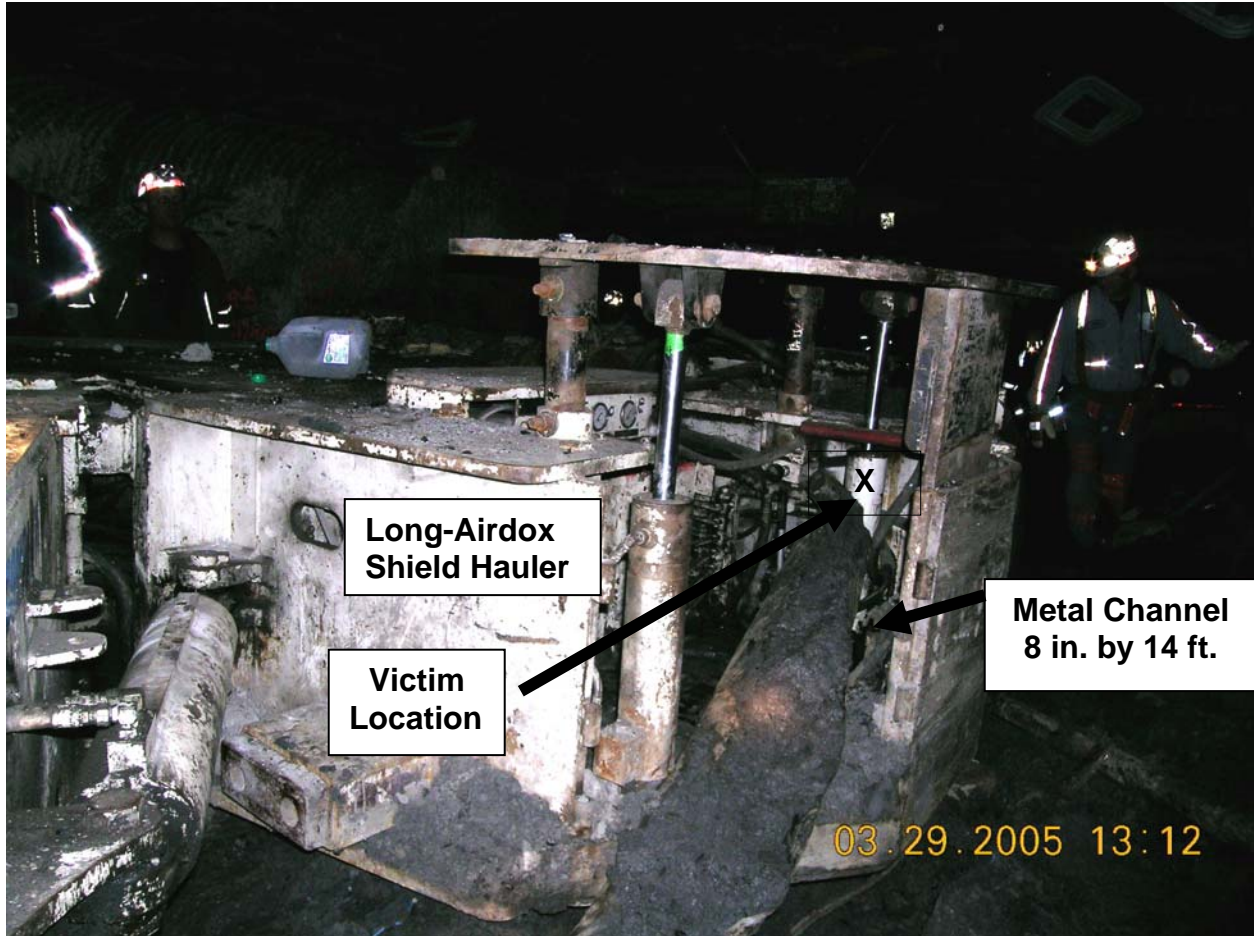
Photograph of Re-created Accident Scene  
Showing Long-Airdox Shield Hauler

Causal Factor: The doors had been removed from the operator's compartment of the shield hauler. The standards, policies, and administrative controls in use at this mine did not ensure that the shield hauler was maintained in safe operating condition.

The accident occurred when the victim backed the Model 636 Long-Airdox shield hauler across a roadway that had not been cleared of extraneous material causing a 14-foot length of metal channel to enter the operator's compartment fatally injuring the operator. The accident resulted from failure to maintain roadways clear of extraneous material, inadequate examinations, and failure to maintain equipment in safe operating condition by removing the doors of the operator's compartment.

Corrective Actions: The operator provided the shield hauler with a cage and doors for the operator's compartment and procedures established to maintain the equipment.
