Report of Investigation

Fatal Fall of Roof Accident

June 6, 2005

South Central Coal Company, Inc.  
South Central Mine  
Spiro, Le Flore County, Oklahoma  
Mine ID No. 34-01787

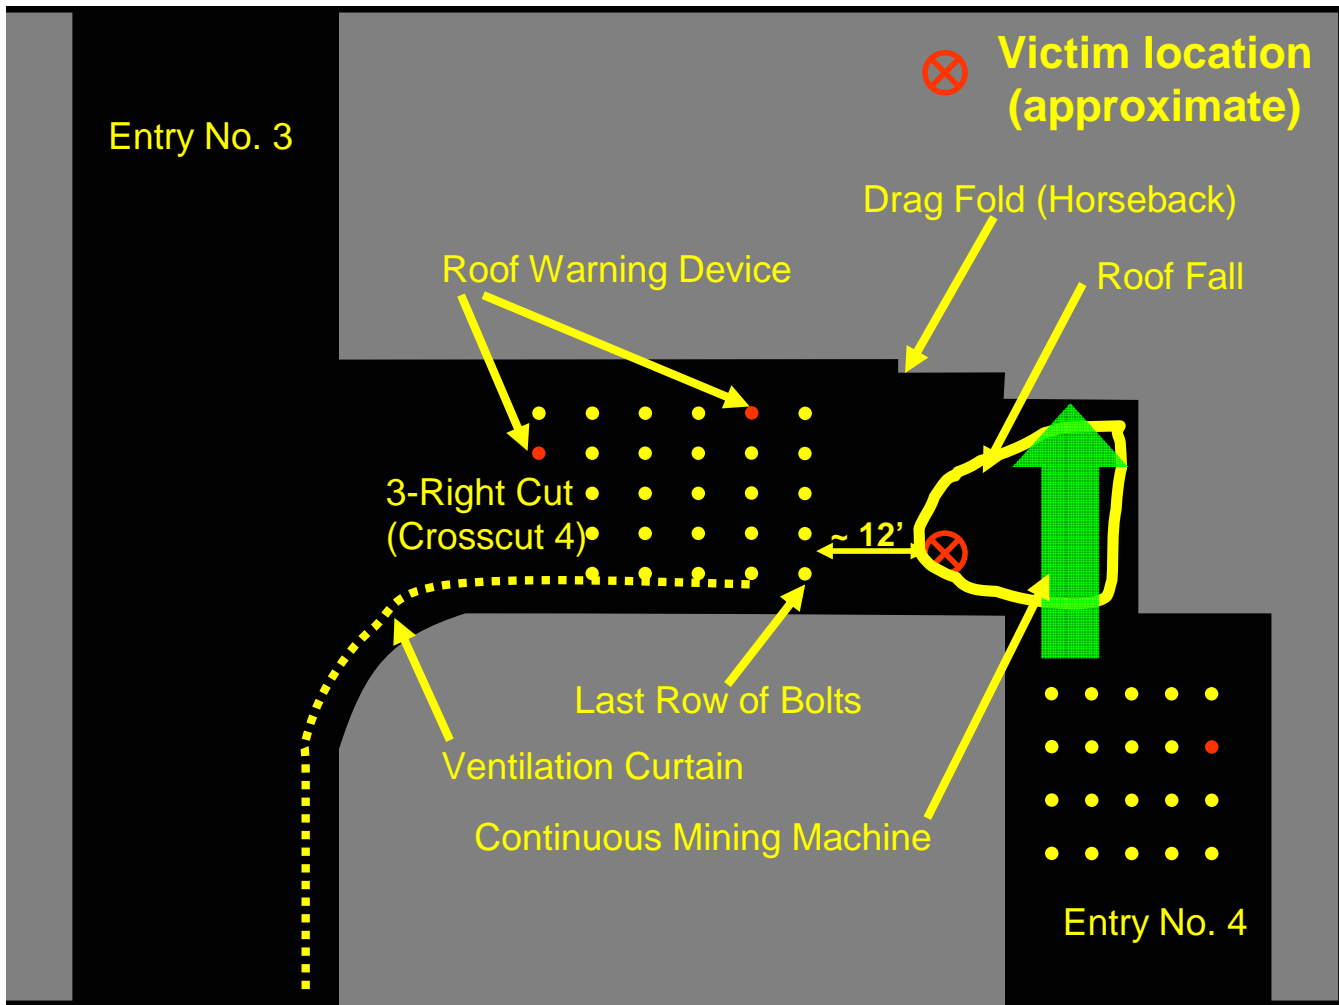
SKETCH OF ACCIDENT SITE  
1<sup>ST</sup> SOUTH SECTION

Orton left the area, traveled outby around the pillar block and into 3-Right cut. At that time, approximately 11:05 p.m., Carpenter completed the left lift of cut No. 7. As Carpenter backed the continuous mining machine out of the cut, portions of the immediate roof fell and covered the inby 20 feet of the machine. The fall of immediate roof also extended into the unsupported area of the 3-Right cut, striking Orton. When the roof fell, Carpenter noticed a flash of light in the newly created intersection. Carpenter immediately stopped mining, traveled outby around the pillar block and into 3-Right cut where he found Orton under the fall of roof in the unsupported area (see sketch on page No. 1 for Orton's location at the time of the accident).

In 3-Right just outby the accident area, a second roof warning device was installed on the left side of the place, five rows outby the last row of permanent roof supports (see Sketch on Page 1 for location). This placed two roof warning devices in the same crosscut with the second one approximately 16 feet outby the one on the next to last row of bolts (see Appendix D for a picture of these two devices). The 1<sup>st</sup> South section had four other roof warning devices hanging in areas that were not near the last row of permanent roof supports (see Appendix E for the location of devices on the section). These extra warning devices defeated the intent of the warning system, potentially caused confusion, and promoted complacency as to the proper location of the end of permanent roof supports.

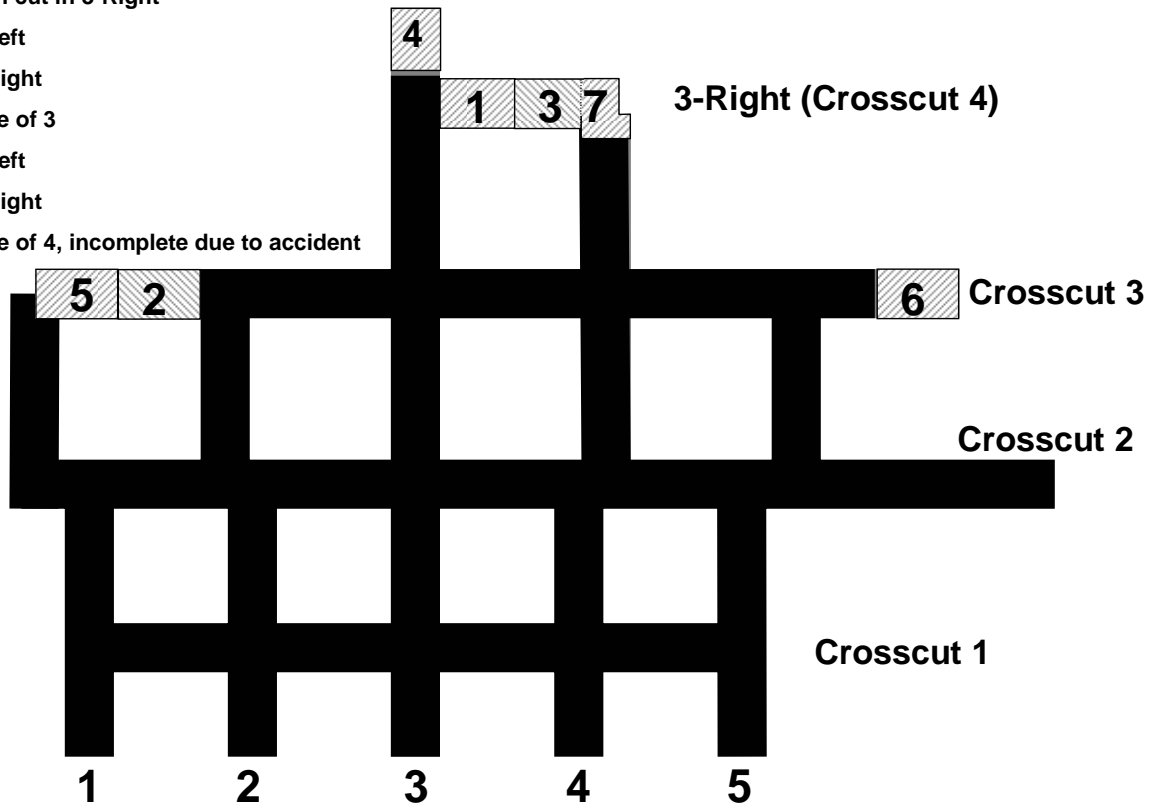
## AFTERNOON SHIFT CUT SEQUENCE

While mining entry No. 3 (cut No. 4 on Appendix B), a geologic fault and drag fold were encountered that produced excessive amounts of water from the roof and floor. This water flowed outby and into the 3-Right working place, accumulating in the unbolted area mined during the previous cut (cut No. 3 on Appendix B). After mining was completed in entry No. 3, Jason Schafer, Right Side Roof Bolter Operator, and Troy Rowland, Left Side Roof Bolter Operator, entered the 3-Right working place and installed three rows of bolts. They did not bolt the remainder of the cut because water had accumulated near the face. This left an unsupported area approximately 16 feet long and 21 feet wide. Schafer and Rowland then proceeded to the working place in entry No. 3, where roof rock had fallen near the face. The fallen rock prevented the roof bolting machine drill heads from being extended near the face, so a portion of this cut was also left unsupported.

Continuous Mining Machine Operator, and told him that 3-Right cut (cut No. 3 on Appendix B) was not fully bolted. However, Carpenter had difficulty hearing over the equipment noise and perceived them to say that three rows of bolts were not installed in the face of entry No. 3 and that the cut in 3-Right was bolted. Schafer and Rowland then proceeded to 5-Right while Carpenter moved the continuous mining machine to the working place in entry No. 4 and started mining (cut No. 7 on Appendix B).

While entry No. 4 was mined, Kenneth J. Orton, Electrician/victim, performed duties as helper on the continuous mining machine. When the working face of entry No. 4 cut into the unbolted area of the 3-Right cut, the shuttle car operators noticed water flowing from the face and asked Orton if they had mined into another area similar to the face of entry No. 3, where an abnormal amount of water was encountered.

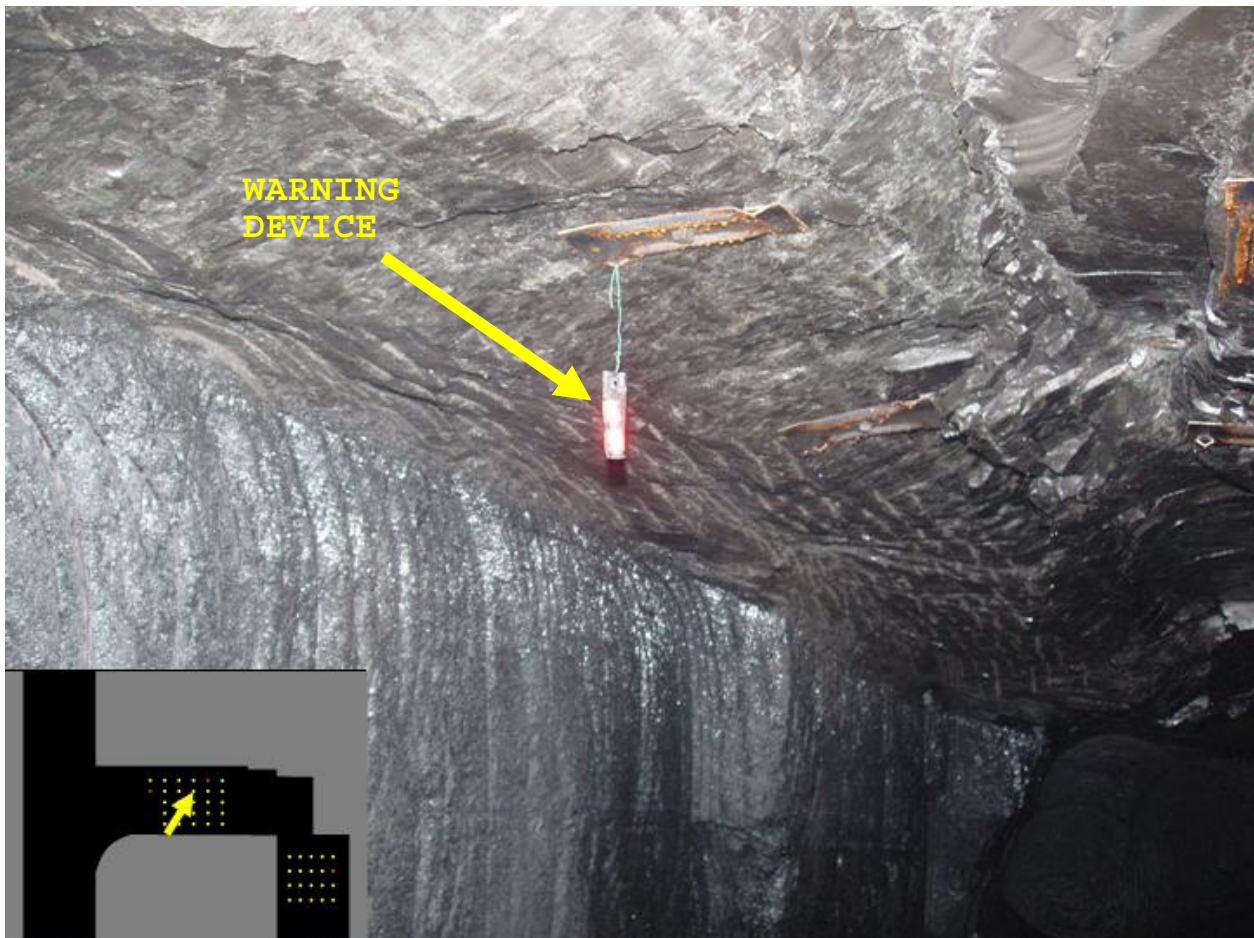
**PICTURE OF ROOF WARNING DEVICE ON NEXT  
TO LAST ROW OF BOLTS AT ACCIDENT SITE**

A reflective warning device was installed on the next to last row of roof bolts on the left side of the entry in the 3-Right accident area (see Appendix C for a picture of this warning device). At the time of the accident, a ventilation curtain was hung from the roof near the right rib in 3-Right, which provided blowing ventilation for the mining and roof bolting operations in the crosscut (see Sketch on Page 1 for the location of this curtain). Although the investigation could not determine Orton's route of travel, he may have walked between the curtain and the rib when he entered 3-Right. Thus, the curtain would have obstructed Orton's view of the reflective warning device located on the left side of the crosscut.

- c) Depending on Orton's route of travel into 3-Right, which could not be determined during the investigation, he may have walked between the ventilation curtain and the right rib. Thus, the curtain would have prevented Orton from seeing the reflective warning device that was hanging from the roof on the left side of the crosscut.

Corrective Action: The mine operator should develop procedures and means to ensure that persons do not work or travel beyond permanent roof supports. These should include removal of roof warning devices when places are completely bolted; installation of roof warning devices on both sides of the entry to ensure that one is readily visible from behind ventilation curtains; ensure that when breakthroughs are made that employees do not travel in the immediate area downwind from the breakthrough; and routinely observe work habits of miners to ensure that miners do not travel or work beyond the last row of permanent roof supports. Management should stress to all employees the critical importance of this safety standard.

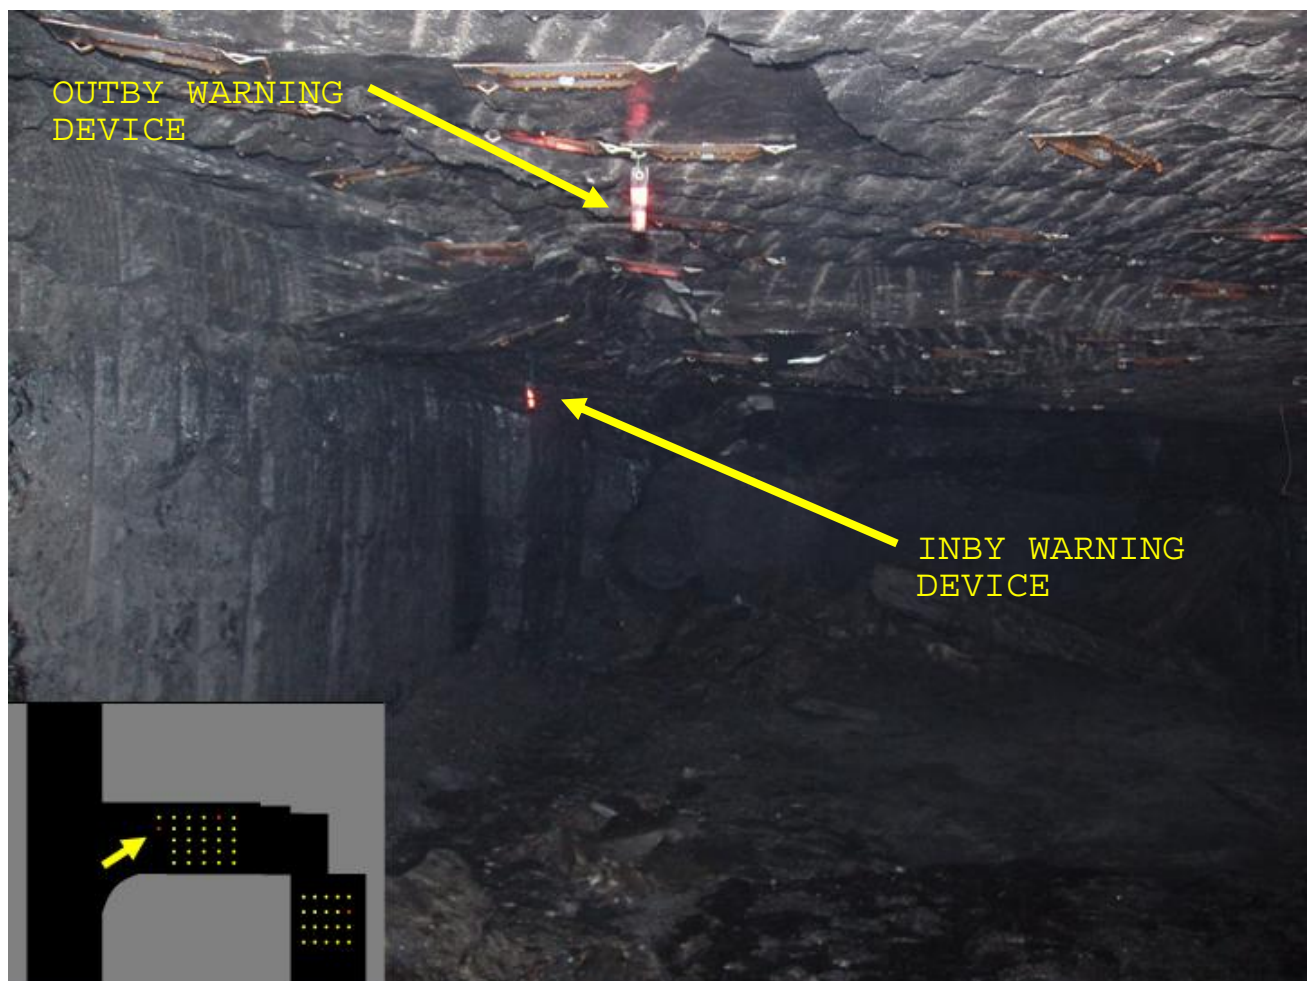
### PICTURE OF ROOF WARNING DEVICES AT ACCIDENT SITE

- d) An extra roof warning device was located outby in 3-Right at the accident site, which, depending on Orton's route of

travel, may have confused him as to the proper location of the end of permanent roof supports or caused complacency as to the use of these warning devices.

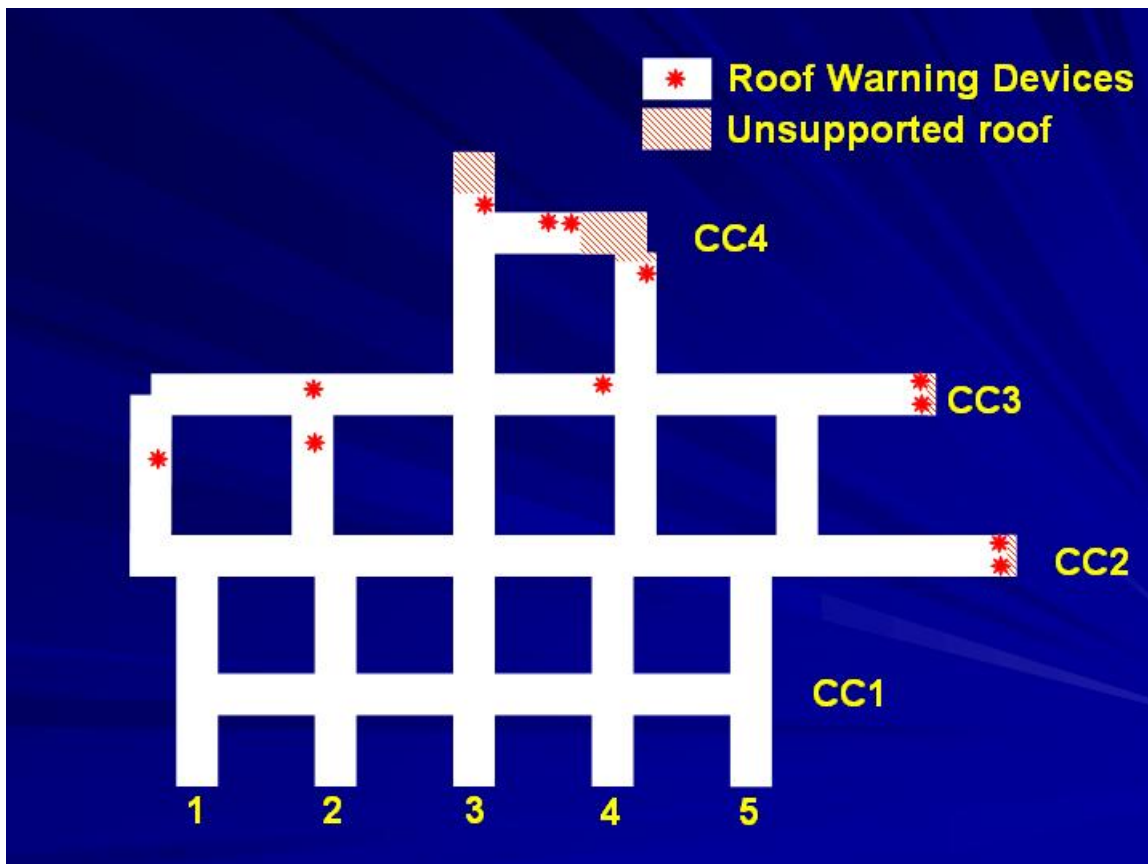
### SKETCH OF 1<sup>ST</sup> SOUTH SECTION AND ROOF WARNING DEVICES

- a. Entry No. 1, between crosscut Nos. 2 and 3.
- b. Entry No. 2, between crosscut Nos. 2 and 3.
- c. The intersection of entry no. 2 and crosscut No. 3.
- d. Crosscut No. 3, between entry Nos. 3 and 4.

These devices were not removed after the places were permanently supported with roof bolts. Failure to remove these devices defeats the intent of the regulation, promotes complacency, and provides a false impression as to where the end of permanent roof support is located; thereby not accurately warning miners where unsupported roof exists.
