REPORT OF INVESTIGATION

Fatal Fall of Roof Accident
January 10, 2006

Mine #1
Maverick Mining Company, LLC
Pikeville, Pike County, Kentucky
ID No. 15-18674

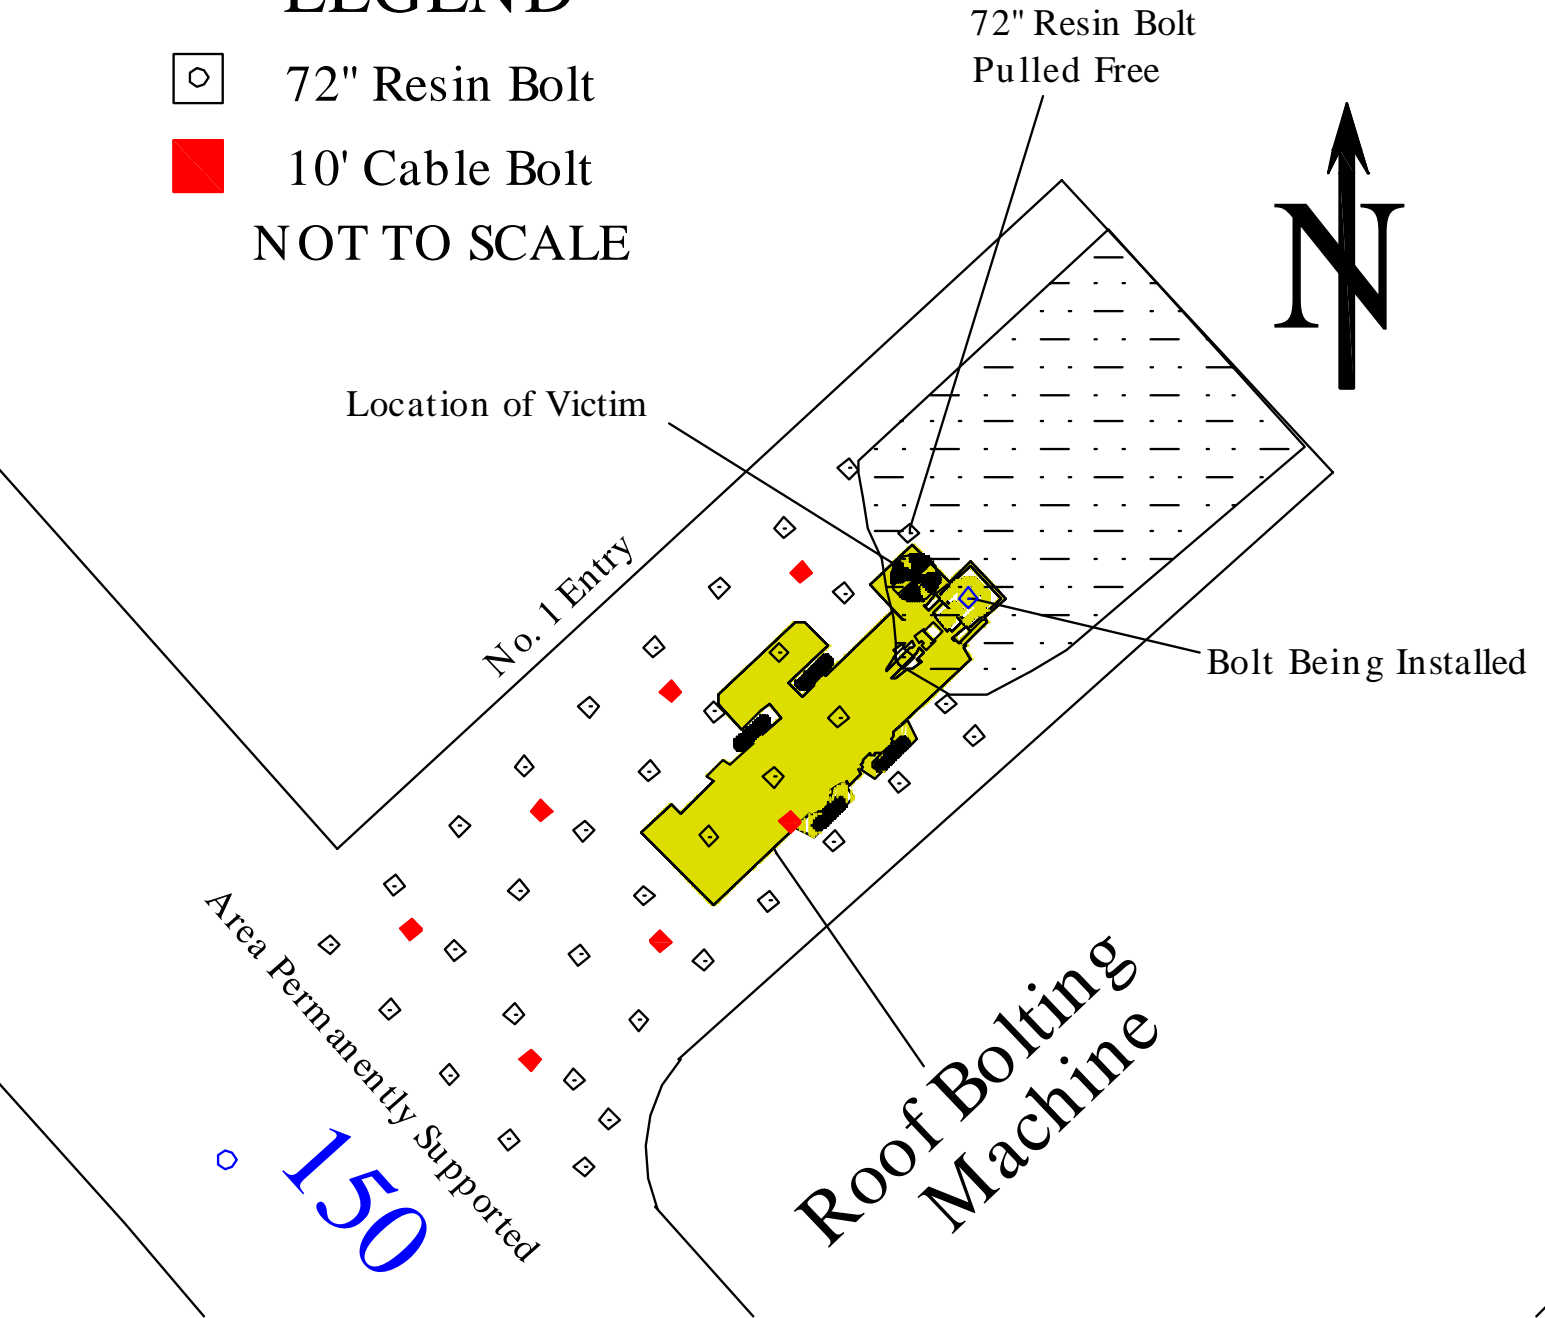
Sketch of Accident Scene
Fatal Fall of Roof Accident
Maverick Mining Company, LLC
Mine #1
MSHA ID No. 15-18674
January 10, 2006

The roof fall occurred in the No. 1 entry, and extended outby from the face for a distance of approximately 20 feet. The fall was approximately 3 feet thick, extended 14 feet across the entry, and was estimated to weigh 126,000 pounds.

The left side of the fall was bounded by a drag fold which ran roughly parallel to the entry, approximately 2 to 3 feet from the rib. A drag fold (often referred to as a "horseback") is an area of intersecting faults that results in rock wedges being formed. One limb of the drag fold extended into the roof on a roughly 45 degree angle. Approximately 3 feet into the roof the drag fold intersected the failure horizon which contained numerous visible slickensided surfaces. The drag fold dismembered the roof beam and the low cohesion along the numerous slickensided surfaces at the fall horizon weakened the immediate roof and made it susceptible to failure.

The last row of 6-foot bolts in this cut was installed in the brow. This row had 5 bolts across installed across the heading. Also, prior to installing this row, the slickensides from the drag fold had fallen out resulting in a gutter that had formed approximately 3 feet horizontally from the rib to approximately 3 feet high. This appeared to be a continuation of the gutter that was observed outby which had resulted from the drag fold. A bolt was installed in the gutter which was 3 feet higher than the horizon of other bolts in the row.

The second bolt in the row (the last bolt installed by the victim) had pulled completely out of the roof when the fall occurred. This was the only bolt installation that failed. The fall extended outby to the last bolt row of the previous cut, where the rock broke around several of the bolts. No bolts had broken and all others remained anchored in the roof.

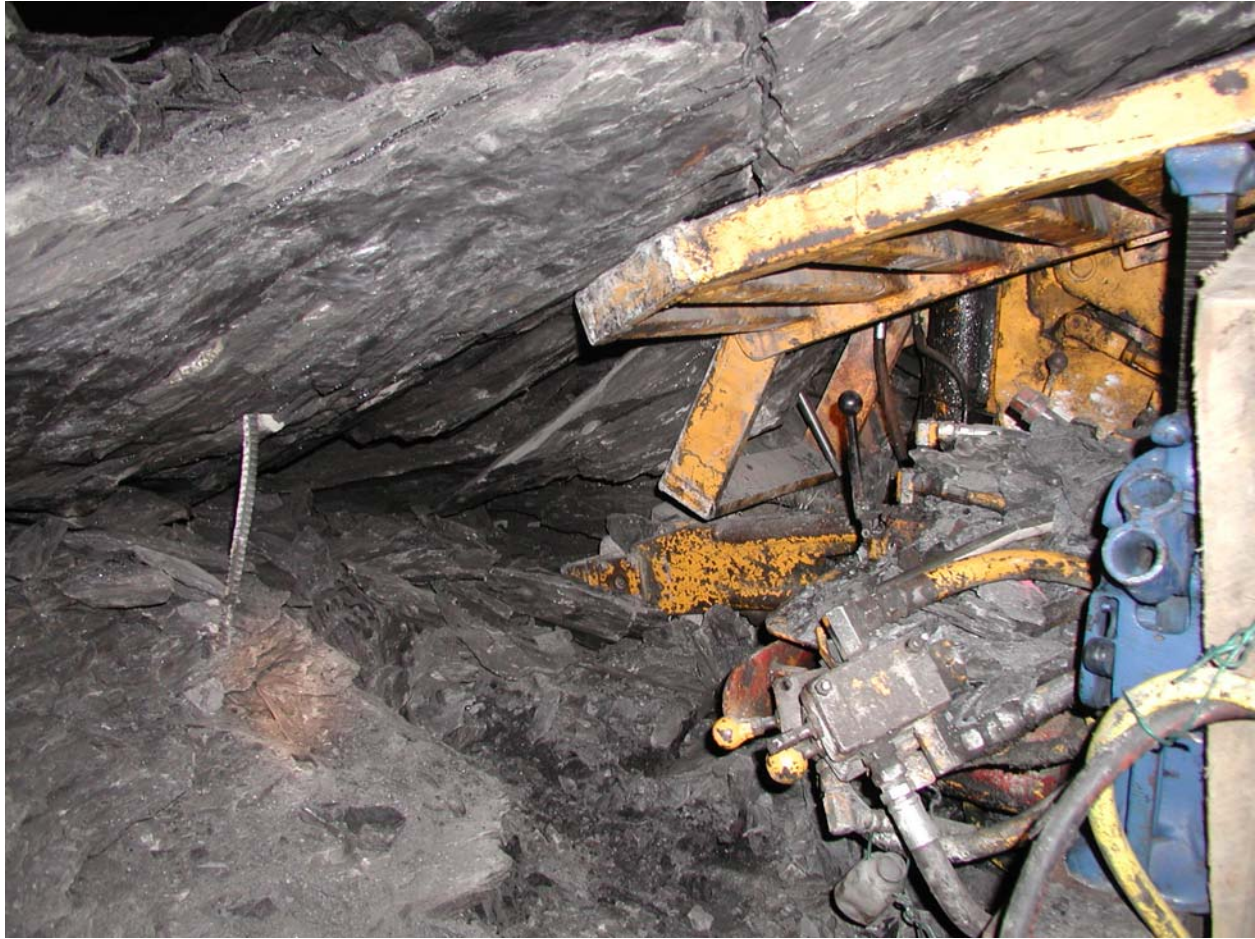
Photograph of Accident Scene
Showing Galis 320 Roof Bolting Machine

Subsequent to the accident, it was observed that half of the clevis was broken off, which allowed the attachment pin to fail or become dislodged. This in turn allowed the ATRS structure to move outby, away from the hydraulic cylinder. When the ATRS frame shifted outby, the rollers on the end of the frame slipped out of the track on the machine and allowed the ATRS to collapse.

The inby end of the ATRS was observed in a collapsed position with the ring structure perpendicular to the safety arms. The outby end of the ATRS was free of the guide track, with the roller pins approximately 18 inches from the roof. The hydraulic cylinder was observed still in its extended position and appeared to be undamaged.

The single-boom bolter ATRS system was required by 30 CFR 75.209 (e) (1) to elastically support a dead weight load of 11,250 pounds. Due to the second bolt in the row having insufficient anchorage, the ATRS system would have in effect been subjected to a rock load almost twice what it was intended to support. Based on this observation, and an analysis of the roof bolt spacing and the ATRS position, the ATRS was subjected to a load of at least 19,000 lbs.

Corrective Actions: The roof control plan was revised to show 3 feet of draw rock taken during coal extraction, limit the depth of cuts to 12 feet, use 8" by 8" plates, and use a dual boom roof bolting machine equipped with a t-bar type ATRS.
