REPORT OF INVESTIGATION

Fatal Powered Haulage Accident
April 7, 2006

No. 1 Mine
Jacob Mining Company LLC
Naugatuck, Mingo County, West Virginia
ID No. 46-05978

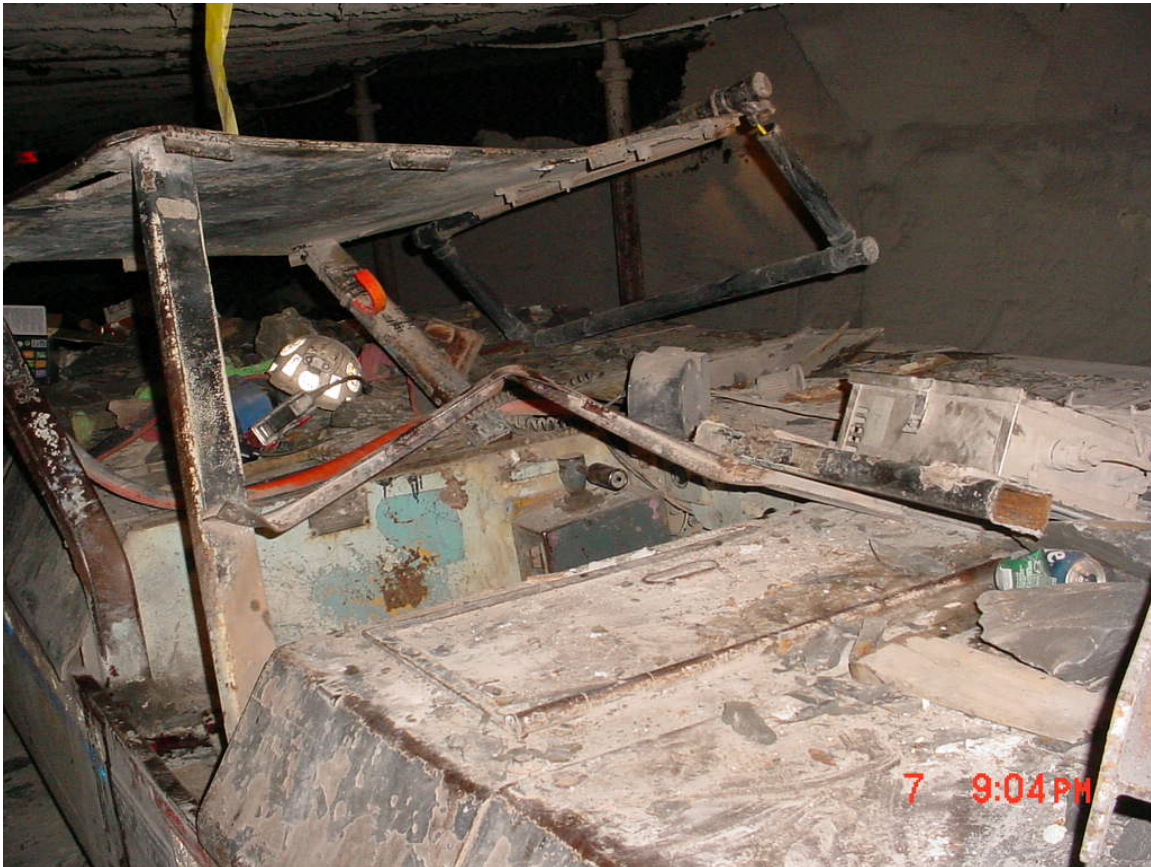
The accident occurred along the main track haulage entry between the Toms Branch switch and the North Marrowbone Creek Portal at crosscut 212 where an old roof fall had previously occurred. When the roof fall was rehabilitated, 4 and 6-inch crossbars and cribs, supported by cribs, jacks, and vertical I-beams, were installed to control the roof. Some of the crossbars had been installed when the area of the mine was initially developed, 10 to 15 years prior to the accident.

The roof support included five 4-inch steel crossbars (approximately 14 feet long) installed perpendicular to the track entry, and four 4-inch steel crossbars (approximately 6 feet long) installed parallel to the track entry. Crib blocks had been installed between the parallel steel crossbars and the mine roof.

On the outby edge of the fall cavity, a crossbeam supported by cribs was installed across the entry. The right crib (looking inby) had been hit by a piece of machinery. On the right side of the track, outby the fall cavity was a 4-inch thick, bent, crossbeam approximately 14 feet in length. Under the right side of the cross beam was a roof support jack, 58 ³/₄" long which had scuff marks where it had been struck by a piece of equipment.

The original height of the track entry at the location of the accident ranged from 6 to 8 feet. However, the installation of the crossbeams reduced the vertical clearance in the area to 55-¼ inches between the top of the right track rail and the crossbeams and 56-½ inches between the top of the left track rail and the crossbeams.

Horizontal clearance in the area was reduced to 11 feet between the cribs supporting the crossbeams. The width of the locomotive was 7 feet 7 inches and therefore should have cleared the crib supports. Prior to the accident, a scoop was used to transport a conveyor belt tailpiece through the low clearance area. The scoop that was used to haul a tailpiece in by the accident scene earlier that day was 9'-3" wide. Since the scoop was not confined to the track rails and had tighter clearance through the area, either the scoop or the tailpiece impacted the crib supports and dislodged the crossbeams.

Page 6, Item 11 of the approved roof control plan dated July 15, 2005 requires, "Where crossbars are installed along haulage roadways they shall be provided with a means to prevent the crossbar from falling in the event the supporting legs are accidentally dislodged." However, no means had been provided at the accident site to prevent the crossbars from falling when the supporting legs were struck by mobile equipment and dislodged.

Corrective Action: Page 6, Item 11 of the roof control plan was revised to require an examination by a certified foreman of all additional roof support. The examination must be conducted on the next preshift examination following the installation of the support. The foreman shall further verify that the crossbars have been properly secured and a record of the observation will be maintained in the preshift or on-shift examination record. The mine operator trained all employees on the revised provision of the roof control plan.

Corrective Action: The mine operator re-instructed all miners in the provisions of the roof control base plan and revisions. All certified foreman and pre-shift examiners were instructed in the proper procedures for conducting, recording, and correcting workplace examinations.
