REPORT OF INVESTIGATION

Fatal Fall of Roof Accident
April 20, 2006

No. 1
Tri Star Coal L.L.C.
Phelps, Pike County, Kentucky
ID No. 15-18102

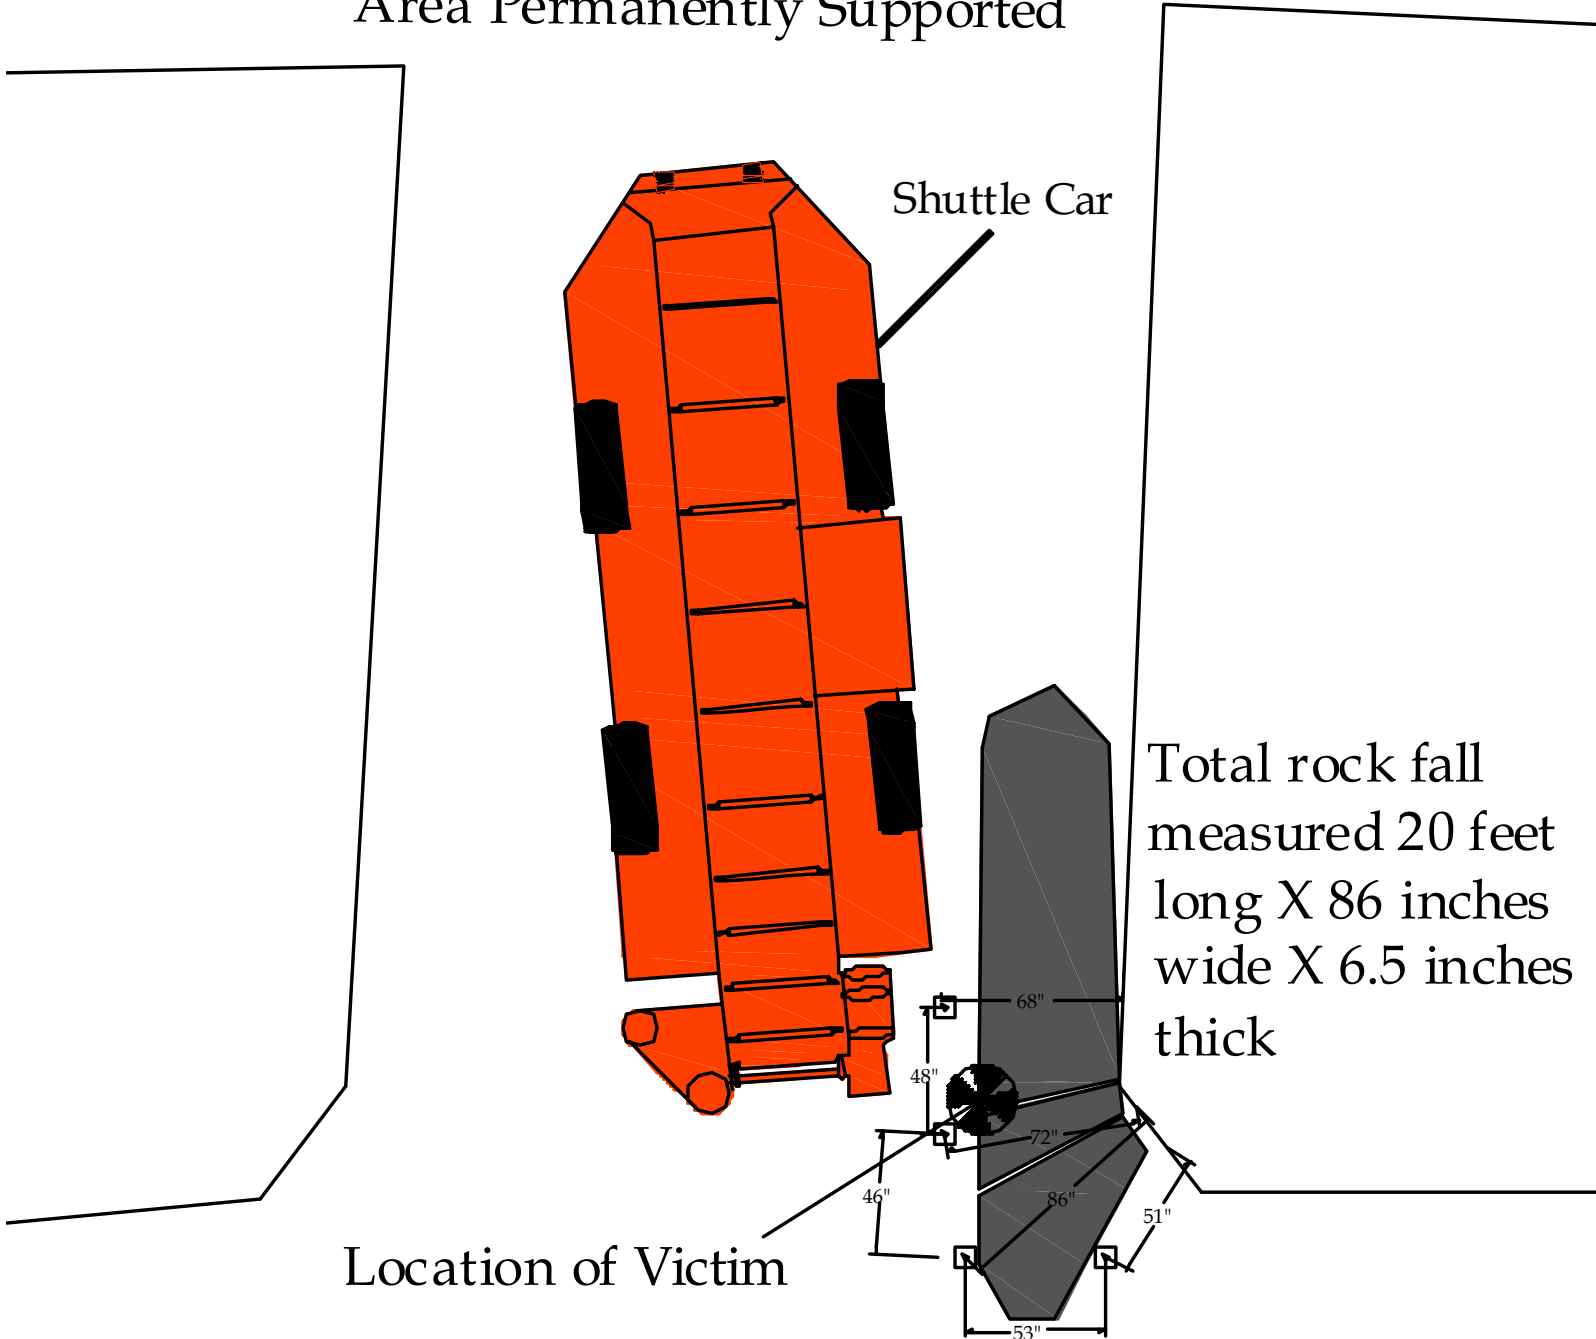
Sketch of Accident Scene
Fatal Fall of Roof Accident
Tri Star Coal, LLC.
Mine #1
MSHA ID No. 15-18102
April 20, 2006

Location of Victim

The fatal roof fall occurred in the No. 6 entry, approximately 68 feet from the pillar line breaker posts. The fall was approximately 20 feet in length, 86 inches in width, and 6.5 inches in thickness. The fall area was located on the right side of the No. 6 entry between the roof bolts and the coal rib. A rib roll had occurred at least several days earlier and had been cleaned up to provide clearance for the belt conveyor/travelway. This rib roll created an area of excessive roof bolt spacing measuring from 56 inches to 86 inches and excessive entry widths ranging from 22 feet 4 inches to 23 feet 6 inches beginning at the outby corner of the pillar block and extending approximately 12 feet inby. The approved roof control plan specifies that roof bolts be maintained within 4 feet of the coal rib and 20 feet maximum entry width.

Corrective Action: All persons working at this mine were given additional training covering the roof control plan and identification and correction of roof hazards. Additionally the roof control plan was revised to reduce the entry widths to 18 feet and reduce the distance between the roof bolts and the rib to 3 feet. All mine equipment was removed from the area inby survey station 336 where the accident occurred, breaker timbers were set across each entry and the area was posted with danger signs.

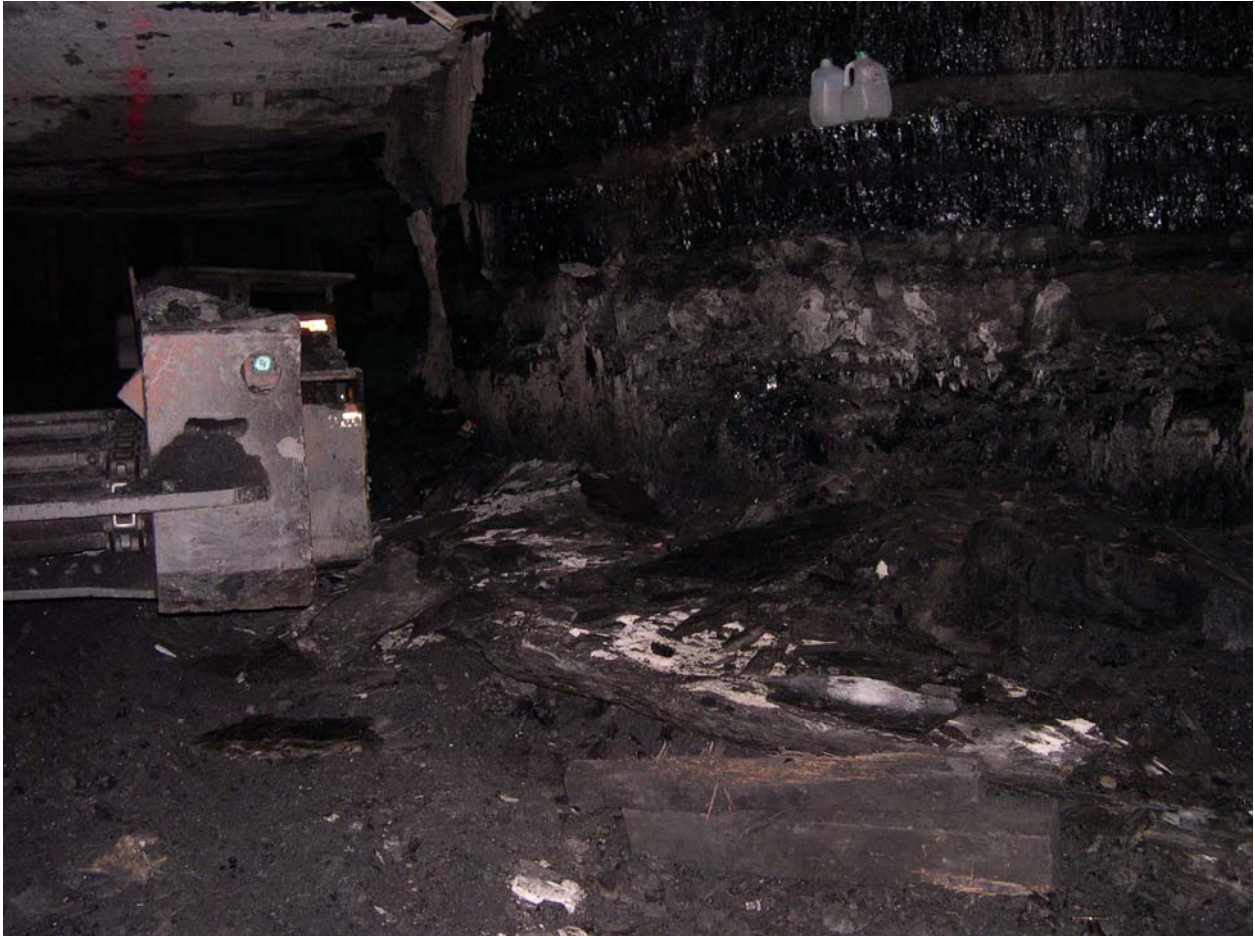
Photograph of Accident Scene

The accident occurred as Bolen was returning to his shuttle car after moving the cable anchor location and scouting his route of travel to the continuous mining machine. A section of roof rock measuring approximately 20 feet by 86 inches by 6.5 inches thick fell from between the roof bolts and the coal rib. The rock struck Bolen pinning him against the mine floor, causing fatal crushing injuries.

Root Cause: Mine management did not ensure that the approved roof control plan was being complied with on the 002-0 MMU working section. Obvious excessive entry width and bolt spacing were present in the No. 6 heading of the 002-0 MMU working section. This condition was present for at least 3 days at the section dumping point. The entry width was approximately 22 to 23 feet and the distance between the coal rib and the roof bolts ranged between 51 inches and 86 inches over a distance of approximately 12 feet in the No. 6 heading. The approved roof control plan specifies a maximum entry width of 20 feet and maximum bolt spacing of 4 feet between the roof bolts and the coal rib. No additional support was installed to correct this obvious hazardous condition.
