**UNITED STATES
DEPARTMENT OF LABOR
MINE SAFETY AND HEALTH ADMINISTRATION**

**COAL MINE SAFETY AND HEALTH
REPORT OF INVESTIGATION**

**Fatal Powered Haulage Accident
May 24, 2006**

**Sycamore Mine No. 2
Wolf Run Mining Company
I.D. No. 46-09060**

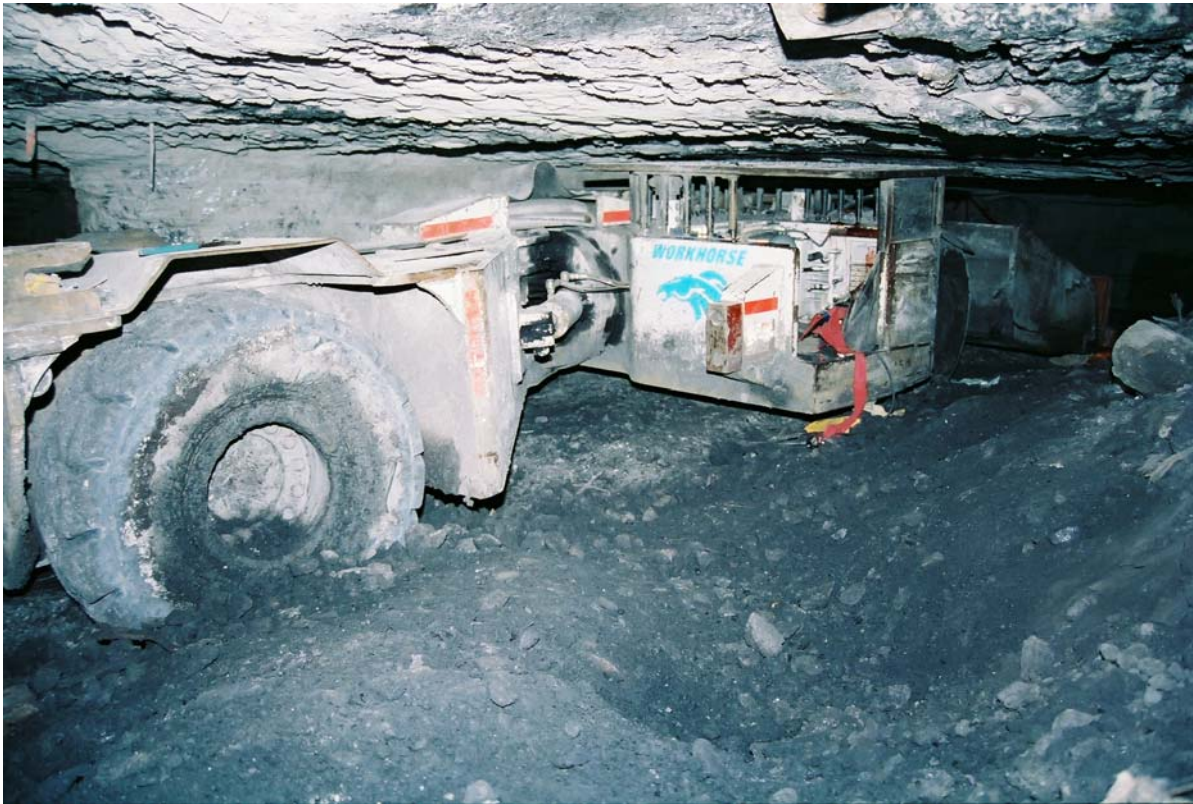
On Wednesday, May 24, 2006, at approximately 2:15 p.m., Todd Upton, a 34-year old Utility Man operating a scoop, was struck and fatally injured by two wooden planks that entered the deck of the scoop. The accident resulted from failure to follow an existing procedure for maintaining haulageways free of extraneous material and is lacking procedure or policy requiring physical protection for scoop operators.

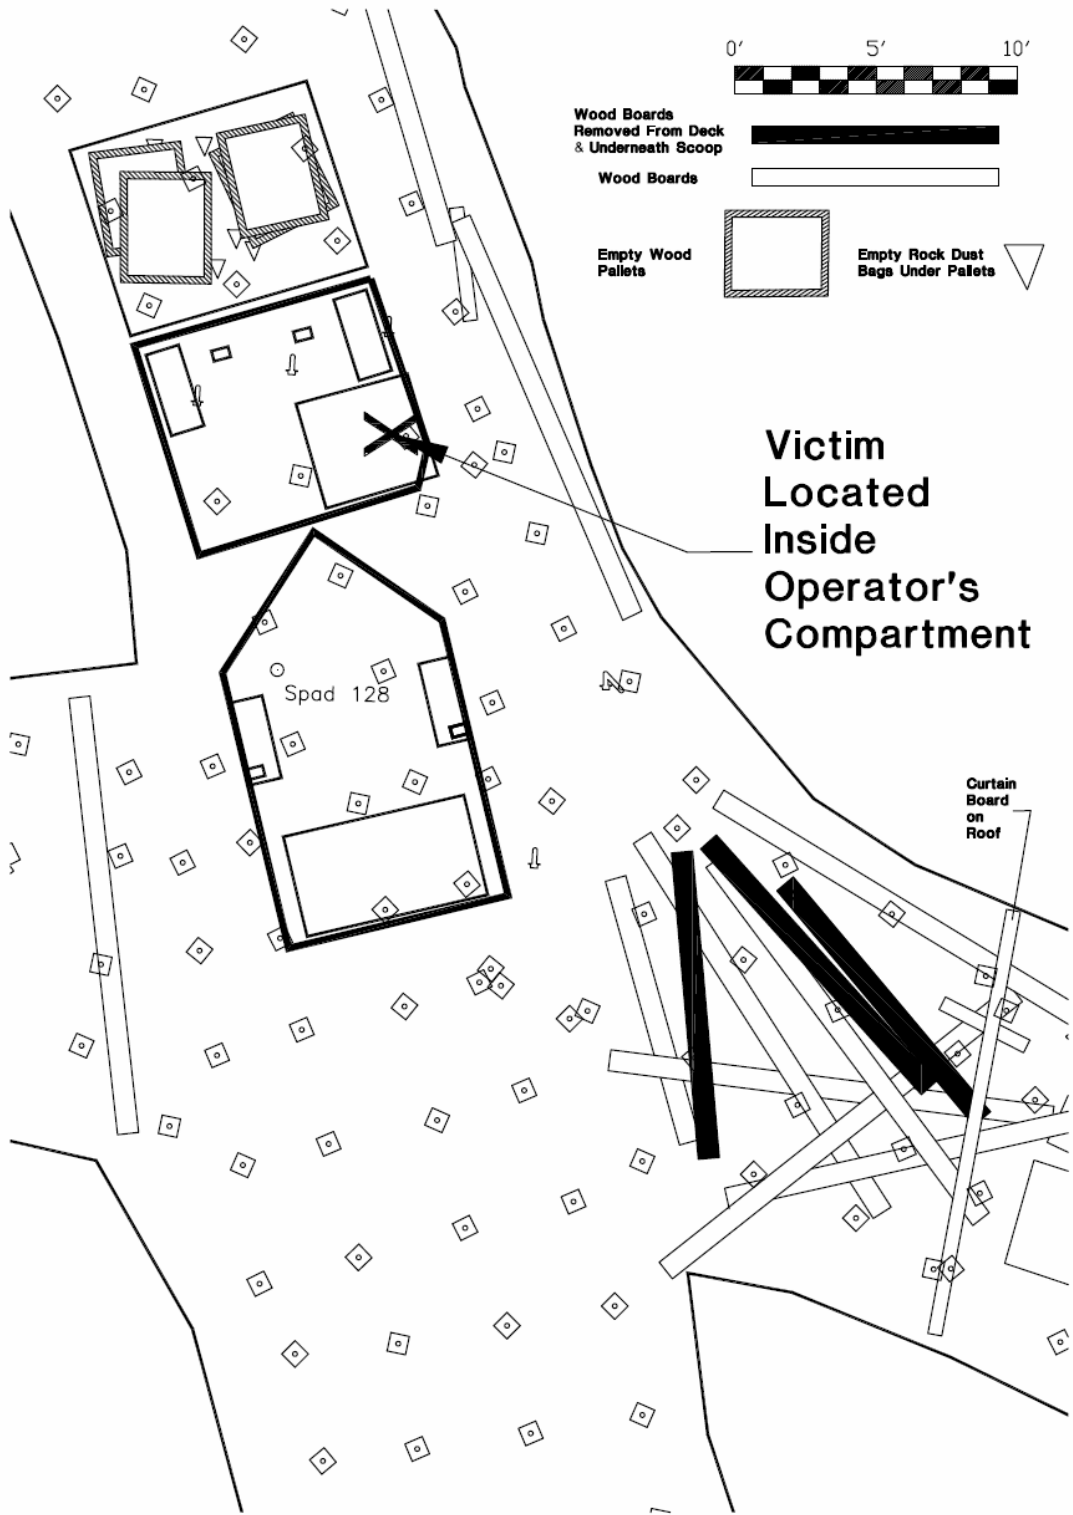
APPENDIX B Accident Site

The roadway, at the accident site, was rolling and slightly damp, defined by two deeply rutted tracks. Roadway height was 52 inches and the width was 17 1/2 feet in the accident area. The immediate roof above the scoop had three dislodged roof bolts with plates missing.

Just inby 12 Block, on the right side next to the rib were two crib blocks and two planks. In the belt side cross-cut at 12 Block, there were 10 planks lying on the ground. The planks were 3 inches thick by nine inches wide by 12 feet long.
