REPORT OF INVESTIGATION

Fatal Fall of Roof Accident
October 12, 2006

No. 7 Mine
Jim Walter Resources, Inc.
Brookwood, Tuscaloosa County, Alabama
I.D. No. 01-01401

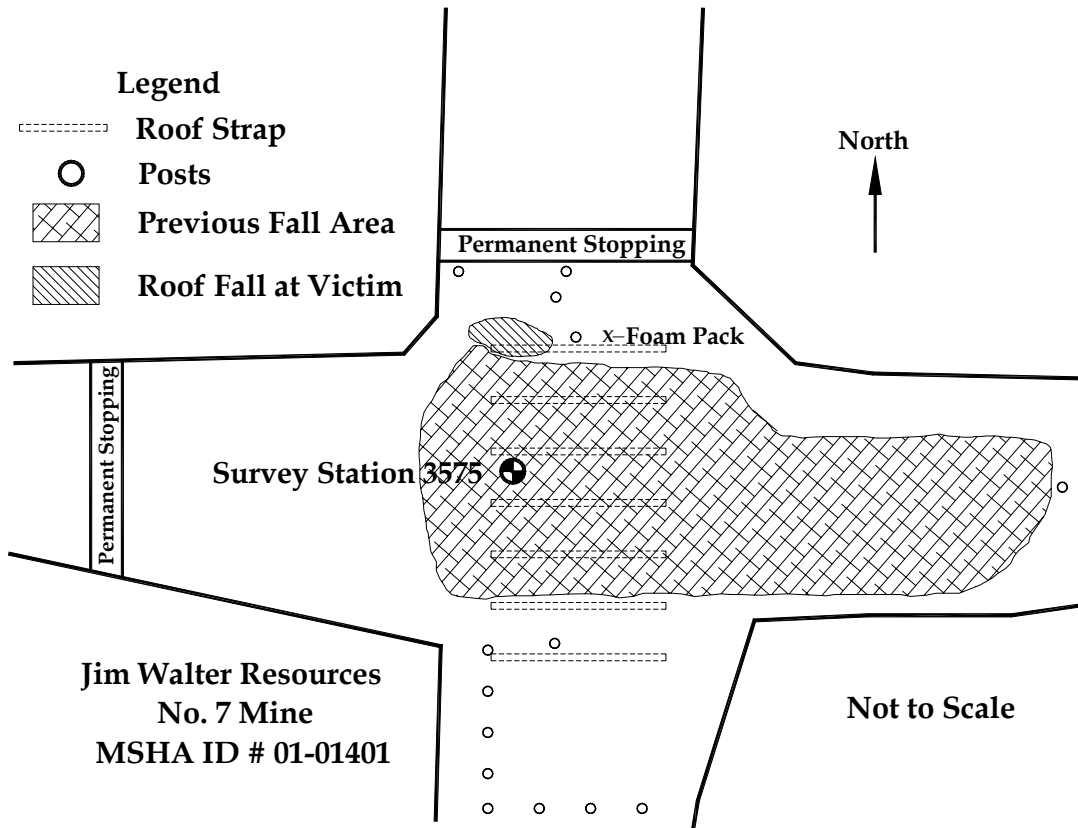
OVERVIEW

Day shift supervisors who worked directly for McKinney noticed at about 5:45 A.M., that the victim's truck had not been moved, and his office had not changed from the previous day. The day shift CRO did not have knowledge of McKinney's location, so the night shift CRO was contacted at his house. The night shift CRO recalled, from what he remembered from the previous shift turnover, that McKinney was still underground, in the vicinity of the old 8 section and North Seals. At approximately 7:00 A.M., the mine activated its missing person protocol, and began a search. McKinney was found at approximately 8:05 A.M., pinned under a piece of roof rock (Overview Sketch).

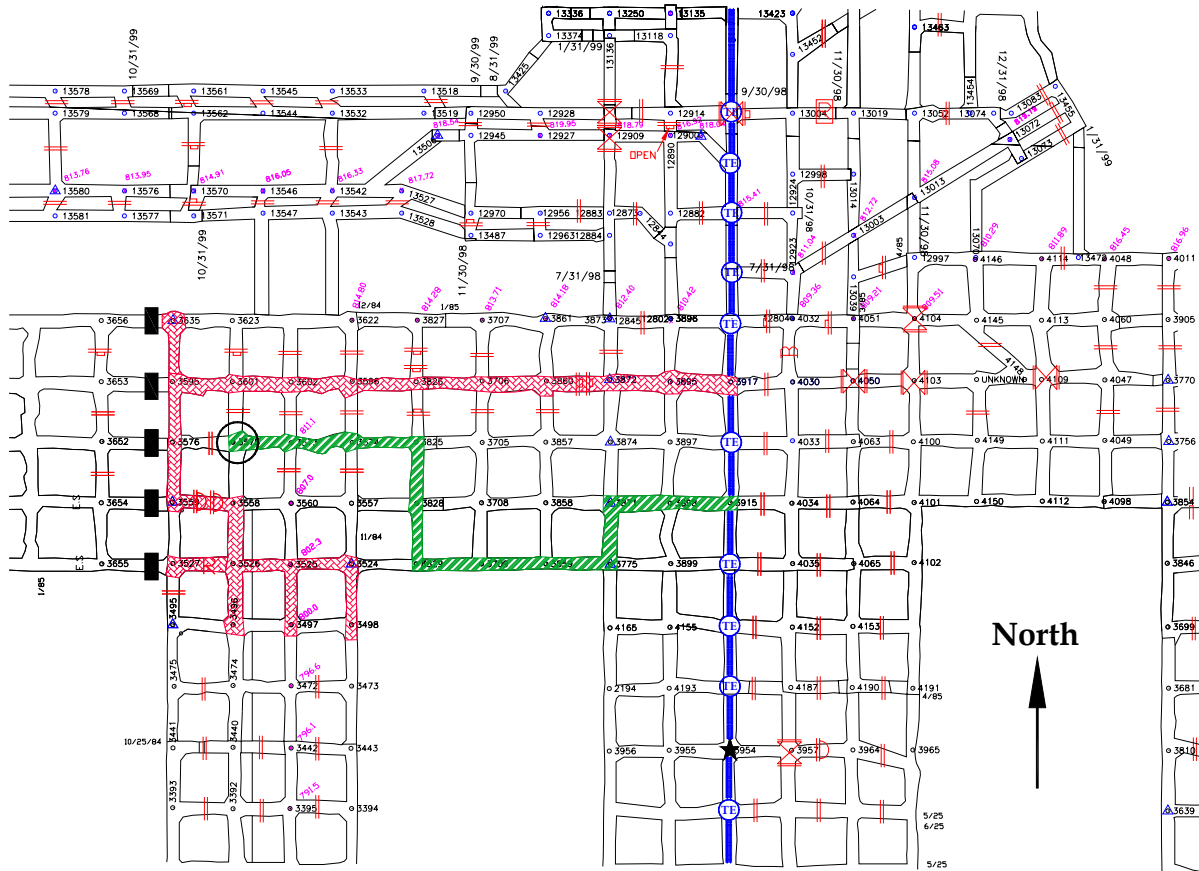
North Mains General Overview

Green (angle hatched) path re-supported during 2003 for 7-6 fan start up project.
-

Red (cross hatched) path traveled by the examiner on a weekly basis to check evaluation points and seals. Red path traveled by miners who hand carried wood posts to re-support the evaluation point area in July of 2006.
-

Blue (solid line marked TE) line indicates the location of the main track entry.

The star indicates last observed location of victim; the circle is where the victim was found.

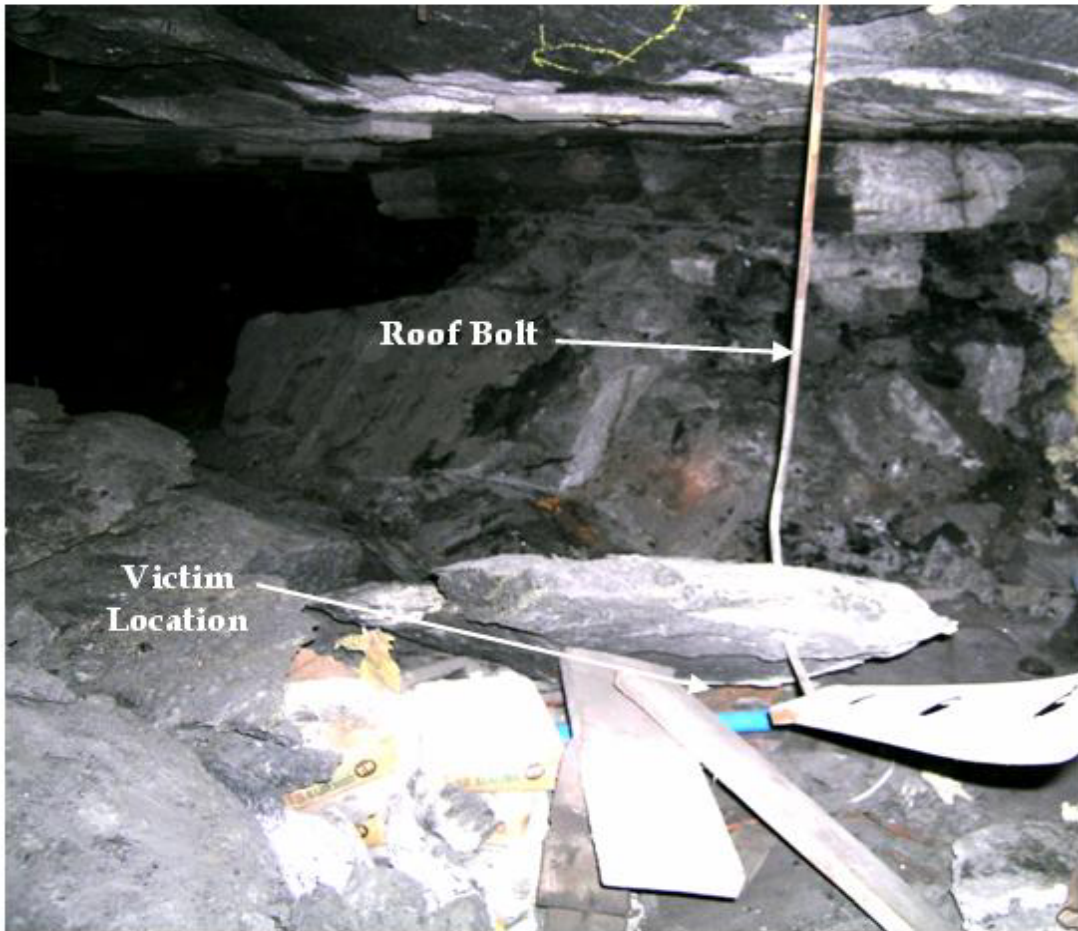
Photograph of accident site

The entries were developed in the Blue Creek coal seam that measured between 5 and 6-feet thick. The roof in the accident area had deteriorated over time, with the immediate roof falling out sometime after 2003 (Overview Sketch, Appendix C). In general, the area was characterized by deteriorated roof and installed support (broken roof bolts and roof straps) conditions. The mine operator was aware of the conditions in this area of the mine, and had installed additional supports on a selected path along entries up to the North Seals during installation of ventilation controls (permanent stoppings) for the 7-6 fan start up in 2003. In addition, the travel

The rock that separated from the roof measured 83-inches long x 43-inches wide x 7-inches thick, and had a roof bolt through one end that had failed at or near the anchorage point. It fell from the brow of a pre-existing fall of immediate roof that started in the crosscut at spad 3575, and extended east a distance of 62-feet. The width of the roof fall varied from 11 to 16-feet (Overview Sketch). In this area, several roof bolts had failed at the mechanical anchors, and some had broken along the shaft of the bolts. The heads of several roof bolts had also pulled through the bearing plates.

At the time of the accident, it appears that McKinney was evaluating, and possibly applying sealant to a ventilation control located just north of spad 3575 (Overview Sketch). A new foam pack was found in close proximity to the accident site, and the stopping had been sealed with the foam sealant. The foam sealant on the stopping was white in color and appeared to have been recently sprayed. He was positioned under the brow when the roof bolt failed, causing the roof rock to fall and strike him.

Corrective Action: The mine operator installed additional standing support in the area of the fall to make the immediate area safe for the investigation. All entrances to the accident site area were timbered off with danger signs posted to keep miners from entering the areas of unsafe roof.
