**UNITED STATES
DEPARTMENT OF LABOR
MINE SAFETY AND HEALTH ADMINISTRATION**

REPORT OF INVESTIGATION

**Fatal Roof Fall
June 16, 2008**

**Harmony Mine
UAE Coalcorp Associates
Mount Carmel, Northumberland County, PA
ID No. 36-07838**

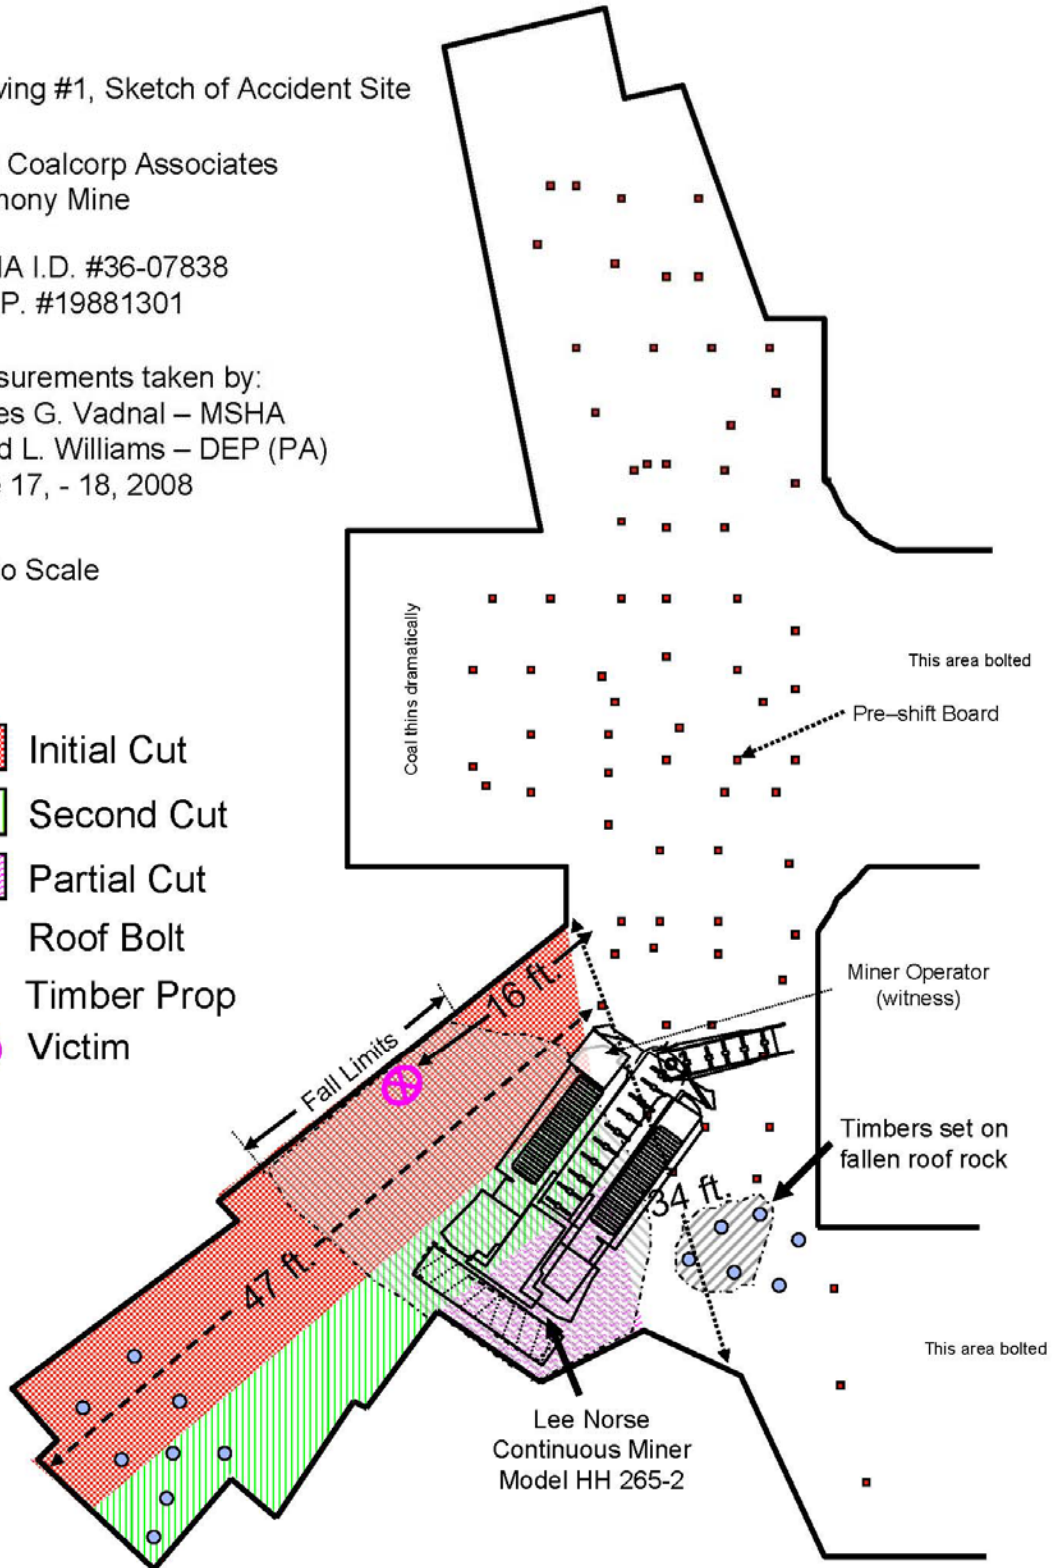
Drawing #1, Sketch of Accident Site

At approximately 9:20 a.m., Oliveri went to the miner. He asked Carey, located at the right coal rib, about 16 feet inby the last permanent supports, if he was OK where he was standing. Oliveri asked Carey because of the presence of the roof roll. Carey answered that he was "all right." Oliveri began loading the shuttle car with the continuous miner. The shuttle car was not completely loaded when Oliveri was instructed by Carey to take a partial cut off the left solid pillar line to complete loading of the shuttle car. Oliveri started the cut on the pillar line when a section of the roof collapsed. The roof fall was approximately 30 feet wide, 20 feet long and 4 inches to 4 feet thick. The fall covered the front of the continuous miner, extending the width of the entry, pinning Carey against the coal rib.

positioning himself along the east end of the solid pillar line, approximately 16 feet inby the last permanent roof support (please refer to drawing of the accident scene on page 3). He positioned himself at this location prior to the mining of the third cut.

This provision was violated by the continuous miner operator advancing approximately 27 feet inby the last row of permanent roof support. He advanced beyond permanent roof support during the initial and the second cuts of coal.

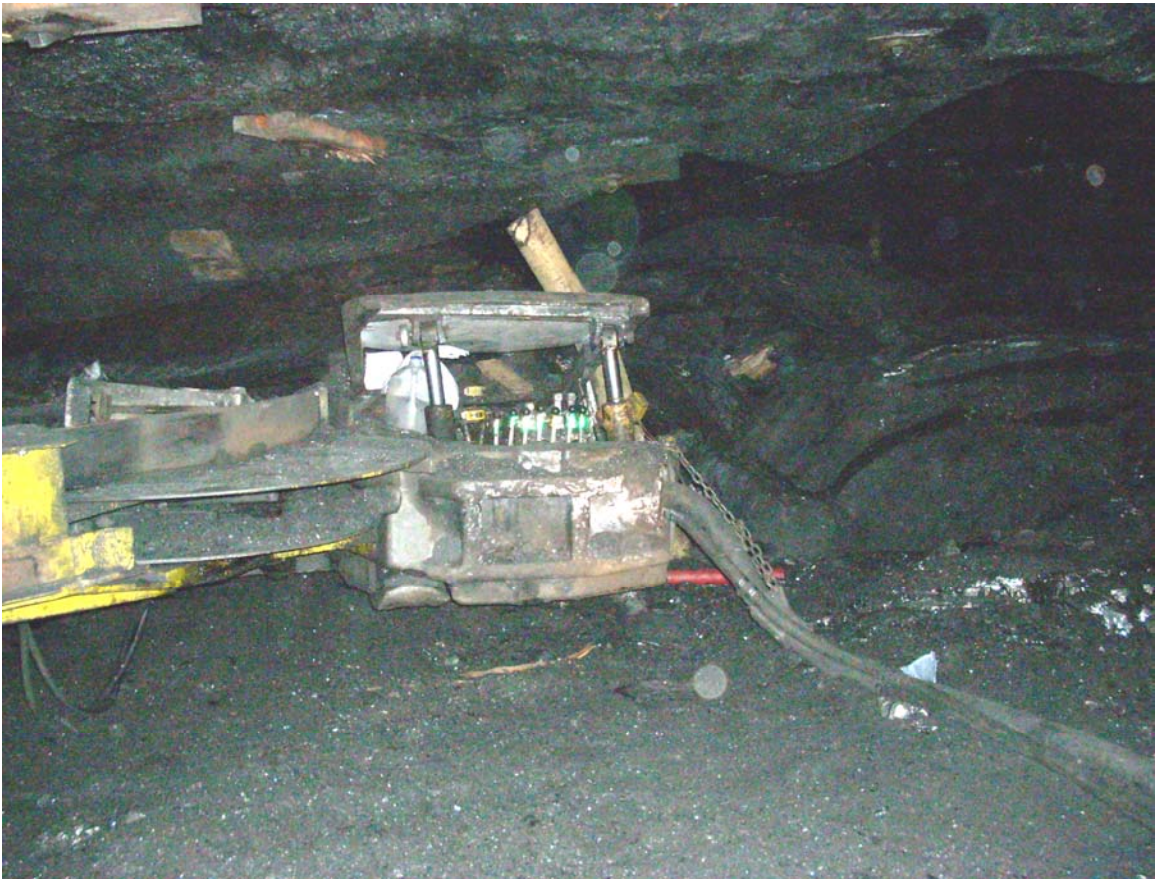
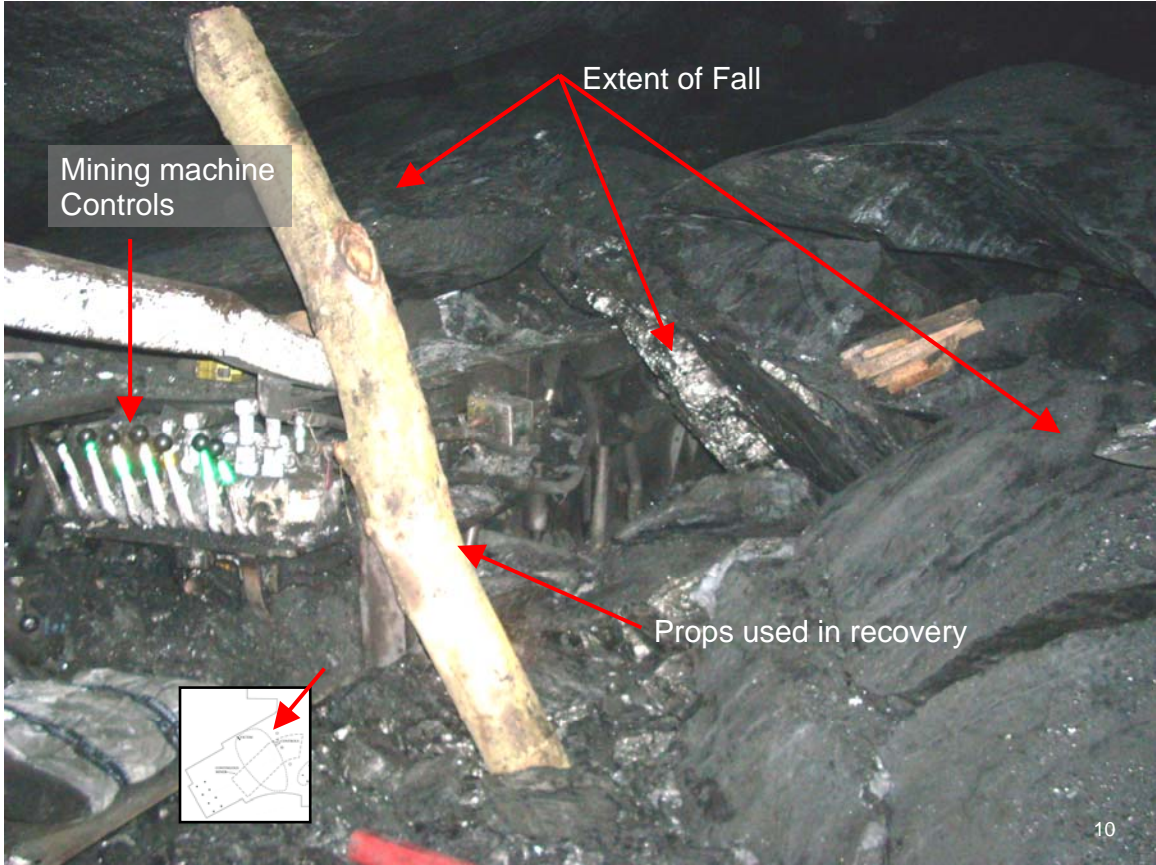
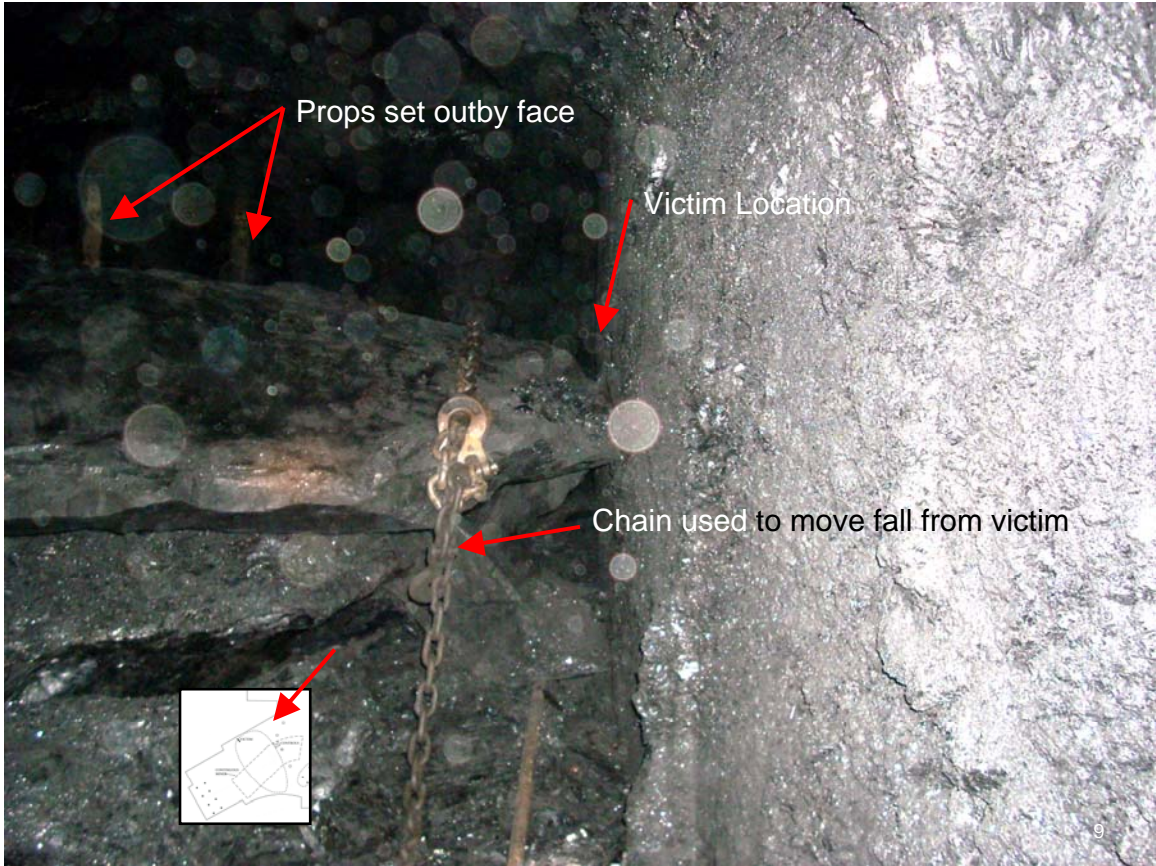
APPENDIX C - Photographs of the Accident Scene

Roof lithology (composition) had changed in the area of the accident from conglomerate to very hard, dark grey shale with a slickenside upper surface. The roof fall varied in thickness from 4 inches on the outby end of the fall to an estimated 4 feet on the inby end.

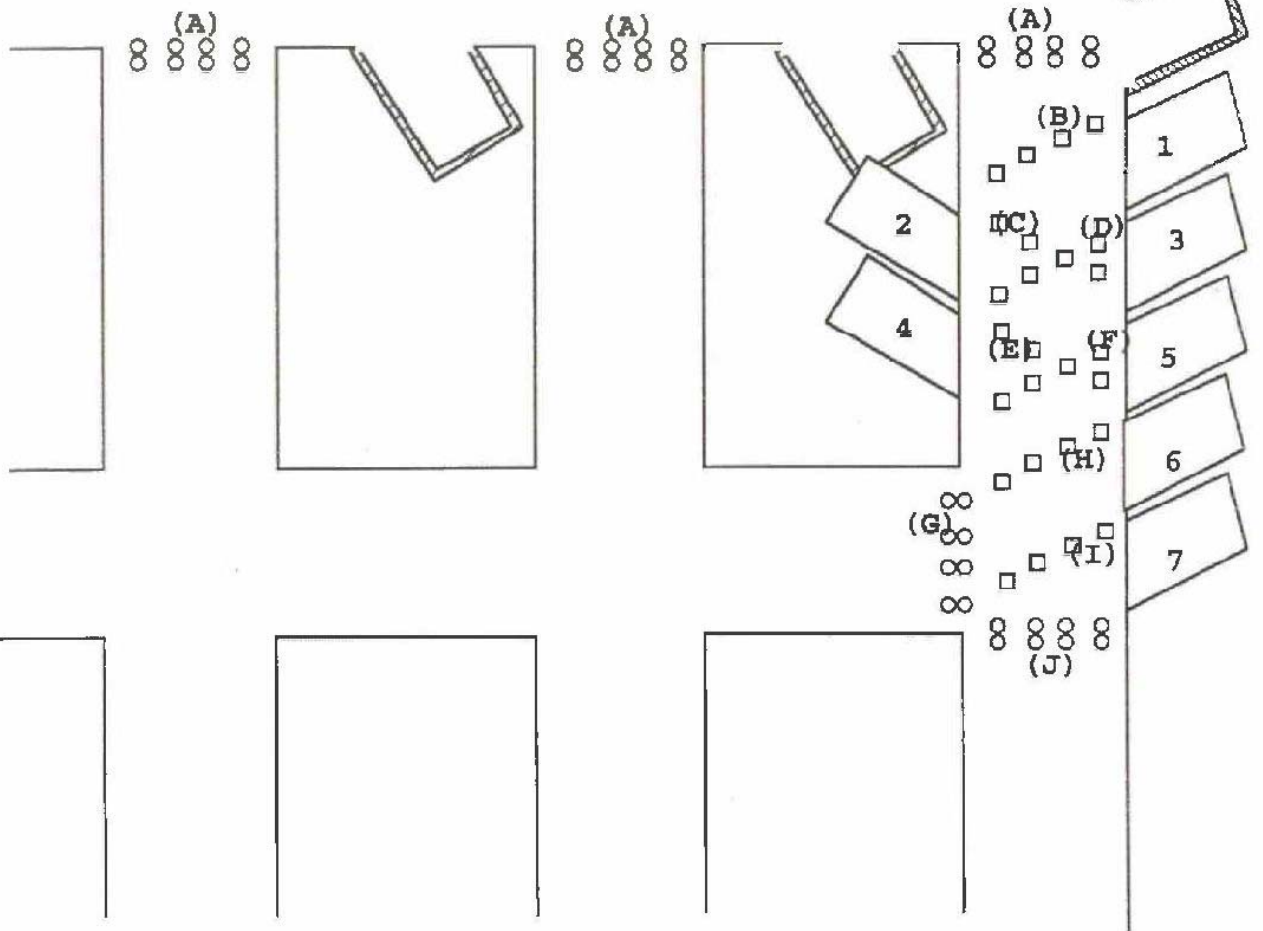
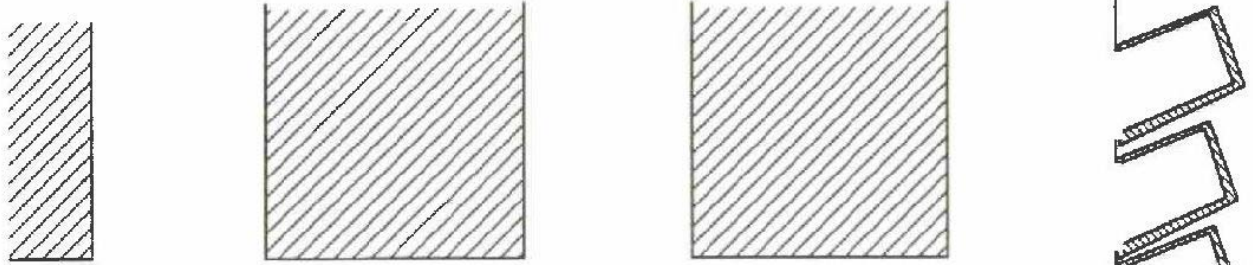
DRAWING No. 5
 Pillar Extraction
 Solid Rib & Pillar

2. *"Pillar removal precautions" statements 3-5: Turn posts shall be set at location[s] prior to starting lifts No. 1 through No. 3."* These provisions were violated by turn posts not being provided for the three lifts that were mined. Four turn posts per lift are shown on drawing number 5, (page 21).
