DEPARTMENT OF ENERGY

Office of River Protection

Double-Shell Tank Integrity Project

Overview of Double-Shell Tank (DST) Integrity Project

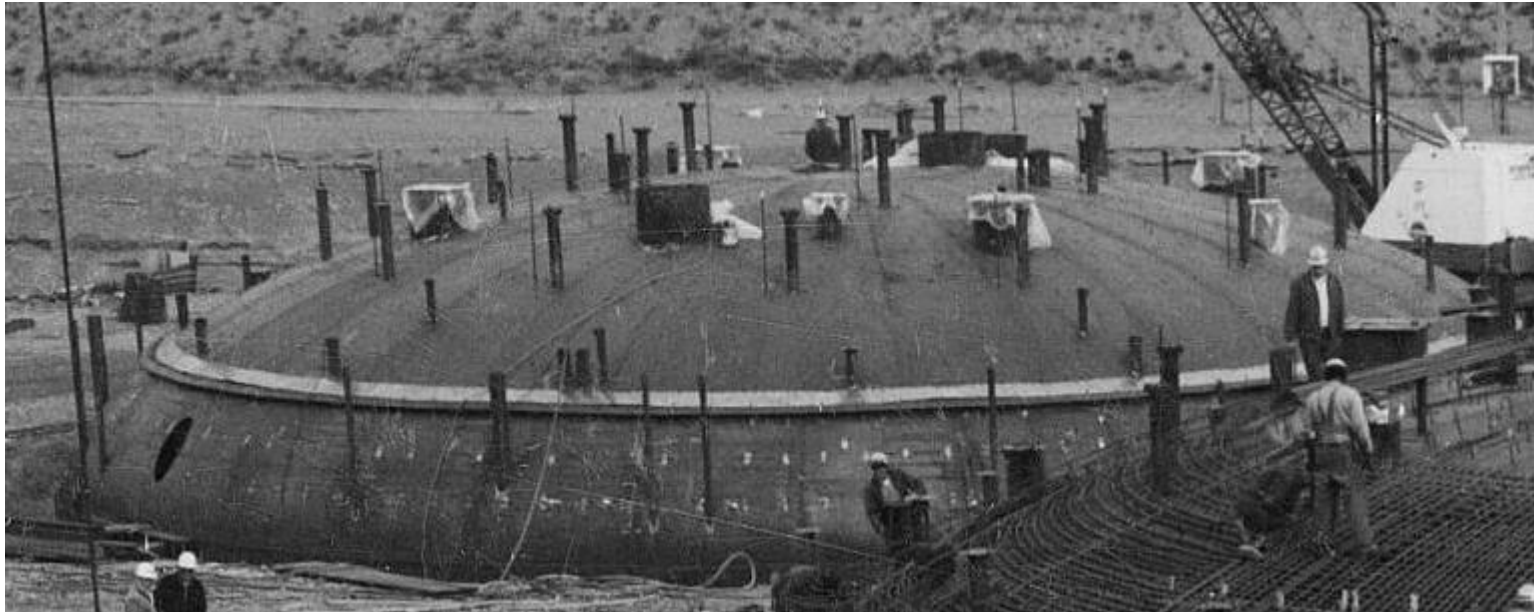
Water Intrusion Inspection

Interface between primary tank and secondary liner inspected because this interface wasn't welded. The secondary liner rides on top of the primary tank and the interface is covered with lead flashing, which was tack welded into place.

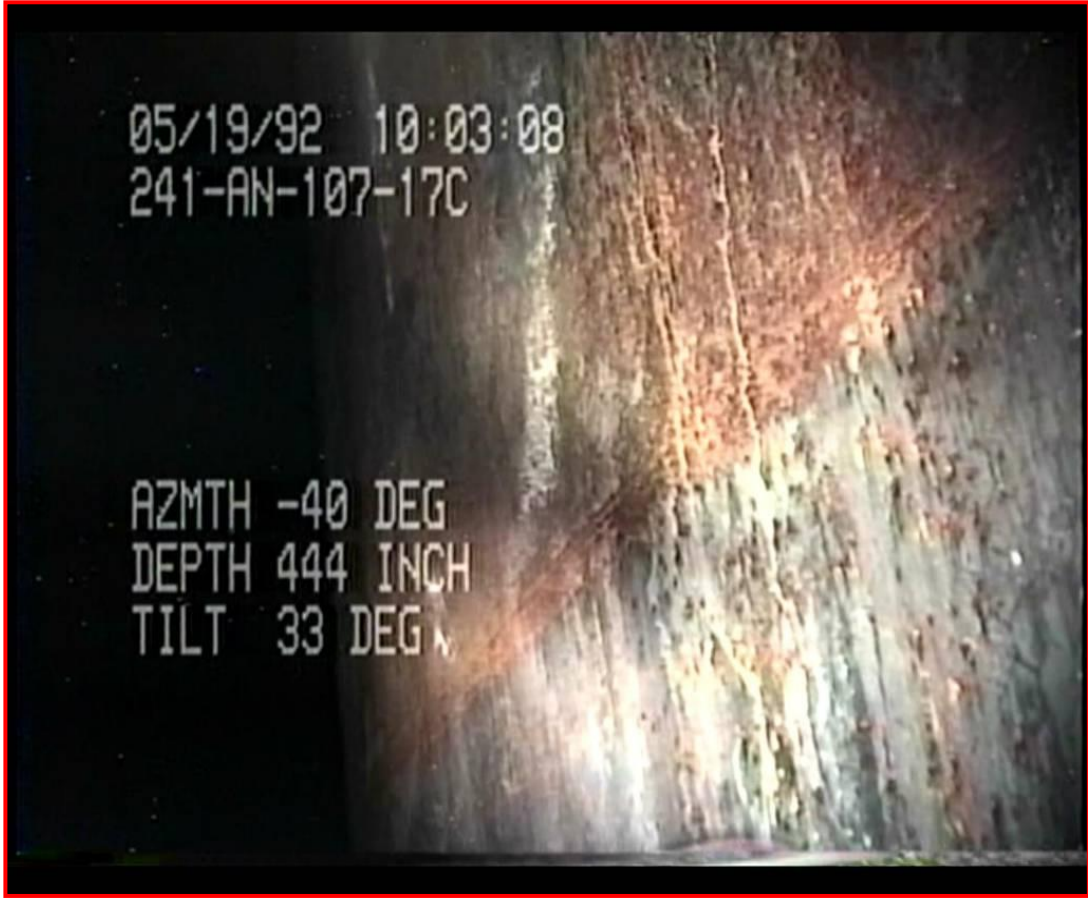
Photo Identification	AN-107-03
Date of Inspection	May 19, 1992
Date of Review	FY 2006
Location	Exterior of primary tanks shell, along Course 3 and 2, joining the bottom edge of the primary shell plate F7301M2 number 5A and primary shell plate F7301M2 number 5B viewed through Riser 46.
Description	DVIDID# 10258 Corrosion along circumferential weld joining Course 2 and 3. Noticeable corrosion product directly above weld continues to Course 1. Possible surface condensation on the outside of primary shell has accelerated corrosion in this area.

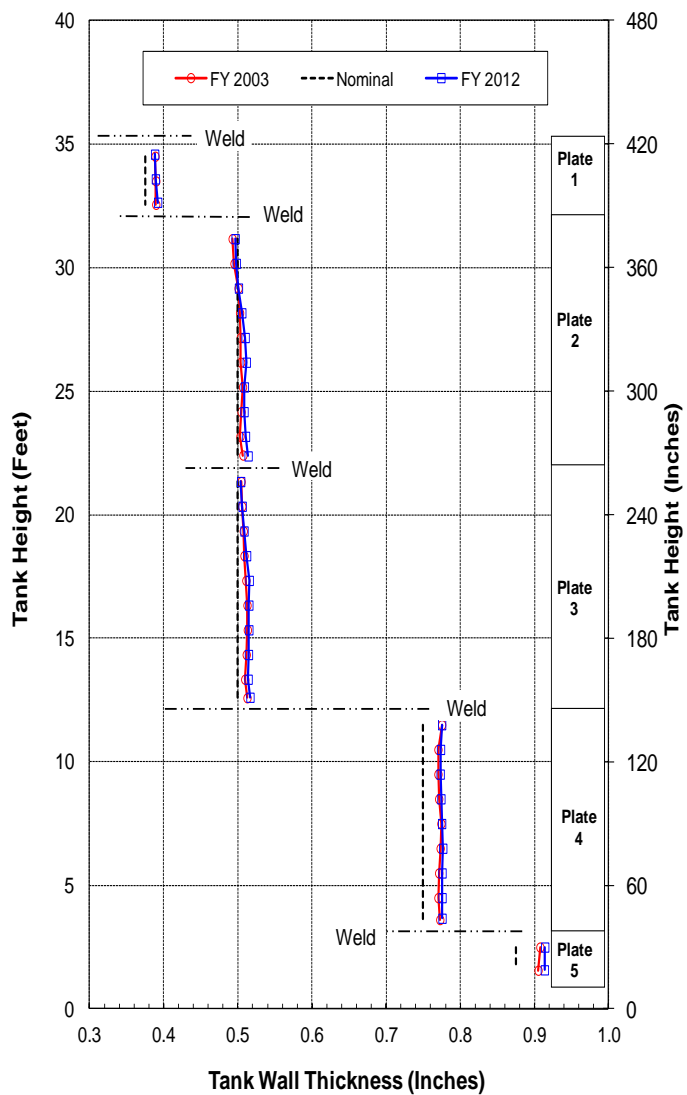
241-AZ-102 2003-2012 Average
Wall Thickness Riser 90

- Three areas of reportable wall thinning
 - Total area < 10 square inches
 - Thinnest area 0.413 inches
 - Plate 2 in Riser 90
- No reportable pitting or linear indications

- No reportable wall thinning
- No reportable pitting
- No linear indications

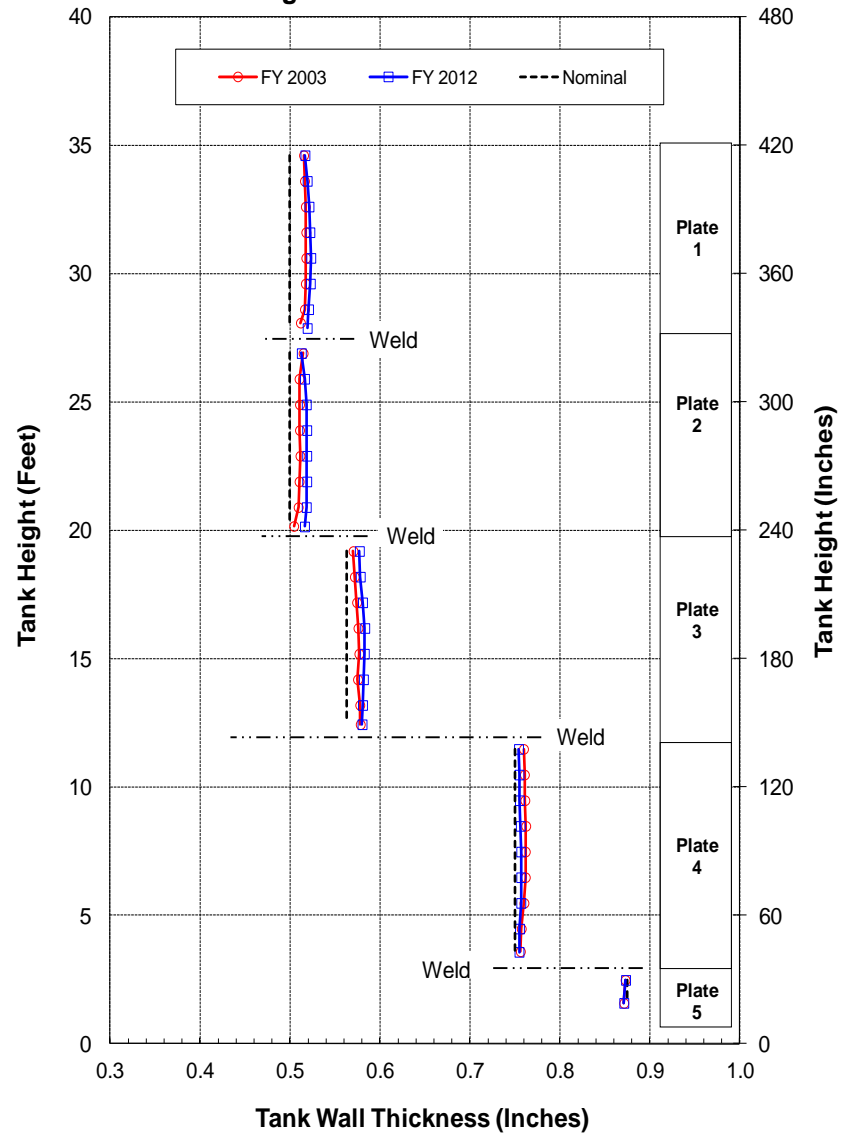
241-AP-105 FY 2003 & FY 2012
Average Wall Thickness Riser-031

- No reportable wall thinning
- One pit > 10 percent
- No reportable linear indications

- No reportable wall thinning
- No reportable pitting
- No linear indications

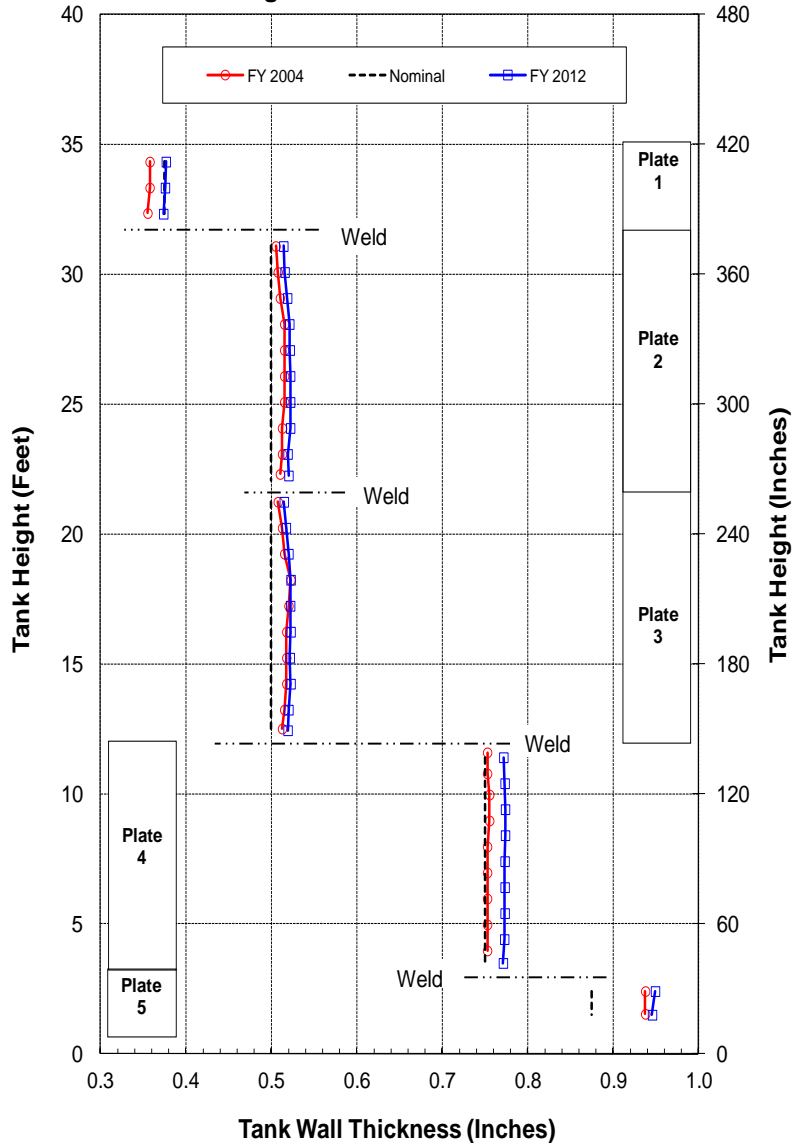
241-SY-101 FY 2004 & FY 2012
Average Wall Thickness Riser-026

- Two areas of reportable wall thinning
- Two pits > 10%
- No reportable linear indications

- Six areas of reportable wall thinning
- Six pits > 10%
- No reportable linear indications

- No reportable wall thinning
- No reportable pitting
- No linear indications
