NATIONAL TRANSPORTATION SAFETY BOARD

RAILROAD ACCIDENT REPORT

DERAILMENT OF CSX FREIGHT TRAIN Q316 AND
SUBSEQUENT HAZARDOUS MATERIAL RELEASE
AT COX LANDING, WEST VIRGINIA
JUNE 20, 1998

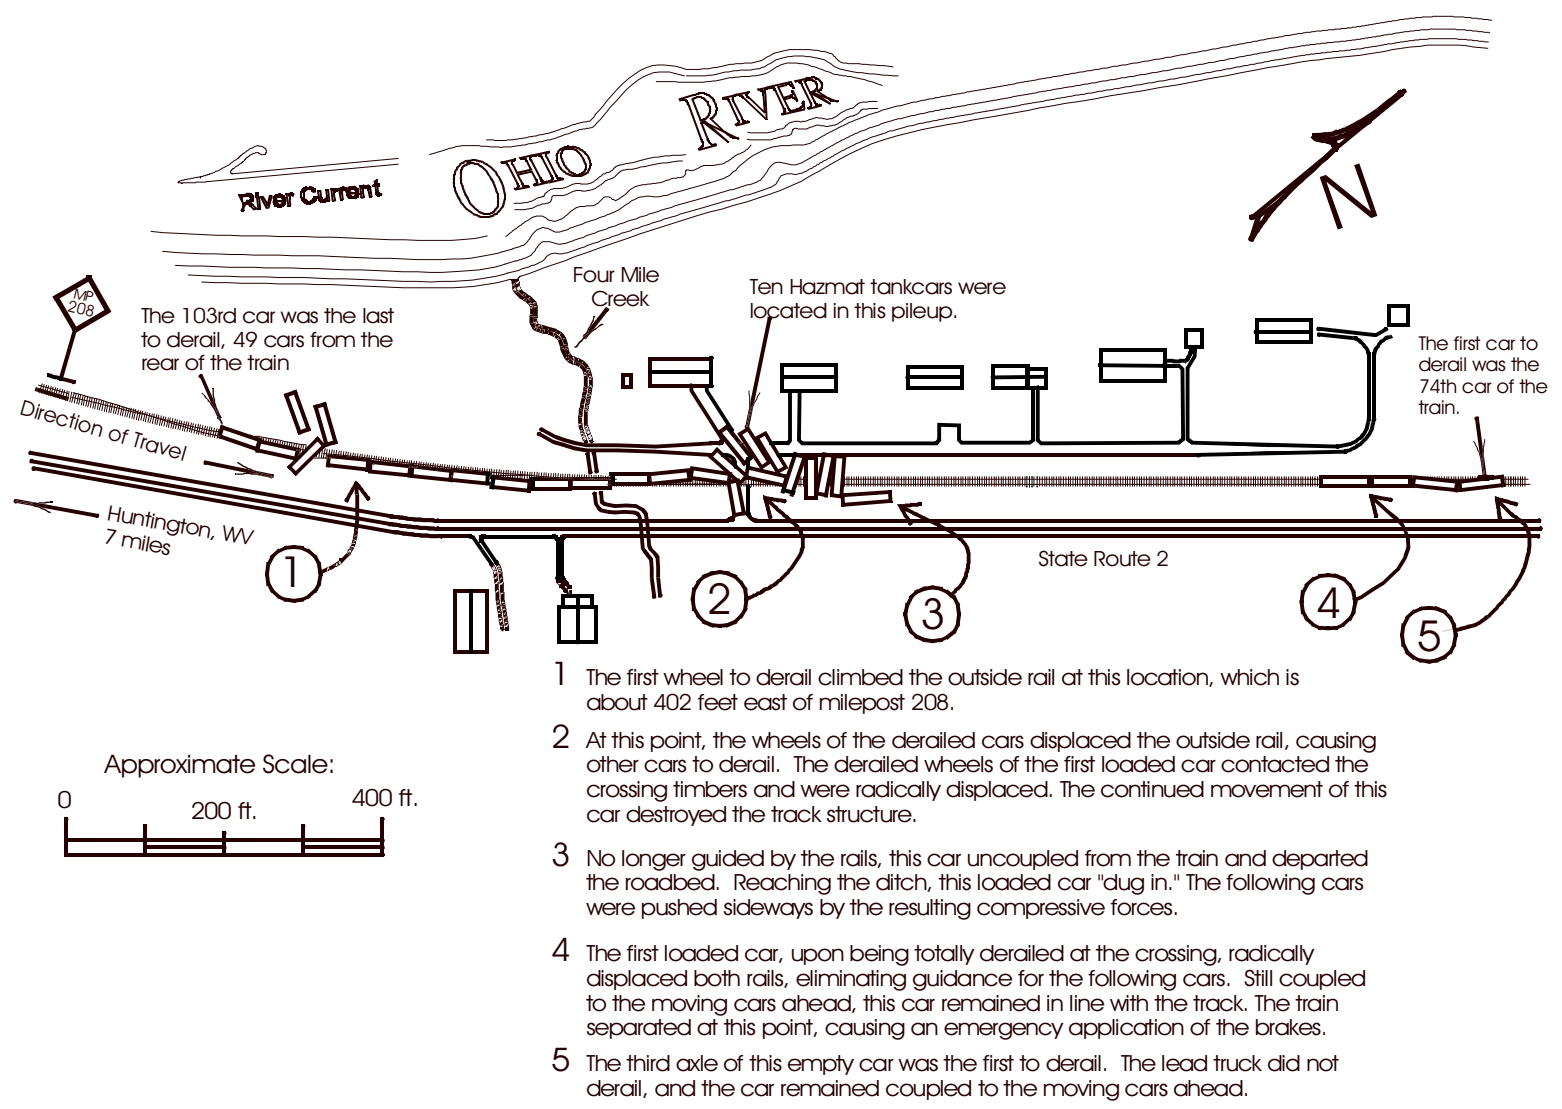
Figure 2. Final resting place and point of derailment

- 1 The first wheel to derail climbed the outside rail at this location, which is about 402 feet east of milepost 208.
- 2 At this point, the wheels of the derailed cars displaced the outside rail, causing other cars to derail. The derailed wheels of the first loaded car contacted the crossing timbers and were radically displaced. The continued movement of this car destroyed the track structure.

- 3 No longer guided by the rails, this car uncoupled from the train and departed the roadbed. Reaching the ditch, this loaded car "dug in." The following cars were pushed sideways by the resulting compressive forces.

- 5 The third axle of this empty car was the first to derail. The lead truck did not derail, and the car remained coupled to the moving cars ahead.

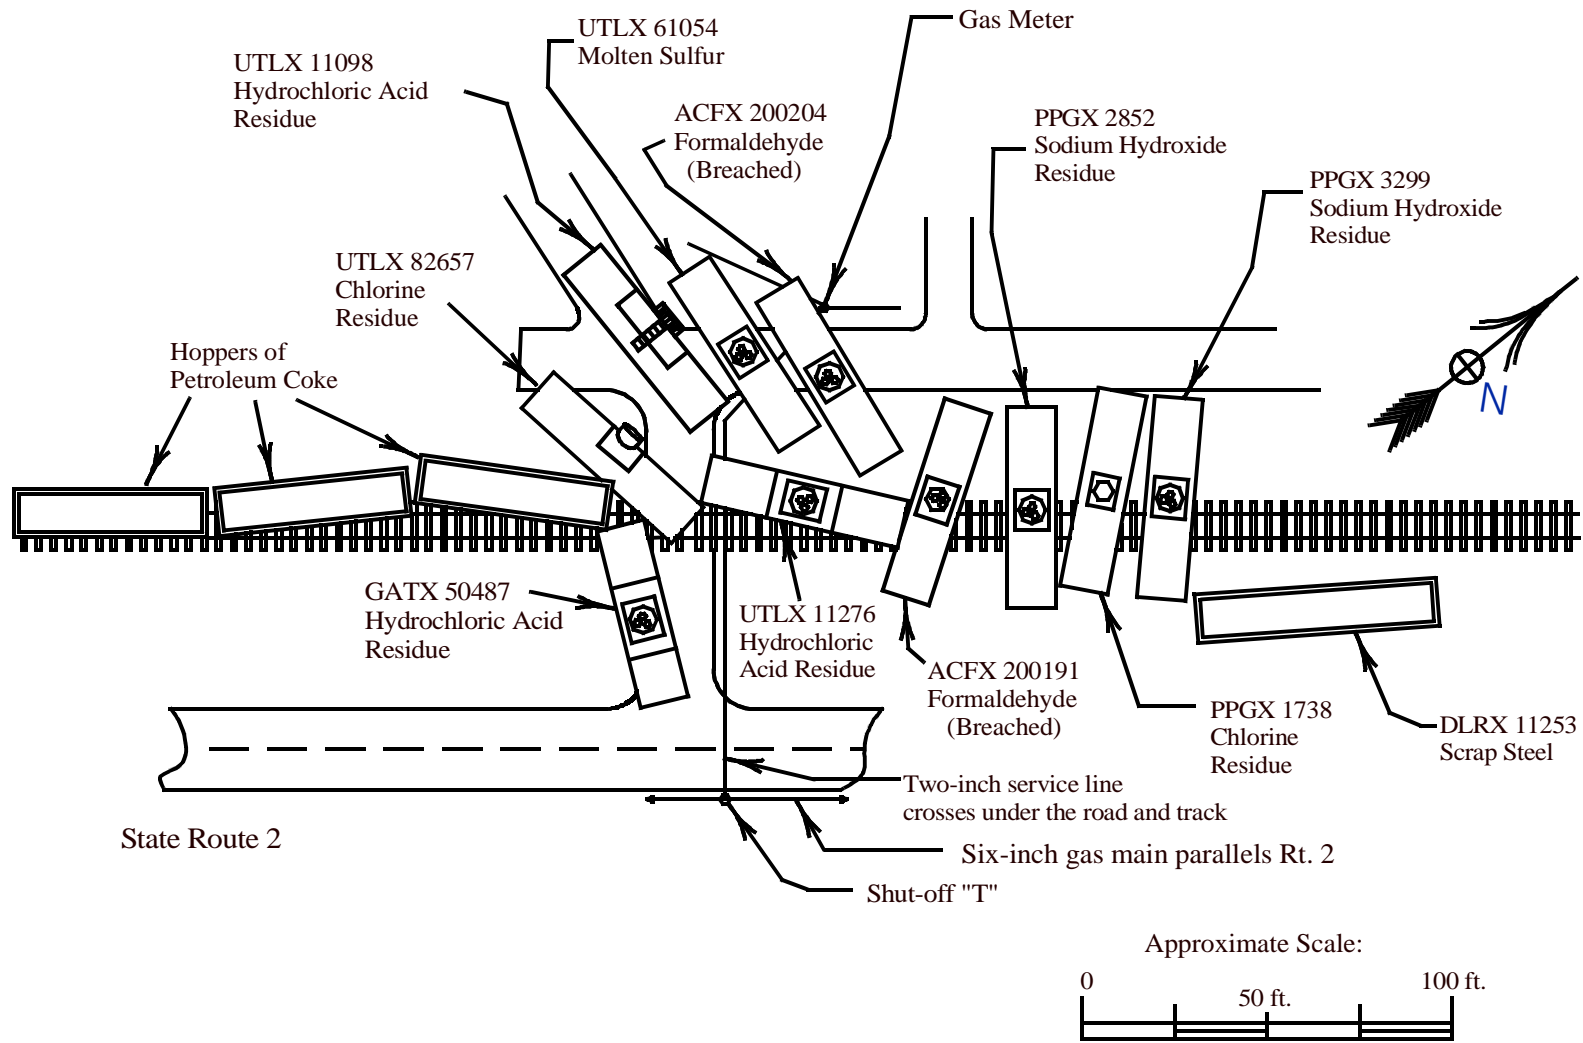
Figure 3. Overhead view of the primary pileup

Of the 30 cars that had derailed, 3 were loaded cars of hazardous material, and 8 others contained hazardous material residue. Two of the loaded cars were tank cars containing formaldehyde at a 37-percent solution. Both tank cars were damaged during the pileup and eventually leaked a combined volume of about 21,500 gallons of formaldehyde solution.

Several tank car heads were struck during the derailment, but none of the heads were breached as a result of coupler impact. All the tank cars that were involved in the primary pileup were classified as destroyed because the estimated cost of repair exceeded the cars' value. All of these cars contained hazardous material or hazardous material residue. Two of these cars released product; eight did not.
