August 31, 2001  
IPN-01-063

SUBJECT: Indian Point 3 Nuclear Power Plant  
Docket No. 50-286  
**Thirty-Day Response to NRC Bulletin 2001-01**  
**"Circumferential Cracking of Reactor**  
**Vessel Pressure Vessel Head Penetration Nozzles"**

**Thirty-Day Response to NRC Bulletin 2001-01  
"Circumferential Cracking of Reactor Vessel  
Pressure Vessel Head Penetration Nozzles"**

Entergy Nuclear Operations, Inc.  
Indian Point 3 Nuclear Power Plant  
Docket No. 50-286

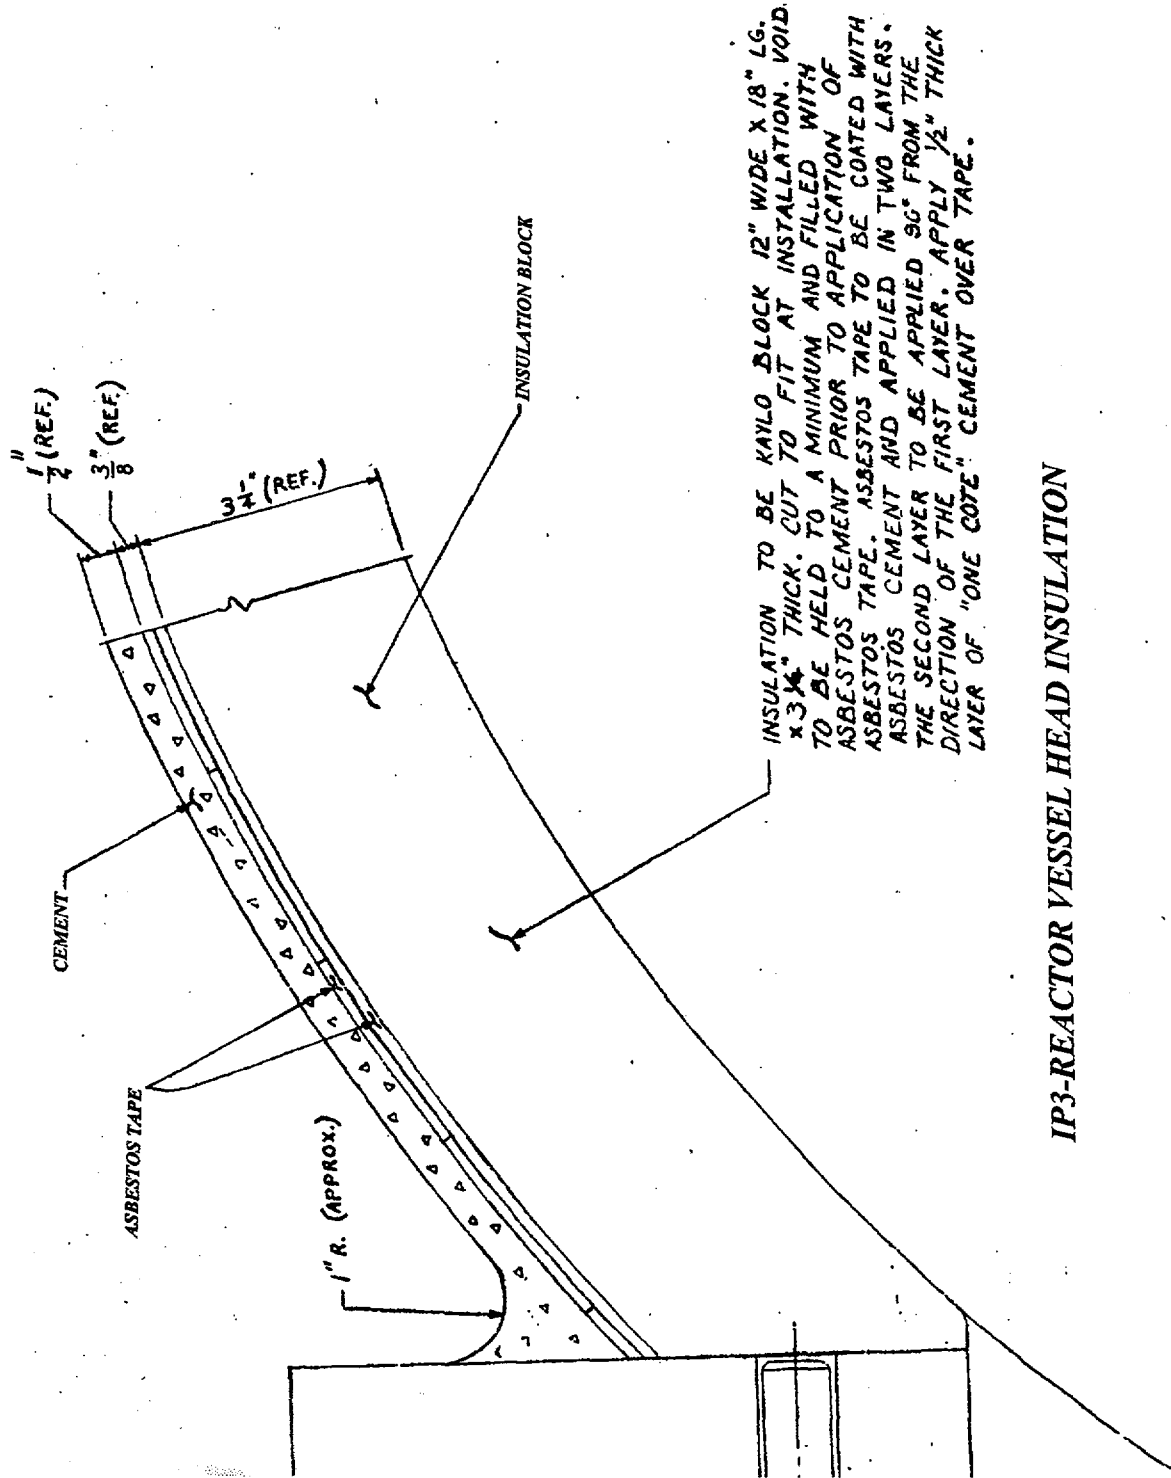
Figure 1  
INDIAN POINT 3 REACTOR VESSEL HEAD INSULATION

As reported in Table 2-1 of MRP-48 (Reference 3), Indian Point 3 has block contoured RPV head insulation. A note on a plant drawing (Figure 1, Reference 4) describes it as:

*"Insulation to be Kaylo Block 12" wide x 18" lg. x 3-1/4" thick. Cut to fit at installation. Voids to be held to a minimum and filled with asbestos cement prior to application of asbestos tape. Asbestos tape to be coated with asbestos cement and applied in two layers. The second layer to be applied 90 degrees from the direction of the first layer. Apply 1/2" thick layer of 'One Cote' cement over tape."*

The actual application shows evidence of trowel-applied material extending upwards at the side of some of the penetrations, indicating use of cement-adhesive at these intersections. See Image T2-2338.
