Subject: Duke Power Company, Oconee Nuclear Station, Unit 1
Docket No. 50-269
Reactor Vessel Head and Penetration Nozzle Condition Report

**Oconee Unit 1
End-of-Cycle 20 Refueling Outage
Reactor Vessel Head Penetration Nozzle Indication Report**

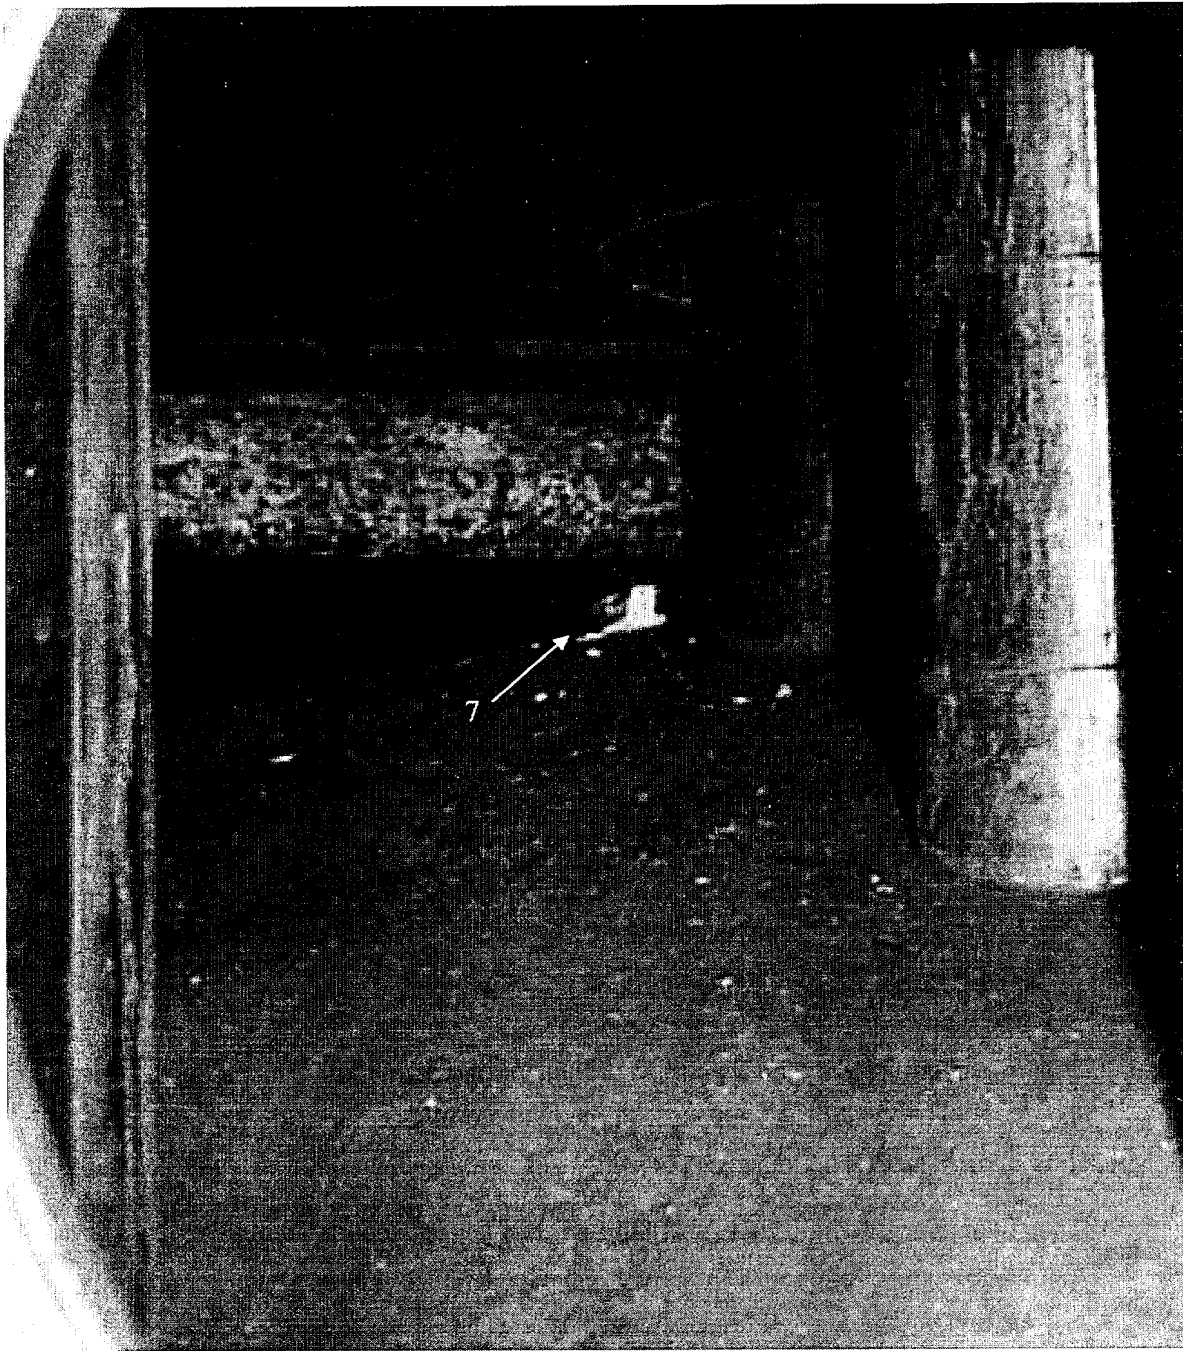
Nozzle 7 was masked by a fresh looking deposit (white) with a band going up the side of the nozzle. The band extending up the nozzle, shown in Figure 1, opened the possibility that the boric acid crystals may have originated from a CRDM flange leak. Further video inspections, after the head was placed on the stand, disclosed that the band stopped before tying into any leakage indications from above (which would be more indicative of a CRDM flange leak). Ultrasonic inspection looking for indications in Nozzle 7, showed 5 axial indications (none of which constituted a leak path within the nozzle) extending from below the J-groove weld up into the nozzle area adjacent to the weld. The longest of the indications extended up about 2/3 of the length through the adjacent weld thickness. The liquid penetrant examination of the bore of Nozzle 7 after removal of the nozzle revealed two axial indications high in the original weld. This could indicate a leak path through the weld. The video inspection for CRDM flange leaks found no leaking flanges, and a review of a video of the top of the head made during the previous outage did not show evidence of the new deposit around nozzle 7. All the evidence above make a circumstantial case that Nozzle 7 was leaking through the weld and that the leak initiated during the past operating cycle.

Figure 1 Oconee Unit 1 CRDM Nozzle 7, Top of RV head inspection for Boric acid crystals, 03/31/02

Two CRDM Nozzles (numbers 7 and 8) were repaired during this outage using the automated Framatome-ANP "ID Ambient Temper Bead Repair" technique as described in the Relief Requests 02-02 and 02-03. Corrective action taken and future outage plans remain consistent with Duke's NRC Bulletin 2001-01 and 2002-01 submittals.

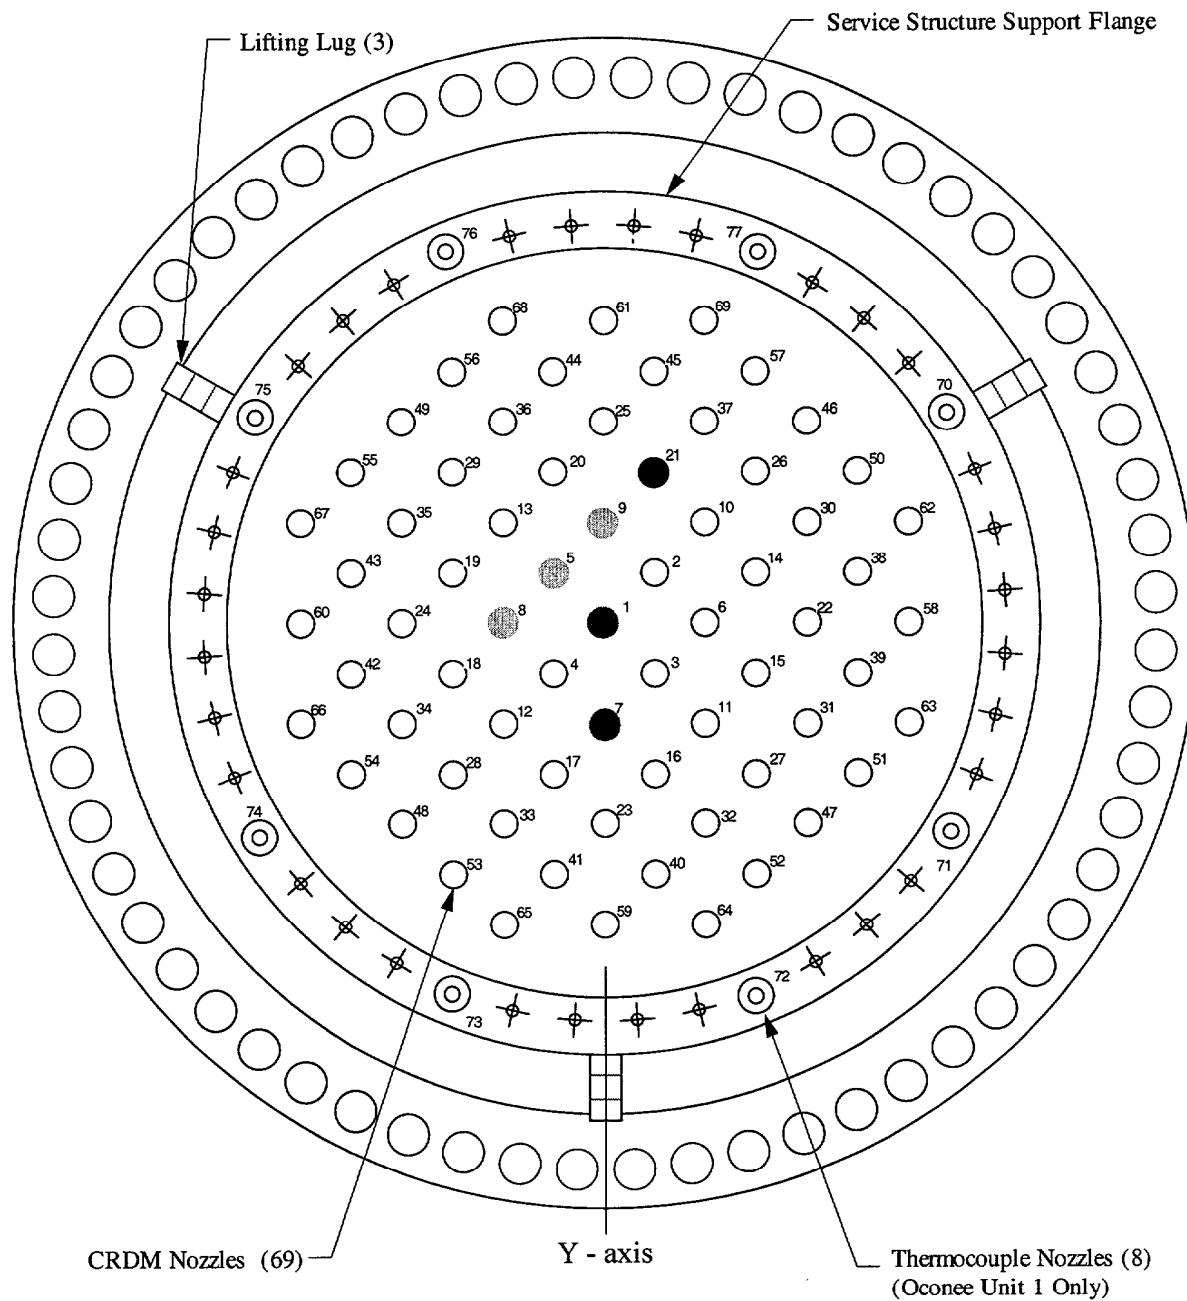
After the head was cleaned and placed on the reactor vessel head stand, a visual inspection was performed looking for wastage. The inspection using fiber scopes where needed was able to see 360° around each nozzle and no wastage was identified. Figure 2 shows the location of the above described CRDM nozzles on RV head for this outage (EOC-20) and the location of Nozzle 21, which was found to be leaking in November 2000.

- Nozzles 1 and 7 identified as masked during EOC-20
- Nozzles 5, 8 and 9 identified as not being able to see 360° around nozzle
- Nozzle 21 identified as leaking by top of head visual inspection during EOC-19 and repaired

Figure 2 Bare metal visual inspections of RV head, Oconee Unit 1 CRDM nozzles identified as suspect, during EOC-20 refueling outage, March 31, 2002
