H. B. ROBINSON STEAM ELECTRIC PLANT, UNIT NO. 2
 DOCKET NO. 50-261/LICENSE NO. DPR-23

**SUBMITTAL OF RESULTS OF REACTOR
 PRESSURE VESSEL HEAD AND VESSEL HEAD PENETRATION
 NOZZLE INSPECTIONS PERFORMED DURING REFUELING OUTAGE 21**

**RESULTS OF REACTOR PRESSURE VESSEL
HEAD AND VESSEL HEAD PENETRATION NOZZLE
INSPECTIONS PERFORMED DURING REFUELING OUTAGE 21**

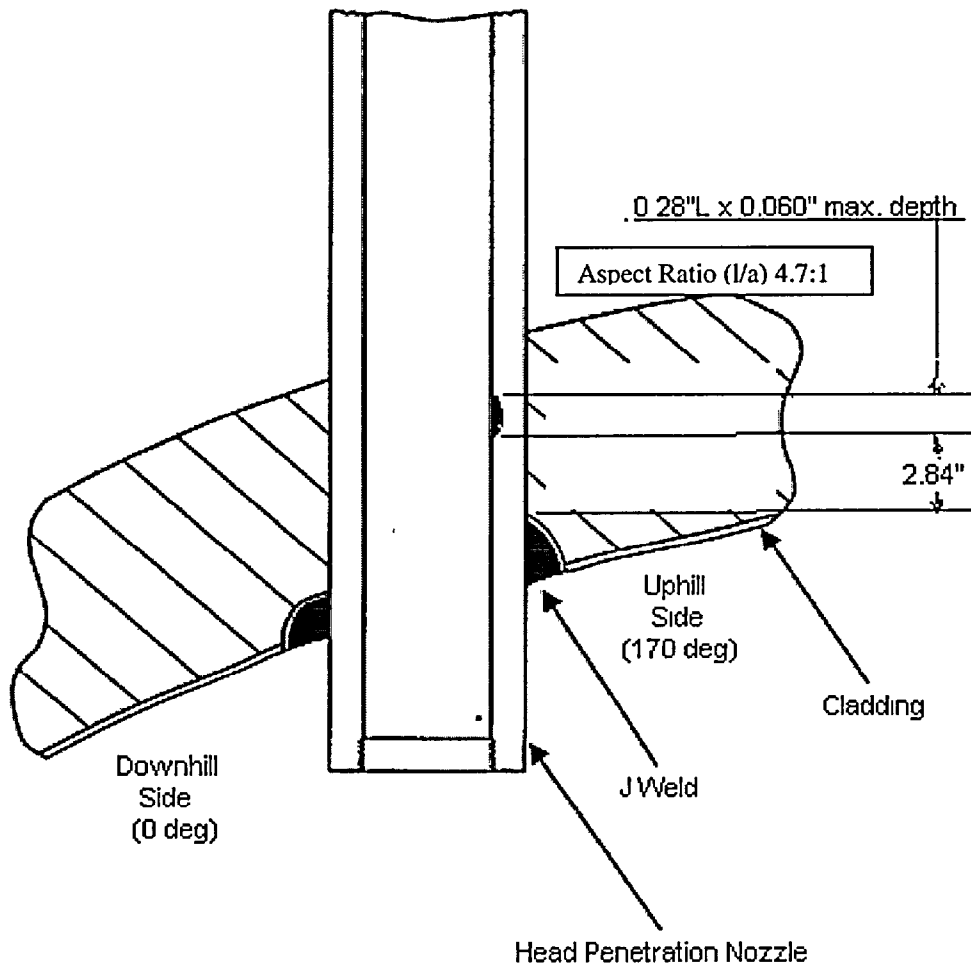
DRAWING OF PENETRATION NUMBER 47 RECORDABLE INDICATION

The NDE of the RPV head penetrations found no evidence of service-related degradation. One recordable indication was identified that did not require repair. An engineering analysis of this indication has been completed, and the crack growth model associated with this analysis shows that the applied stress intensity factor for the indication is below the threshold for crack propagation. The engineering analysis further concluded that the indication is most likely a scratch or other surface anomaly resulting from the manufacturing process, and there is no concern for this indication during future service. Attachment IV provides a figure that shows the general size, location, and orientation of the indication.

One recordable parent tube indication was identified in Penetration Tube No. 47. The indication was visible with the PCS24 TOFD ultrasonic testing transducer pair oriented for detection of axial indications. The indication is located wholly in the Alloy 600 penetration tube material and is axial in orientation. The bottom edge of the 0.28 inch long indication is located at 2.84 inches above the top edge of the weld at the 170-degree location, nearly at the uphill peak, with a depth less than 0.060 inch. The flaw aspect ratio is 4.7:1. An engineering analysis of this indication has been completed, and the crack growth model associated with this analysis shows that the applied stress intensity factor for the indication is below the threshold for crack propagation. The engineering analysis further concluded that the indication is most likely a scratch or other surface anomaly resulting from the manufacturing process, and there is no concern for this indication during future service. Attachment IV provides a figure that shows the general size, location, and orientation of the indication.
