Existing Projects Review

Lower Entiat River

U.S. Department of the Interior
Bureau of Reclamation
Pacific Northwest Region
Pacific Northwest Regional Office
Boise, Idaho

April 2012

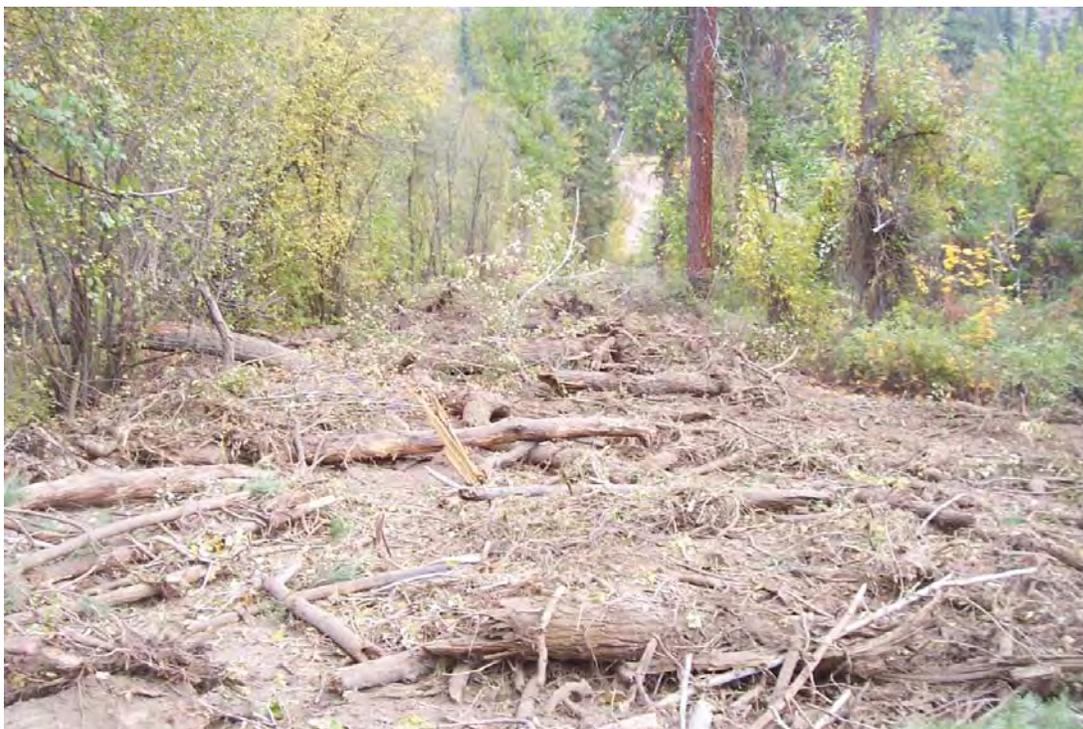
Figure 5. Entiat National Fish Hatchery Complexity. Photo of slash scattered across the footprint of the levee following removal. Photo taken in September 2011.

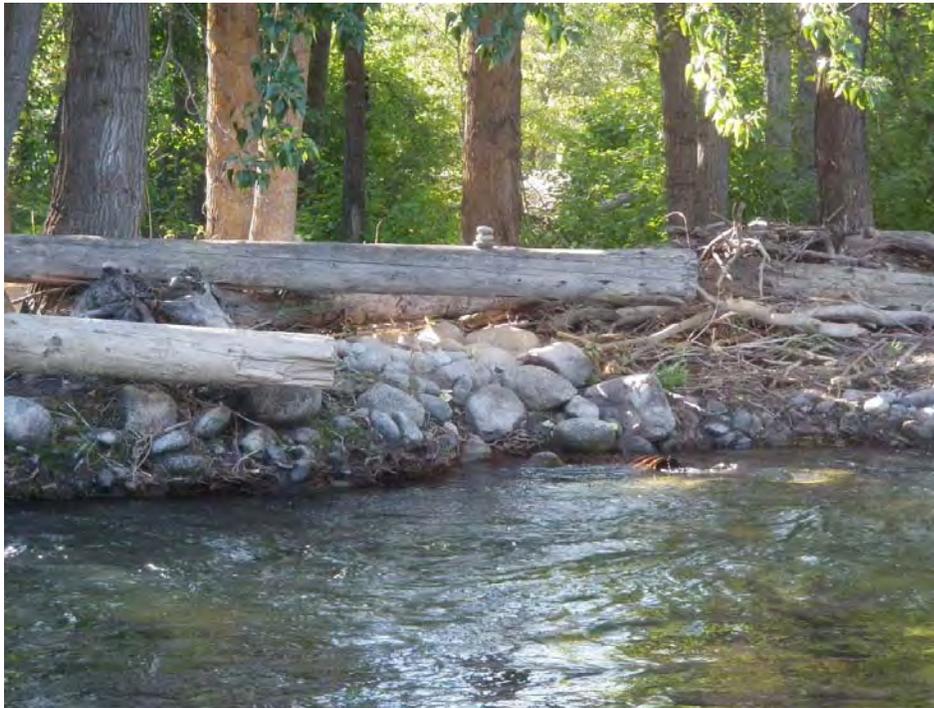
Figure 7. Wilson Side Channel. Photo of the Wilson side channel inlet culvert nearly overtopped with water in September 2011.

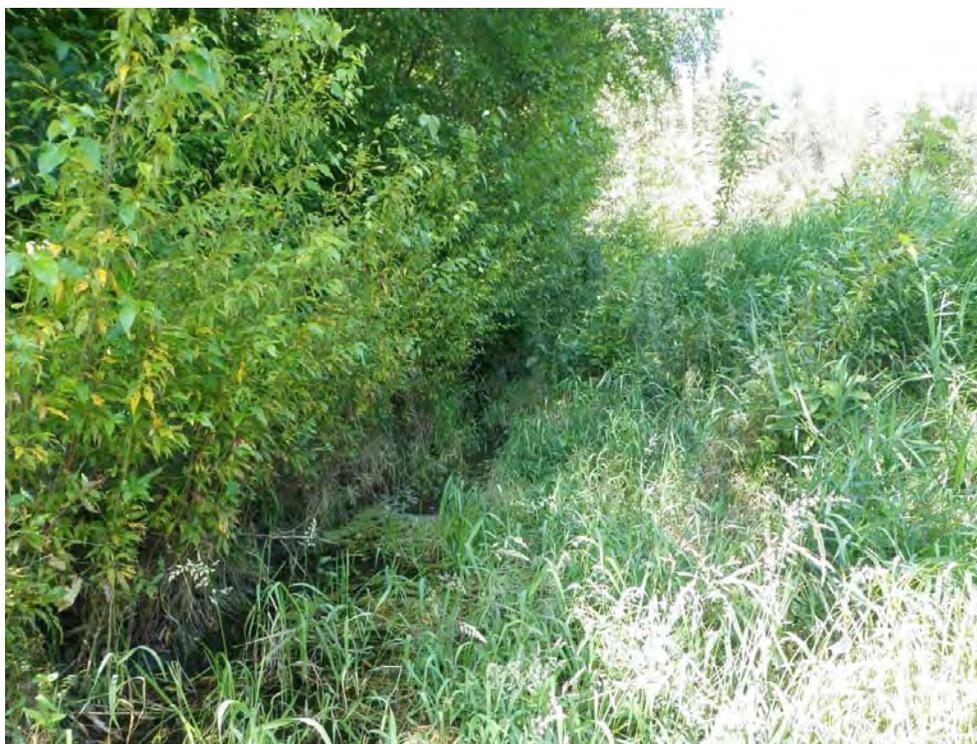
flow, and possibly fish passage, is significantly obstructed by the encroachment of reed canary grass and other vegetation (Figure 15). Project goals depend on an unobstructed surface connection between the pond and the river. Log and rock barbs installed in conjunction with rock boulder clusters in the mainstem of the Entiat River are performing well, although significant repairs to the structures were apparently required following a large flood in 2006 (NRCS 2011). Following repairs, each of the structures provides cover and relatively slow-water habitat along the right bank of the Entiat River near the outlet of the pond channel. The arrangement of barbs and boulder clusters along the outside of a bend near bedrock has enabled the river to maintain a deep pool at exactly the location where the pond outlet enters the mainstem. It is unknown if the pool will be maintained during another high-flow event capable of mobilizing large volumes of coarse bed armor found throughout this reach, but its location along the outside of the bend in conjunction with instream structure may improve this likelihood. Although the log and rock structures provide slow-water refuge, high-flow instream velocity at the outlet of the side channel remains great enough to prevent significant deposition of fine sediment potentially blocking ingress and egress from the pond outlet channel.

Figure 15. Small Pond. Photo of the pond outlet channel near its confluence with the Entiat River taken in July 2011. The channel is largely choked with reed canary grass and other vegetation.

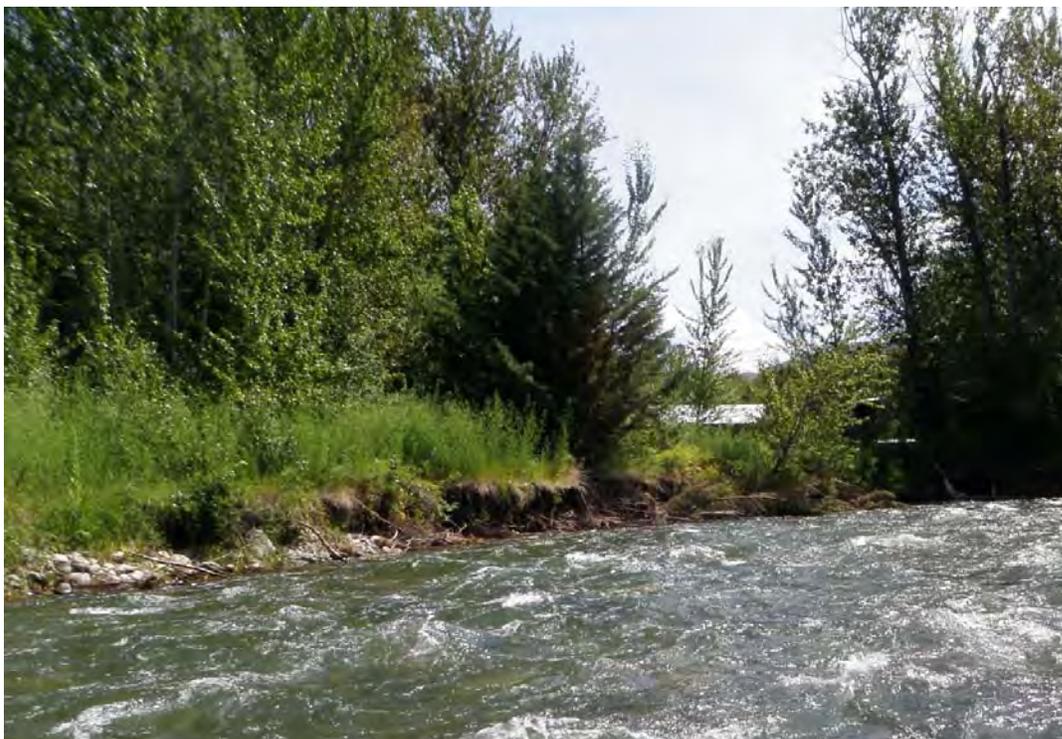
Figure 18. Hanan-Detwiler Diversion. Bank erosion on the left bank approximately 500 feet downstream of the Hanan-Detwiler diversion.

Bank erosion continues to occur on the left bank below the structure, but there is no evidence that the weir and root wads are exacerbating the condition.

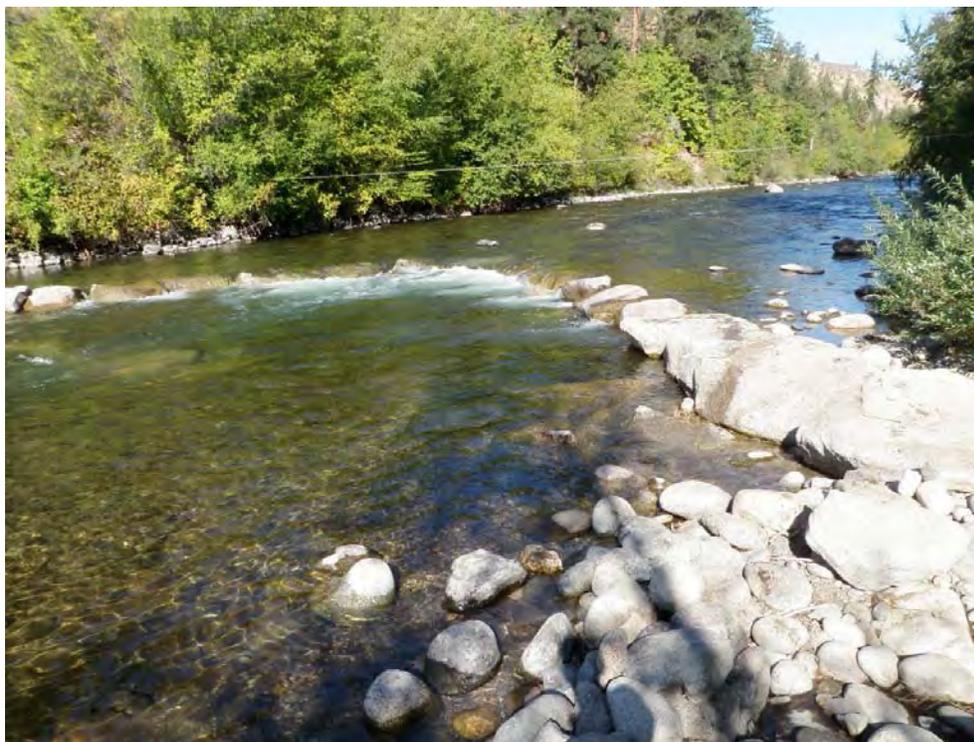
Figure 19. Hanan-Detwiler Diversion. Photo of Hanan-Detwiler structure in September 2011. Note the large pool artificially constructed below the structure.

In typical alluvial rivers, cross vane weirs influence local hydraulics only up to a certain discharge, beyond which the increased hydraulic effect is negligible. At and above that discharge, the channel tends to evenly mobilize and distribute bedload with little added influence from the weir, and a pool associated with the weir fills with mobile sediment (live bed). As flow decreases (the declining limb of the hydrograph), the upstream delivery of bedload ceases, but the local hydraulic effect of the weir maintains local transport conditions in the vicinity of the pool somewhat longer than the surrounding area, thereby reestablishing the pool.

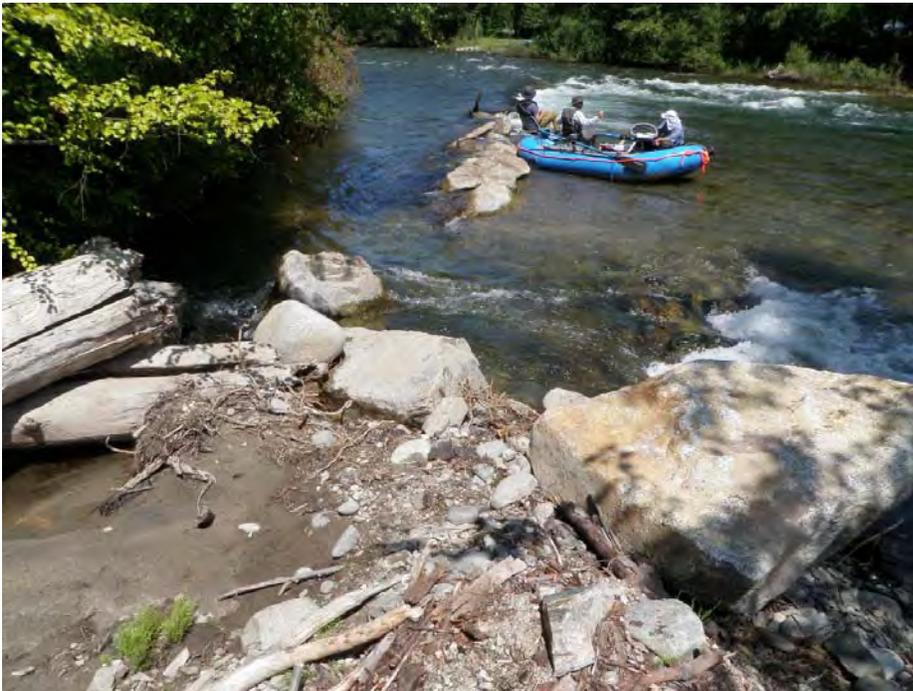
Figure 20. Hanan-Detwiler Diversion. Photo taken July 2011 looking upstream where boulders were relocated from the structure in order to plug the diversion at the site of the diversion headworks.

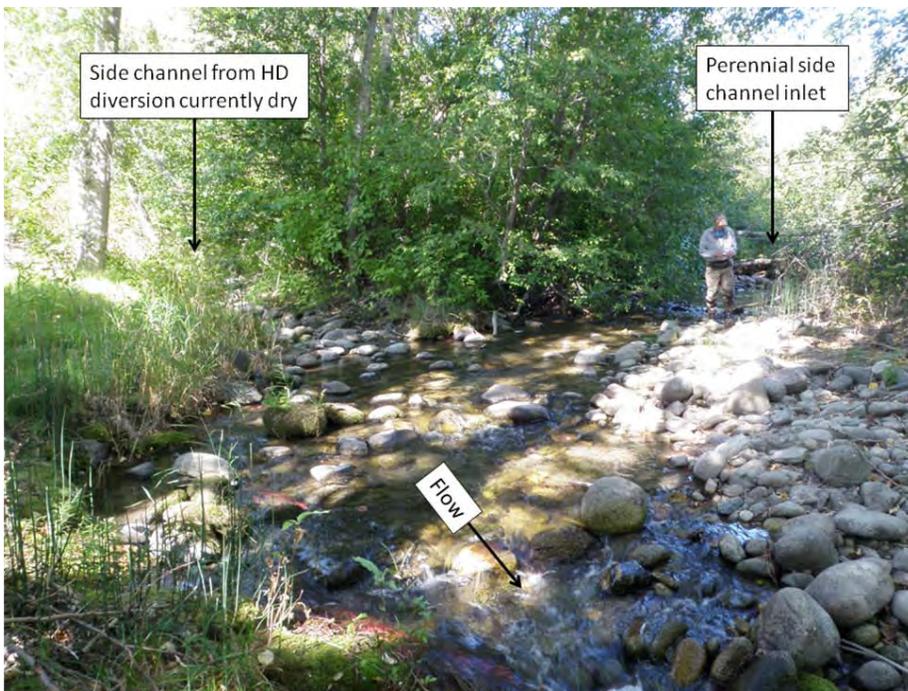
Figure 21. Hanan-Detwiler Diversion. Confluence of the dry fish return channel and a perennial side channel of the Entiat River. The dry channel is over 1,500 feet long and is dependent on the Hanan-Detwiler diversion for water.

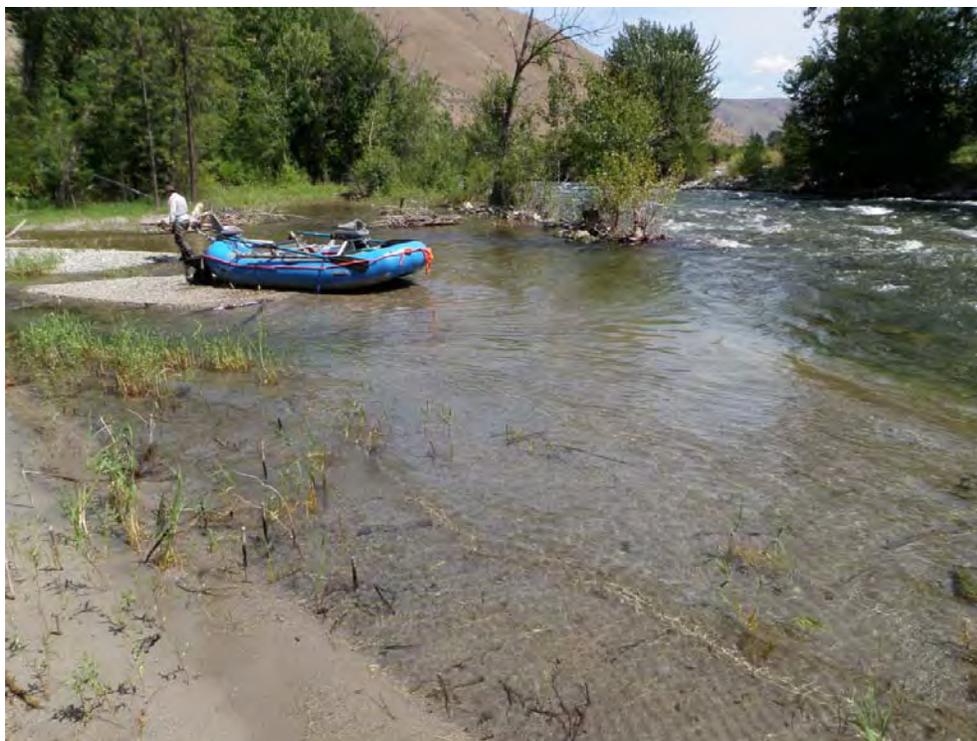
In each year following construction, the side channel inlet has filled with large amounts of sand and gravel sediment (Figure 30 and Figure 31). When observed at high flow, large volumes of water are entering the side channel and immediately overtopping the right bank, passing over the adjacent floodplain and reentering the main stem of the Entiat River. Without a well-defined ridge (or other structure) along the right bank of the inlet channel to force more high flow into the side channel as shown in the hydraulic model, it appears that there is not sufficient flow passing through the side channel to flush fine sediment. As a result, the side channel inlet is at risk of becoming plugged with fine sediment. At the time of this report, the project is considered partially successful, but future sediment deposition at the inlet to the side channel will likely continue to decrease the side channel's effectiveness and the success of this project.

Figure 30. Bridge-to-Bridge, Phase II (Harrison Side Channel). Sand and gravel deposition at the inlet of the Harrison Side Channel. Photo taken in July 2011 at roughly 1,000 cfs. Note the large volume of flow passing over the right bank of the side channel inlet (beyond the raft) passing across the floodplain and back into the Entiat River without entering the side channel.

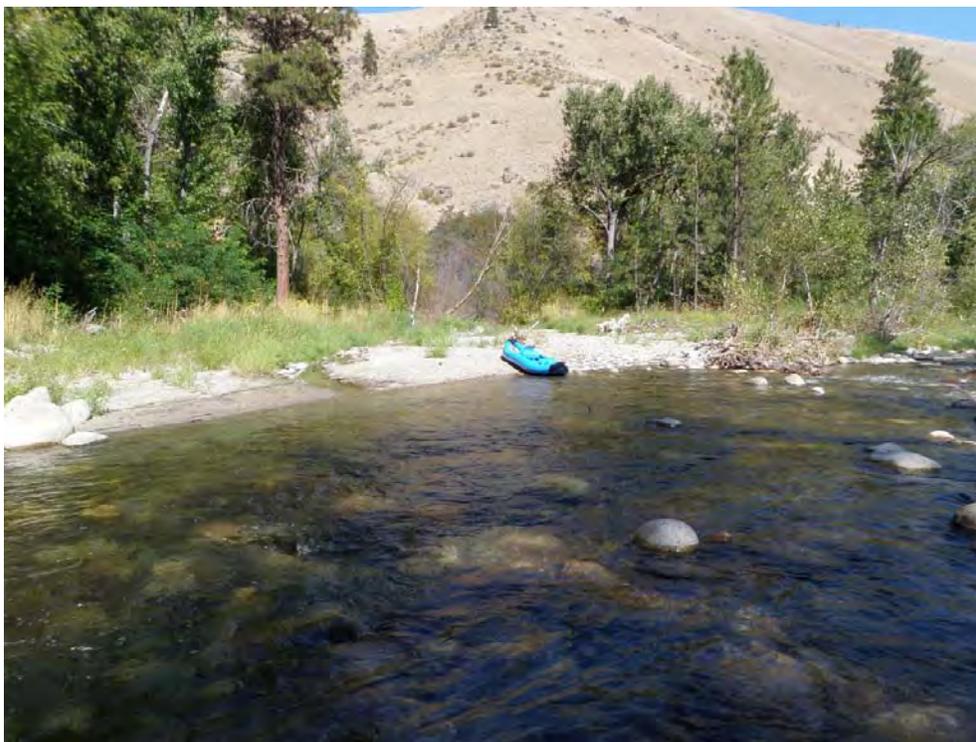
Figure 31. Bridge-to-Bridge, Phase II (Harrison Side Channel). Sand and gravel deposition shown at the inlet to Harrison Side Channel. Photo taken during low flow in September 2011 (approximately 400 cfs); note the channel inlet is only about 3 feet wide (to the left of the kayak in the photo) and nearly completely filled in.

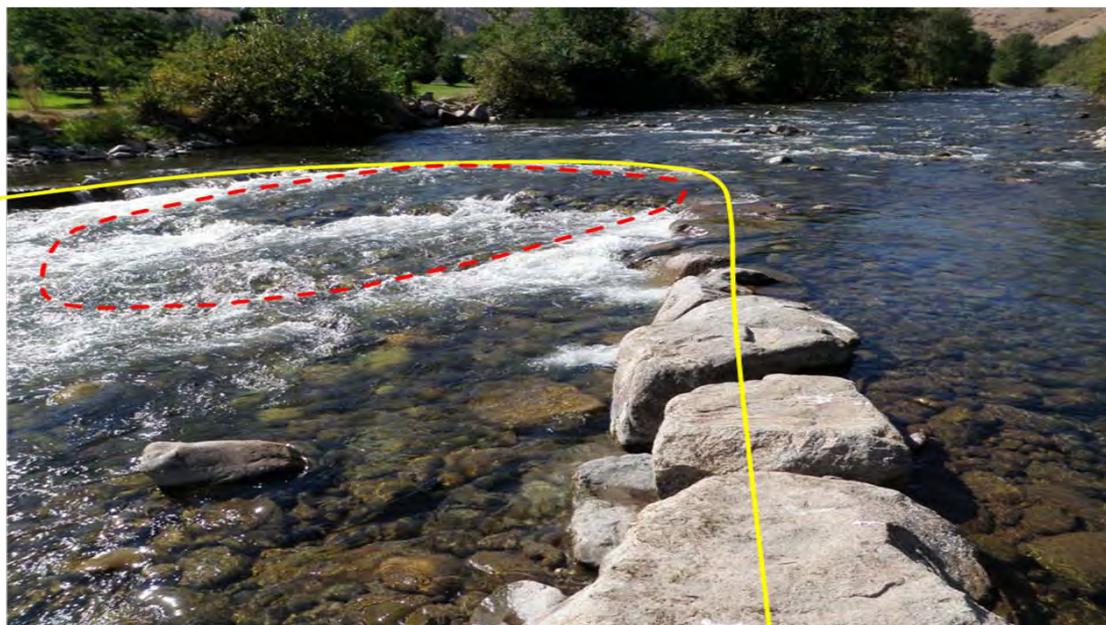
Figure 36. Bridge-to-Bridge Phase I (Whitehall Weir). Deposition shown through the throat of the weir (red dashed outline). The location of the weir is outlined in yellow. Photo taken September 2011.

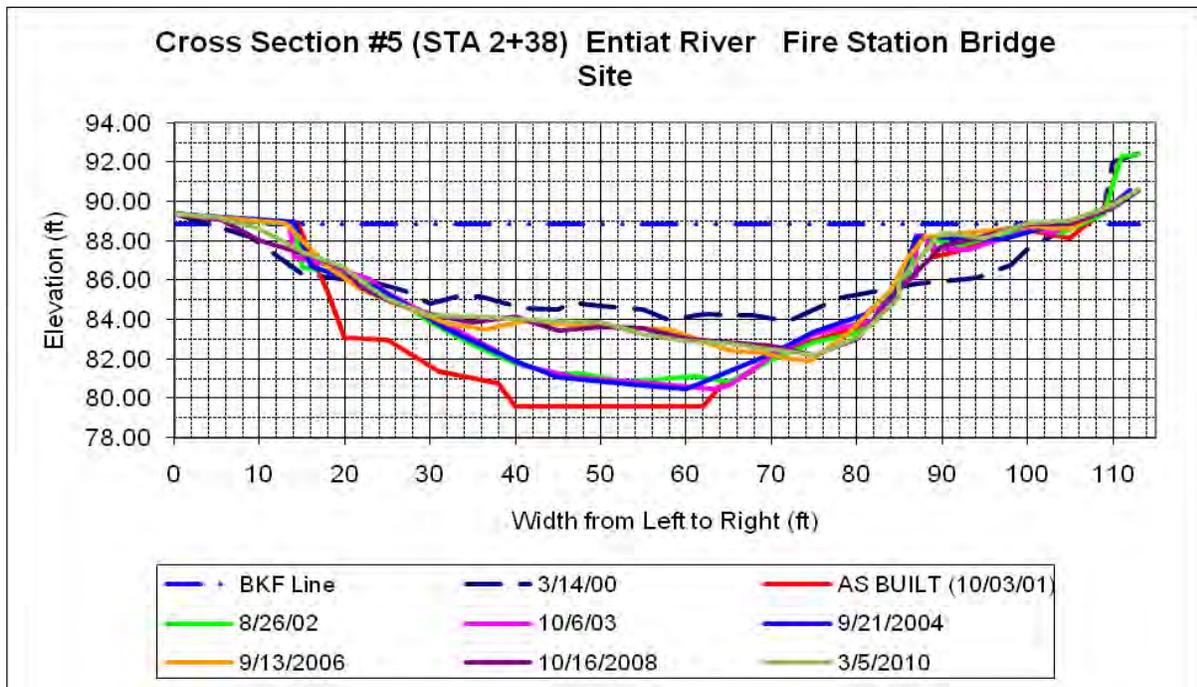
Figure 39. Fire Station Weirs. NRCS monitoring results from the upper weir illustrating pre-construction conditions (March 14, 2000), as built conditions (October 3, 2001) and conditions from six subsequent measurements taken over the next 10 years. It can be seen that the excavated pool below the cross vane has filled with sediment approaching the preconstruction conditions.

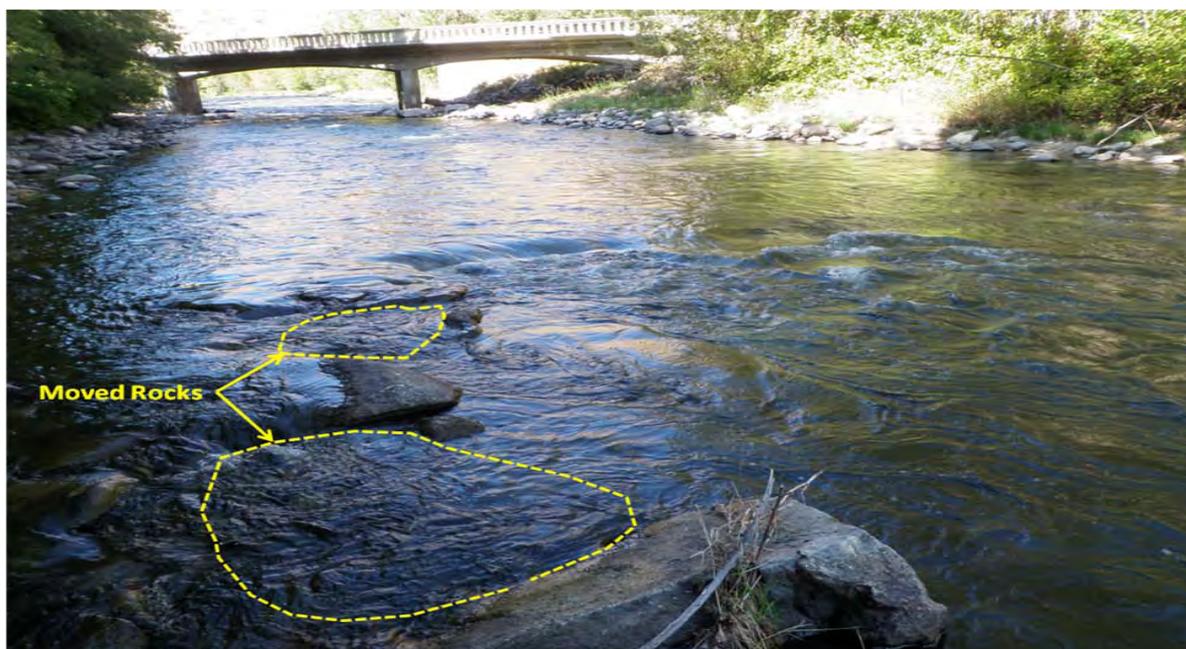
In addition to the excavated pools partially filling with sediment and possibly exacerbating the condition, several of the boulders comprising both weirs have moved (Figure 40 and Figure 41). An assessment of both weirs was completed by Reclamation in 2006 following the large flood which documented the movement of several footer and header rocks. In every instance, weir rock movement was attributed to slumping and/or rolling of the footer rocks associated with poor construction methods or scour and undercutting. During the field reconnaissance in 2011, it did not appear that any additional rocks had moved since 2006.

Figure 40. Fire Station Weirs. Photo of upper Fire Station weir taken September 2011 at low flow (about 400 cfs), illustrating where two header rocks were moved out of the weir. Several header and footer rocks were moved from this weir by high flows.

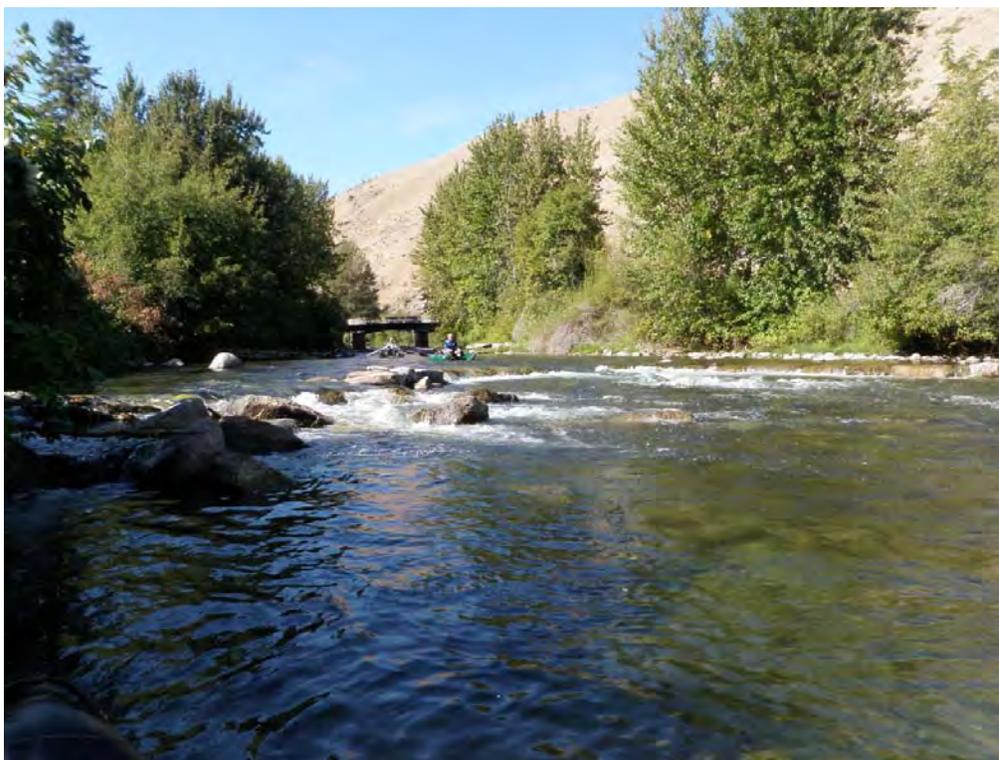
Figure 41. Fire Station Weirs. Lower weir where several rocks were moved by high flows. Photo taken in September 2011.

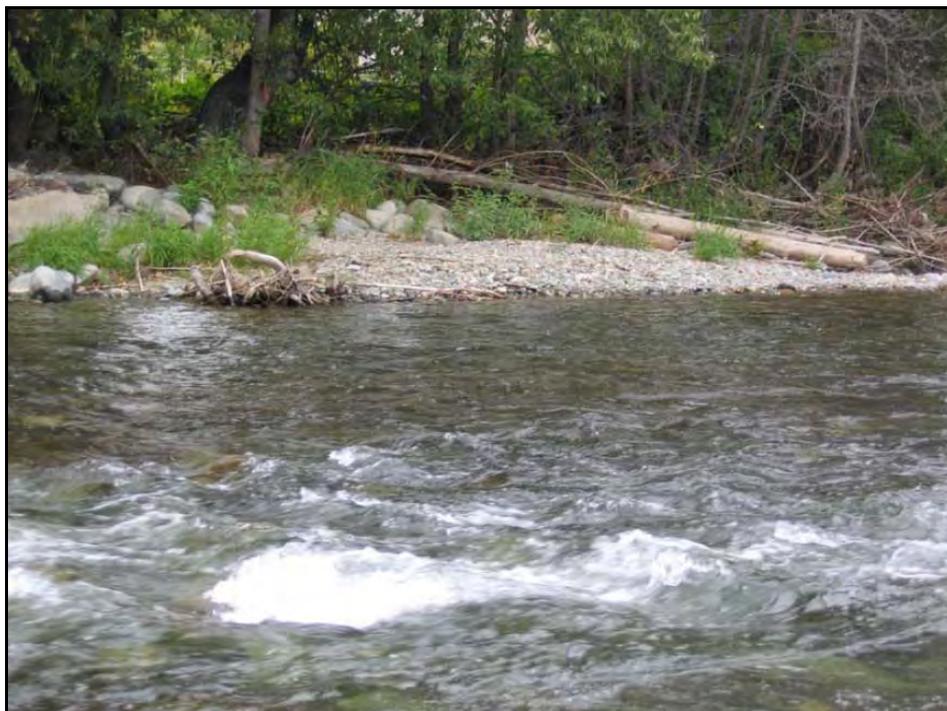
The four LWM elements installed adjacent the weirs were also observed during the field reconnaissance in 2011. All four of the LWM structures had been partially buried by gravel deposition resulting largely from their location within the relatively slow-velocity water of the eddy that forms below the arms of the weirs (Figure 42). As a result of this deposition, the relatively small LWM structures may not be providing the desired level of cover intended by the design.

Figure 42. Fire Station Weirs. Photo taken at low water in 2006 illustrating gravel deposition on the left bank in the lee of the lower weir partially burying the LWM structure in this location. The top of the root wad can be seen on the left side of the photo.

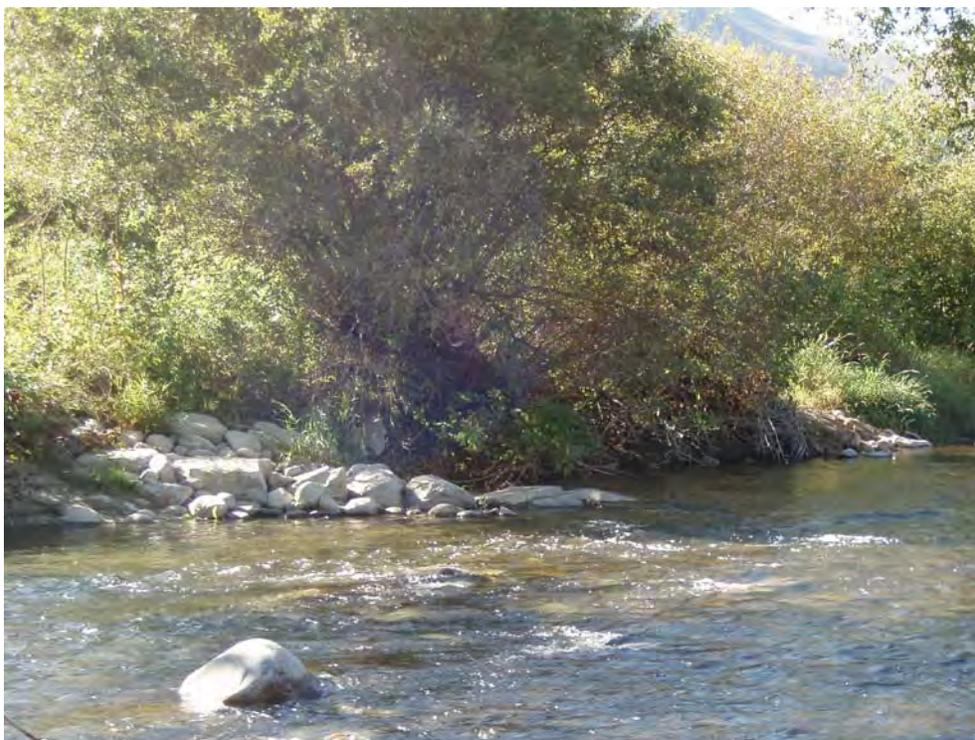
It appears that all of the other rock barbs were installed following the low-height barb design. These structures do not intercept as much flow as the larger bank-height barbs and have less hydraulic effect. None of the rock barbs obstruct enough of the hydraulic radius of the channel to force enough flow convergence to scour a large pool into the heavily armored bed (Figure 49). Similar to the cross vanes, the hydraulic effect of the barbs is insufficient to mobilize the armored bed at flows below the threshold condition in this subreach, and a pool will not form nor will an excavated pool be maintained. Despite this, all of the barbs create relatively slow-water eddies along the banks which increases both hydraulic diversity and instream complexity.

Figure 49. Milne. Photo shows a rock barb that does not occupy a large portion of the channel's hydraulic radius (not very tall and does not extend into channel very far). No scour pool has formed at the point of the barb. The photo was taken at low flow, looking upstream in September 2010.

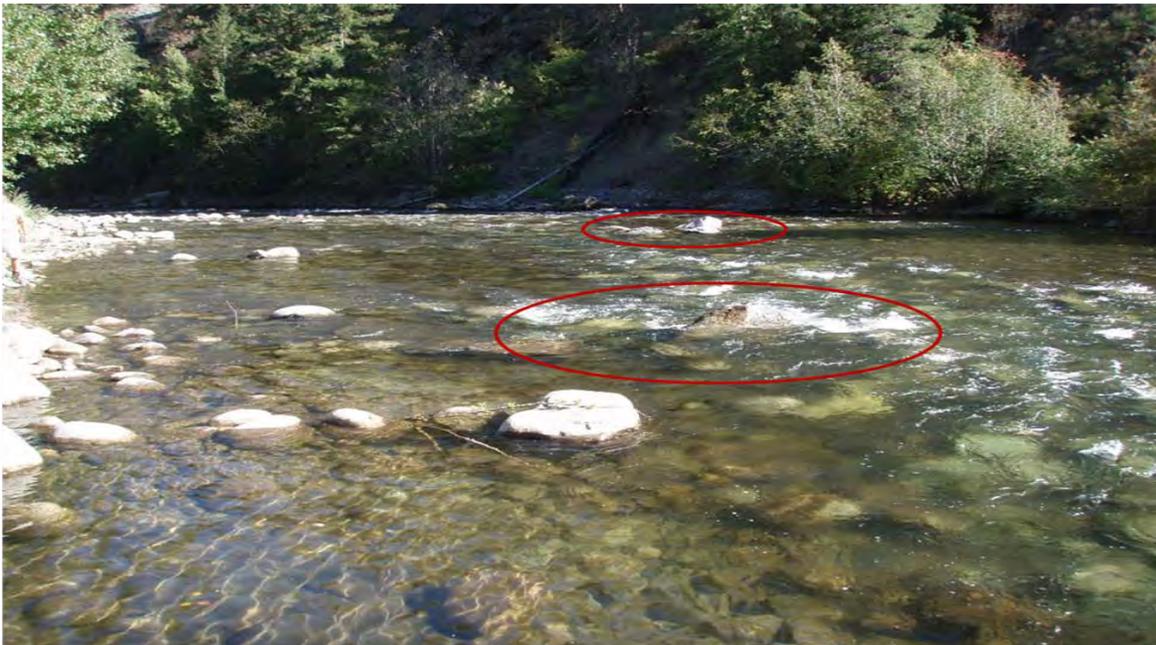
The boulder clusters were built with large gaps between the rocks, and all of the structures are overtopped at relatively modest flows (roughly less than 1000 cfs) (Figure 52). As a result of the frequent overtopping and gaps between boulders, little or no gravel deposition was observed behind the boulder clusters. At low flows, the structures provide hydraulic refuge and diversity, but at high flows, the effect is overwhelmed by plunging flow overtopping the boulders.

Figure 52. Milne. Photo looking downstream at two boulder clusters taken at low flow in September 2010.

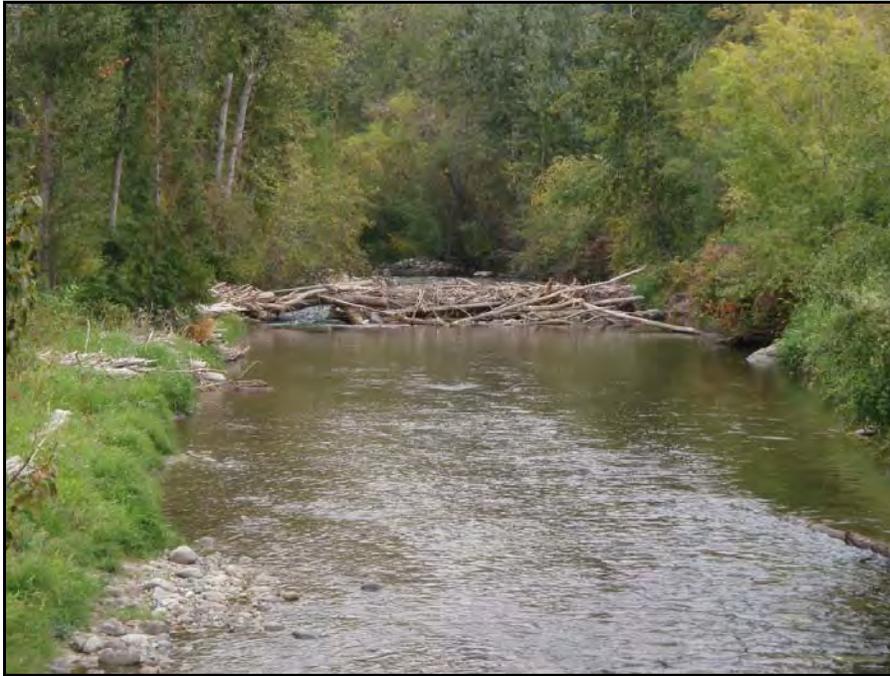
Figure 62. Below the Bridge. Photo taken in September, 2011 from the Keystone Bridge looking downstream at the diversion structure which had racked large volumes of woody debris.

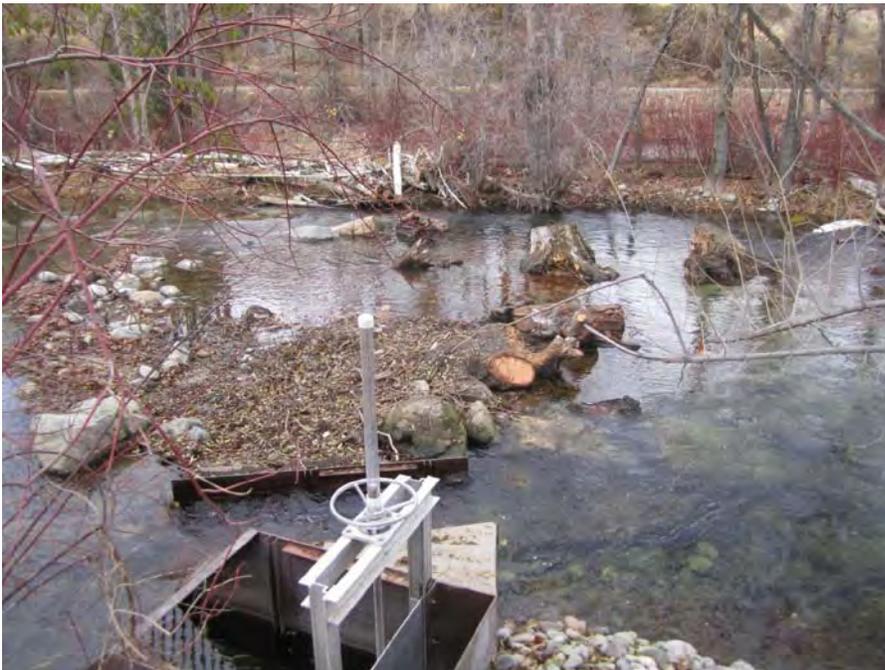
Figure 63. Below the Bridge. Photo taken in November 2011 from the right bank at the point of diversion showing the diversion structure after the excess woody debris had been cleared and the incorporated root wads were trimmed. Most of the wood in the photo is loose debris that was removed from the structure and will be mobilized in the next high-flow event.
