# COMPLETION REPORT Wolf Creek Diversion Dam FCRPS Habitat Improvement Program Wolf Creek, Methow Subbasin, WA

# COMPLETION REPORT WOLF CREEK DIVERSION DAM FCRPS HABITAT IMPROVEMENT PROGRAM WOLF CREEK, METHOW SUBBASIN, WA

PREPARED BY
U.S. BUREAU OF RECLAMATION
PACIFIC NORTHWEST REGION
COLUMBIA/SNAKE SALMON RECOVERY OFFICE,
BOISE, IDAHO

**MARCH 2009**

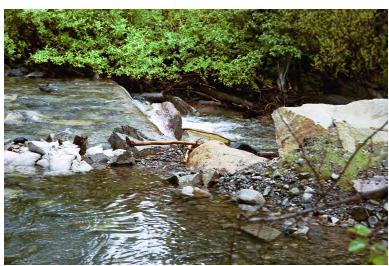
Cover Photo 1. Wolf Creek Diversion Dam prior to rehabilitation to meet fish passage standards. Note sandbags that help direct water into the headgate channel.

The Wolf Creek Diversion Dam (Cover Photo 1) was identified as a low-flow barrier to fish movement. This project was initiated with the goal of providing passage for fish at all species and life stages, meeting diversion flow requirements for the irrigators, and reducing the visual impact of the structure in river. The Bureau of Reclamation was requested to work with Wolf Creek Reclamation District (WCRD or the District) to design and install a new facility.

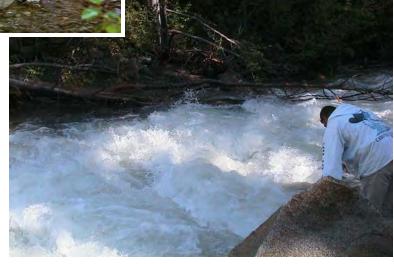
Cover Photo 2. High flows over Wolf Creek Diversion Dam after rehabilitation to meet fish passage standards.

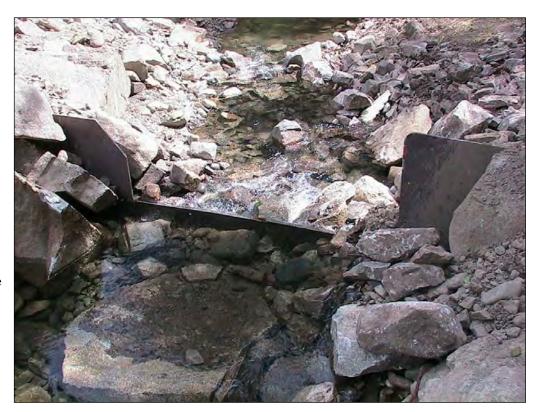
Photo A-1. View of steel weir at the entrance to the ditch about 60 feet upstream of the intake structure. The weir is designed to provide grade control and prevent cutting of the canal section during high flows.

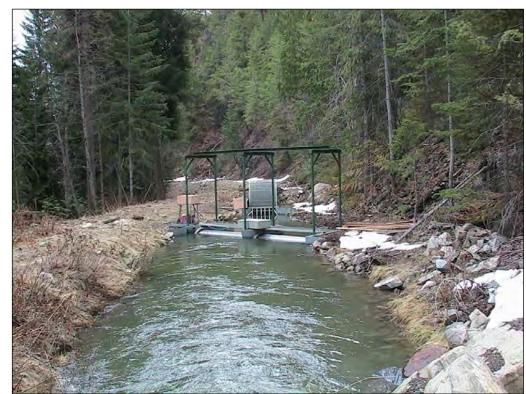
Photo A-2. **Downstream** view of the fish screen, staging area, and pipe bench prior to construction. The canal and fish screen are running near capacity which is about 13 cfs.

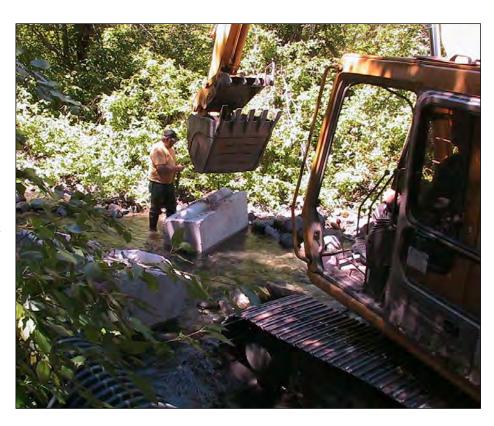
Photo A–3.
Construction begins with placement of ecology blocks for the cofferdam about 25 feet upstream of the existing structure. The ecology blocks divert the creek flow in a 30-inch diameter HDPE pipe which transports the water to the headworks.

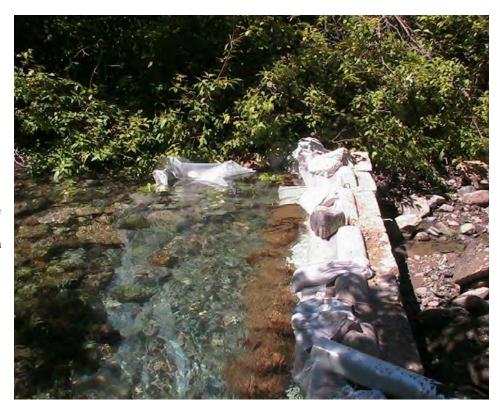
Photo A-4.
Completed
cofferdam
including sandbags
and plastic. The
creek is diverted
into a pipe just out
of the bottom of the
photo. Dewatered
channel can be seen
at the right of the
photo.

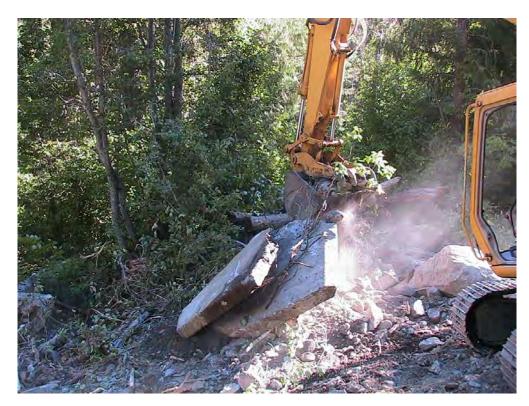
Photo A–5.
The excavator breaks up a section of the previous concrete diversion channel which had been washed out in the 1948 flood.

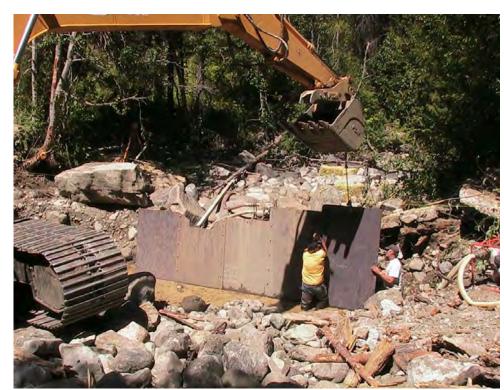
Photo A-6. Assembling the downstream weir (#4) first. It was critical that the middle three plates (of ten) be level and at the proper elevation, so they were bolted together on the bank and set first. Average completion time for each weir was one day.

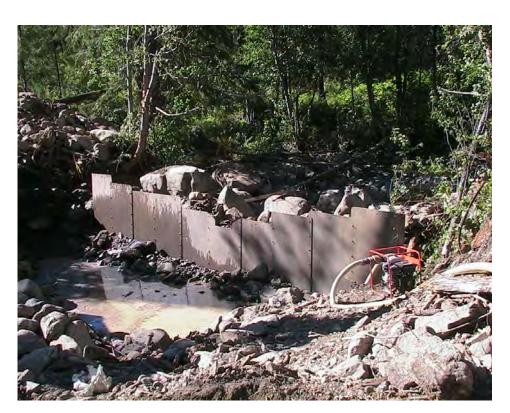
Photo A-7. A downstream view of Weir #4 prior to backfill. The bolted plate is almost completely buried in the existing streambed and should be nearly impossible to move. About 250 cfs can flow between the plates before the creek rises high enough to reach the banks above the plates. **Channel capacity** should be 700 to 900 cfs.

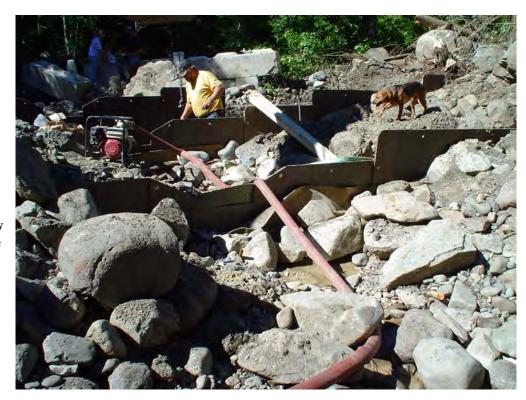
Photo A–8.
The four weir plates prior to final backfill with angular material from the talus slope.
The rise of the plates is clearly visible as is the offset of each one.

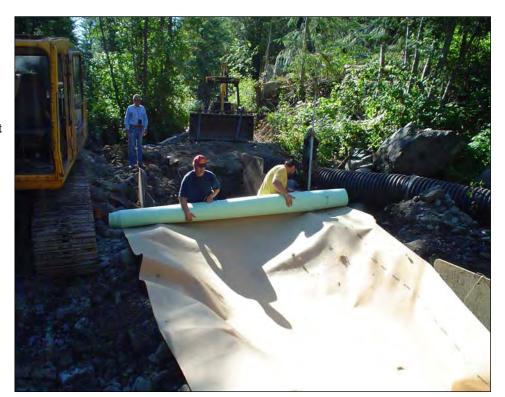
Photo A-9. **Installation of the** geotextile material between two of the weir plates. The geotextile is designed to prevent low flows from running under or around the plates, thereby reducing the fish passage capability. The space between plates was halffilled with native material, the geotextile is installed, and then angular rock from the talus slope is added to bring the backfill to grade.

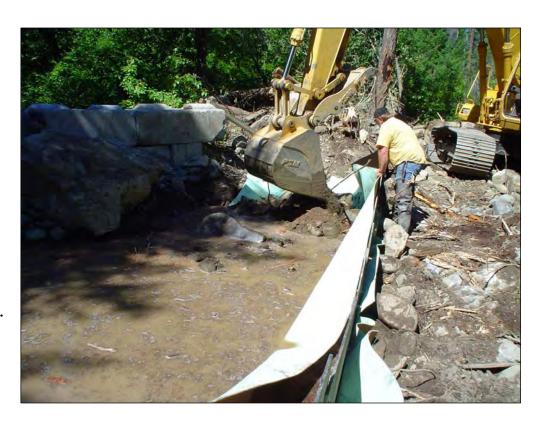
Photo A-10.
Backfill
material is
added to the
geotextile
material to
weight the
fabric down
prior to
installation of
the angular
talus material.

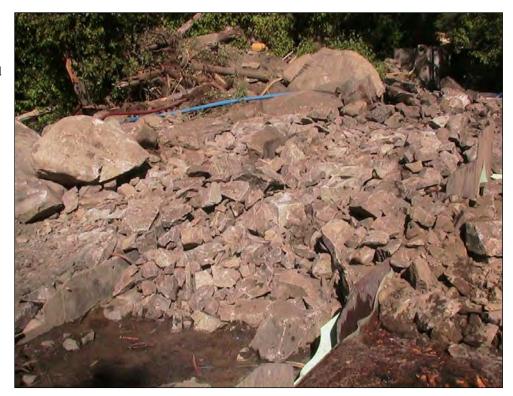
Photo A-11. View of the backfilled weirs: final grading and final fill were completed with talus material. To aid in fish passage, several large-diameter rocks (at left) were randomly placed to help break up the flow, reduce water velocity, and add pockets of slow-moving water.

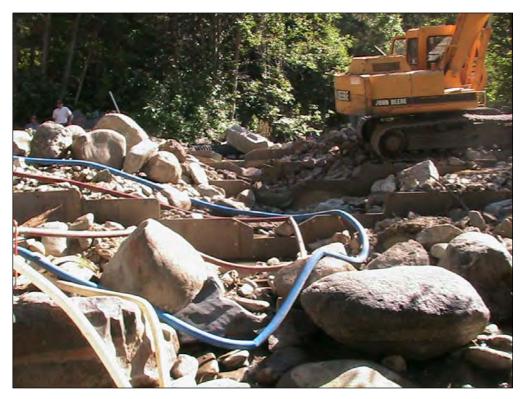
Photo A-12. **Upstream view** of all four weirs set in place and backfilled. Large rocks are being randomly placed to act as roughness to the flow and aid in fish passage at various flows. The staggering of the low-flow notches is noticeable.

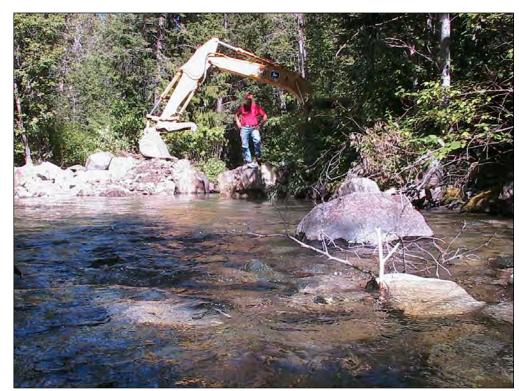
Photo A-14. A view looking downstream toward the entrance to the ditch. A large rock was placed on the creek bank upstream of the ditch entrance to block debris and logs from being forced into the ditch by the current.

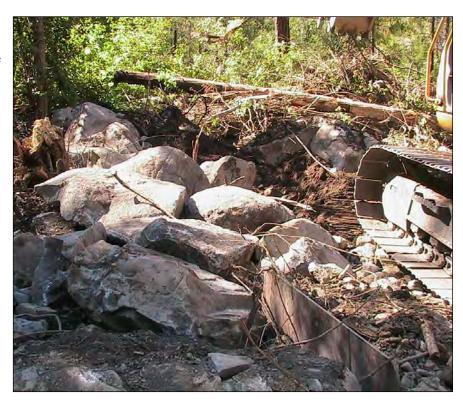
Photo A-15. Final grading of the far bank. The line of rocks from the edge of the upper-most weir (#1) should prevent erosion as water rises above the edge of the plates. Willows, logs, and native soil were used to backfill the remainder of the area. This lead to a relatively quick revegetation of the area. Water will only use the area of the far bank in higher that average flow years. The highest of the line of rocks is slightly lower than the top of the headworks of the diversion.

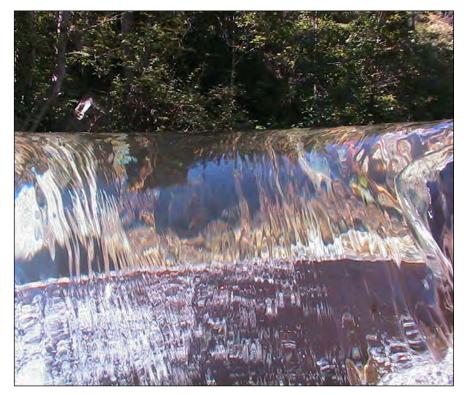
The uppermost pool is expected to collect more bedload than it currently has because the new dam is higher than the old one and the flows are concentrated in the middle of creek (Photo A-16).

Photo A-16. The crystalclear water above the first drop of the uppermost weir (#1) provides a view not usually seen in less steep applications. It was possible to see 10 or 15 feet into the upper pool. It is expected that this pool will collect more bedload than it currently has because the new dam is higher than the old one and the flows are concentrated in the middle of creek.
