PN-3616
PRJ-2.00

MEMORANDUM

Subject: Fulton Diversion Dam Investigations, Methow Subbasin, Washington

Date: September 18, 2007.

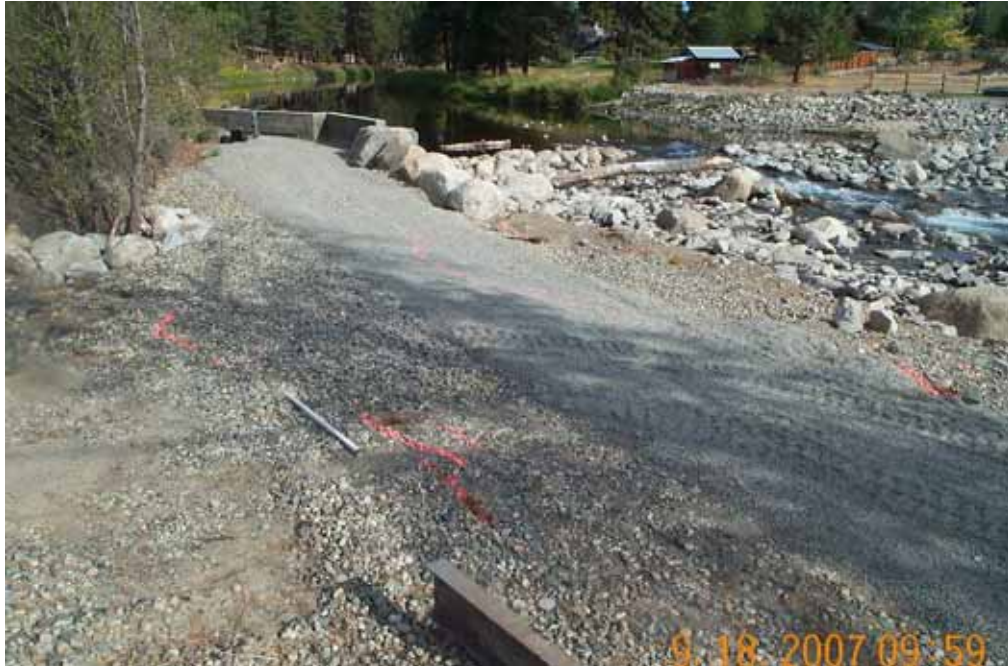
1. Extension cracks and subsidence scarp were observed at the surface and painted orange for photographic documentation prior to excavation disturbance (see Photograph Nos. 1 through 5).

Photograph No. 1. View is to the north looking at extension cracks (orange paint) along the Fulton irrigation pipeline. Fulton Dam, Methow Subbasin, Washington – Bureau of Reclamation Photograph by E. Lyon, September 18, 2007.

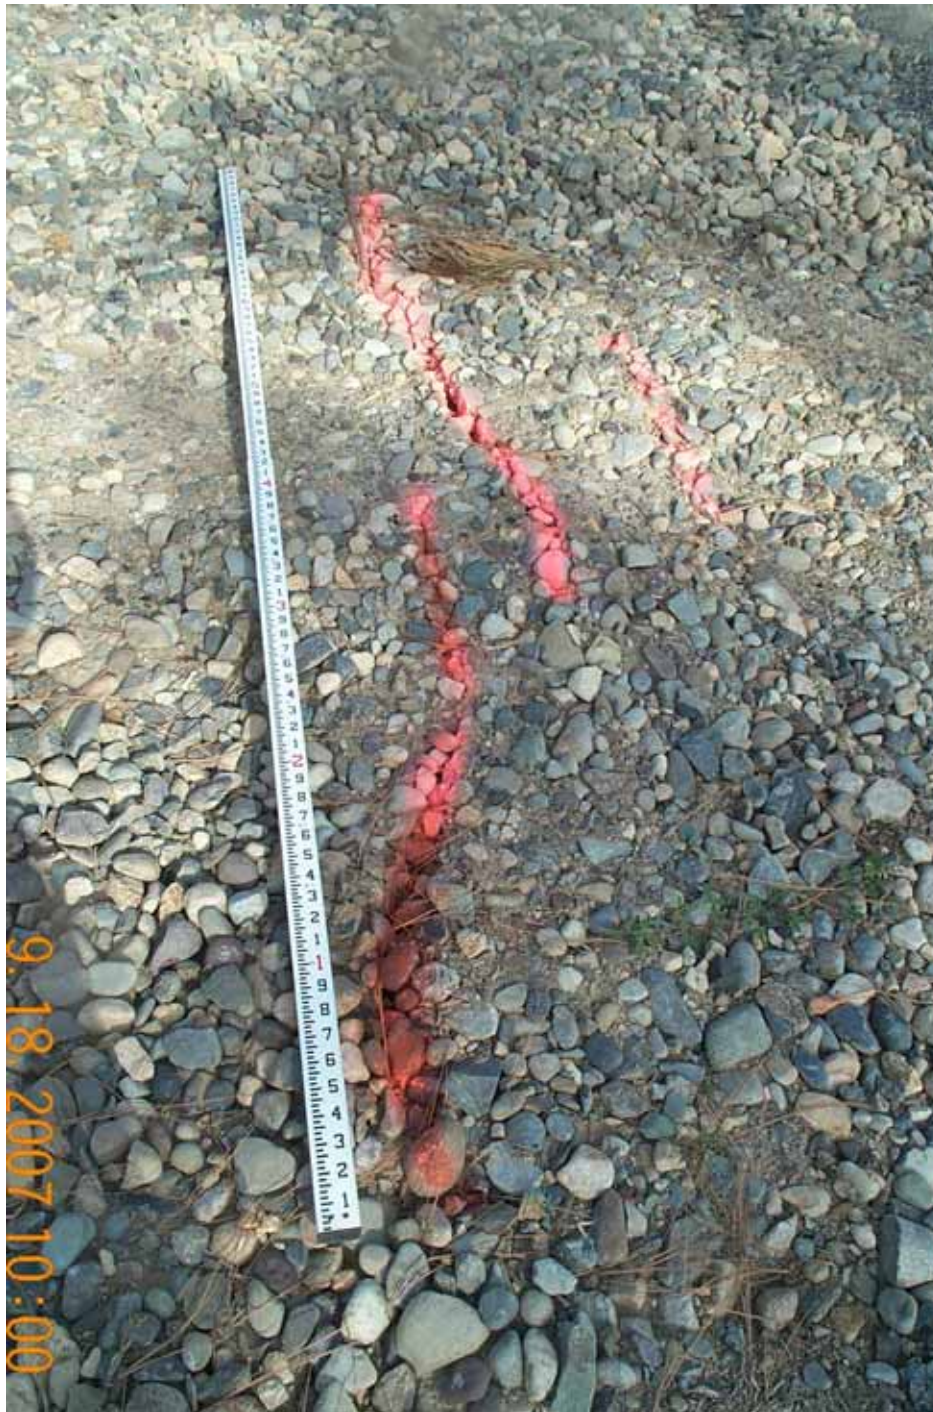
Photograph No. 2. View of to the north looking at extension cracks (orange paint) along the western side of the “slump” along the Fulton irrigation pipeline. Red dye was poured in the center crack prior to excavation. Fulton Dam, Methow Subbasin, Washington – Bureau of Reclamation Photograph by E. Lyon, September 18, 2007.

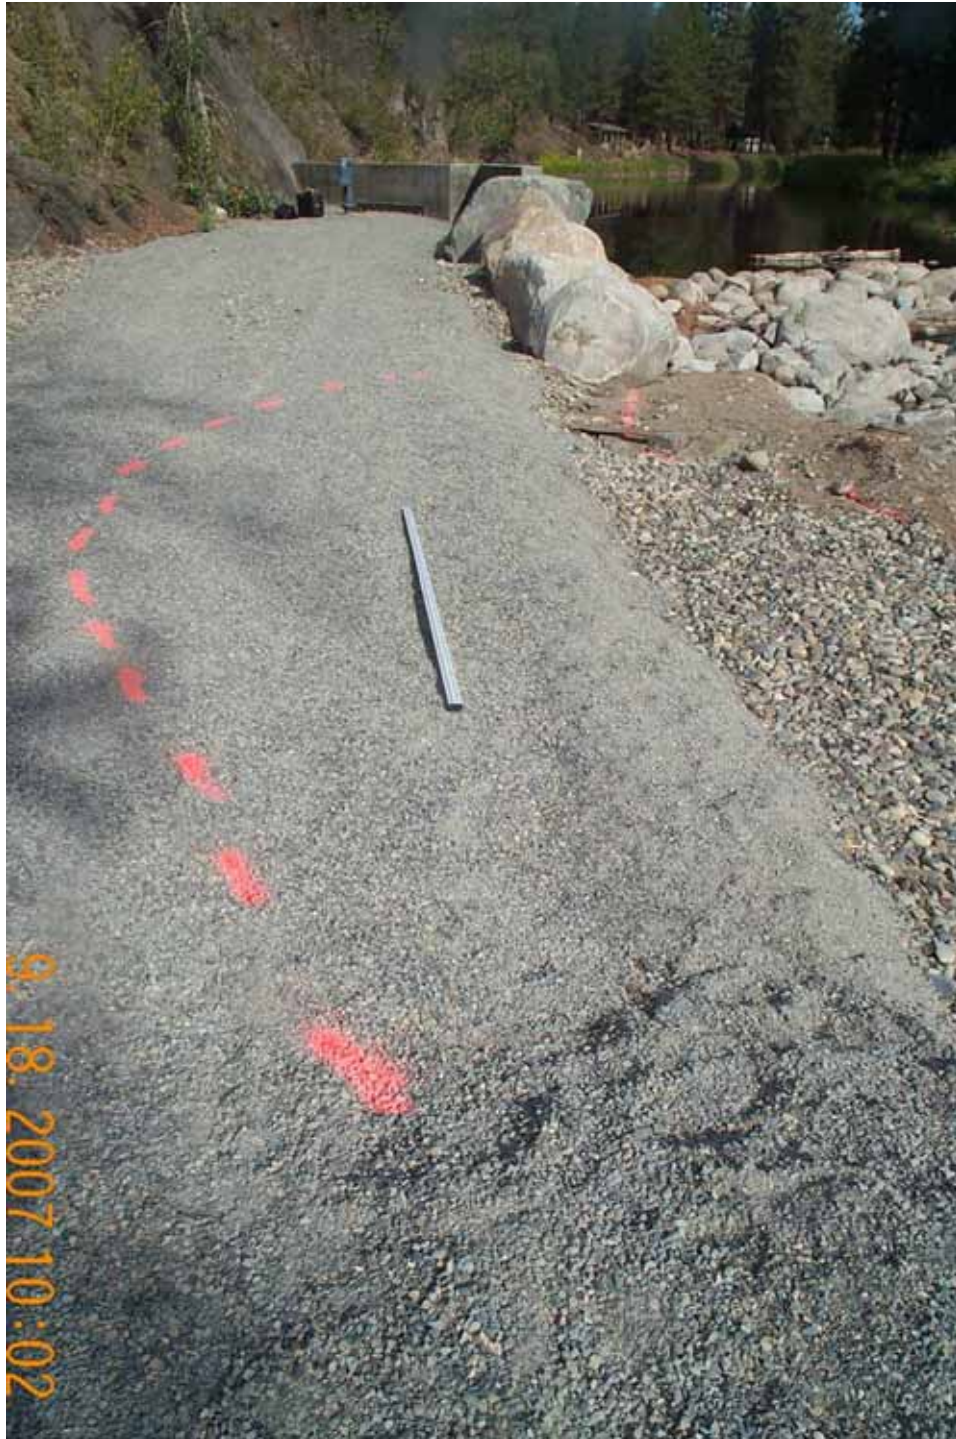
Photograph No. 3. View is to the north looking at the scarp (dashed orange paint) where the surface has settled about ± 1 -foot along the Fulton irrigation pipeline. Fulton Dam, Methow Subbasin, Washington – Bureau of Reclamation Photograph by E. Lyon, September 18, 2007.

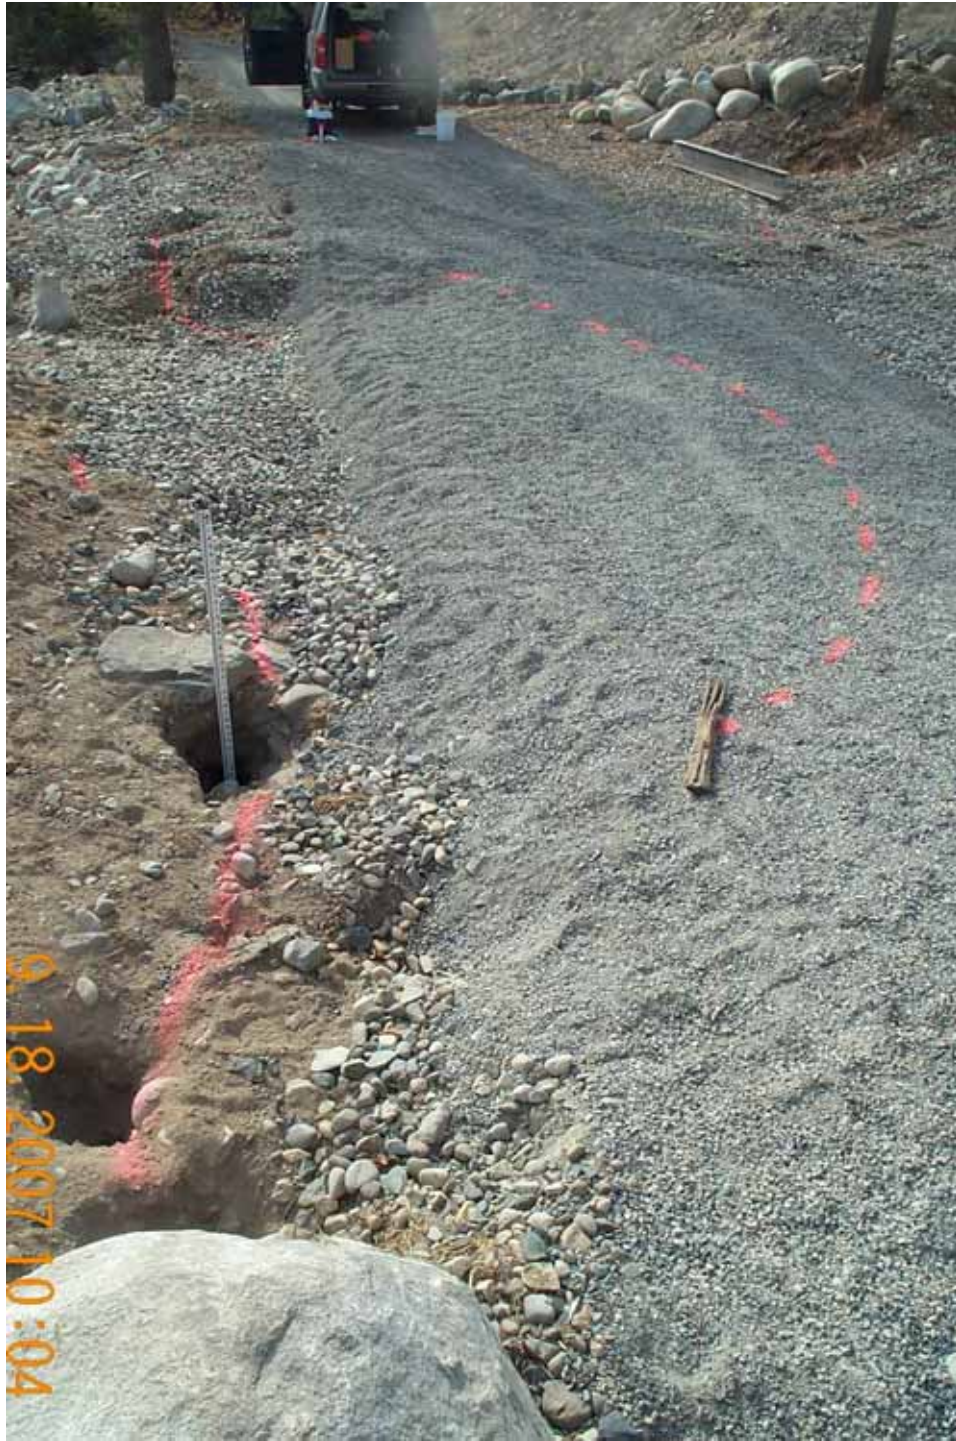
Photograph No. 4. View is to south looking at voids along the east side of the Fulton irrigation pipeline and the settlement area (orange paint). Fulton Dam, Methow Subbasin, Washington – Bureau of Reclamation Photograph by E. Lyon, September 18, 2007.

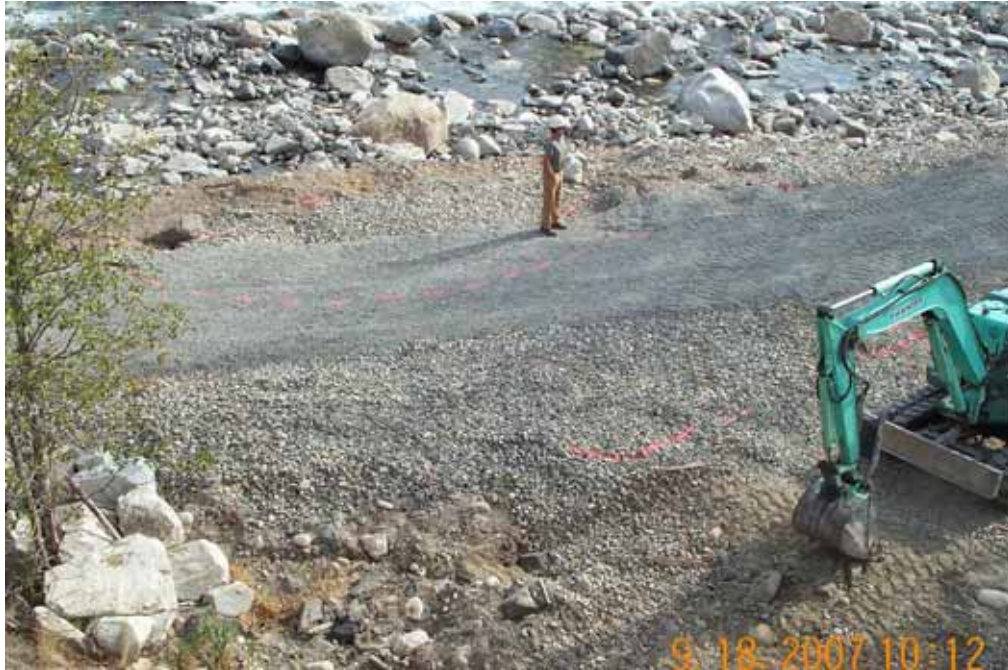
Photograph No. 5. View is to the east looking over the settlement area with extension cracks and slump marked by orange paint. Fulton Dam, Methow Subbasin, Washington – Bureau of Reclamation
Photograph by E. Lyon, September 18, 2007.

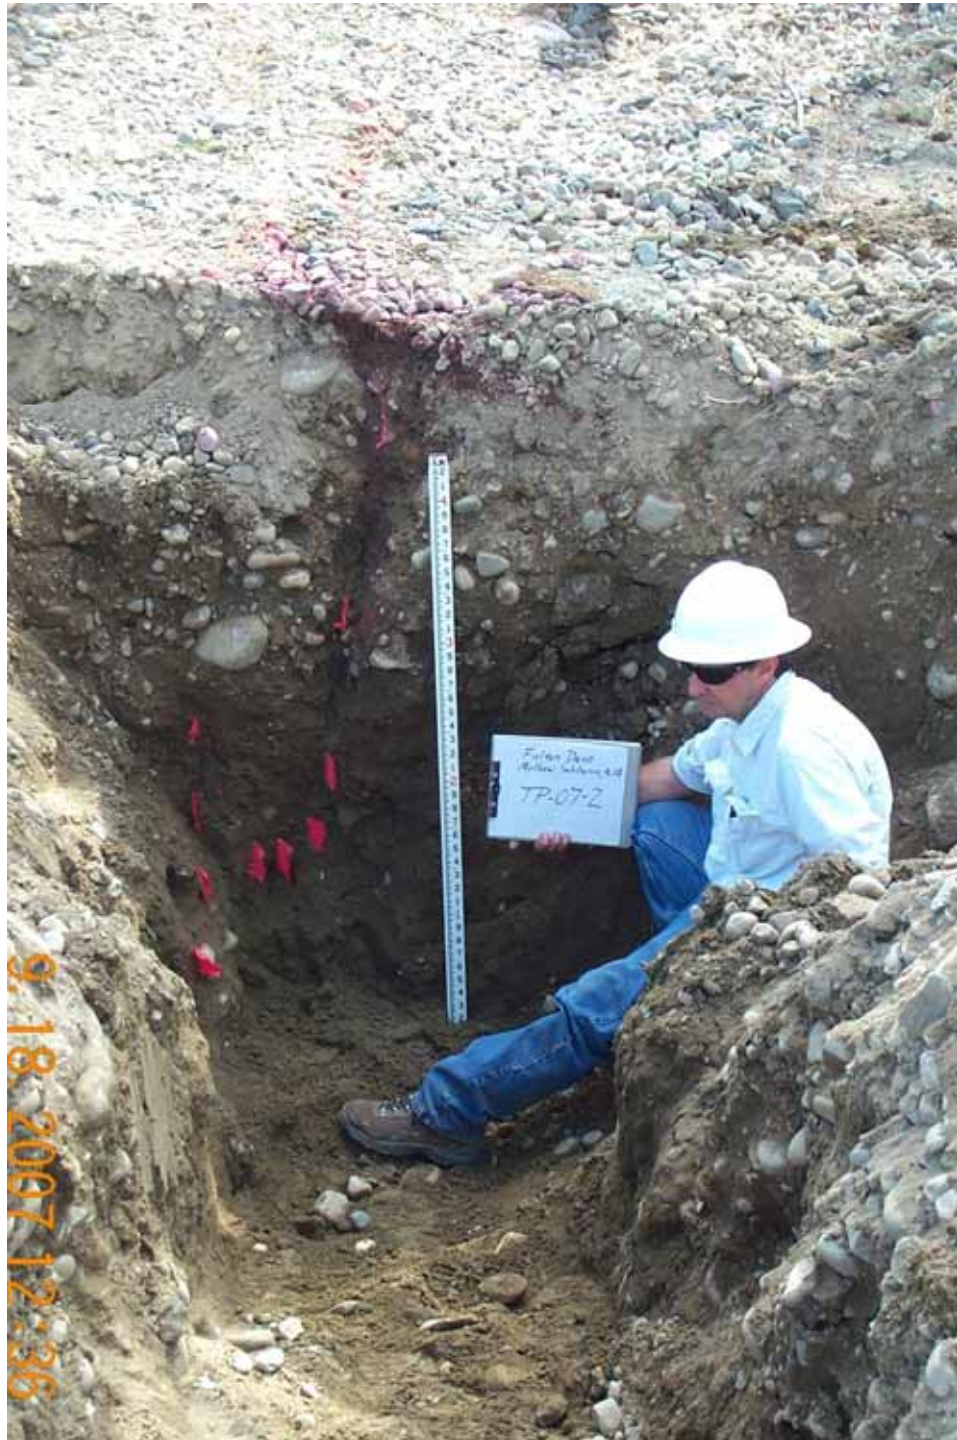
2. A red tracer dye was poured down one of the extension cracks with openness of about 20 mm to observe the trace of the crack during excavation. The crack was excavated (test pit TP-07-2; logs for all test pits are attached) and the dye trace was flagged and photographed (see Photograph No. 6).

3. Extension cracks observed during excavation penetrated about 3 vertical feet and then dipped toward the river where they encountered poorly graded sand with nonplastic fines that were wet.

Photograph No. 6. View is to the south looking at trace of extension cracks (red flags) exposed in test pit TP-07-2. A diluted red tracer dye was flushed down the extension crack so that it could be mapped during excavation. Fulton Dam, Methow Subbasin, Washington – Bureau of Reclamation
Photograph by E. Lyon, September 18, 2007.

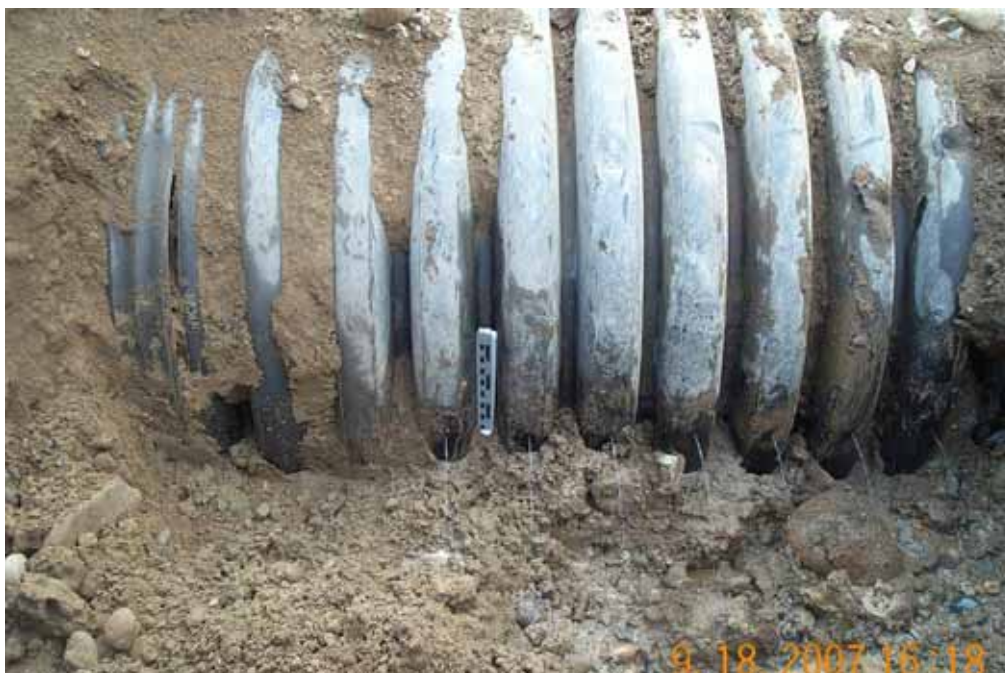
4. A segment of the pipeline was exposed in an excavation on the riverside that revealed water leaking from perforations along the pipe that saturated the poorly graded sand with nonplastic fines placed as backfill (see Photograph Nos. 7 and 8).

Photograph No. 7. View is to west looking at the Fulton irrigation pipeline exposed at depth. Note the horizontal alignment of the perforations leaking water along the pipe and the openness of the joint (left center in photograph). Fulton Dam, Methow Subbasin, Washington – Bureau of Reclamation Photograph by E. Lyon, September 18, 2007.

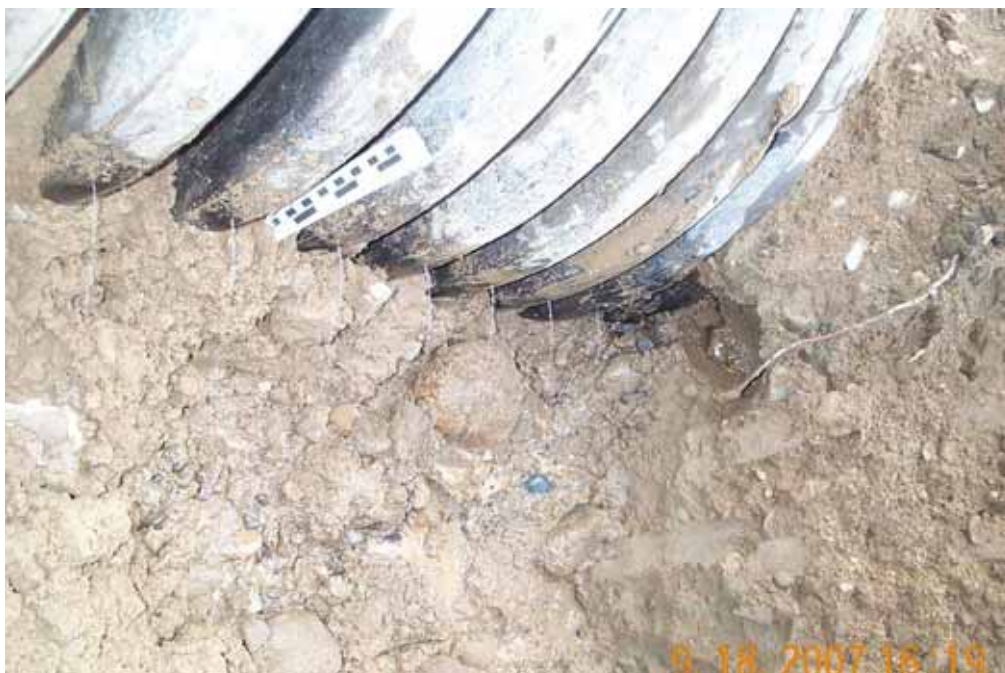
Photograph No. 8. View is to northwest looking at the perforations along the Fulton irrigation pipeline and the perforations leaking water. Fulton Dam, Methow Subbasin, Washington – Bureau of Reclamation Photograph by E. Lyon, September 18, 2007.

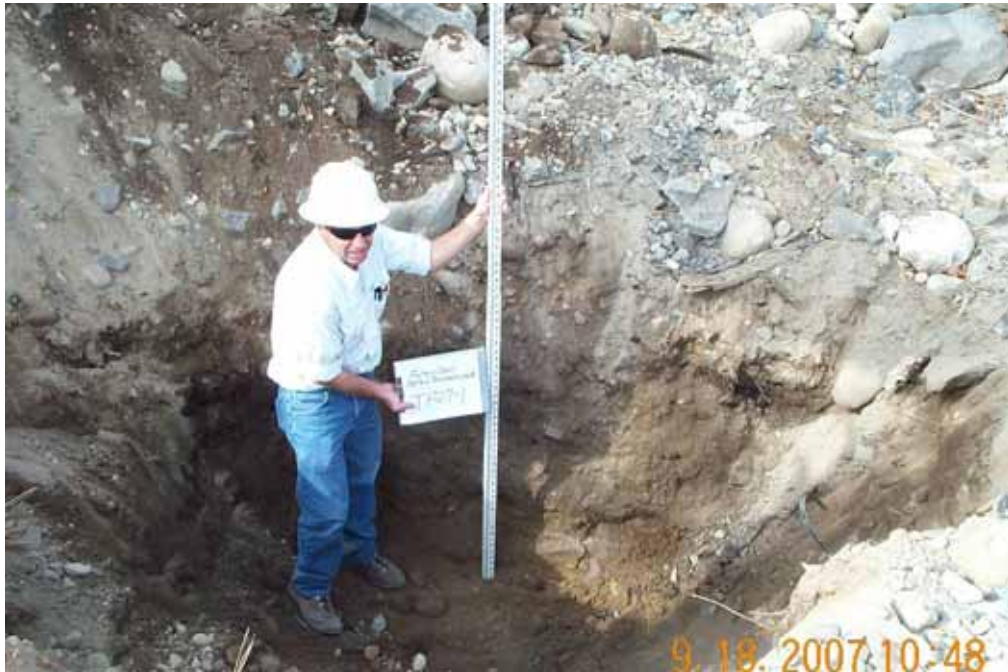
5. Test pit TP-07-1 was excavated in a potential spoil pile west of the pipeline because of runoff concerns and the presence of low density material as observed when the backhoe traveled over the material (see Photograph Nos. 9 through 12).

Photograph No. 9. View is to southwest looking at test pit TP-07-1. Fulton Dam, Methow Subbasin, Washington – Bureau of Reclamation Photograph by R. Link, September 18, 2007.

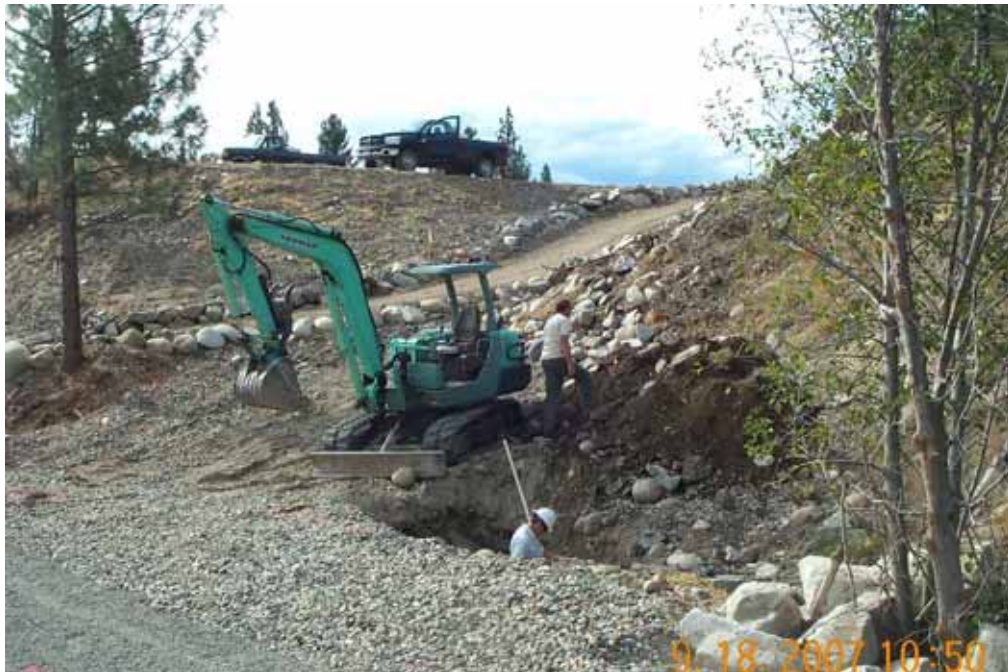
Photograph No. 10. View is to west looking at location of test pit TP-07-1 where a depression was filled with spoils along the Fulton irrigation pipeline. Fulton Dam, Methow Subbasin, Washington – Bureau of Reclamation Photograph by R. Link, September 18, 2007.

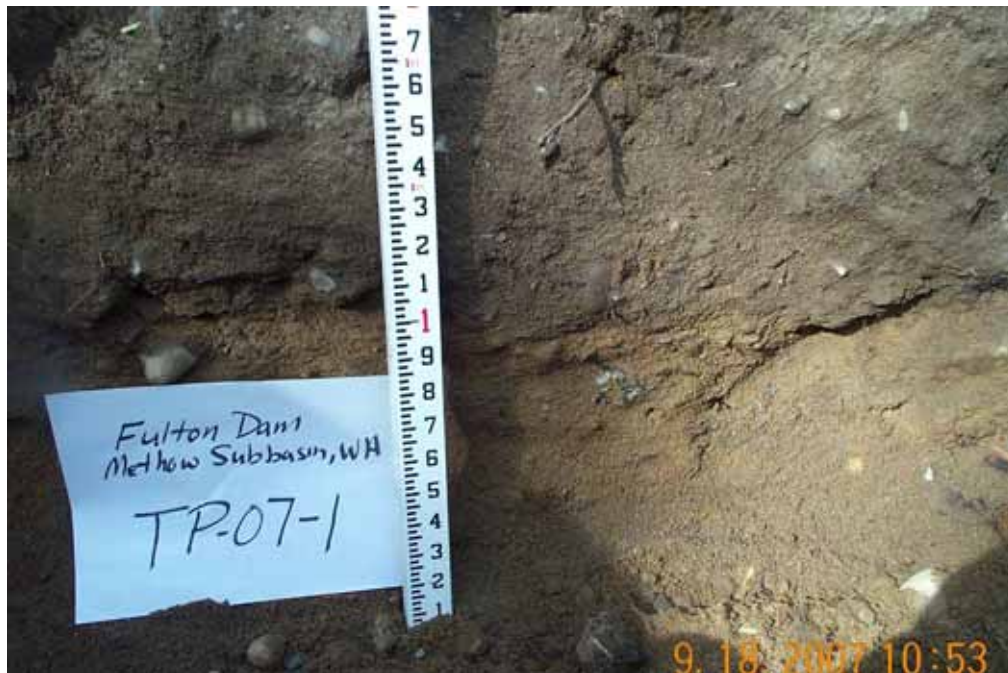
Photograph No. 11. View of spoil material overlying native or backfill material in test pit TP-07-1. Fulton Dam, Methow Subbasin, Washington – Bureau of Reclamation Photograph by E. Lyon, September 18, 2007.

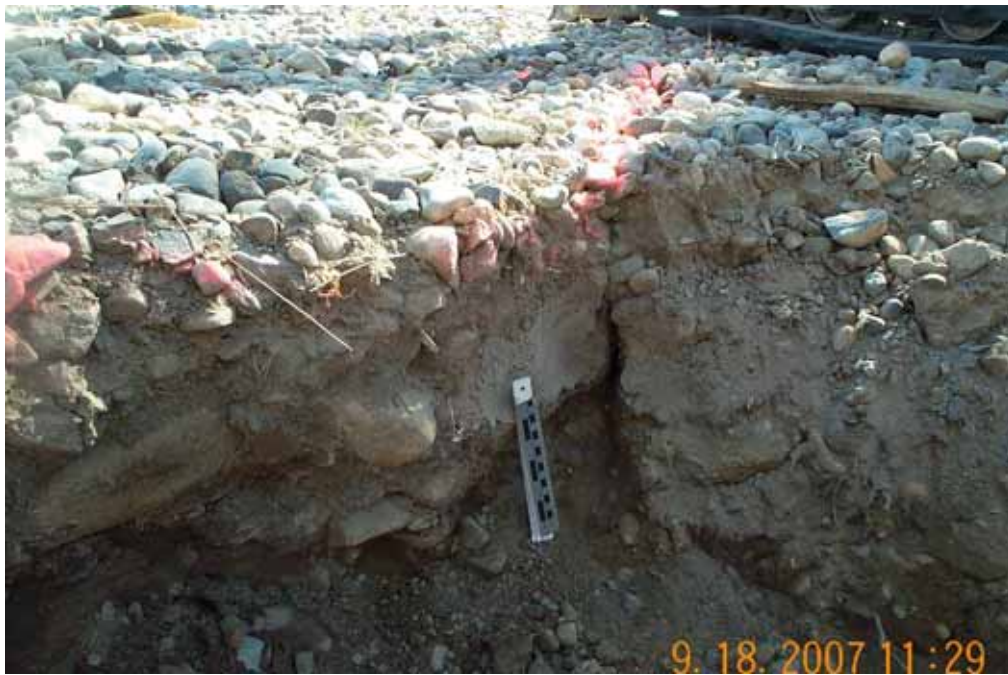
Photograph No. 12. View is to south looking at an excavated extension crack that generally dips to the east toward the river exposed in test pit TP-07-1. Fulton Dam, Methow Subbasin, Washington – Bureau of Reclamation Photograph by E. Lyon, September 18, 2007.

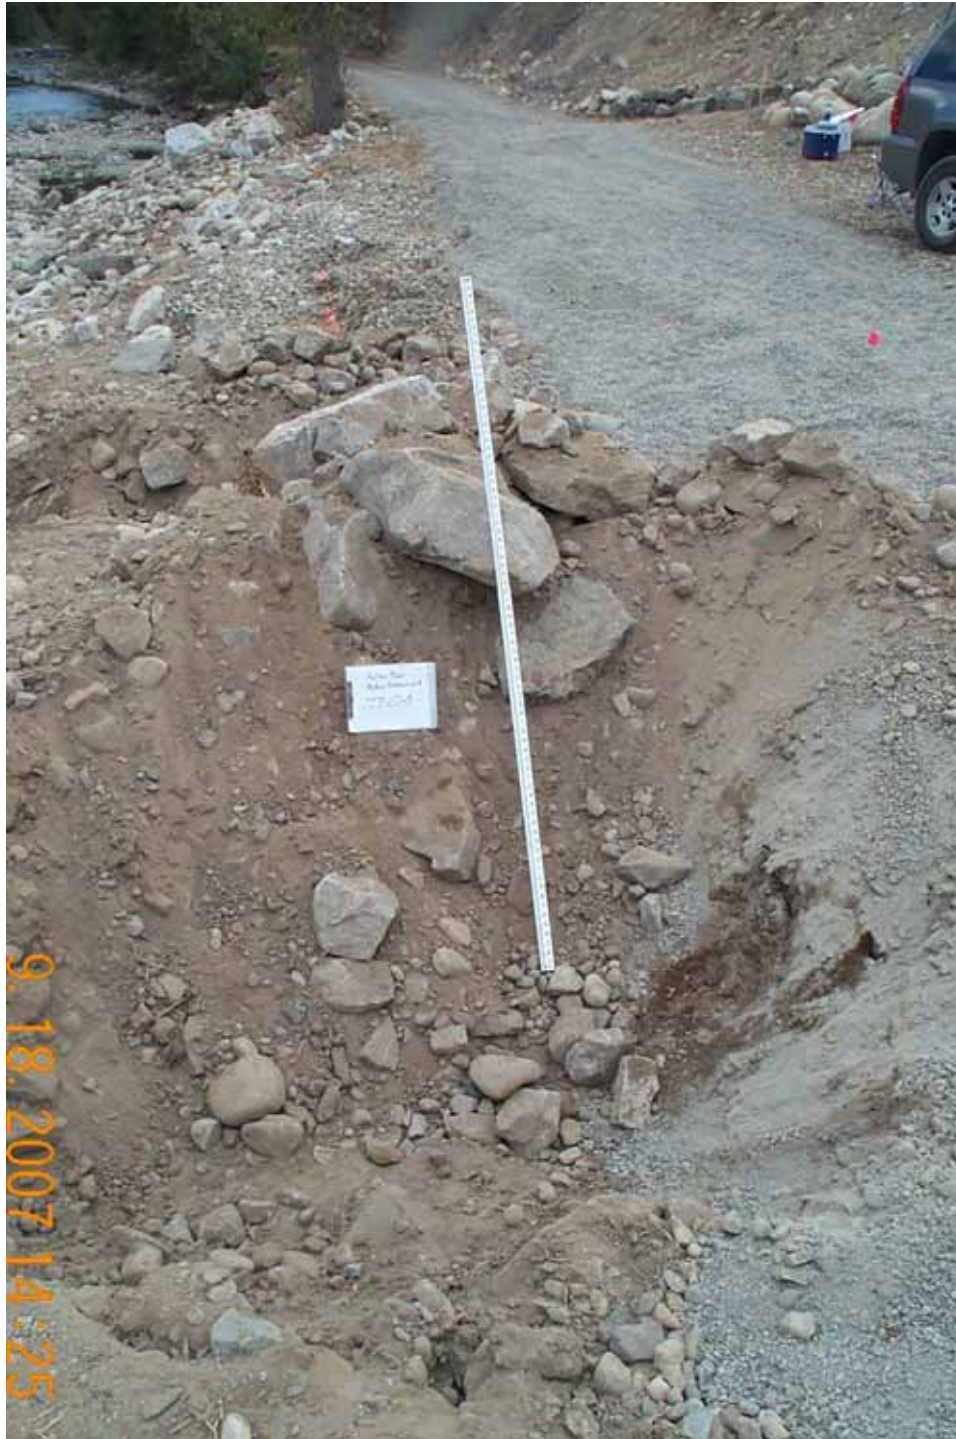
6. Two test pits (TP-07-3 and TP-07-4) were excavated through the riprap that revealed a generally poorly graded mixture with the maximum rock size of less than 24 inches as measured along the intermediate axis (see Photograph Nos. 13 and 14). The bedding was comprised of predominantly poorly-graded coarse and fine cobbles, coarse to fine gravels, and sand with nonplastic fines.

Photograph No. 13. View is to the south looking at test pit TP-07-3 excavated through the placed riprap along the roughened channel on river right. Fulton Dam, Methow Subbasin, Washington – Bureau of Reclamation Photograph by E. Lyon, September 18, 2007.

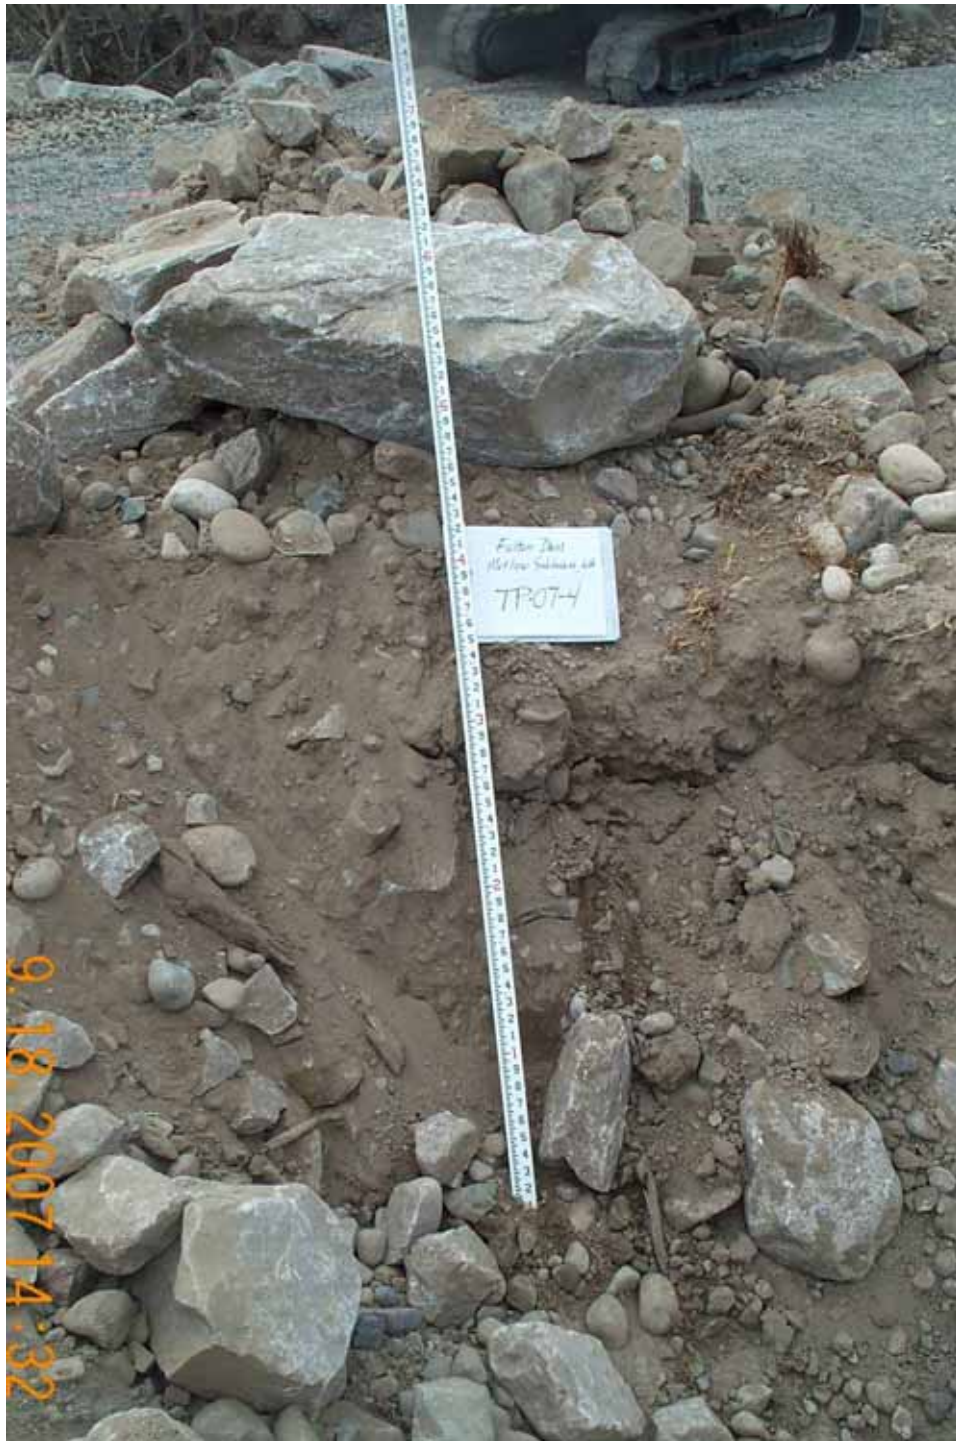
Photograph No. 14. View is to the north looking at test pit TP-07-4 excavated through the placed riprap along the roughened channel on river right. Fulton Dam, Methow Subbasin, Washington – Bureau of Reclamation Photograph by E. Lyon, September 18, 2007.

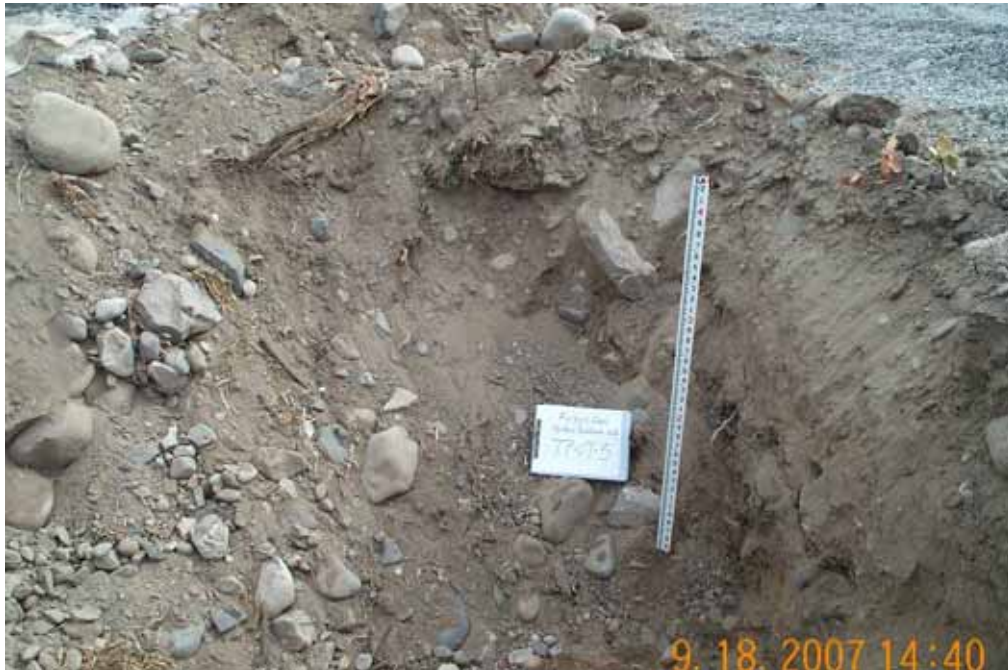
7. Test pit TP-07-5 was excavated between the riprap placement area and the pipeline that contained predominantly coarse and fine cobbles, coarse to fine gravels, and sand with nonplastic fines, and hay bales and trash (see Photograph No. 15). The area had experienced considerable settlement, suggesting that it was not properly compacted.

Photograph No. 15. View is to the south looking at test pit TP-07-5 excavated west of the riprap placed along the roughened channel on river right. Fulton Dam, Methow Subbasin, Washington – Bureau of Reclamation Photograph by E. Lyon, September 18, 2007.

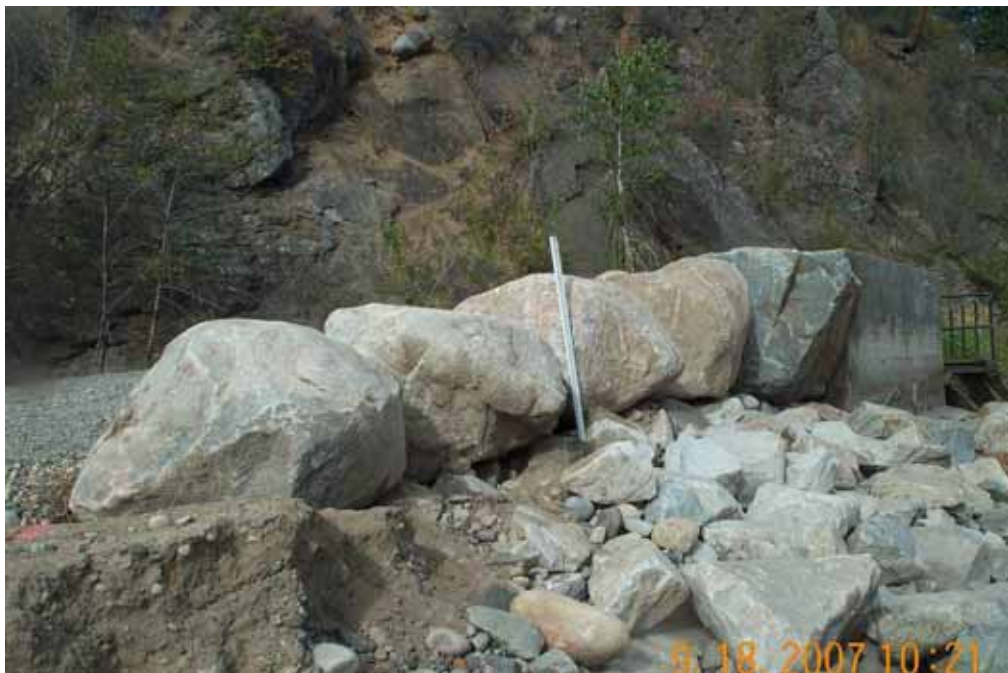
8. The line of five large boulders placed at the downstream end of the headgate's concrete wall on the right bank was examined to determine the extent of scouring during the 2006 runoff. Significant scouring of backfill materials had occurred around the bases of the boulders and three were in jeopardy of toppling into the roughened channel (see Photograph No. 16).

Photograph No. 16. View is to the west looking at scour that has occurred at the base of the 4-foot-diameter boulders placed on the right bank along the roughened channel. Three of the boulders are precariously held in place and are in jeopardy of toppling. Fulton Dam, Methow Subbasin, Washington – Bureau of Reclamation Photograph by E. Lyon, September 18, 2007.
