**COMPLETION REPORT  
MILL CREEK DITCH  
FISH PASSAGE IMPROVEMENT PROJECT  
MILL CREEK, PESHATIN CREEK  
WENTATCHEE SUBBASIN, WASHINGTON**

**PREPARED FOR  
CHELAN COUNTY CONSERVATION DISTRICT  
WENATCHEE, WASHINGTON**

**BY U.S. BUREAU OF RECLAMATION  
PACIFIC NORTHWEST REGION  
UPPER COLUMBIA AREA OFFICE  
WENATCHEE FIELD STATION**

**JULY 2005**

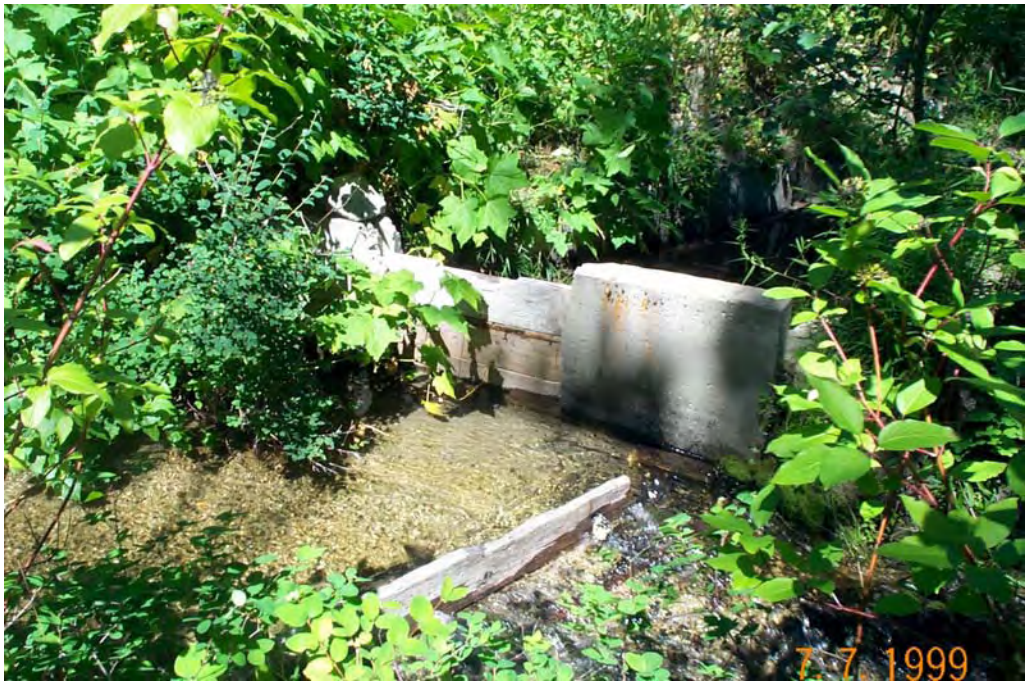
**Photo A-1. Mill Creek Diversion, July 1999.** (photo by Chelan County Conservation District)

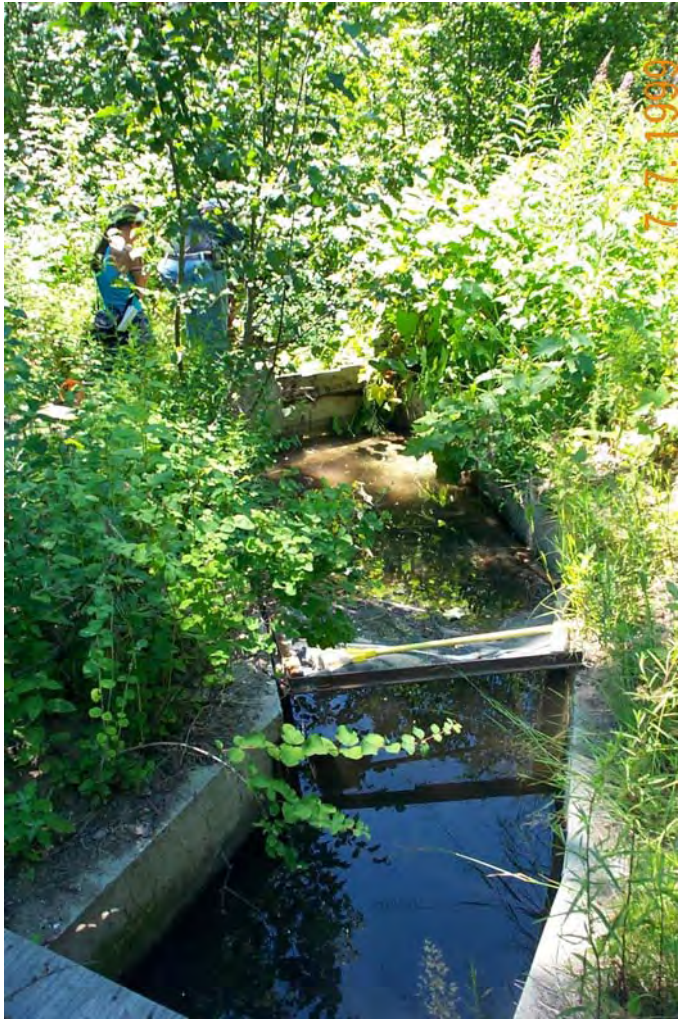
**Photo A-2. Mill Creek Diversion ditch, looking upstream, circa July 1999.** (photo by Chelan County Conservation District)

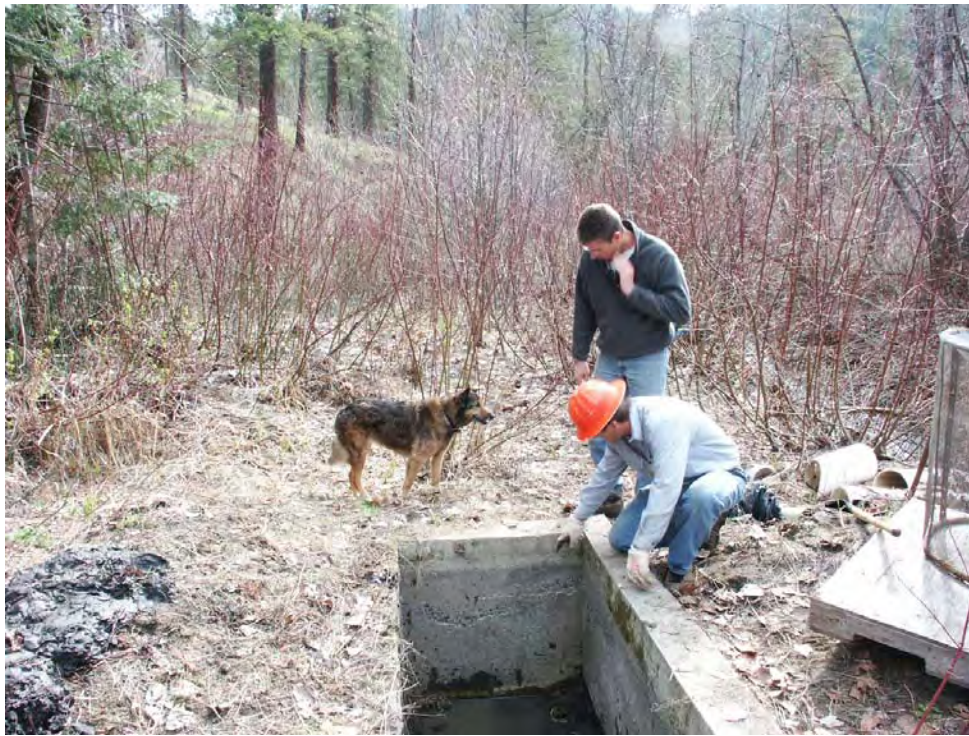
**Photo A-3. Existing Mill Creek Diversion structure prior to construction.**

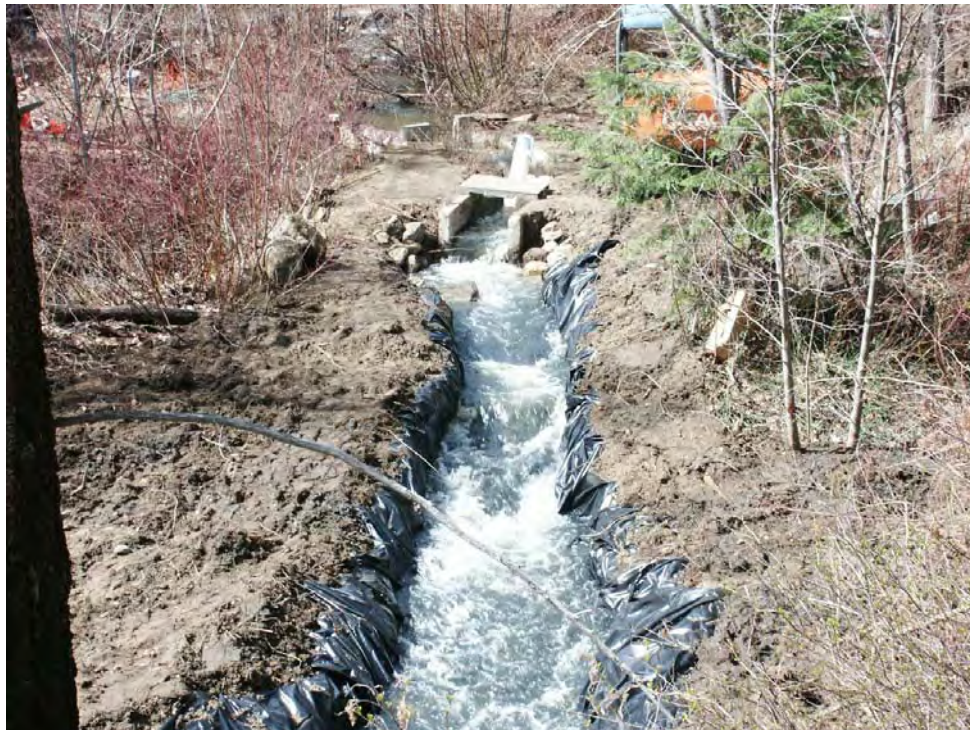
The use of the polyethylene liner created some concerns and eventually some minor complications. Originally, the project job had been bid with construction scheduled for the fall, when flows would be seasonally low. Under those circumstances, the plastic sheeting probably would have worked satisfactorily. However, with construction delayed until the spring, an early runoff brought substantially higher flows through the work area than originally anticipated. Because of the additional stresses, the liner tore in several places but was repaired.

**Photo A-4. Diverting water through temporary bypass channel; note use of polyethylene liner to limit erosion.**

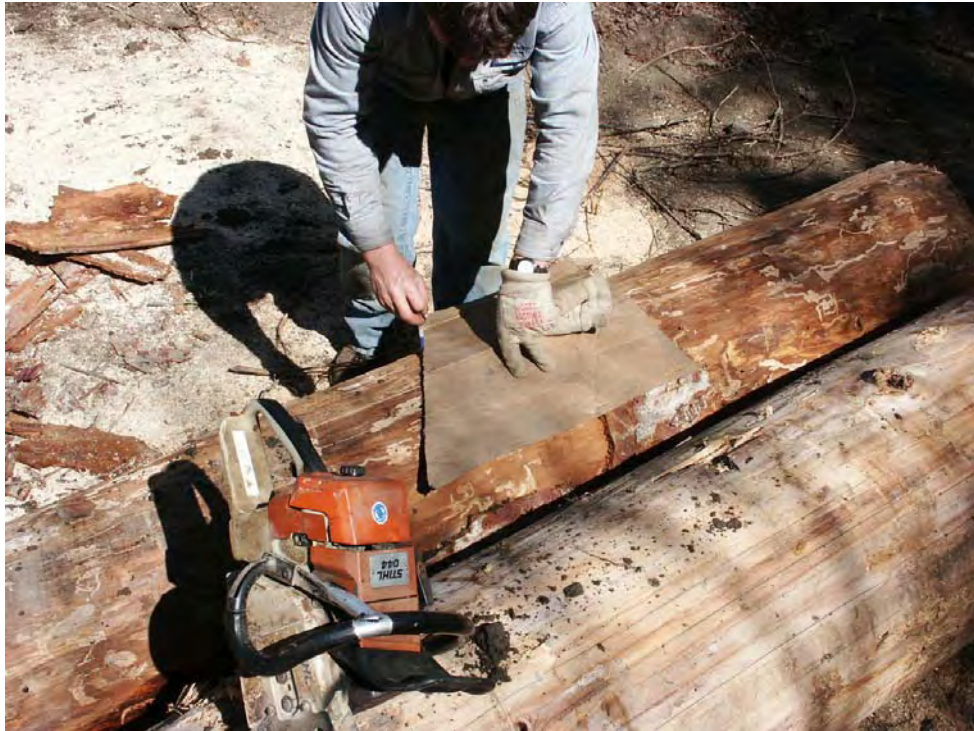
The “low flow center cross-pieces” and “arms” were cut by chainsaw from the logs to design length and the butts were angled (photo A-5). The cross-pieces were notched to size.

**Photo A-5. Preparing to cut logs for weir arm. The template was used to ensure the proper angle for butting the ends of the logs.**

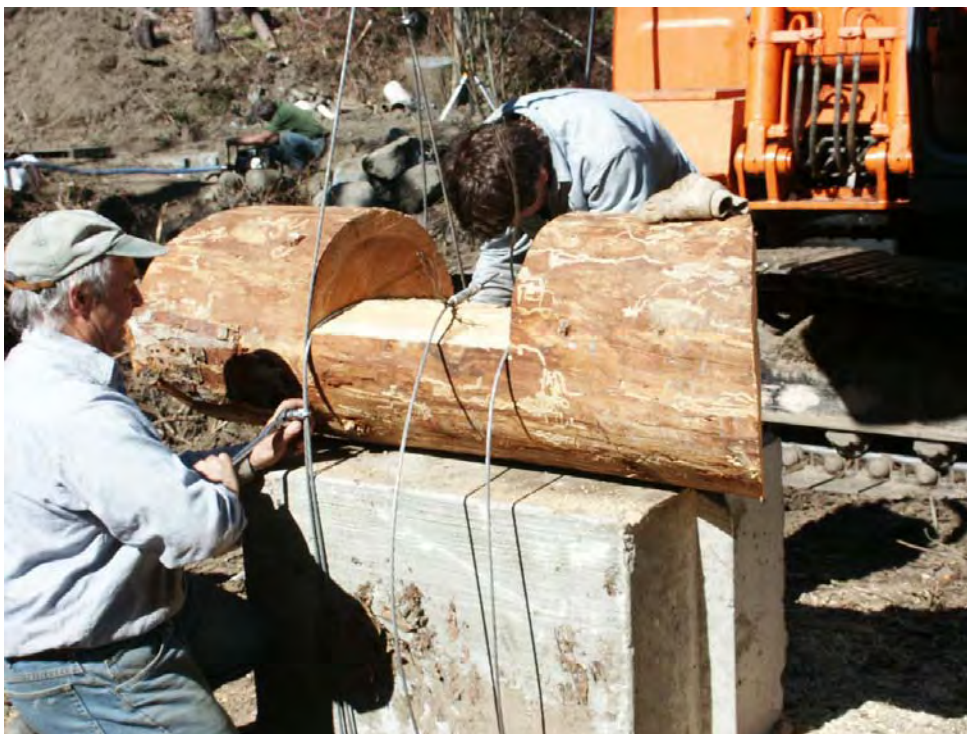
**Photo A-6. Workers use cable to secure the weir's notched, low-flow center crosspiece.**

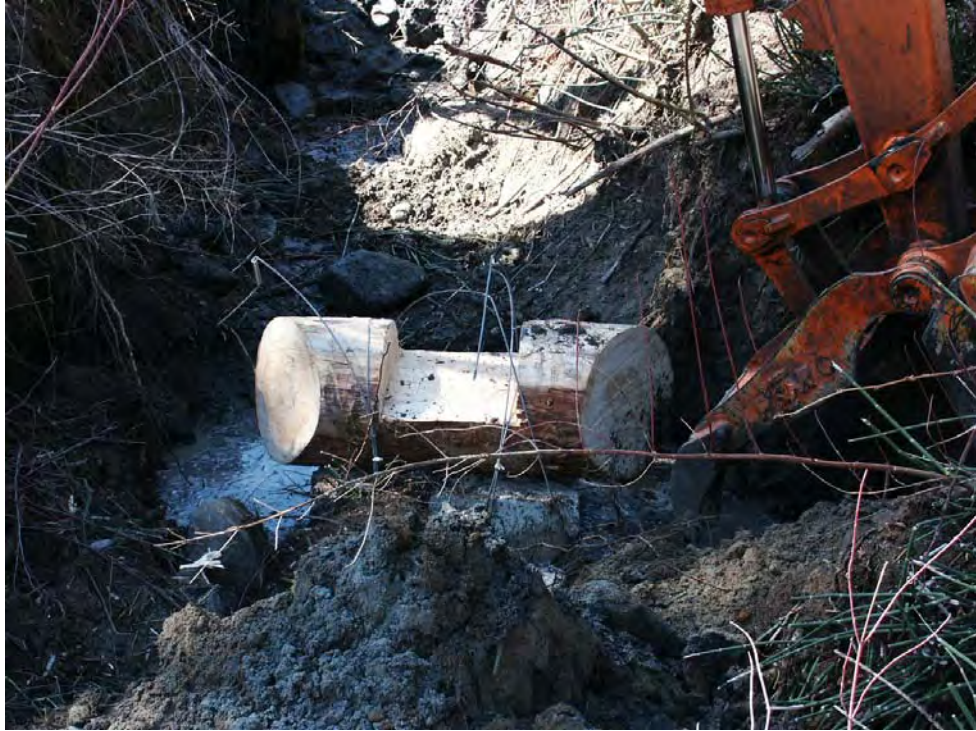
**Photo A-7. Weir No. 6 (downstream-most) was placed first.**

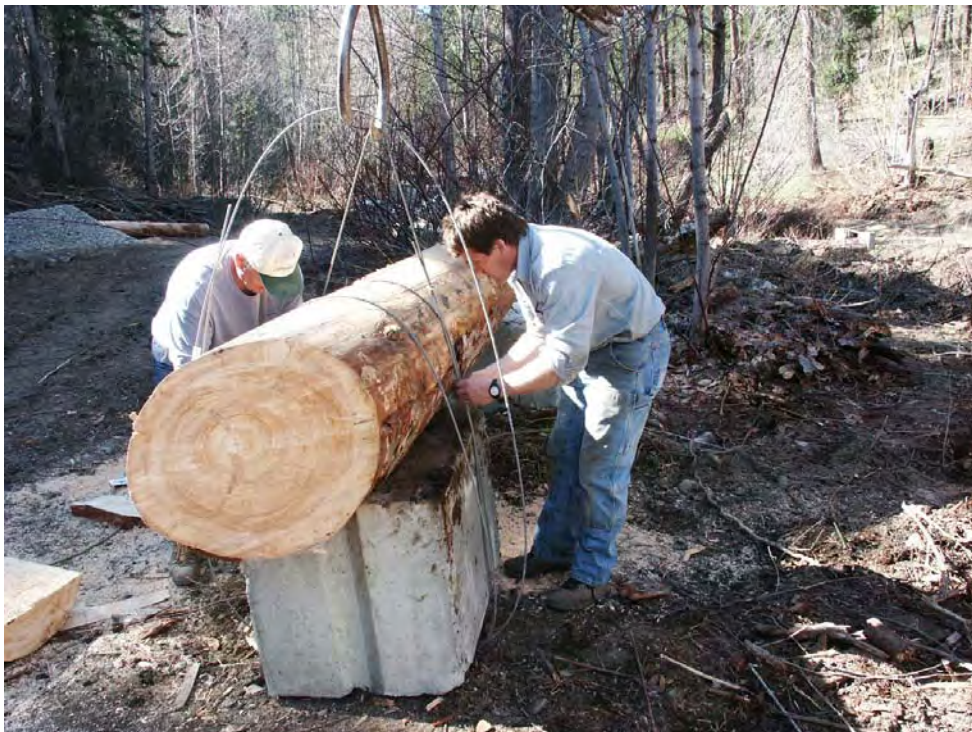
**Photo A-8. Fastening an angle-cut arm to an "ecology block" pier.**

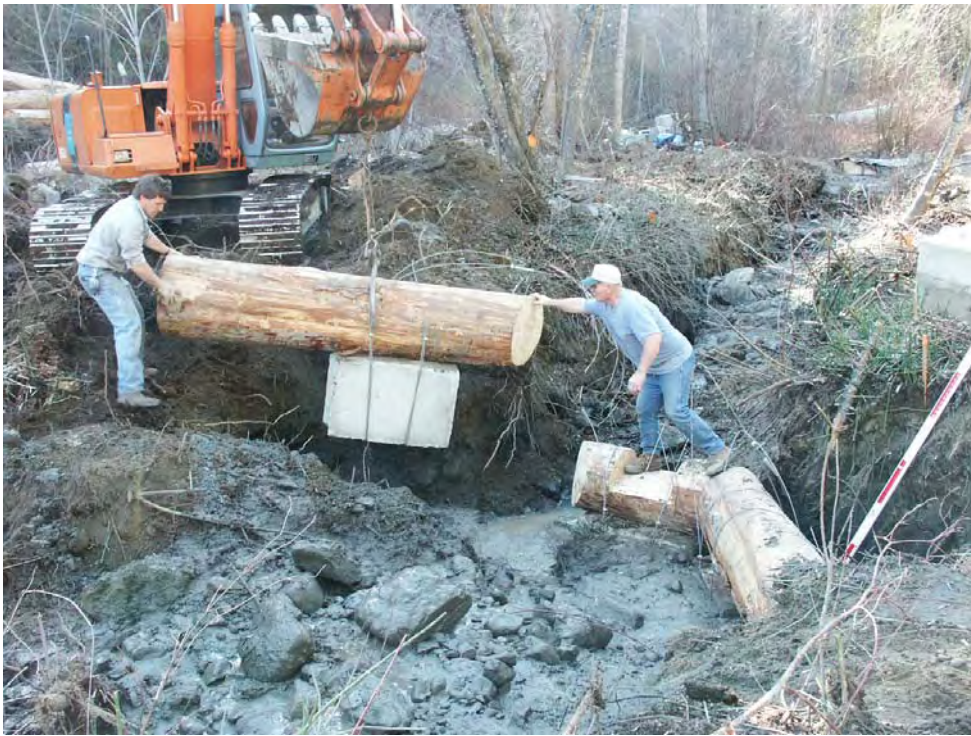
**Photo A-9. Maneuvering right-side arm for Weir No. 6 into place.**

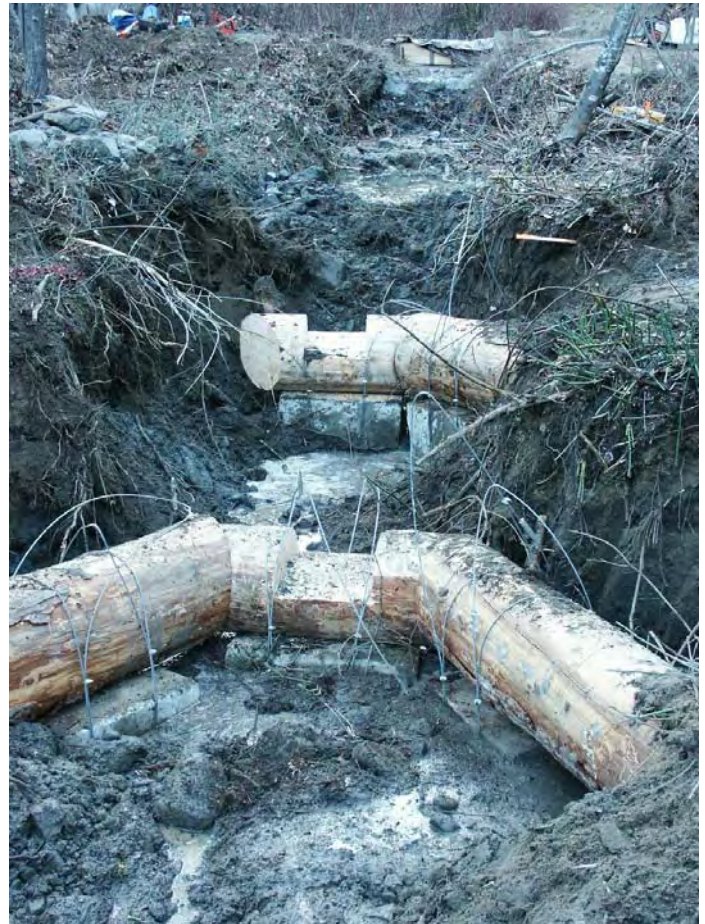
**Photo A-10. Weir No. 6 fully installed; Weir No. 5 with center piece and left arm is in place.**

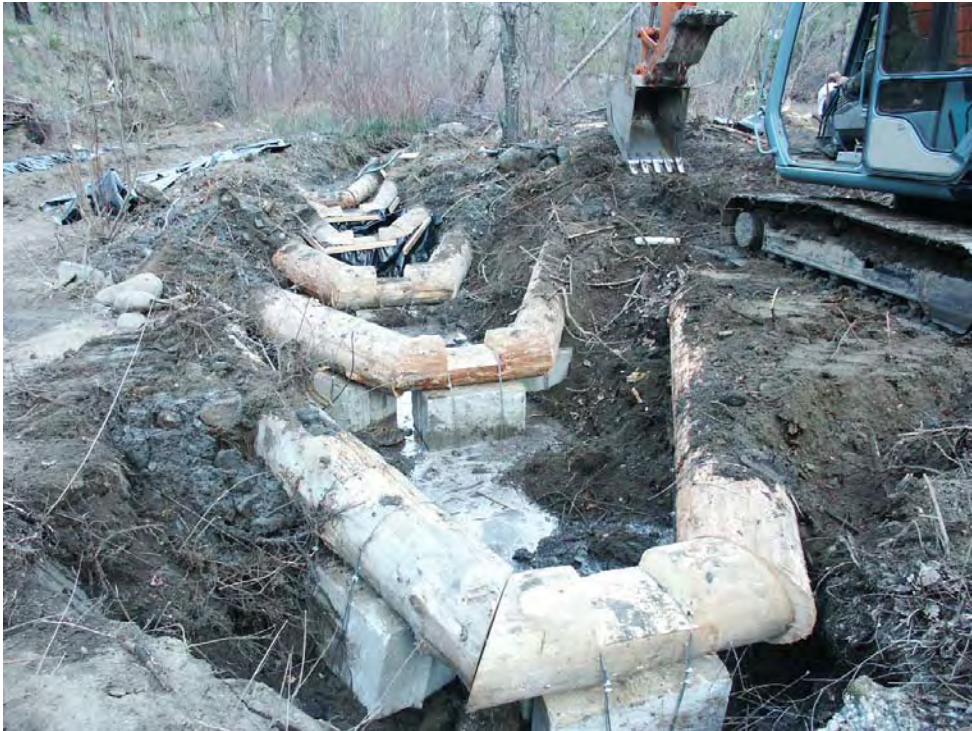
**Photo A-11. Backfilling between weir arms, looking downstream.**

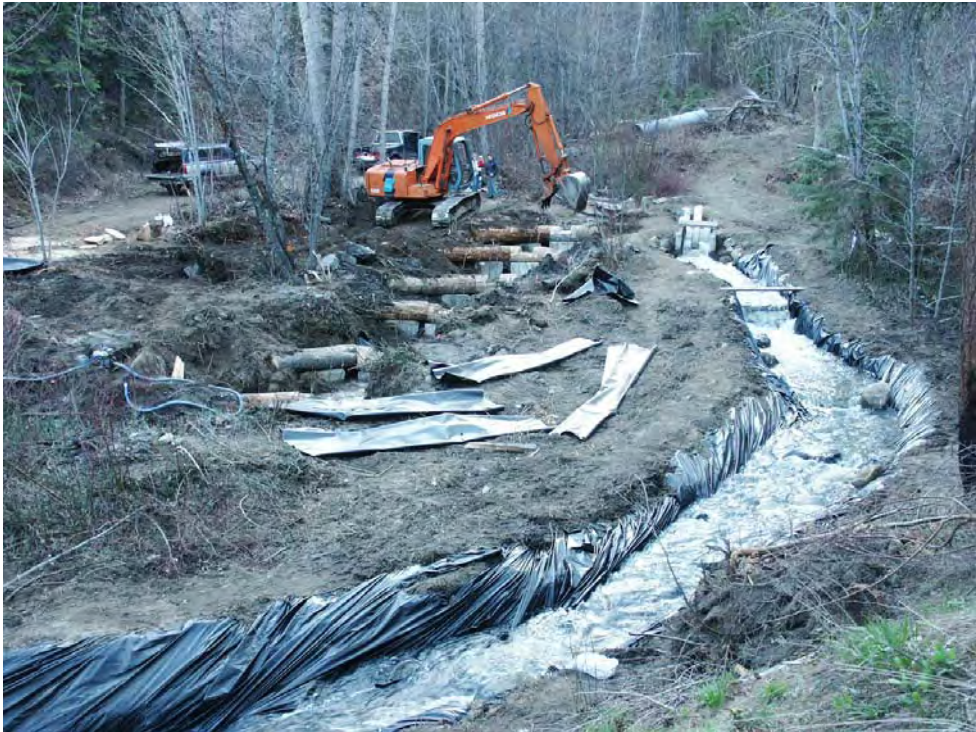
**Photo A-12. Panoramic shot (looking upstream) at temporary bypass and weirs.**

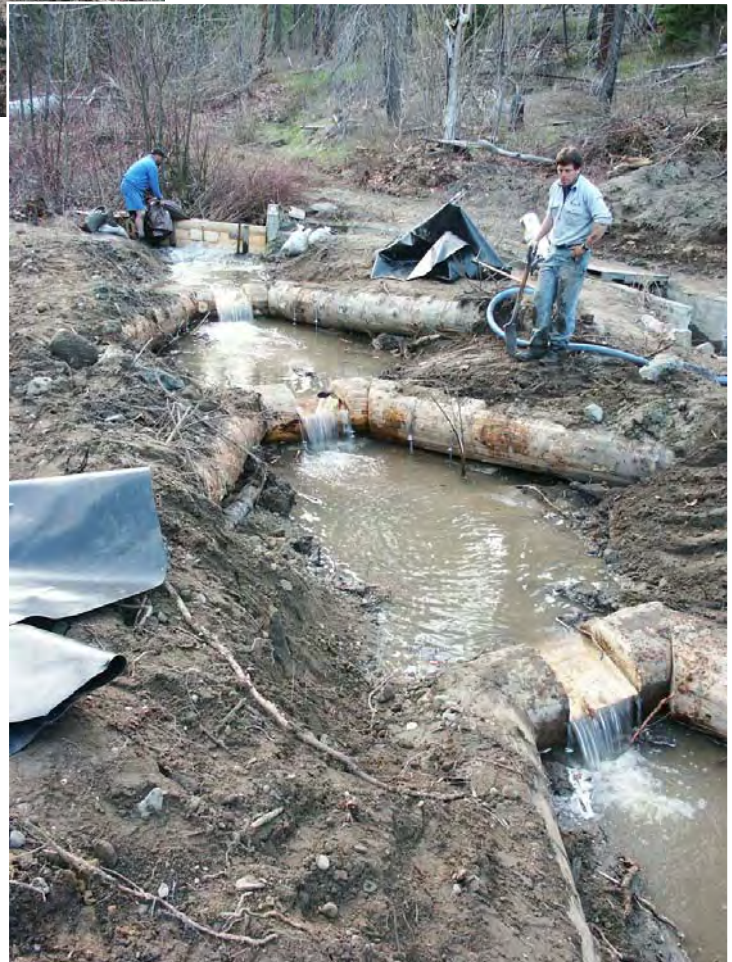
**Photo A-13. Looking upstream at completed weirs; groundwater has filled the individual scour holes.**

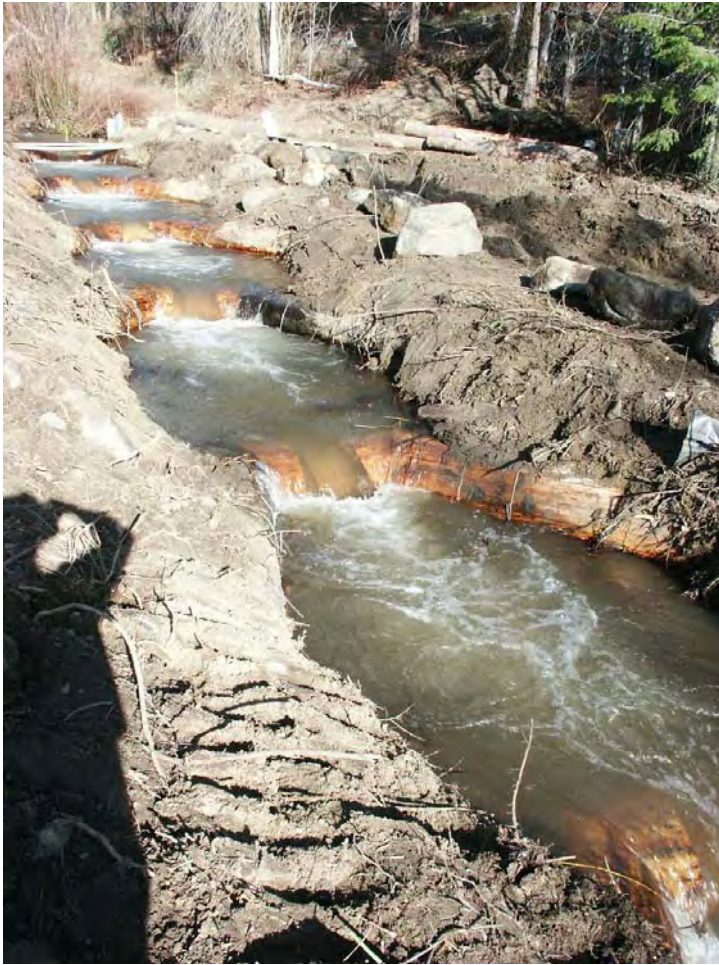
**Photo A-14. The bypass has been closed and "first water" flows through the new weirs on Mill Creek; note lack of clarity of water clouded by sediment.**

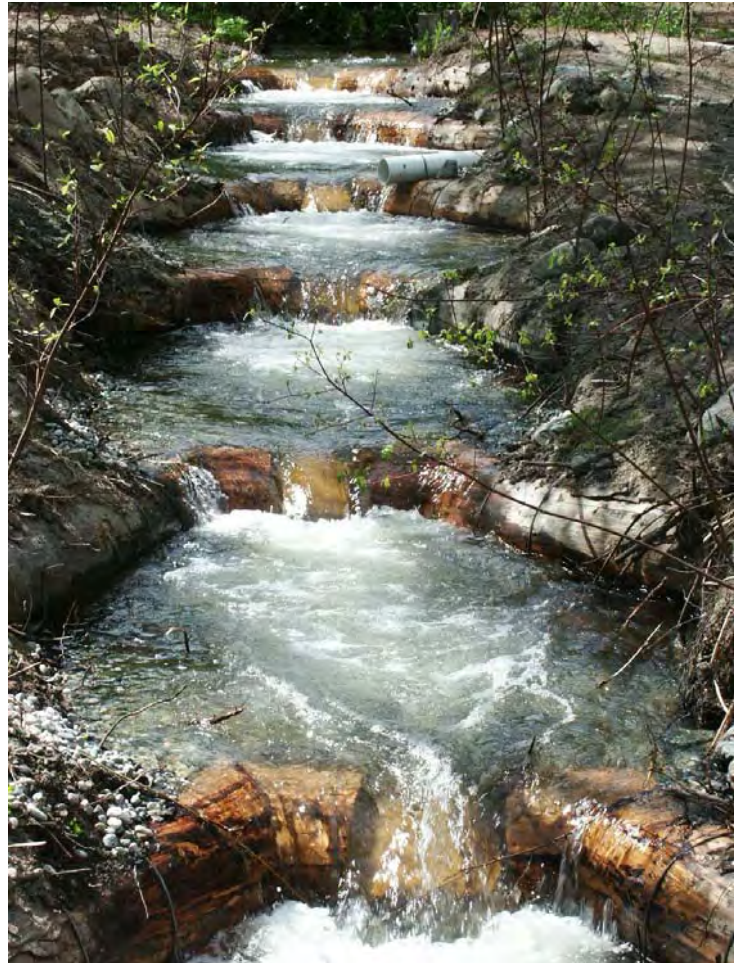
Because the screen was non-conforming, the return pipe came off at the wrong angle. The contractor's initial installation put the outlet of the pipe in the wrong spot and the bend in the pipe didn't meet NOAA criteria. This was adjusted, and now satisfies the criteria (photo A-17).

**Photo A-17. Final bypass pipe alignment.**

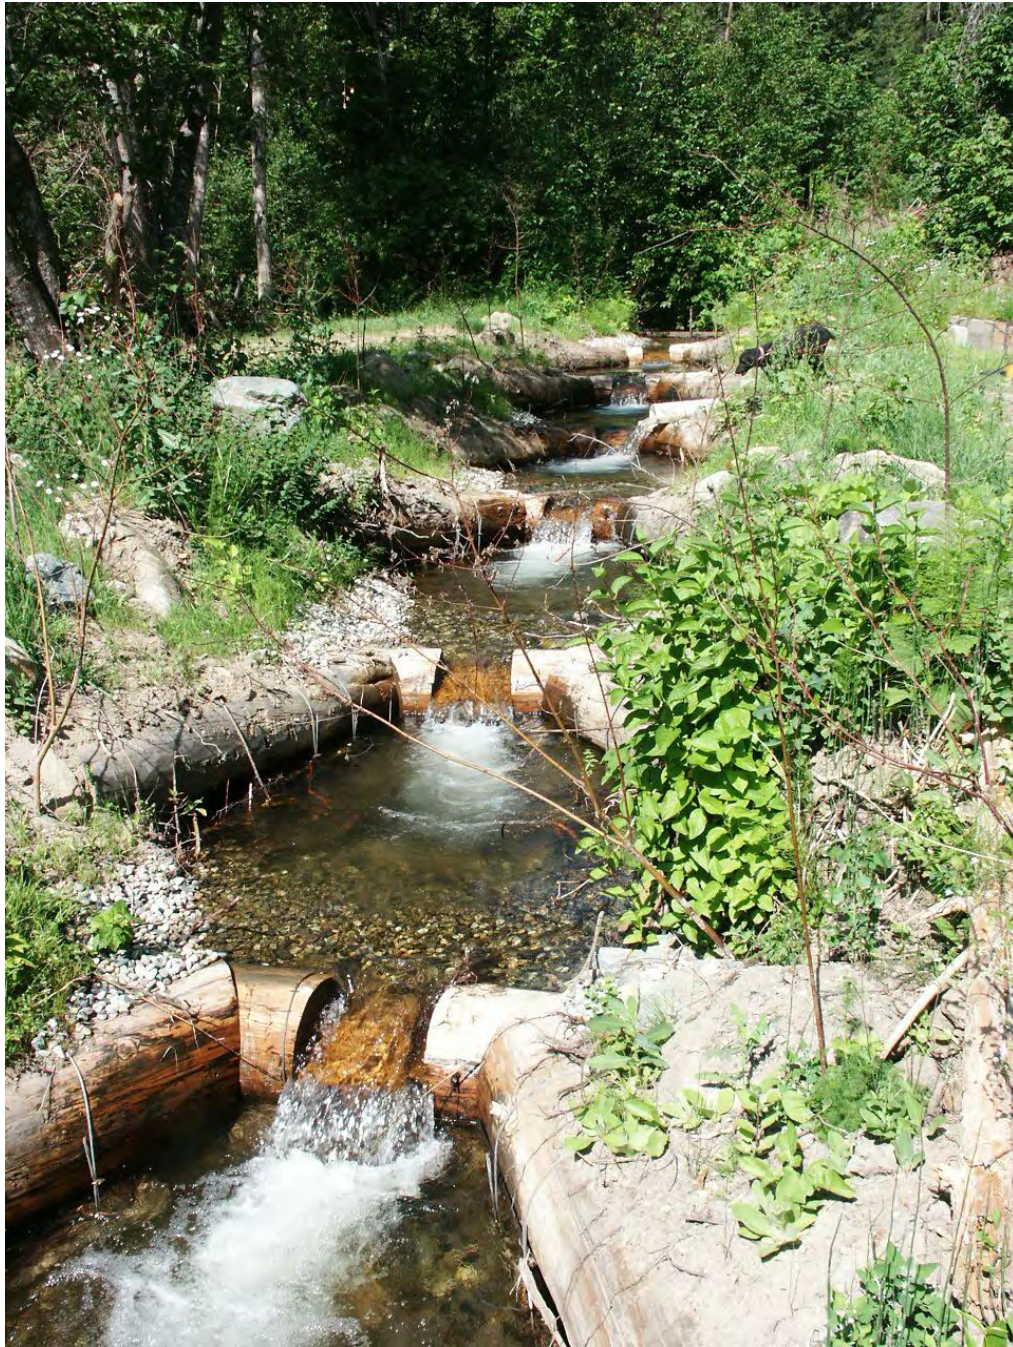
**Photo A-19. The new Mill Creek Diversion weirs, six months after revegetation; note gravels visible in ponds.**

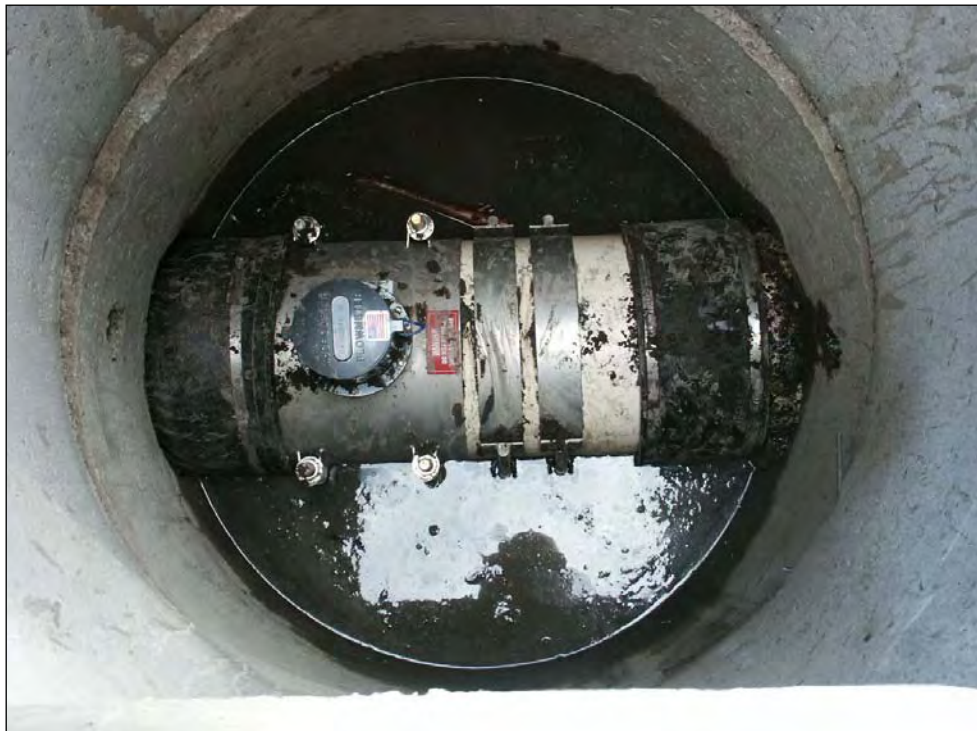
**Photo A-21. Flow meter installed downstream from the diversion structure near the point-of-diversion.**
