# **NATIONAL TRANSPORTATION SAFETY BOARD**

## **AIRCRAFT ACCIDENT REPORT**

**RUNWAY COLLISION  
UNITED EXPRESS FLIGHT 5925  
AND BEECHCRAFT KING AIR A90  
QUINCY MUNICIPAL AIRPORT  
QUINCY, ILLINOIS  
NOVEMBER 19, 1996**

**Adopted: July 1, 1997  
Notation 6793C**

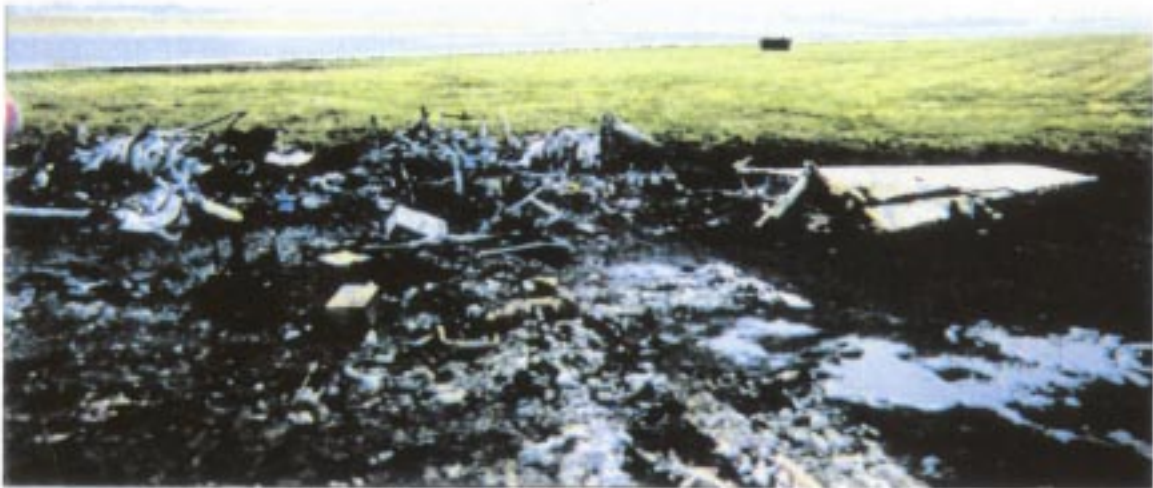
2b. View (looking forward) of the King Air wreckage

Except for the outboard sections of the right wing and the right horizontal stabilizer, the King Air was consumed by the postcrash fire. No evidence of the main cabin door or the emergency exit hatch could be found. The nose gear was folded forward in the down-and-locked position. The radome and a small section of the airplane's left wing leading edge were found on the runway next to the wreckage. The radome was torn and exhibited chipped paint

and abrasive marks on its exterior, and the section of the left wing's leading edge showed black paint transfer that matched the color of paint on the Beech 1900C's propellers. Examination of the control cables to the fuel controls of both engines revealed positions consistent with normal engine shutdown. The cockpit-mounted radio controls were consumed by the postcrash fire. The nose-mounted communication radio units were found crushed and partially burned. No information about the radio's functioning or its settings at the time of the accident could be obtained from the wreckage.

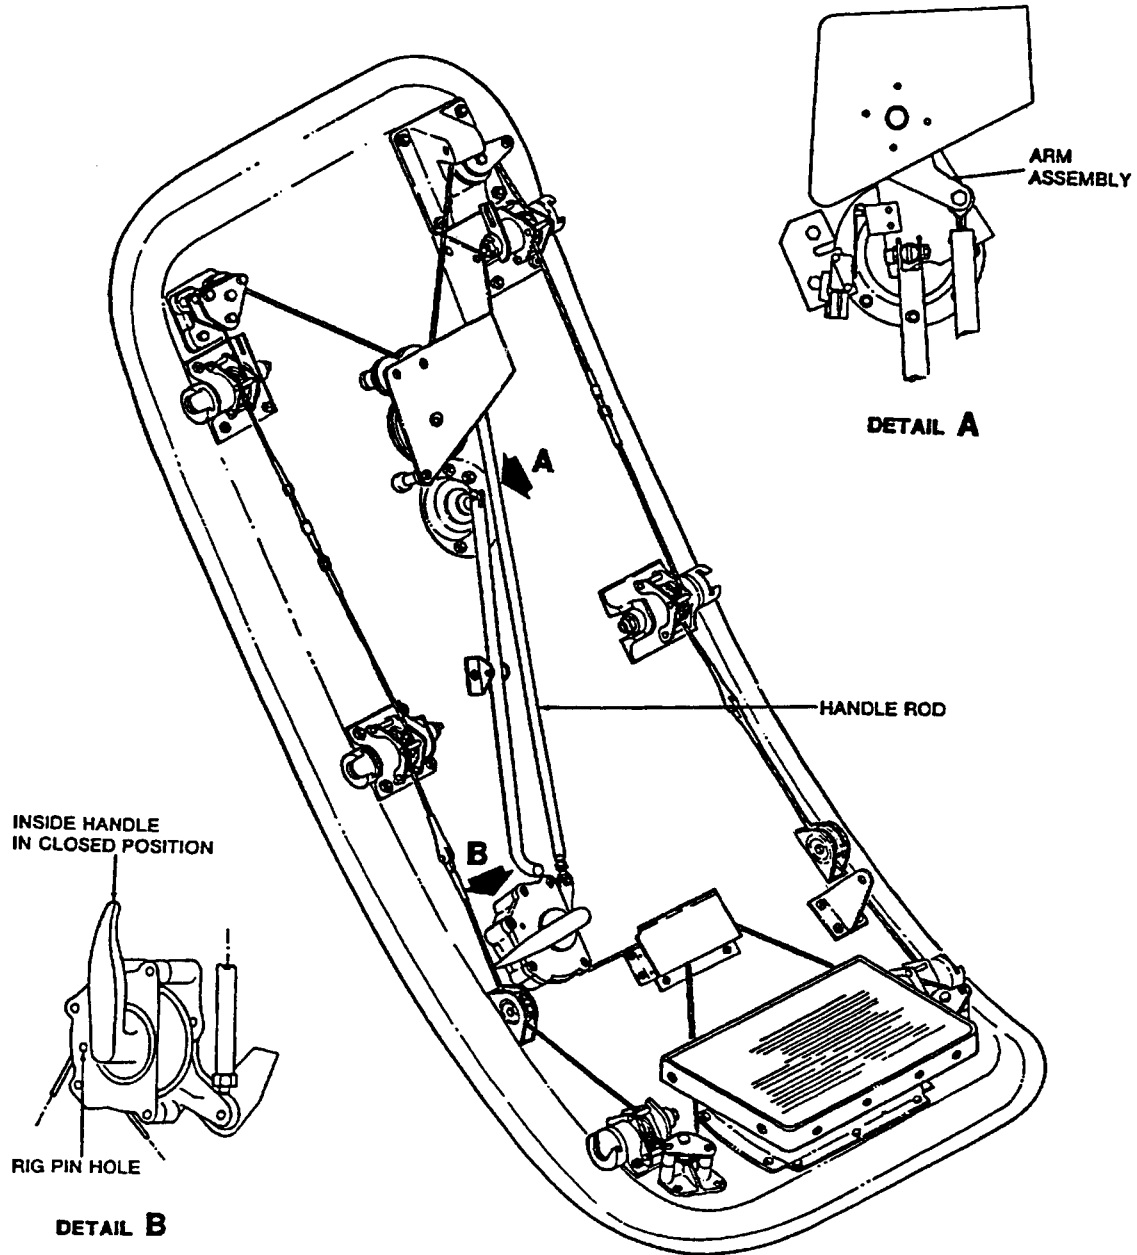
Figure 4.—Beech 1900/1900C air stair door and latching mechanism.

The FBO pilot stated that he found the forward air stair door handle in the 6 o'clock (unlocked) position.<sup>29</sup> He said that he attempted unsuccessfully to open the door by moving the handle in all directions and pulling on the door. He said that he did not see any instructions for opening the door, but he was able to rotate the handle upward to the 5 o'clock position but no further. The United Express pilot stated that he then intervened because he believed that the FBO pilot probably did not know how to open the door. The United Express pilot stated that he depressed the button above the handle while rotating the handle from the 3 o'clock position downward to the unlocked position. He stated that the handle felt "normal" as he rotated it. However, he was unable to open the door. The FBO pilot then tried again to open the door by rotating the handle upward, but he was again unsuccessful.

1. All cams were either fully or partially latched;
2. The exterior door handle was frozen in the latched position with aluminum melted around it;
3. The position of the interior door handle assembly could not be determined because there was no frame of reference to compare it to surrounding structure;
4. The door control cable was attached at both handle assemblies and was fractured at both turnbuckles. The metallurgical examination of the turnbuckle fracture surfaces revealed a topography typical of copper alloys subject to static failure influenced by high temperatures and steady state strain rates.

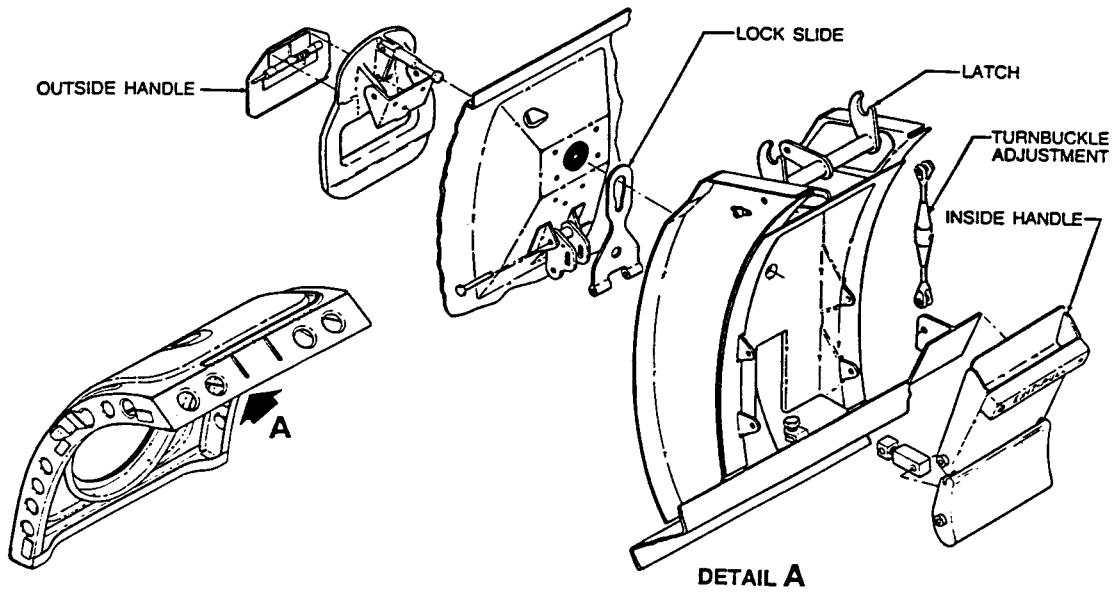
Figure 5.—Diagram of overwing exit hatch.

During wreckage recovery, the overwing exit hatch release latches and turnbuckles were examined. No conclusion could be drawn regarding their positions before the postcrash fire because the release latch secured to the airframe could have fallen from its latched position when the surrounding structure burned away.
