Corrosion Investigation in Man-Rated Percussion Ignition Devices

NSWC IHEODTD, E2 CAD/PAD Division
11th CAD/PAD TECHNICAL EXCHANGE WORKSHOP
MAY 2016
CADPAD@navy.mil

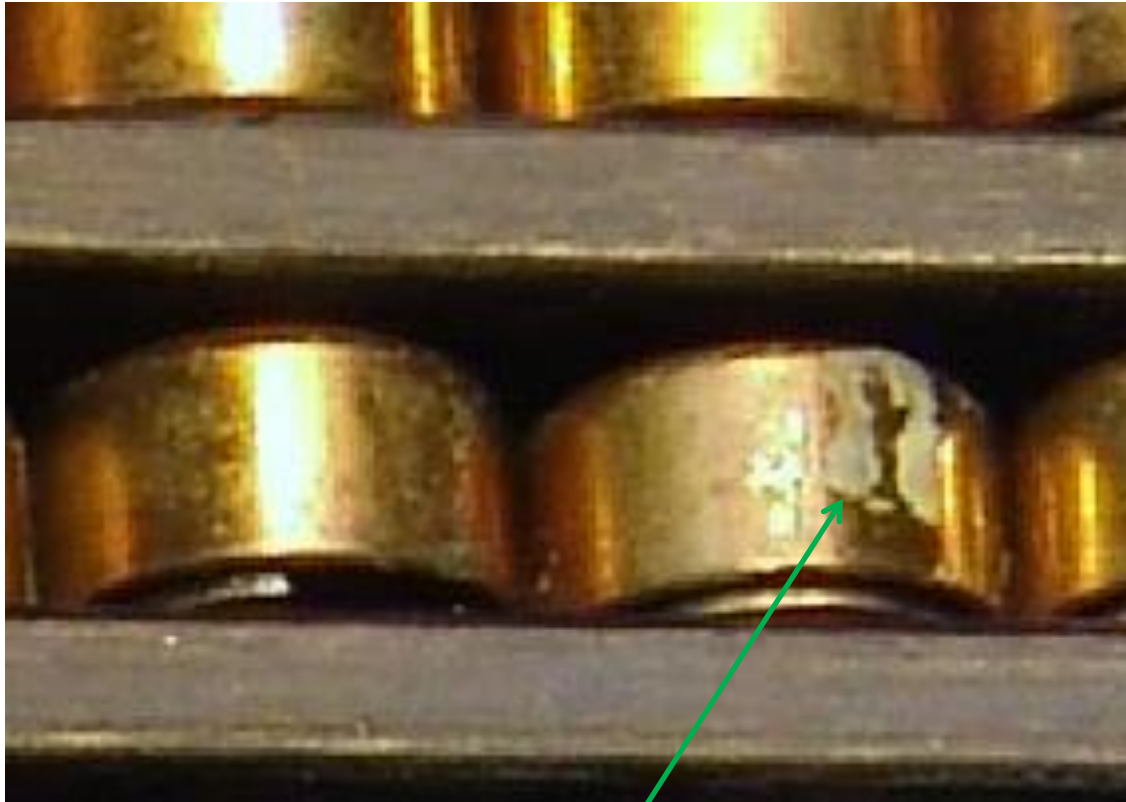
Green Patina

- Greenish colored areas indicate patina product
 - Patina is an oxidative process
- Patina corrosion becomes a secondary protectant, does not permeate like dezincification

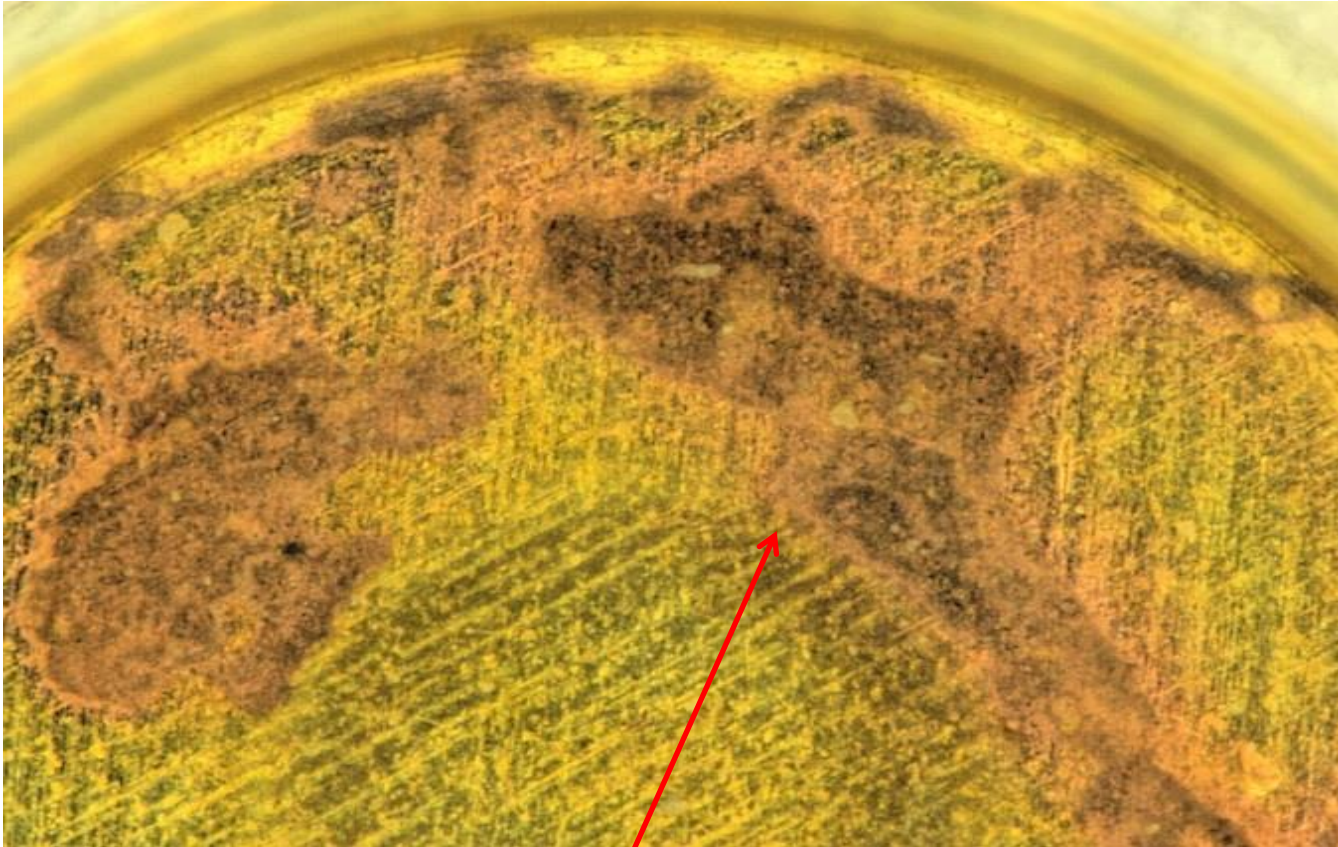
De-Zincification Condition

- First discovered early 2014 during vendor inspection of GFM
- GFM was returned and replaced. ISE visually inspected for confirmation and documentation.
- Suspect GFM was sent to metallurgist for XRD, EDS, Micrographs, etc..
- **Reddish** colored areas indicate de-zincification
 - De-Zincification is selective leaching of zinc
 - Removal of zinc exposes copper in copper-zinc alloy

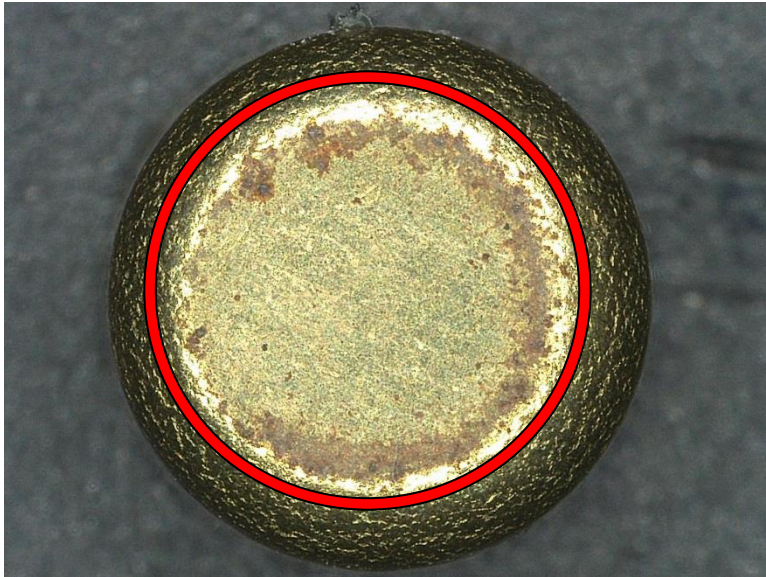
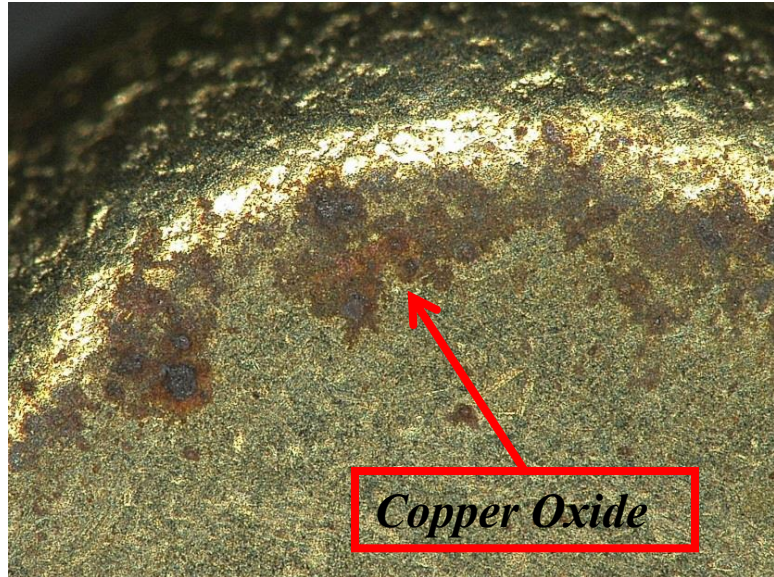
- C26000 series brass cups (70/30) with red colored corrosion product
 - Corrosion product identified at copper oxide.
- Preferential corrosion site (Inside the red circle, high stress area).
 - Chemical / microstructural abnormality may exist in the C26000 series.

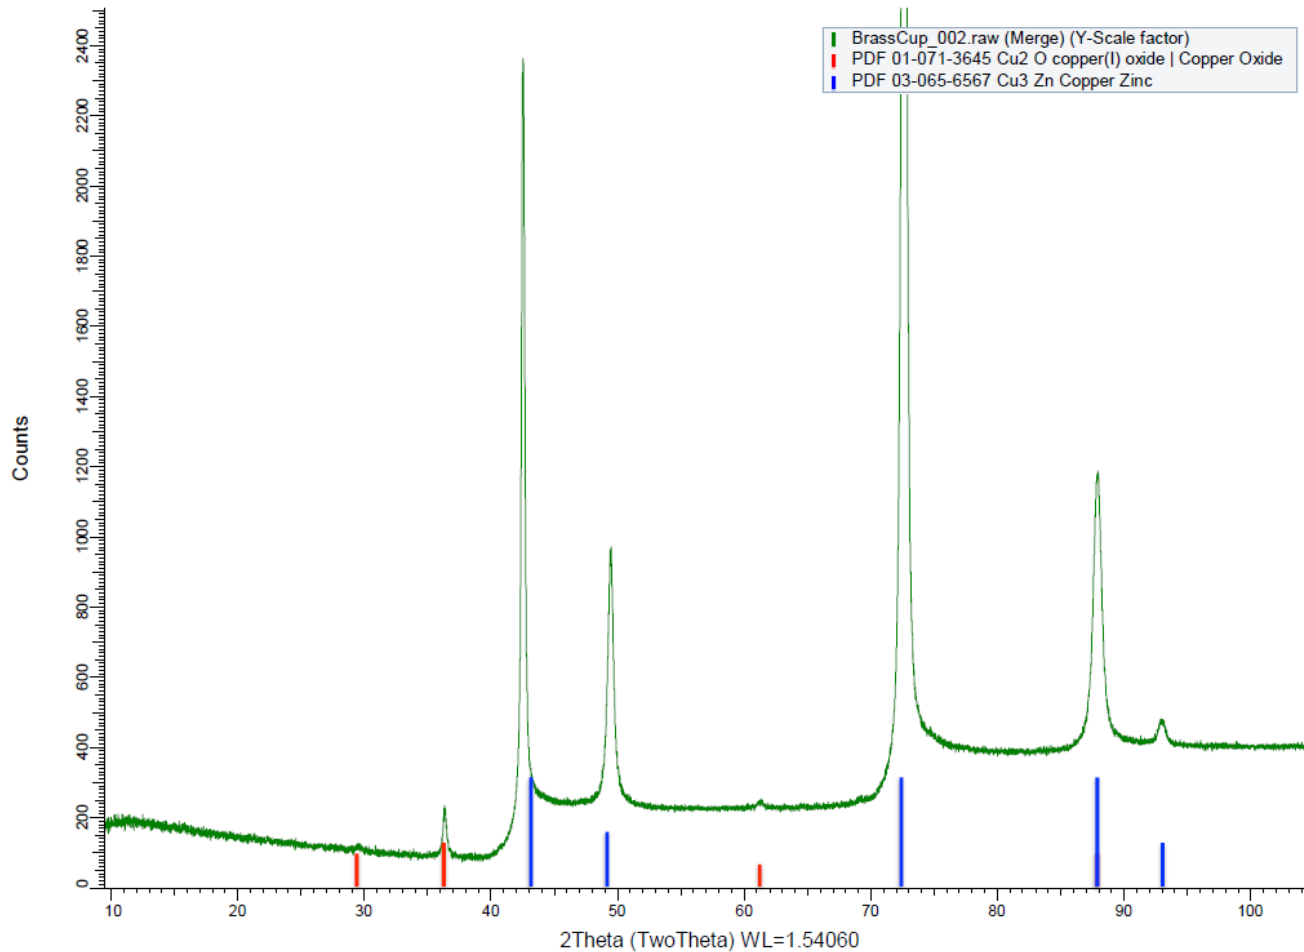
- Copper oxide (CU₂O) shown as primary corrosion product

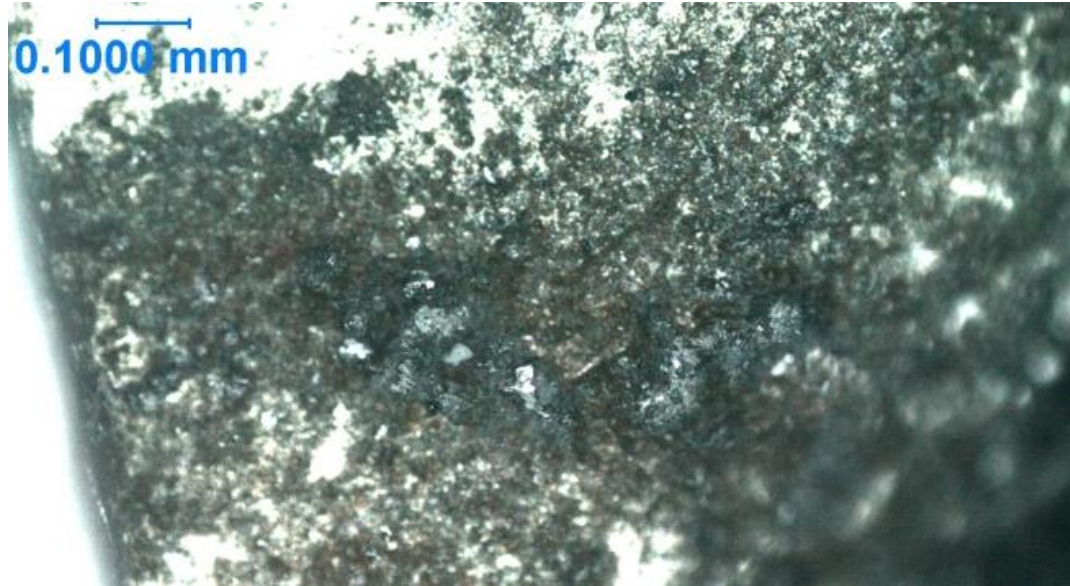
PVU Cup Surface Pitting : Observed “worst case” magazine condition

- Pits have depth. Measured cross-section 0.0004” , respectively
- Slight surface compromise.
- Pitting type corrosion suggest parts have come in contact with acid/chemical or ammonia type atmosphere

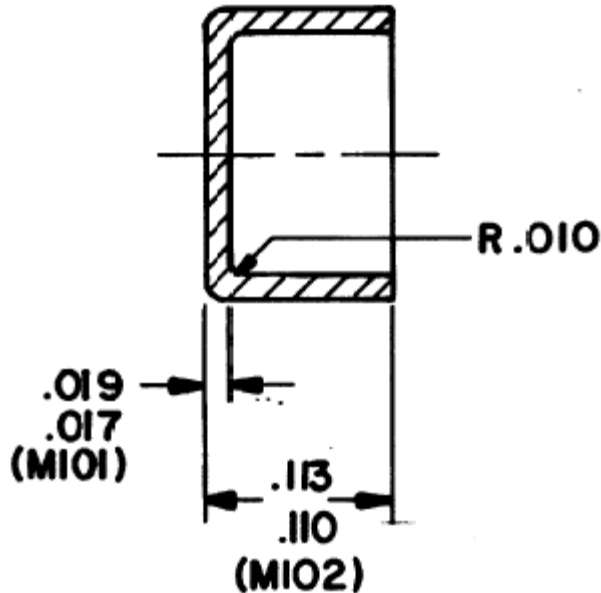
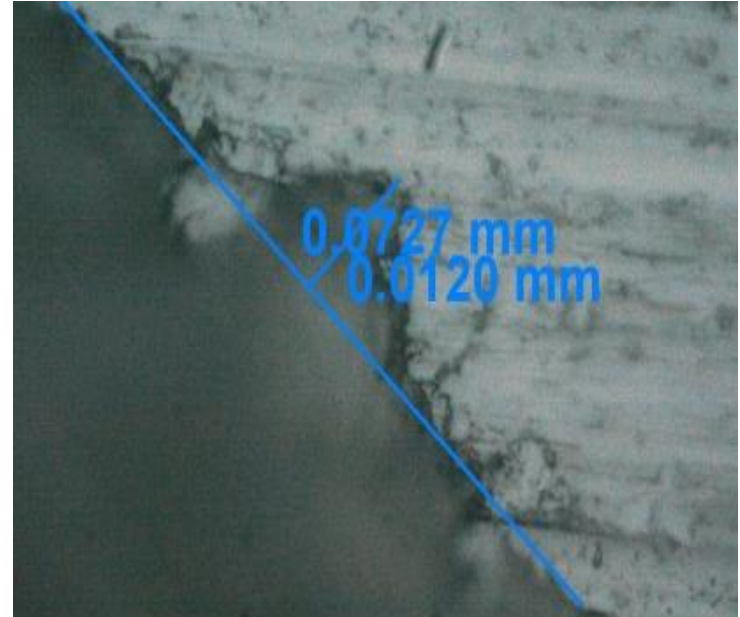
- 2.0% approximate decrease in cup thickness from pitting at the Least Material Condition (LMC)
- Surface Thickness = 0.0166 " (approx.)

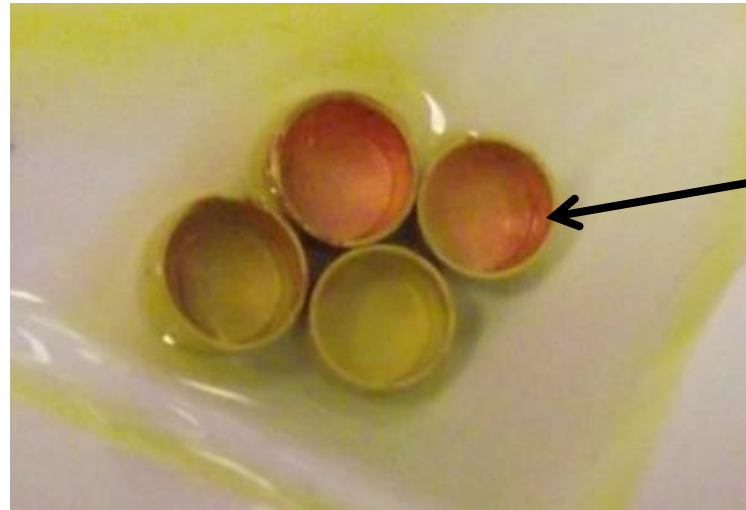
Copper Oxide

Iosso Soak - Concentrate

- Iosso Case Cleaner most corrosive in testing.
- Diluted Sagebrush Tumble Bright had developed green patina.
- Formall 2035 was the least corrosive.
- Brulin Copper Protectant was used as a baseline during the testing.

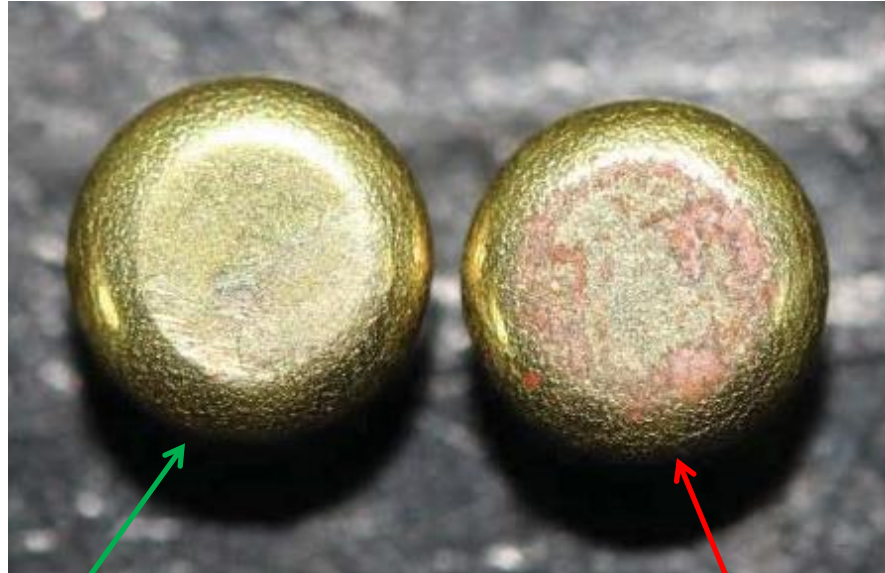
Accept

Reject

- Mitigation Method – Visual Screening
- Discoloration was observed utilizing 1X - 10X Magnification.

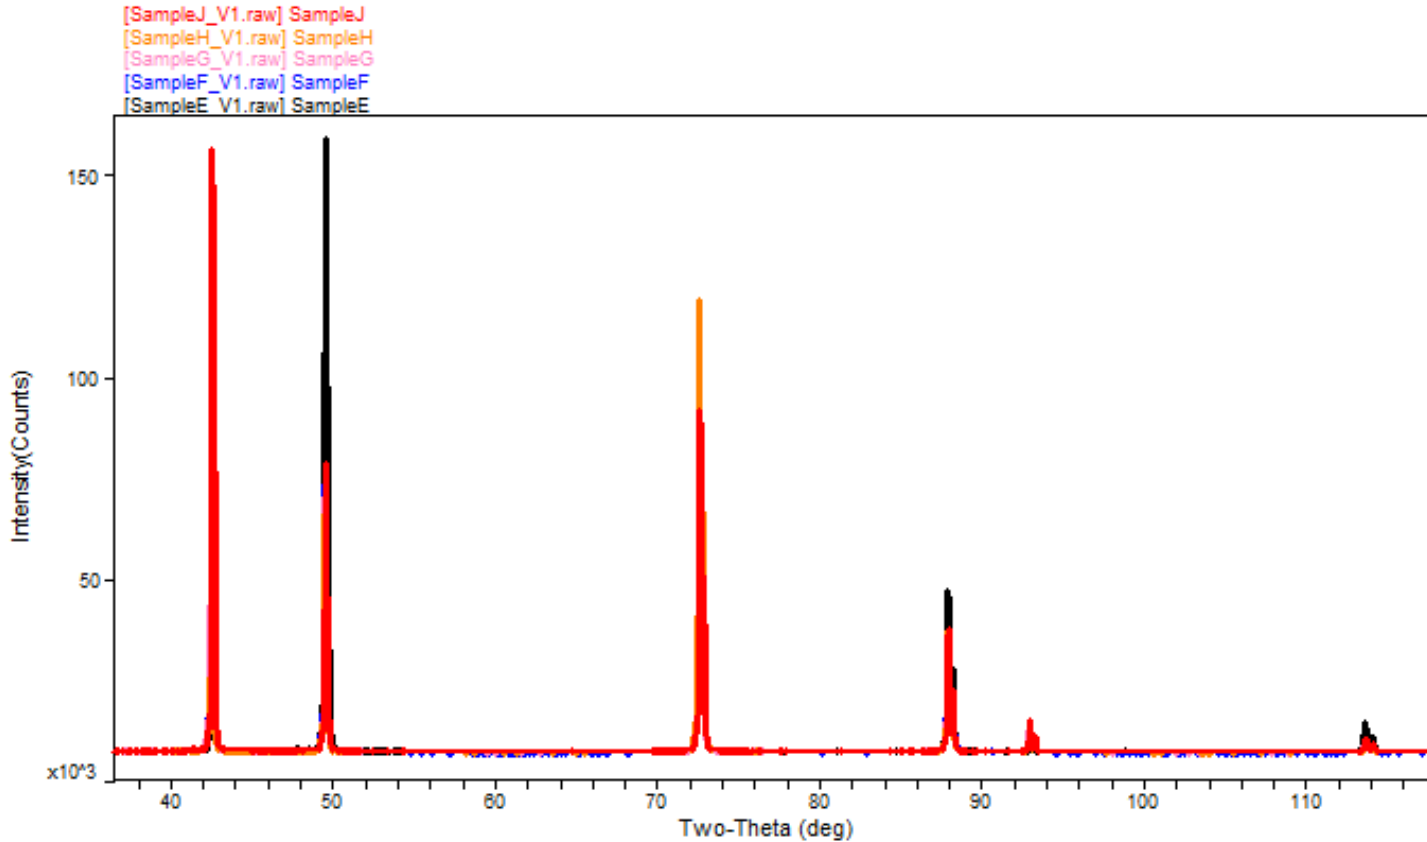
Overlay of raw powder patterns

- XRD Compiled Results (Three Models)
- R_{wp} values under 4.00 generally indicate that the analysis is within a tolerable degree of accuracy.
- E, F, and H Strip Stock is identified to have high beta phase
- E Strip Stock was highlighted due to higher error (R_{wp}). Suggest values wt's may be skewed.
