INSPECTOR GENERAL

SEPTEMBER 30, 2013

DoD Is Not Properly Monitoring the Initiation of Maintenance for Facilities at Kandahar Airfield, Afghanistan

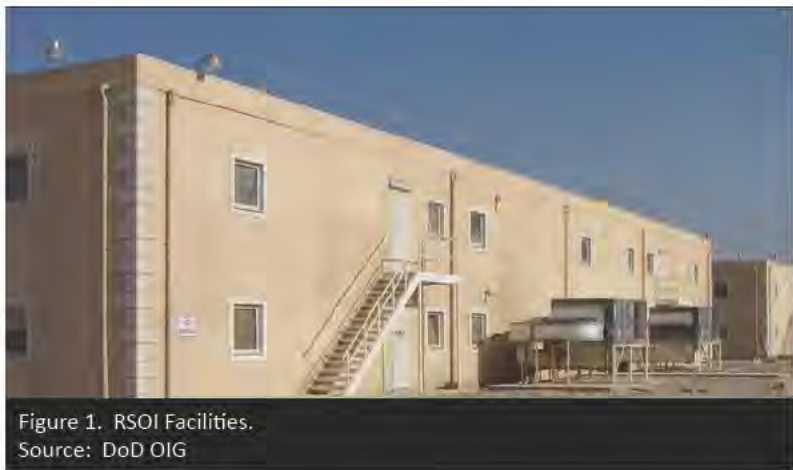
Figure 1. RSOI Facilities.
Source: DoD OIG

~~(FOUO)~~ In 2012, the RSOI facilities, which cost about \$12.1 million to construct, required repairs that cost an estimated \$5.6 million, or 46 percent of the construction cost, before they could be added to the Density List. The RSOI facilities (see Figure 1) had construction deficiencies that required repairs from the LOGCAP contractor and a TF POWER contractor before they could be added to the Density List. Additionally, the fire suppression system and fire detection system did not meet fire code requirements, and both were inoperable, as of January 7, 2013. Although LOGCAP contractor personnel added the RSOI facilities to the Density List in 2012, they did not accept the fire suppression system and fire detection system.

The RSOI facilities...required repairs that cost an estimated \$5.6 million, or 46 percent of the construction cost, before they could be added to the Density List.

⁸ The RSG at KAF was aware that the RSOI facilities' fire detection system and fire suppression system were not operational before the audit was announced. On December 23, 2012, the Command Central occupants were made aware that the fire detection system and the fire suppression system were not operational. The Air Force was aware, before the audit was announced, that the fire suppression system for the facilities at the Yankee and Zulu Ramps were inoperable.

~~(FOUO)~~ USFOR-A should expedite repairs to the fire suppression system at the RSOI facilities. Additionally, USACE-TAD should review the actions of the official(s) that conducted contract oversight and approved the inoperative fire suppression system and fire detection system at the RSOI facilities; and, as appropriate, initiate corrective measures and actions to hold personnel accountable.

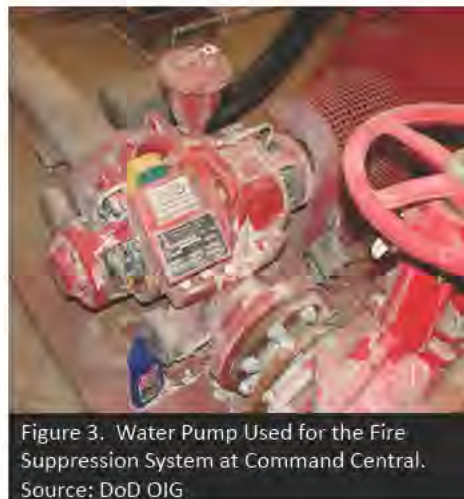
Figure 3. Water Pump Used for the Fire Suppression System at Command Central.
Source: DoD OIG

~~(FOUO)~~ On a December 23, 2012, visit to the Command Central facility to verify the problems reported by the LOGCAP contractor, a DCMA fire subject matter expert found that the fire detection system and fire suppression system were not operational.

Figure 3 shows the poor condition of the water pump used for the fire suppression system at the Command Central facility. Specifically, when the fire alarm was pulled, nothing happened. In addition, the interior doors appeared to have had their locking mechanisms removed, which would prevent the doors from locking unexpectedly upon alarm activation. The tenants did not know that the fire detection system and fire suppression system did not work; therefore, the DCMA official instructed the facility managers to change their standing operating procedures and notify the occupants.

~~(FOUO)~~ On January 16, 2013, the Director, TF POWER, stated that TF POWER planned to repair the fire suppression system and the fire detection system at the Command Central facility. USFOR-A should expedite repairs to the fire suppression system and the fire detection system at the Command Central facility. Additionally, USACE-TAD should review the actions of the official(s) that conducted contract oversight and approved the inoperative fire suppression system and fire detection system at the Command Central facility; and, as appropriate, initiate corrective measures and actions to hold personnel accountable.

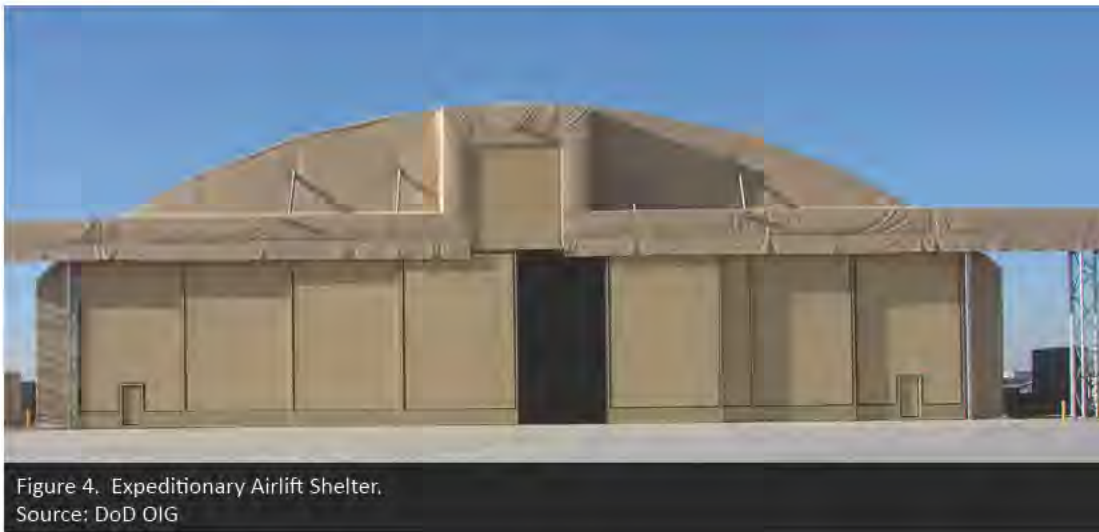
Figure 4. Expeditionary Airlift Shelter.
Source: DoD OIG

The LOGCAP contractor rejected the Expeditionary Airlift Shelter (see Figure 4) from inclusion on the Density List because they identified construction deficiencies in the electrical and HVAC system. The LOGCAP contractor performed two technical inspections on the Expeditionary Airlift Shelter in August and October 2012, which identified electrical deficiencies, such as an unapproved conduit method for primary and secondary transformers, improperly protected grounding electrode conductors, and two grounds terminated under a lug designed for one. HVAC deficiencies included two large units that were not operational, an absent fire damper, and the wall penetration was not rodent proofed. The LOGCAP contractor requested correction to these construction deficiencies before adding the Expeditionary Airlift Shelter to the Density List. As of March 22, 2013, the Air Force was not using the Expeditionary Airlift Shelter because it would not accept the facility until it was added to the Density List.

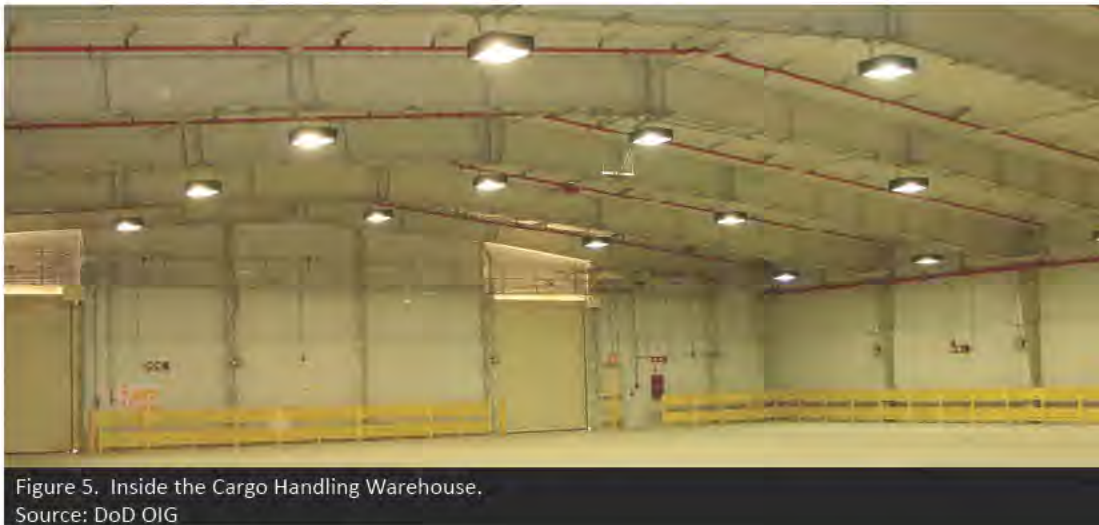
Figure 5. Inside the Cargo Handling Warehouse.
Source: DoD OIG

LOGCAP contractor personnel also rejected the Cargo Handling Warehouse from inclusion on the Density List because they identified construction deficiencies with its electrical and HVAC systems. The LOGCAP contractor performed two technical inspections in September and November 2012 and identified that electrical panels did not have proper working clearances, individual conductors were too small for the cable trays, and the conductors in the cable tray inside the fire pump house needed to be derated. In addition, the LOGCAP contractor identified that the HVAC unit was inoperable and had safety hazards. The LOGCAP contractor requested correction to these construction deficiencies before adding the Cargo Handling Warehouse to the Density List. On January 4, 2013, we conducted a walkthrough of the vacant warehouse before the

facility was accepted by the Air Force (see Figure 5). On February 4, 2013, the Air Force partially accepted the Cargo Handling Warehouse from USACE-TAD because of mission needs. The Air Force uses the warehouse only for temporary storage, according to a 451st ECES official. However, on March 22, 2013, we visited the warehouse and it was empty.

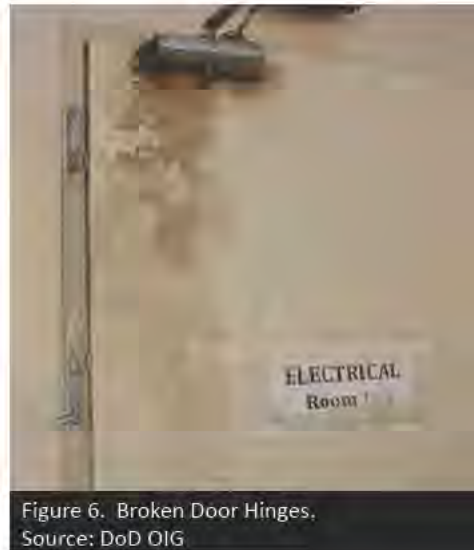
For example, on December 24, 2012, one facility had two doors that were off their hinges. The USACE-TAD construction contractor previously repaired the two doors, but they required additional repairs. In an undated performance evaluation of the construction contractor at 98 percent completion, the USACE resident engineer wrote that the contractor did not immediately correct deficient work after it was identified by USACE personnel.

Later on January 4, 2013, a 451st ECES official stated that facilities were not up to the LOGCAP contractor's standards for placement on the Density List. The doors of one facility we visited were off their hinges (see Figure 6) and its latrines did not work because of a broken water line. On a subsequent walkthrough on January 25, 2013, we identified two other facilities with several doors that had broken hinges. When we performed the walkthroughs, the facilities were about a year old, according to a 451st ECES official.
