### Missouri River Reported Channel Problem Areas

7 Problem Areas Reported

#### Areas of Concern

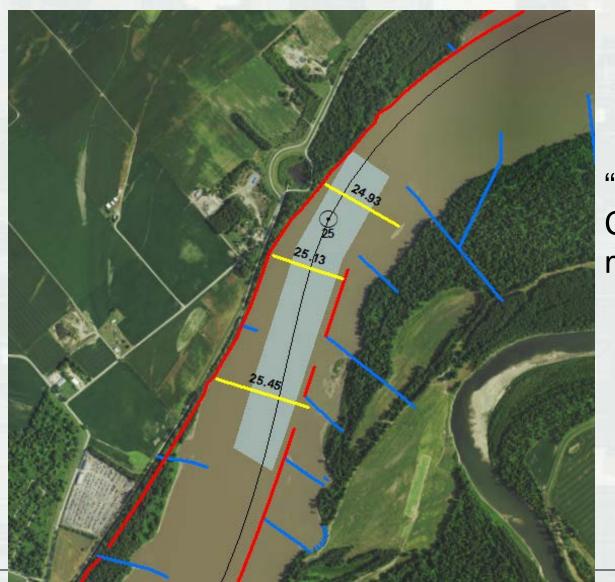
#### Area of Concern RM 25.5

"Brian Island. Crossing is the main Problem"

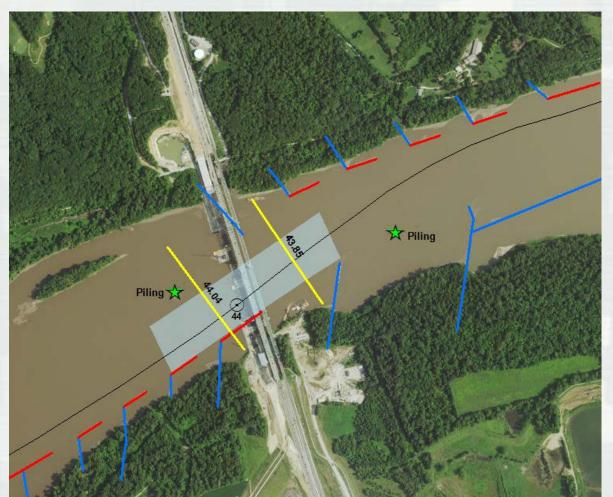
"Piling in river near Bridge. Right Side is Marked as Channel. Right descending bank shoals. 10' St. Charles gage will be problem. Wing dike notched DS of bridge"

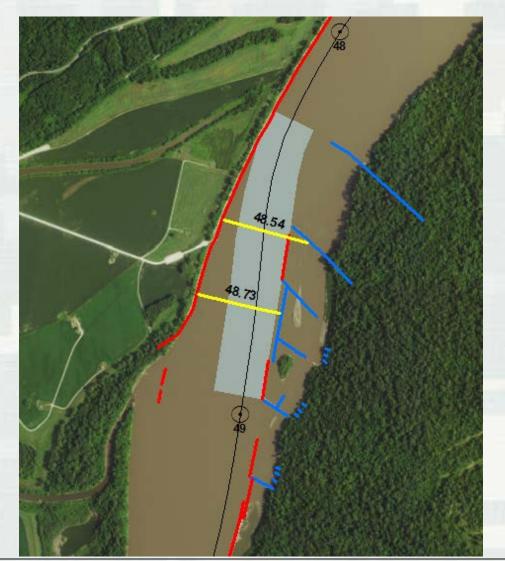
#### Area of Concern RM 48.5

"Shallower than in past. Flushed out currently. When the river drops from high to low, the crossing fills in"

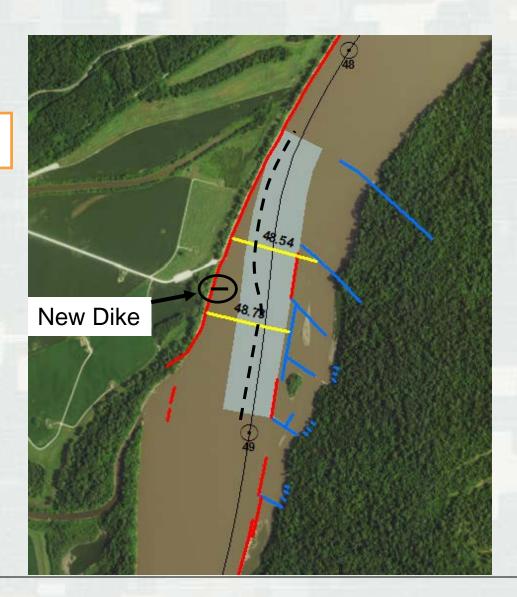
#### Area of Concern RM 48.5

All structures within 2' of design criteria.

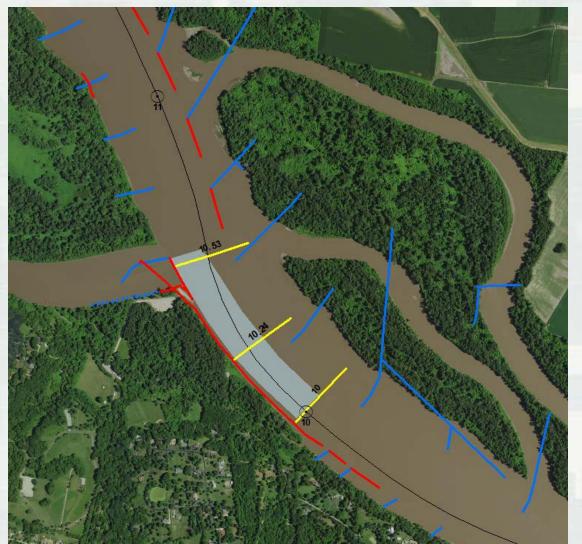
#### Area of Concern RM 10-10.5

"Historic problem area, close to chute exit. Check new dike at bridge and sills in area"

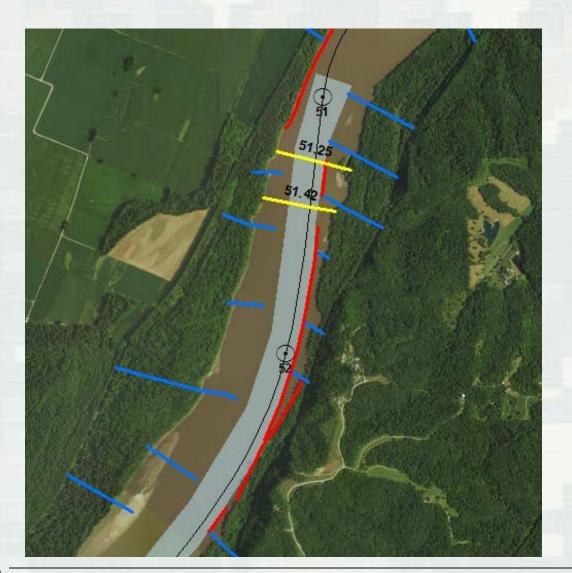
#### Area of Concern RM 51 - 53

"Crossing unstable."

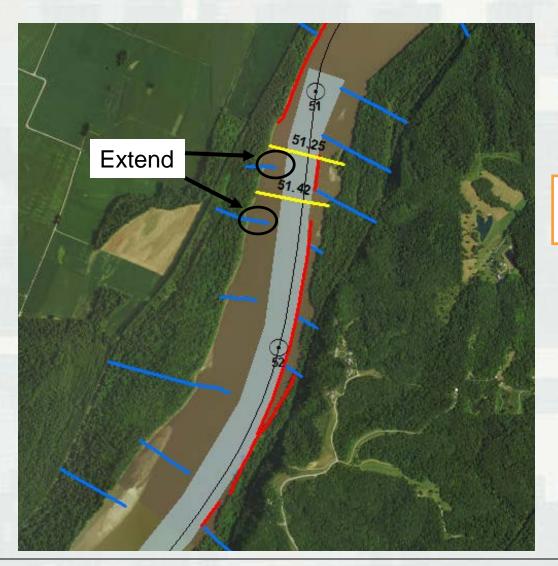
#### Area of Concern RM 51 - 53

All structures within 2' of design criteria.
