Little Goose Lock & Dam

FY17 Downstream Miter Gate Repair

Columbia-Snake River Navigation System

Spring Stakeholder Meeting

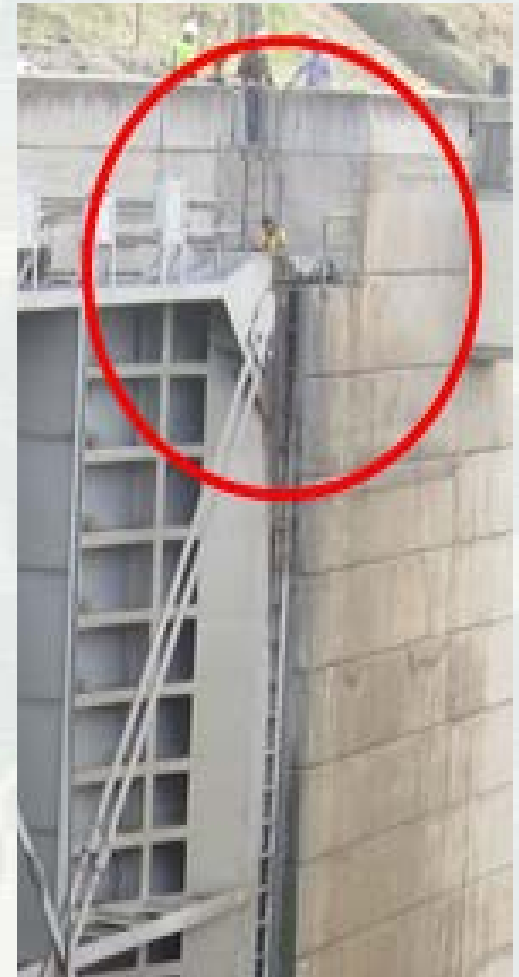
- During the 2014 lock outage, it was discovered that one of the gudgeon linkage eyebars had a significant crack and failure was imminent
- Navlock taken out of service due to concerns of possible catastrophic failure.
- At the time, new gudgeon linkages had already been planned for and were in the process of fabrication
- An emergency repair contract was performed to replace the failed linkage
