McNary Downstream Miter Gate Interim Repairs

May 27, 2015
Columbia-Snake River Navigation System
Spring Stakeholder Meeting

- Two-Leaf arched miter gate
- Gate put in service in 1954
- 106 feet tall x 86 feet wide
- Cracks monitored for past several years
- New critical cracks discovered and repaired in March 2014
- Follow-up inspections performed in September 2014 to confirm structural issues that required repair in March 2015 Outage

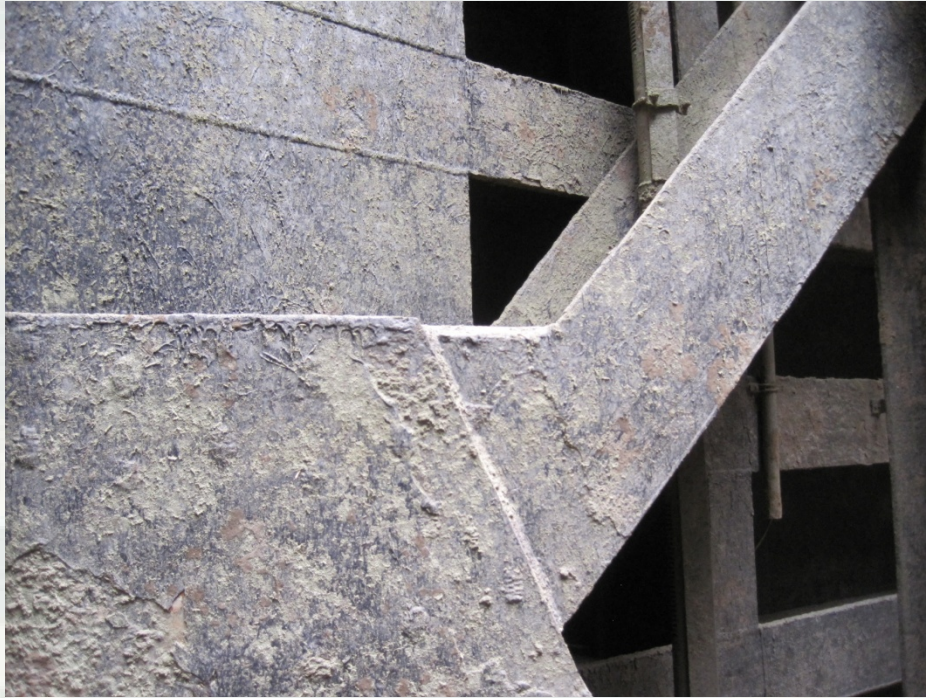
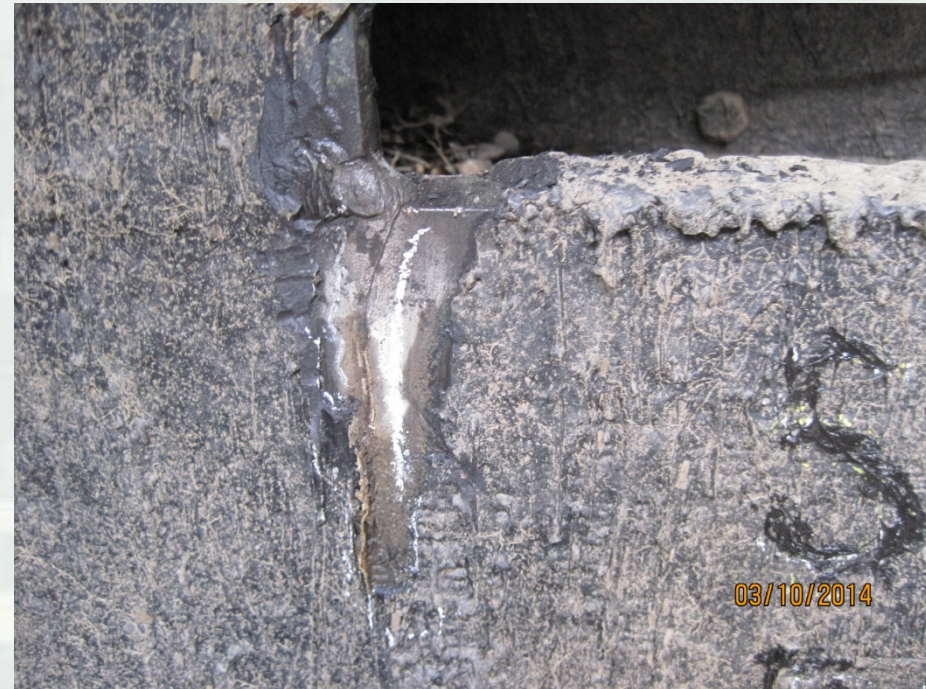
Coal tar coating on submerged areas of the gate structure

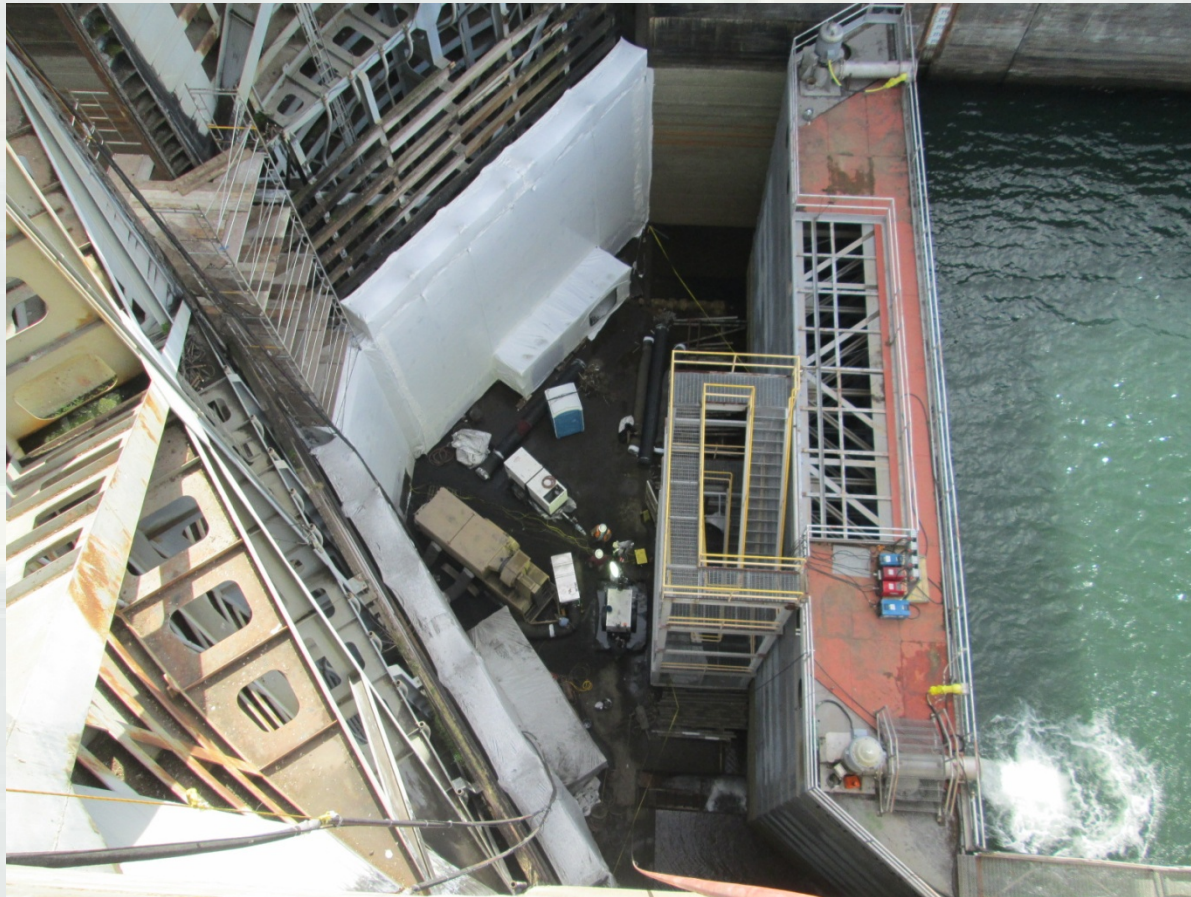
Coal Tar Removal Operations

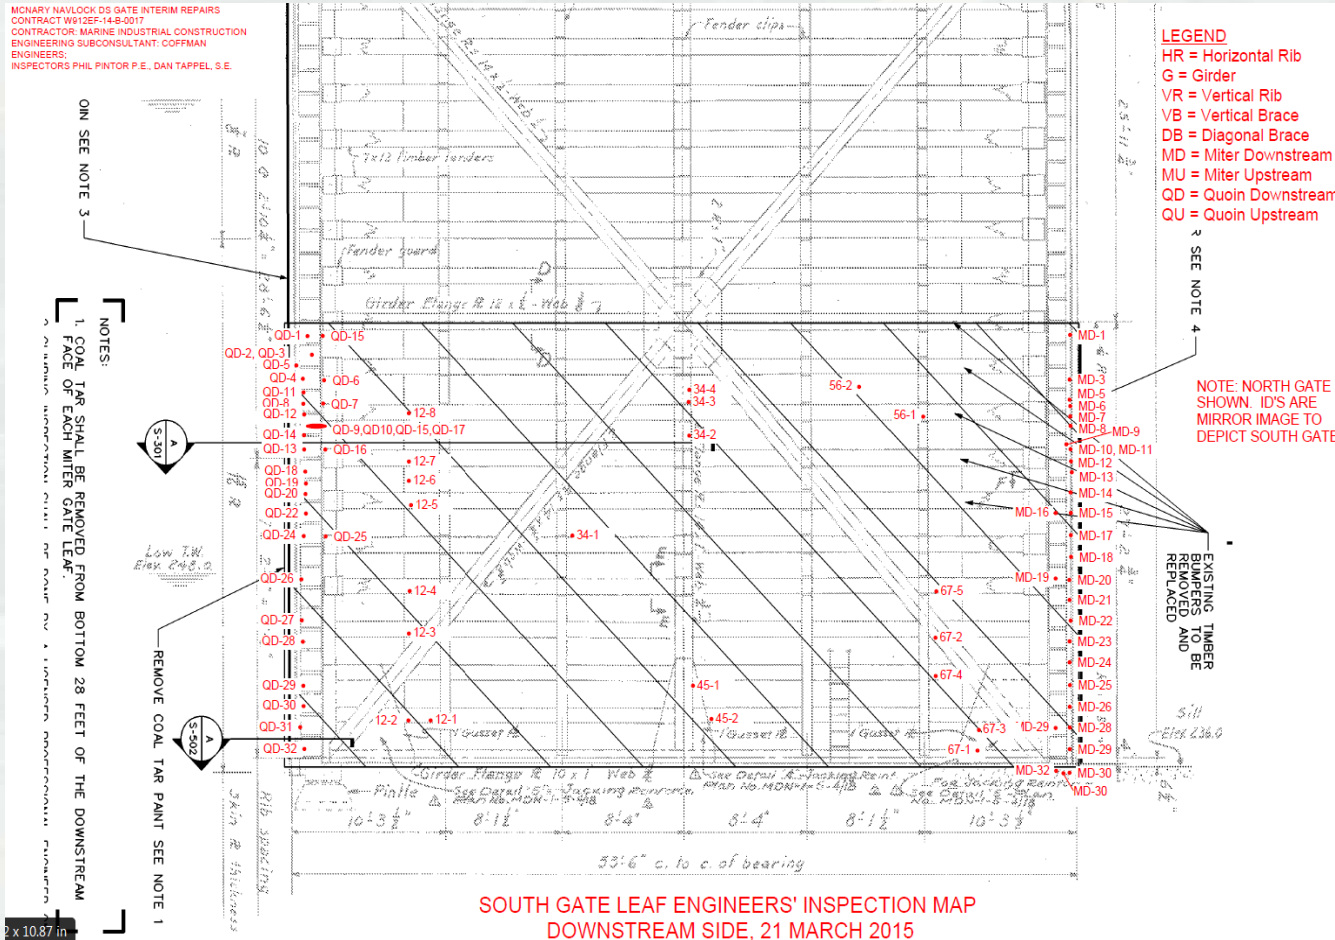
Identified Areas of Structural Concern

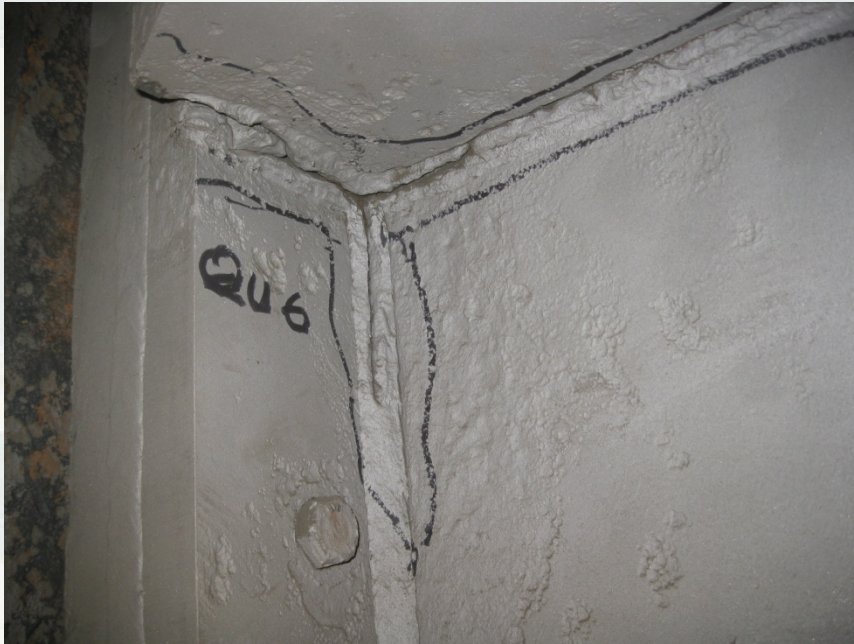
Cracks at Upstream Quoin Block

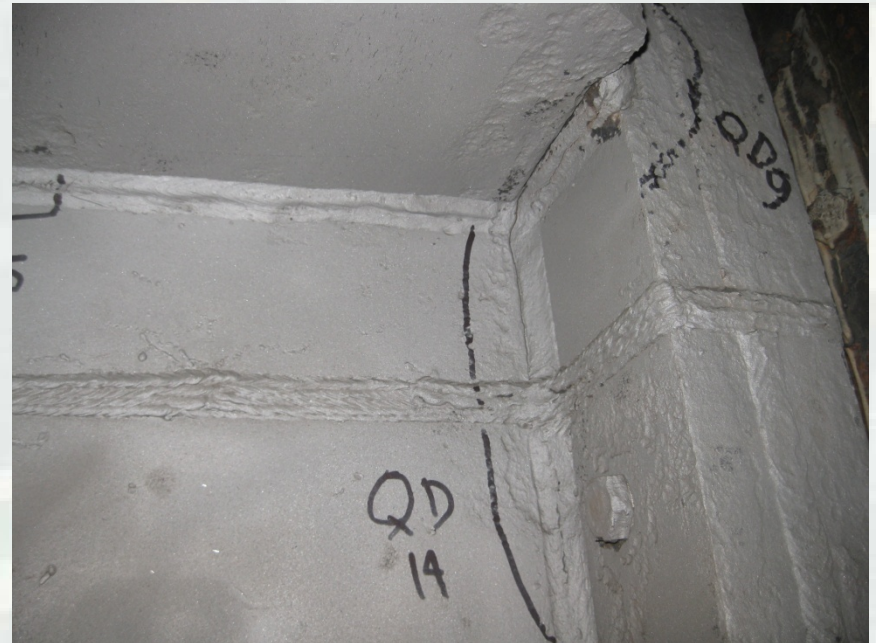
Cracks at Downstream Quoin Block
