**Hurricane Alicia
Galveston and Houston, Texas
August 17-18, 1983**

**Committee on Natural Disasters
Commission on Engineering and Technical Systems
National Research Council**

NATIONAL ACADEMY PRESS
Washington, D.C. 1984

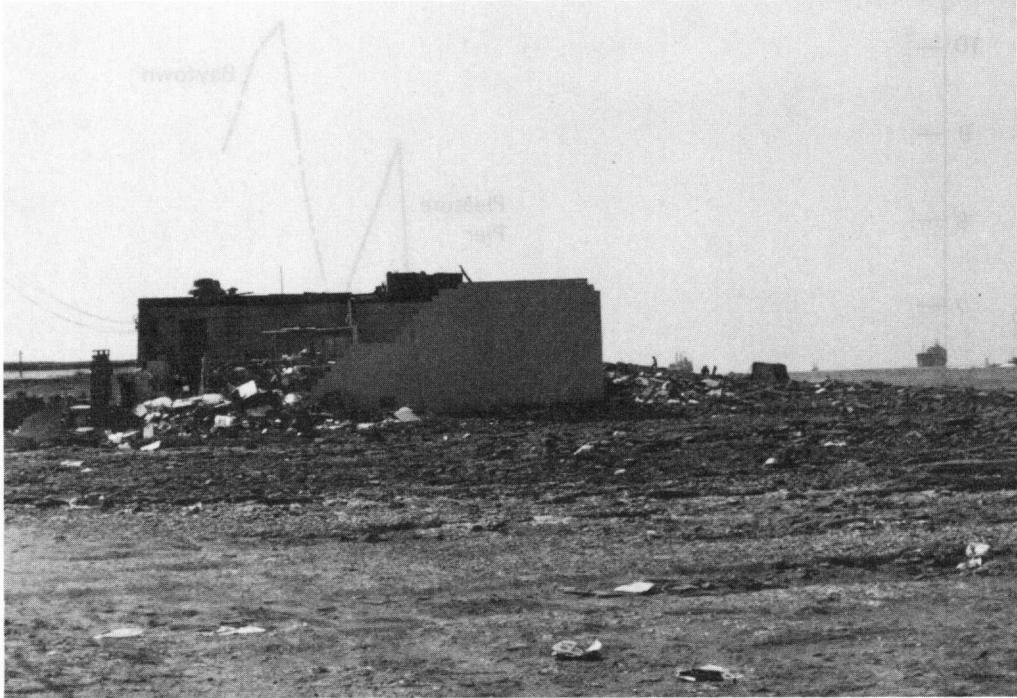
FIGURE 3.4 Scour and building damage near the intersection of the Galveston seawall and the west jetty of Galveston Inlet.

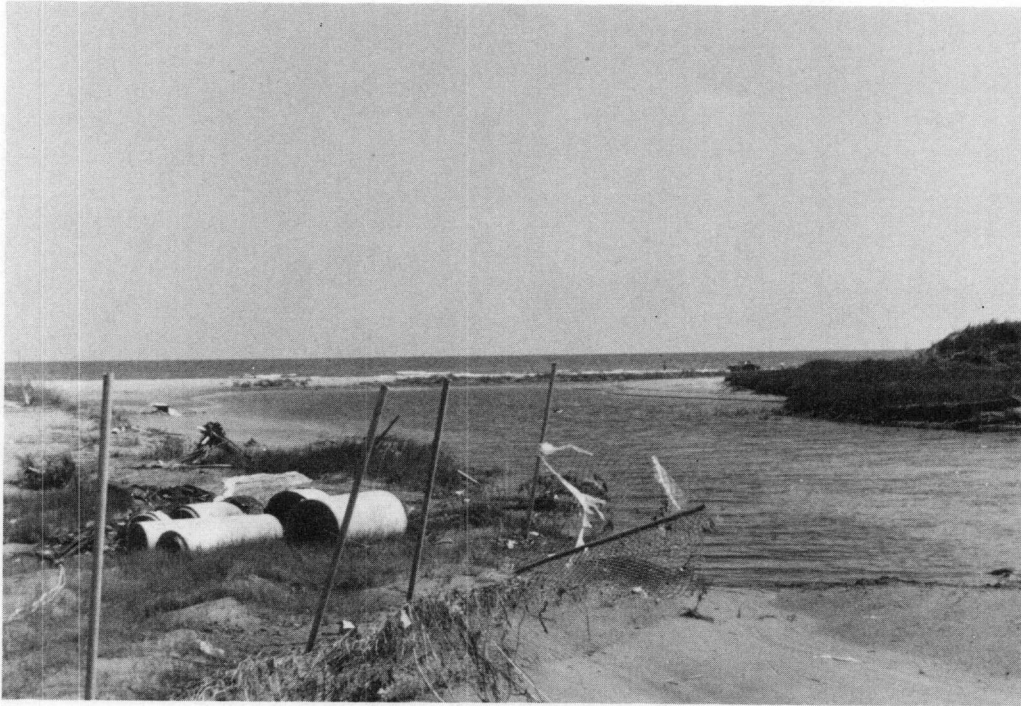
FIGURE 3.6 Landward end of the scour channel shown in Figure 3.5.

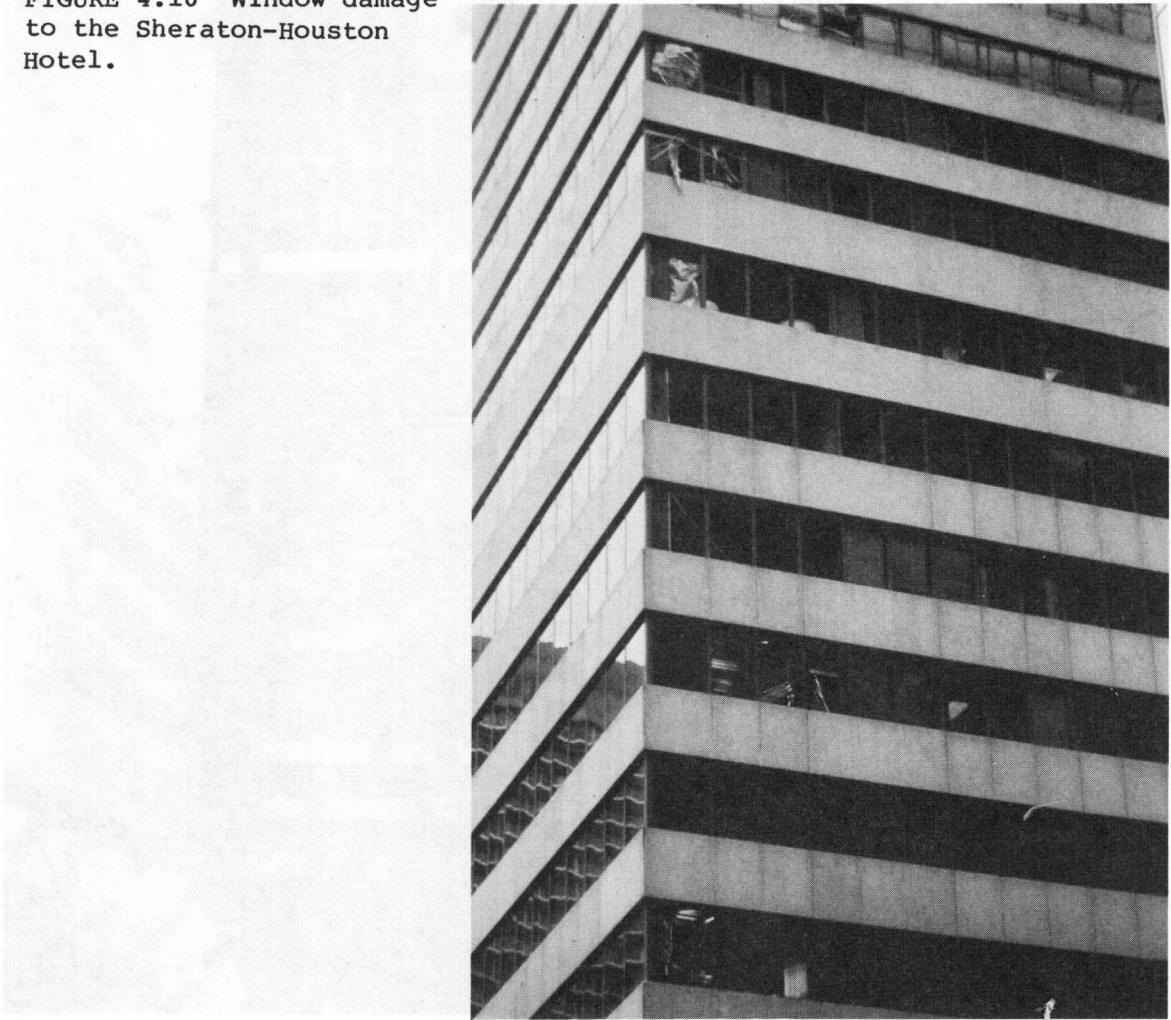
Figure 4.10 shows the nature of glass damage to the Sheraton-Houston Hotel. The damage was more significant on the northeast face of the building.

FIGURE 4.10 Window damage to the Sheraton-Houston Hotel.

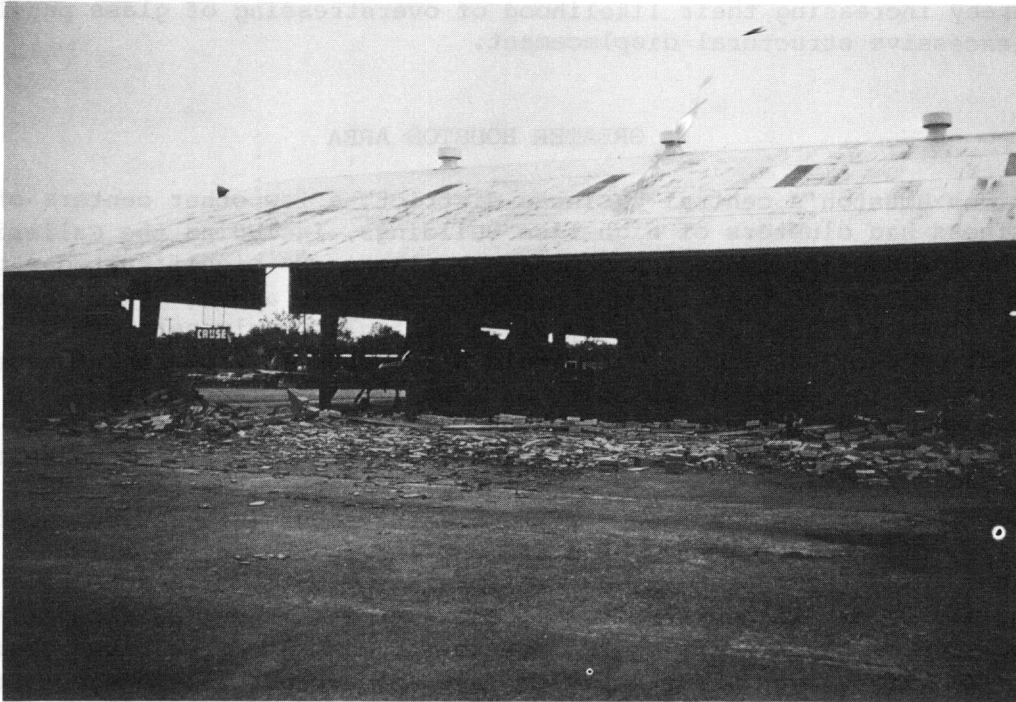
FIGURE 4.13 Collapsed brick wall of airport hangar at Hobby Airport.

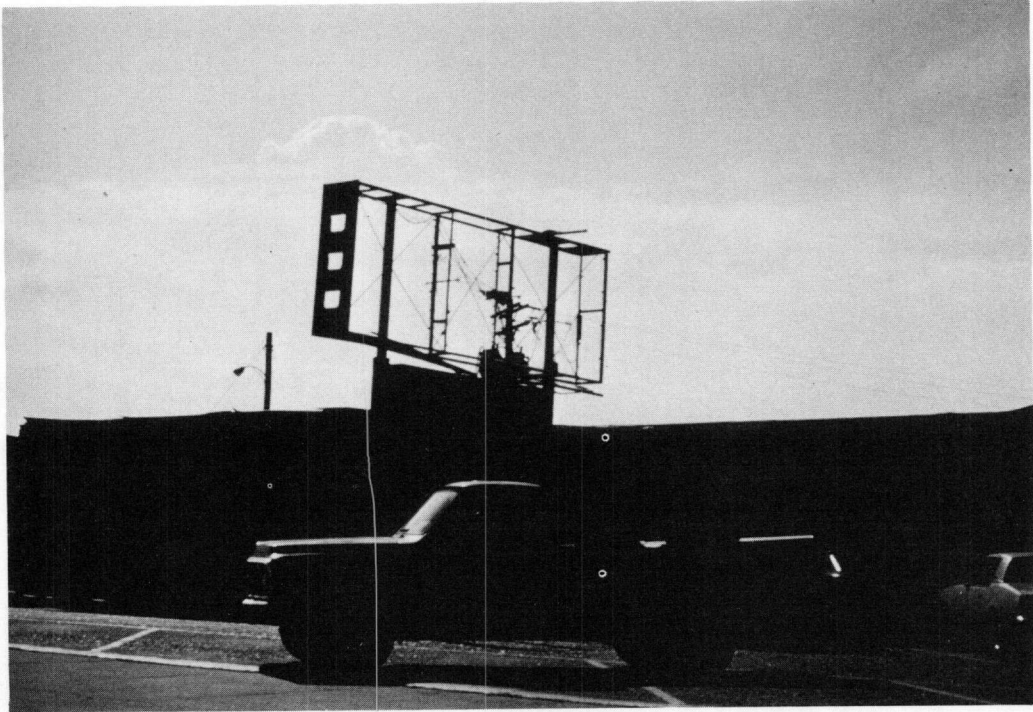
FIGURE 4.14 Damaged billboard.

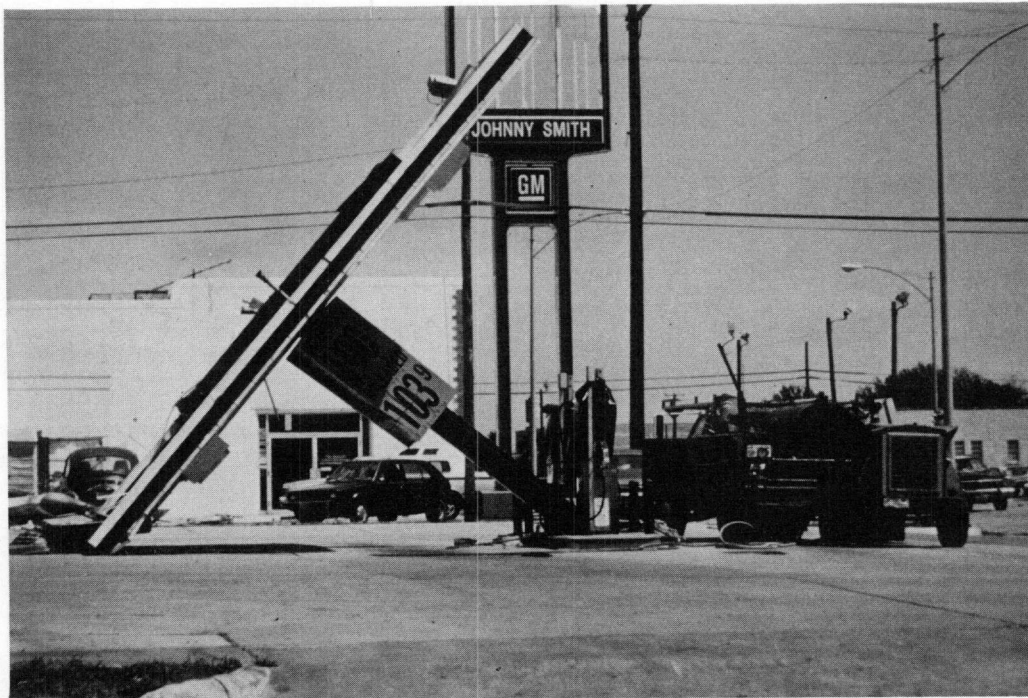
FIGURE 4.15 Example of failure of a roof support pedestal column.

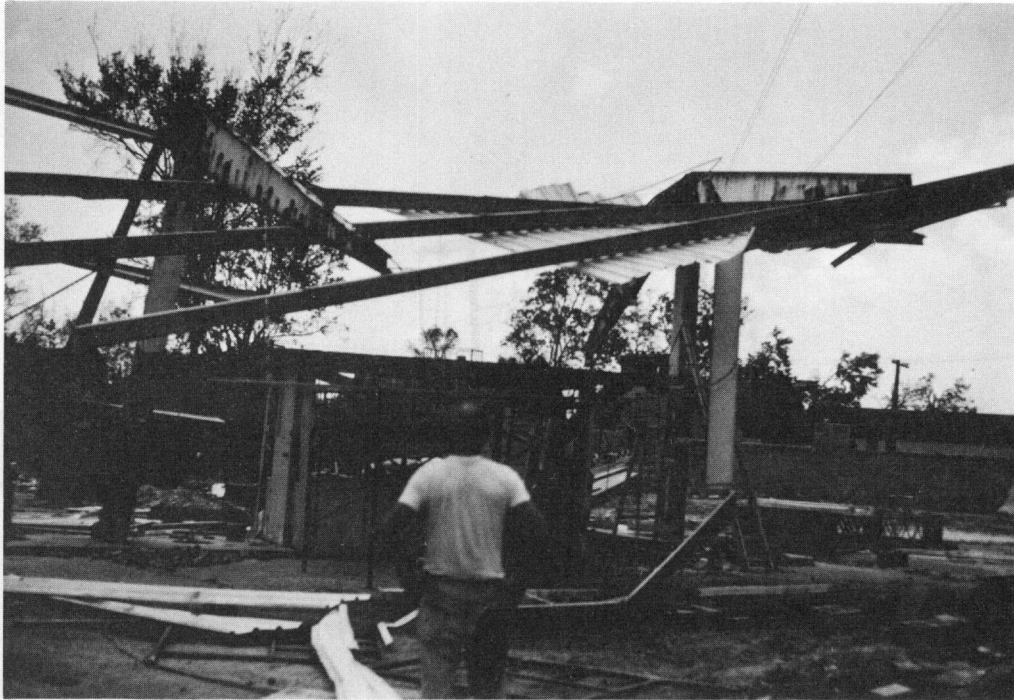
FIGURE 4.16 Failure of sheet metal roof at a gas station.

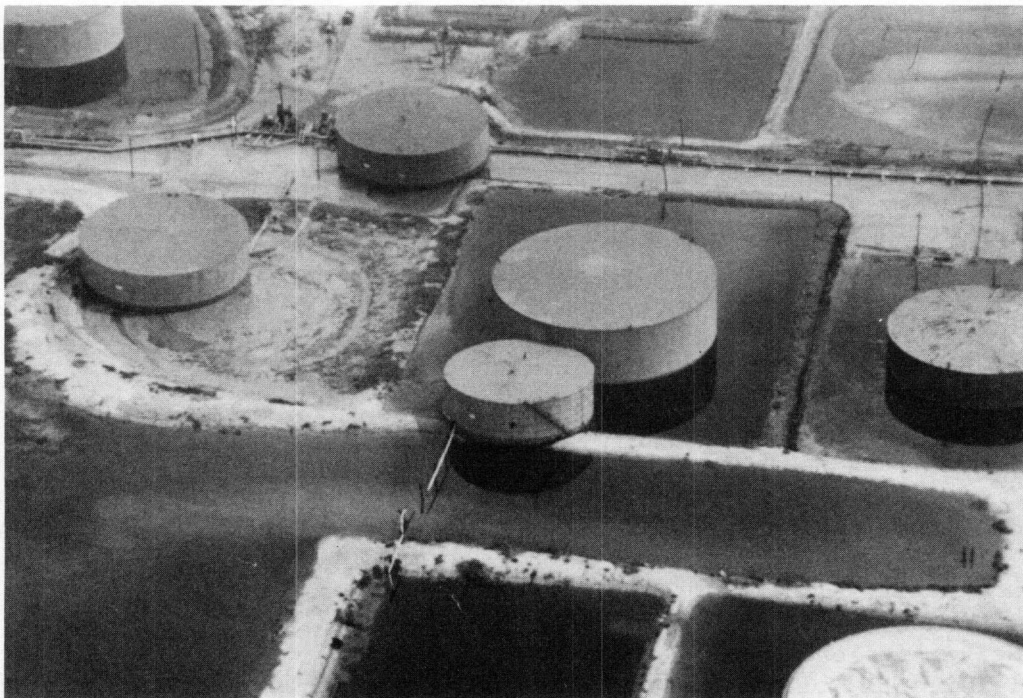
FIGURE 4.18 Displaced oil storage tanks.

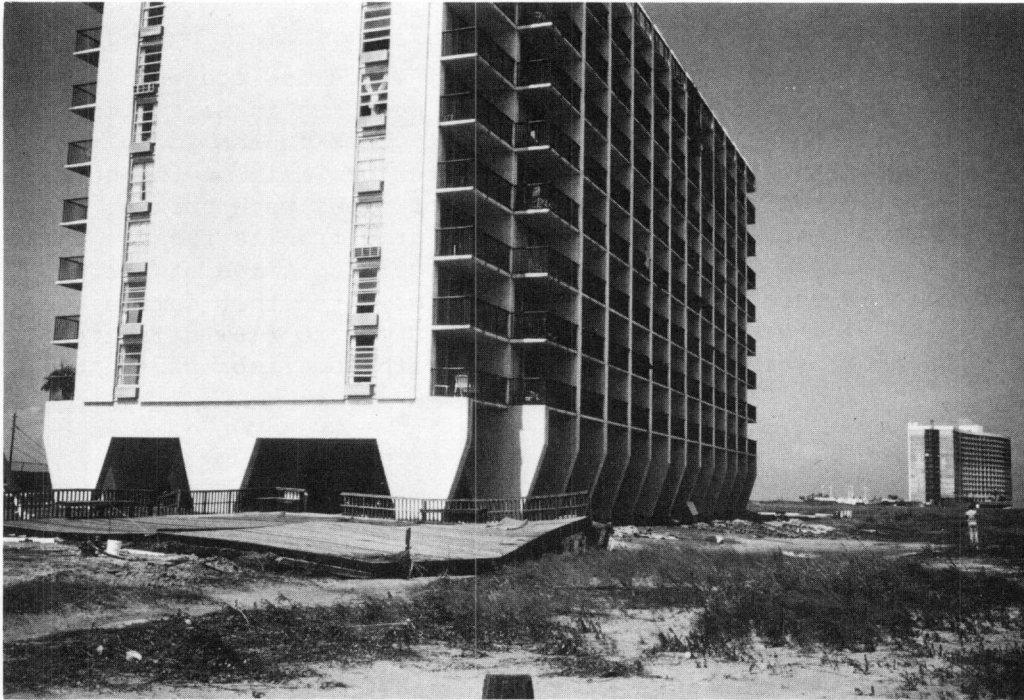
The Galvestonian is a very large high-rise condominium, crescent-shaped in plan, under construction next to the Islanders Inn on East Beach (Figure 4.19). It bore the brunt of winds, waves, and flooding directly from the Gulf. The facade of the building experienced minor damage, and extensive erosion occurred around its foundation. However, the structural integrity of the foundation was not affected (Figure 4.20). The reinforced concrete structural system performed satisfactorily.

FIGURE 4.19 General erosion and damaged deck around Islanders Inn and the Galvestonian (in the background).

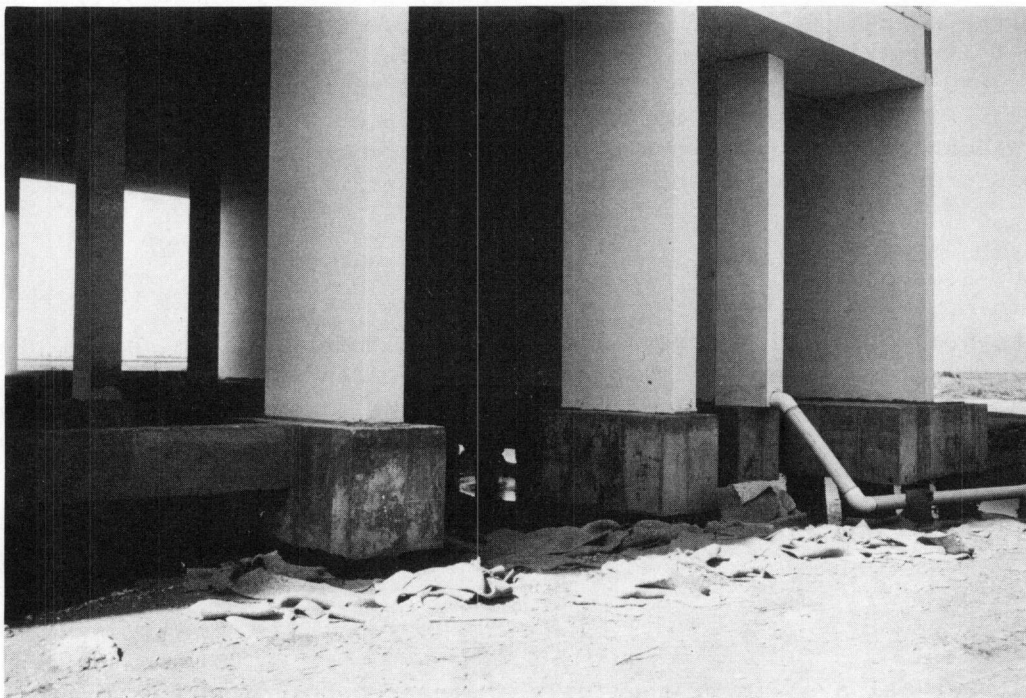
FIGURE 4.20 Erosion around the foundation of the Galvestonian.

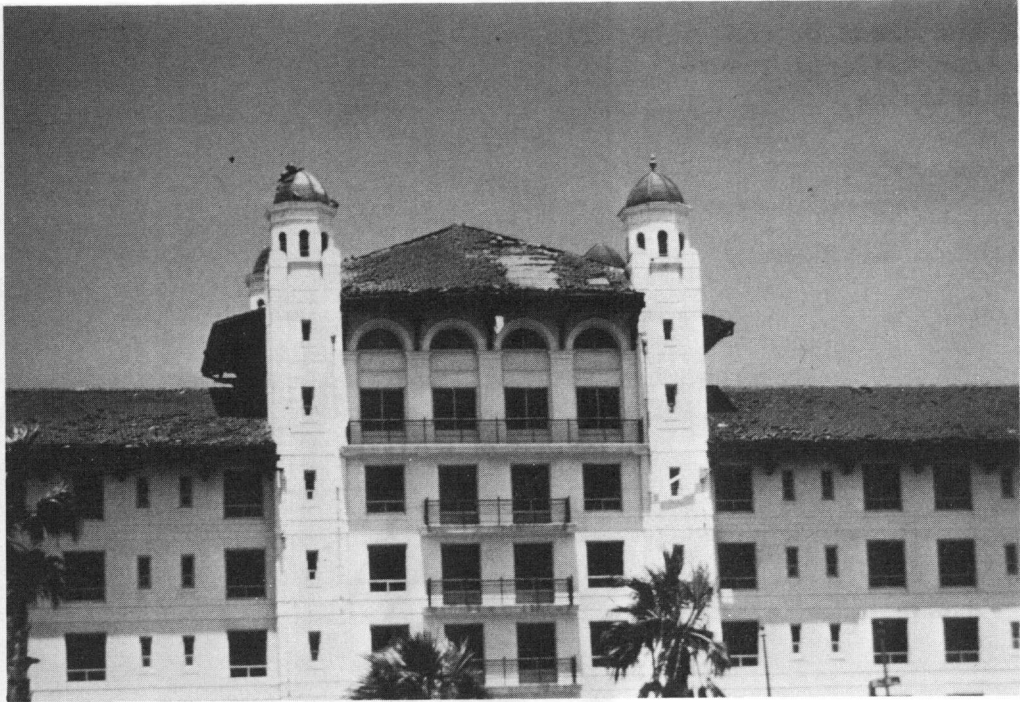
FIGURE 4.22 Damage to tiled roof of the Hotel Galvez.

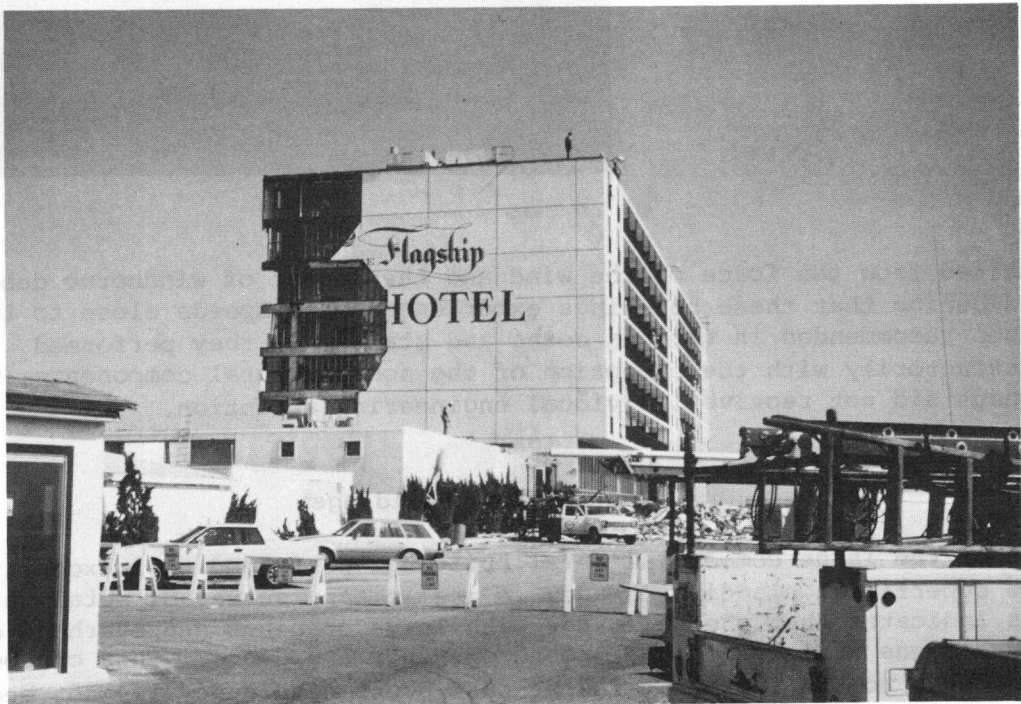
FIGURE 4.23 Damage to the facade of the Flagship Hotel.

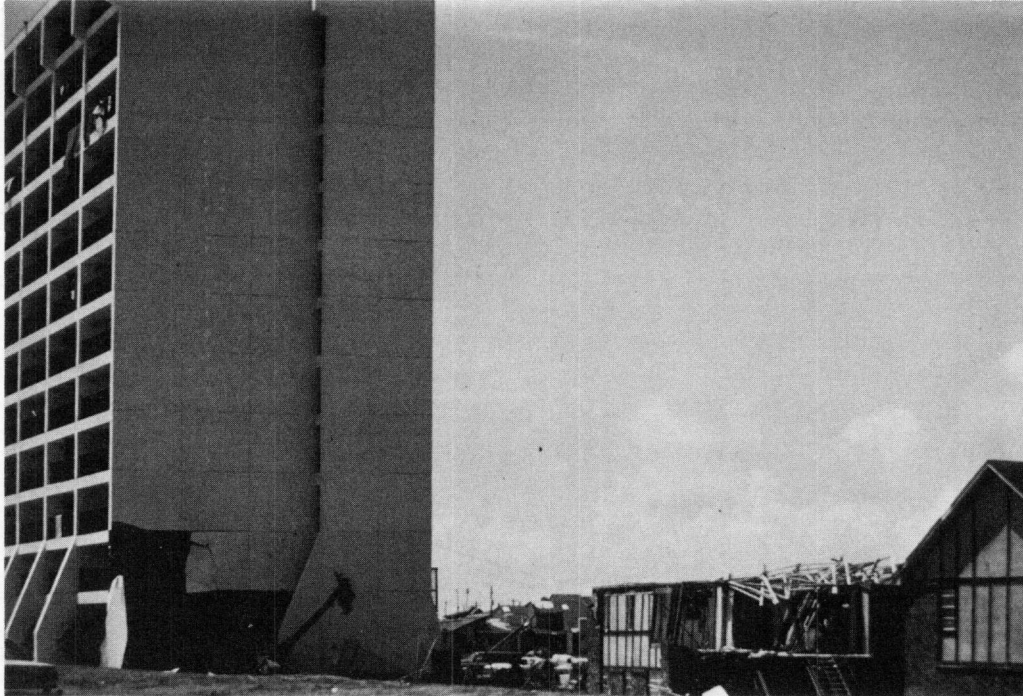
FIGURE 4.24 General view of damage to condominiums on the seawall.

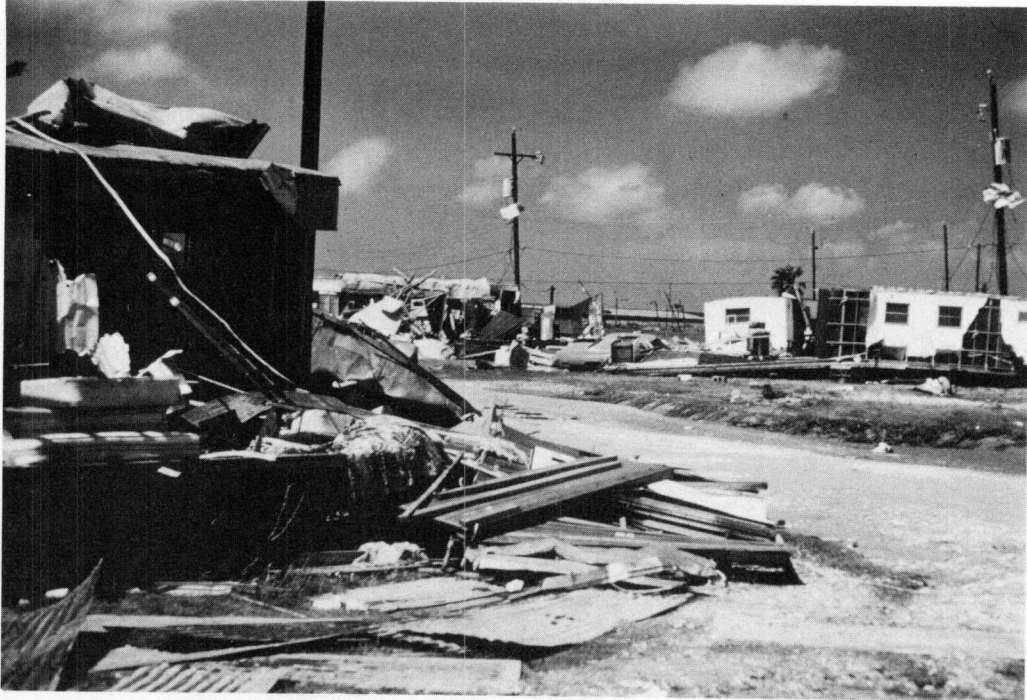
FIGURE 4.26 Damaged mobile home park on East Beach.

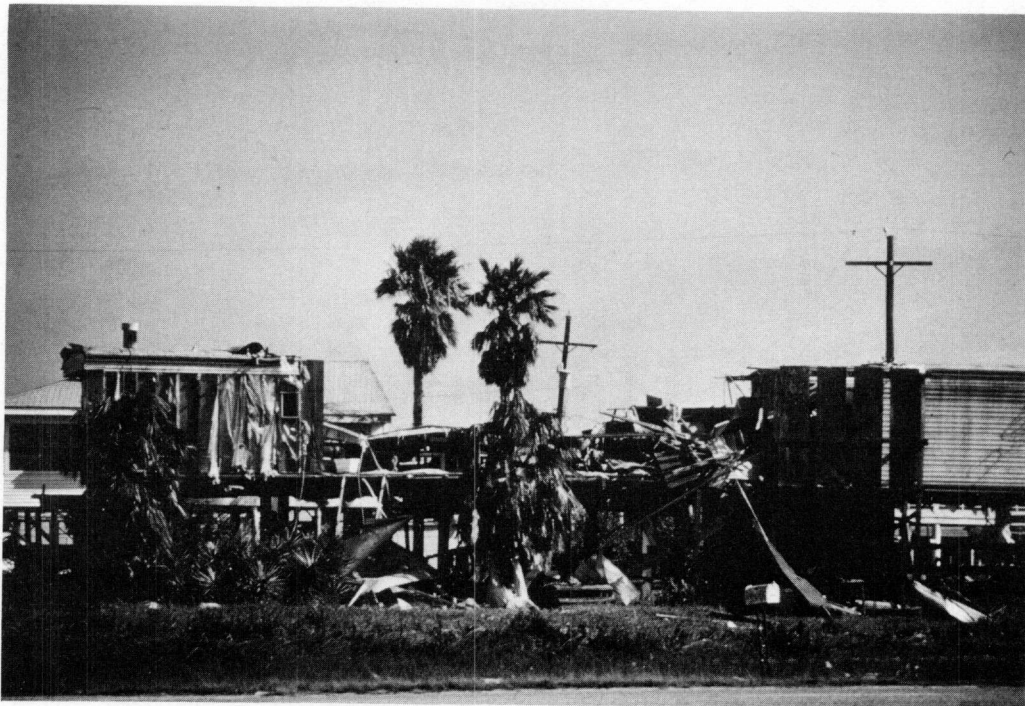
FIGURE 4.27 Damage to an elevated mobile home on West Beach.

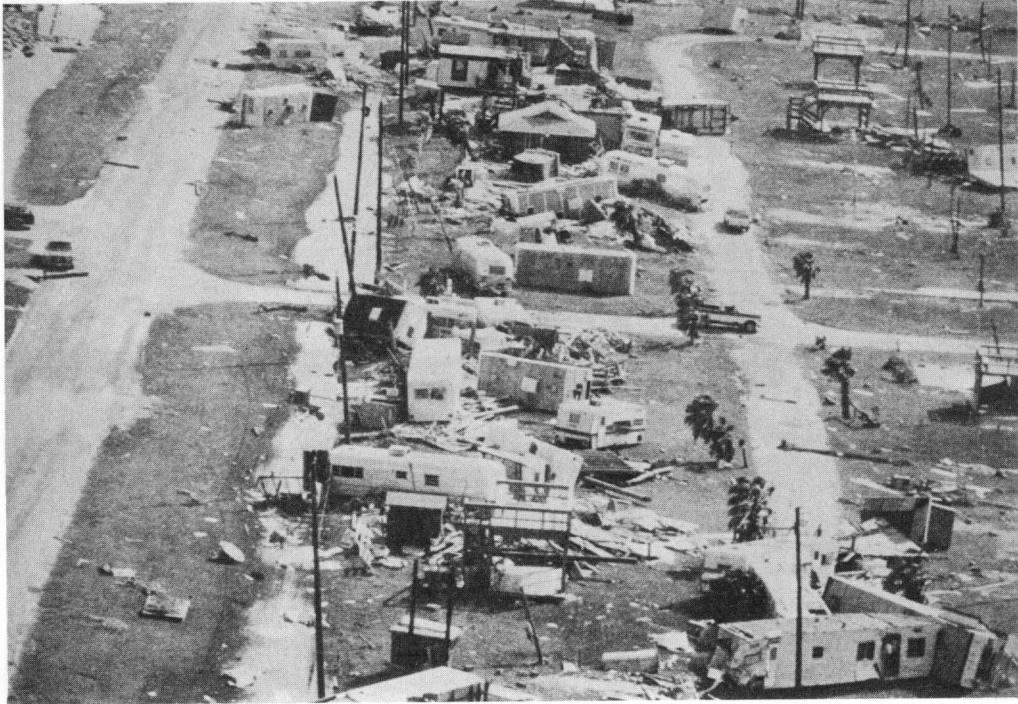
FIGURE 4.28 Damaged mobile home park on West Beach.

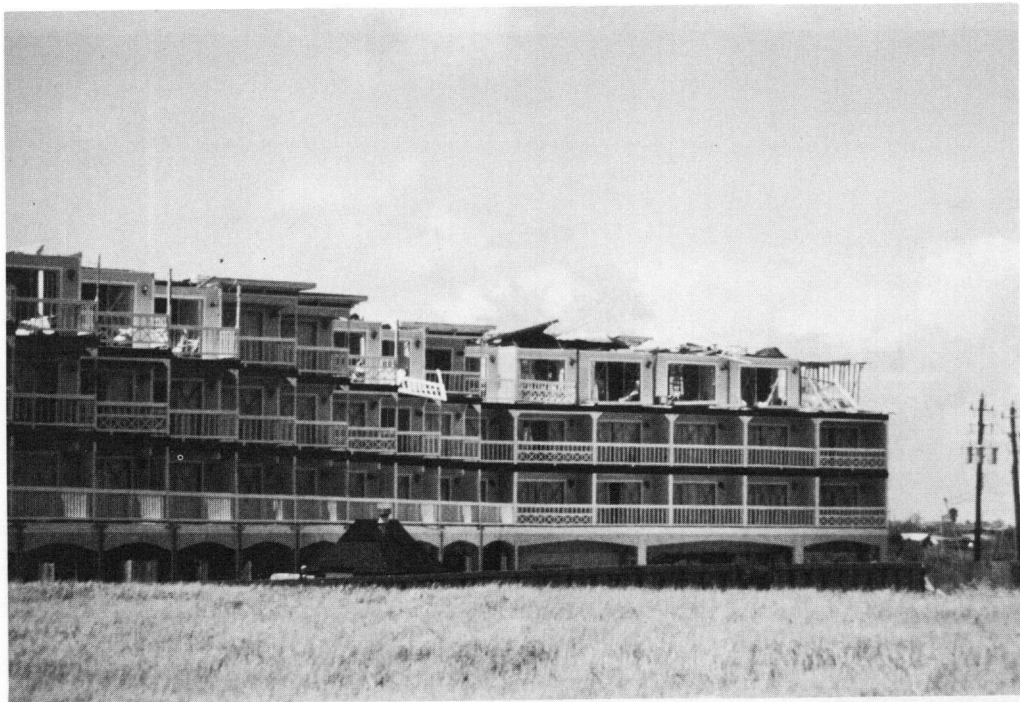
The building was extensively damaged on its eastern side (Figure 4.29). The open land between the Victoria Hotel and an adjoining complex provides conditions suitable for the wind to accelerate.

FIGURE 4.29 General view of the damaged wing of the Victoria Hotel.

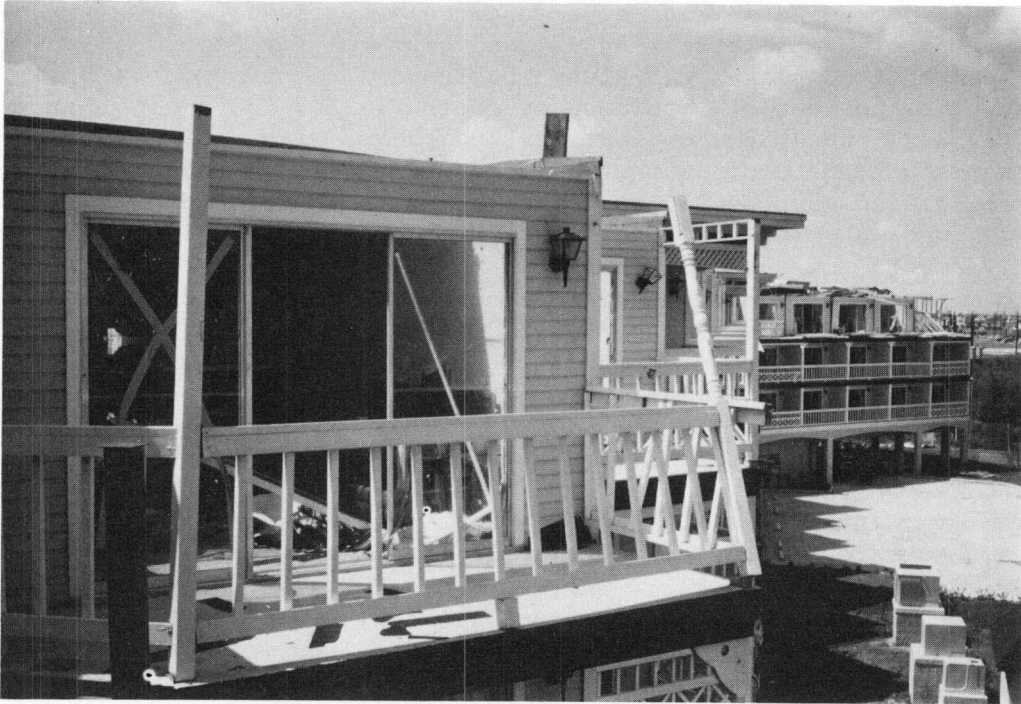
FIGURE 4.30 Closeup of a damaged unit in the Victoria Hotel.

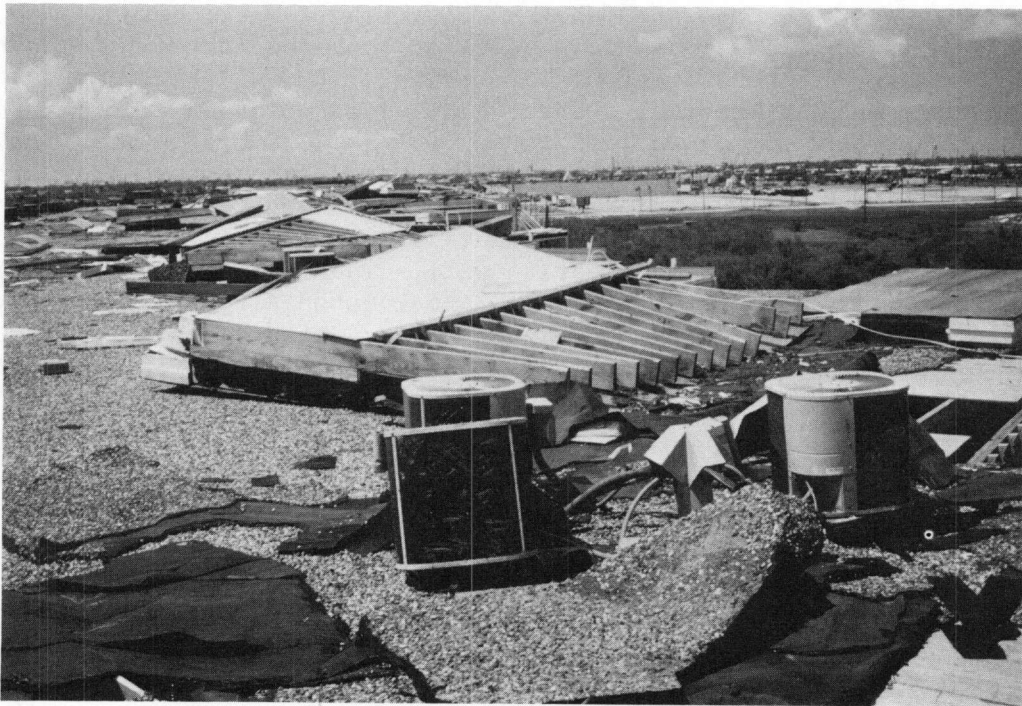
FIGURE 4.31 General view of the roof of the Victoria Hotel, showing damaged overhangs that landed on the roof.

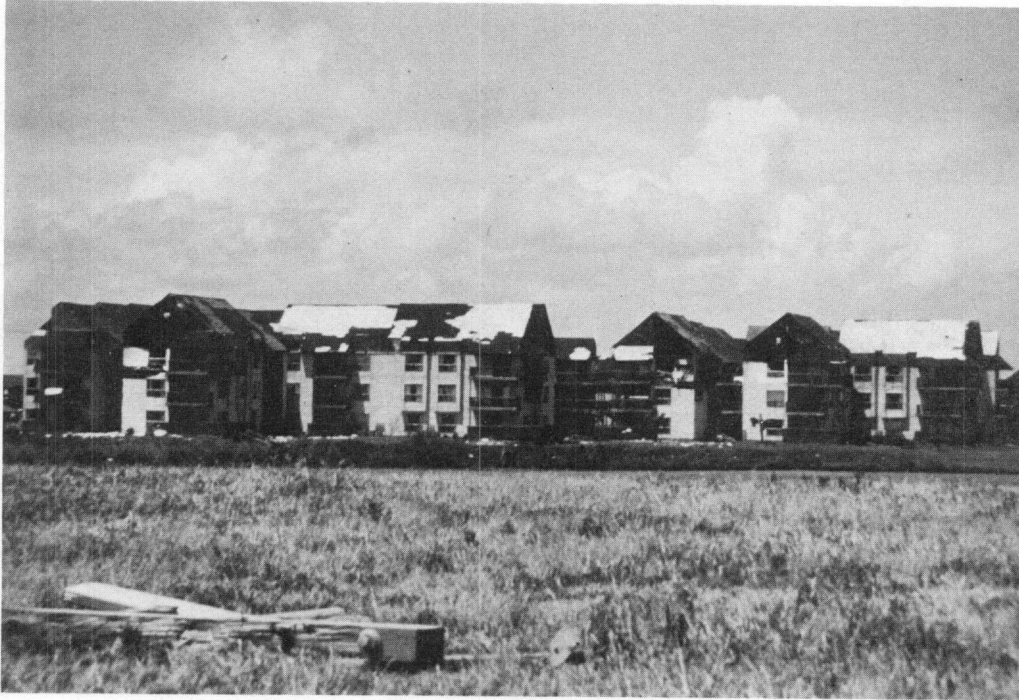
FIGURE 4.32 Roof damage to apartments near the seawall.

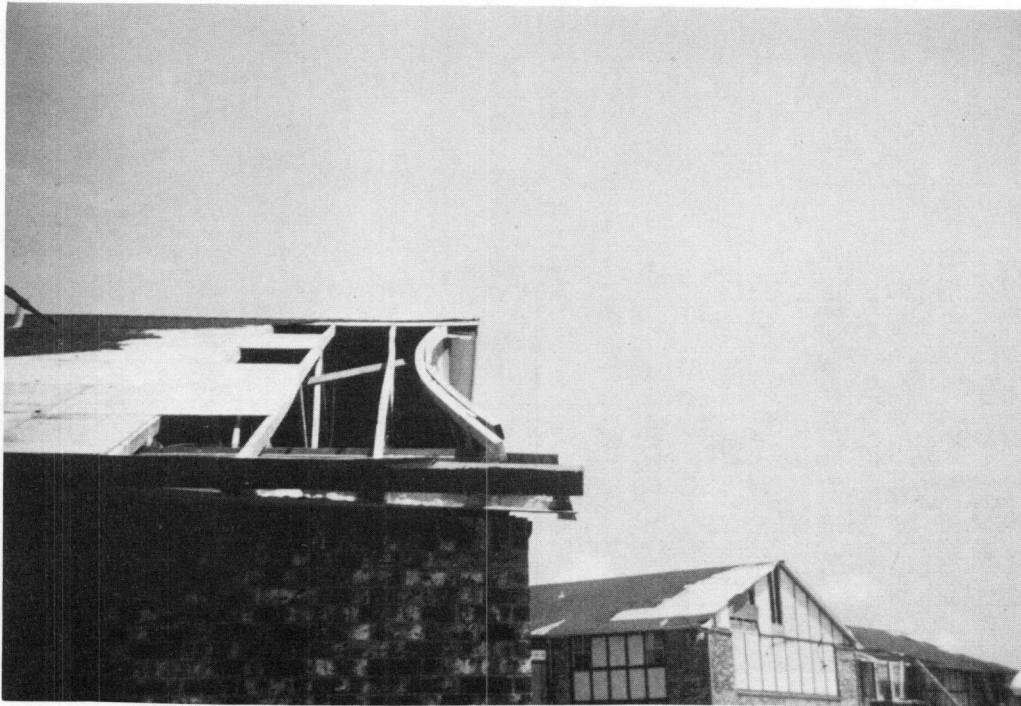
FIGURE 4.33 Damage to a roof truss caused by lack of bracing between trusses.

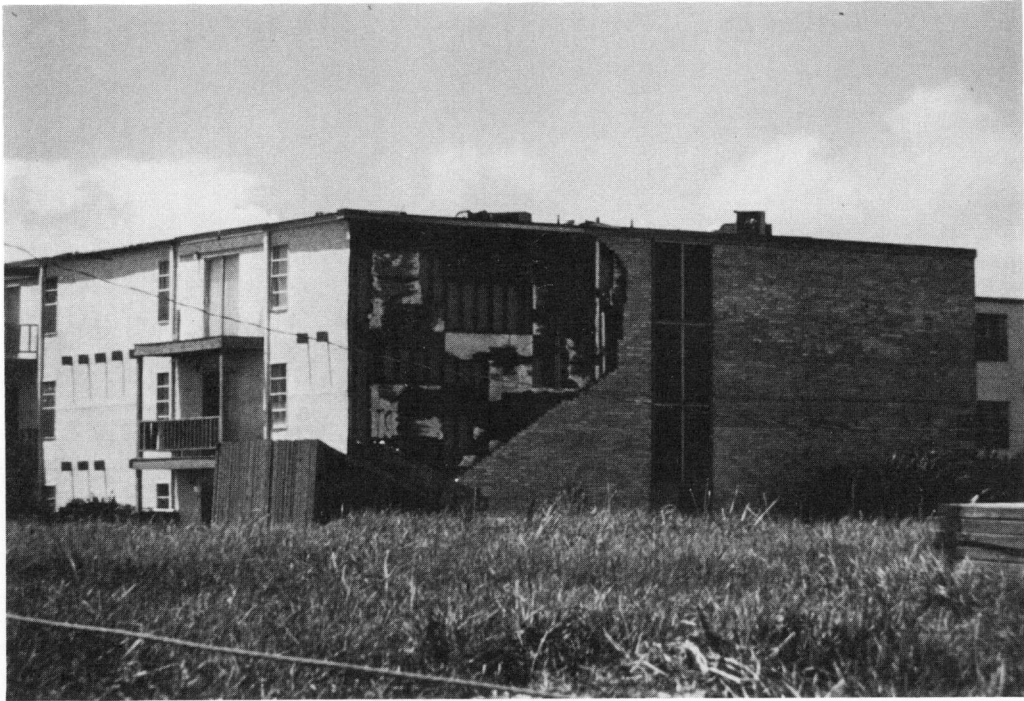
FIGURE 4.34 Failure of veneer brick walls due to lack of ties.

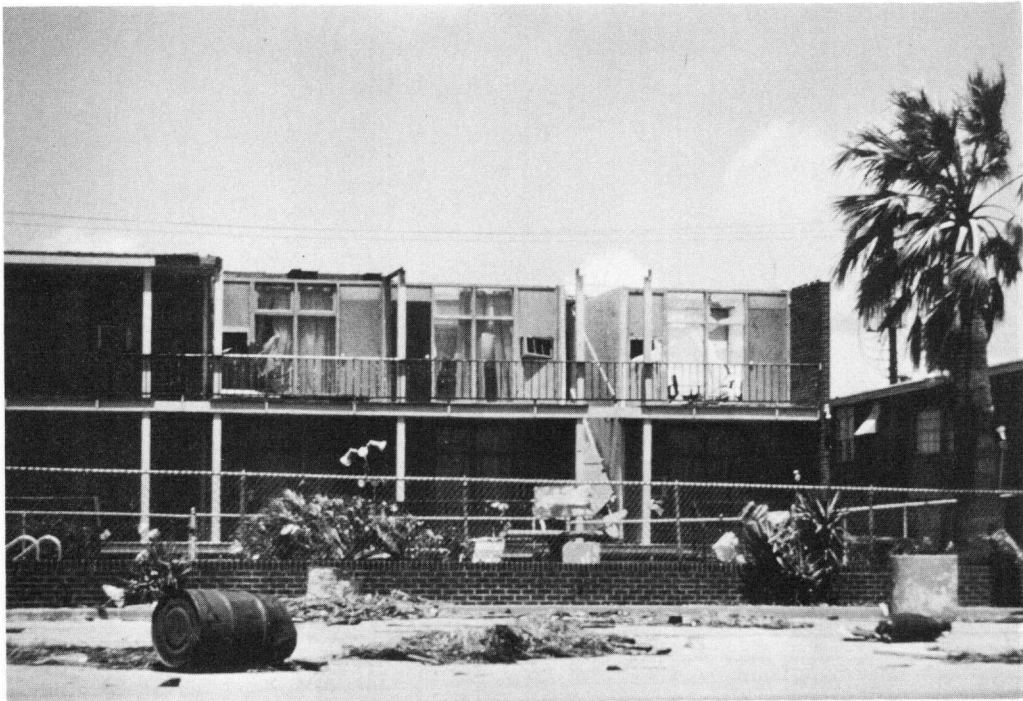
FIGURE 4.35 Partial loss of roof at a motel.

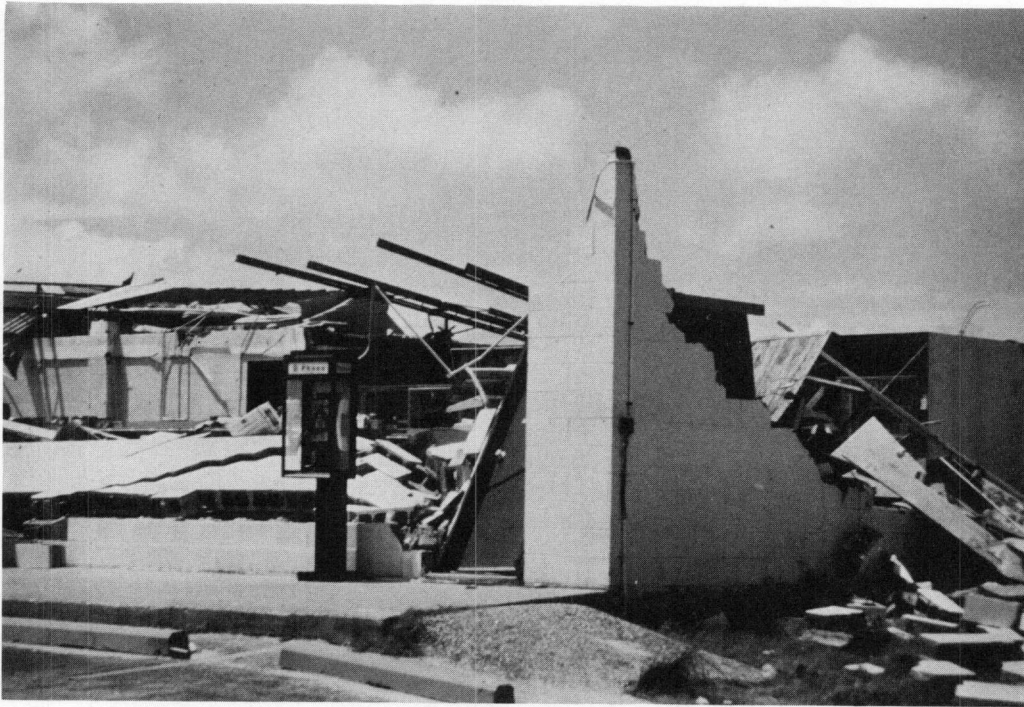
FIGURE 4.36 Typical example of the failure of one of many convenience stores.

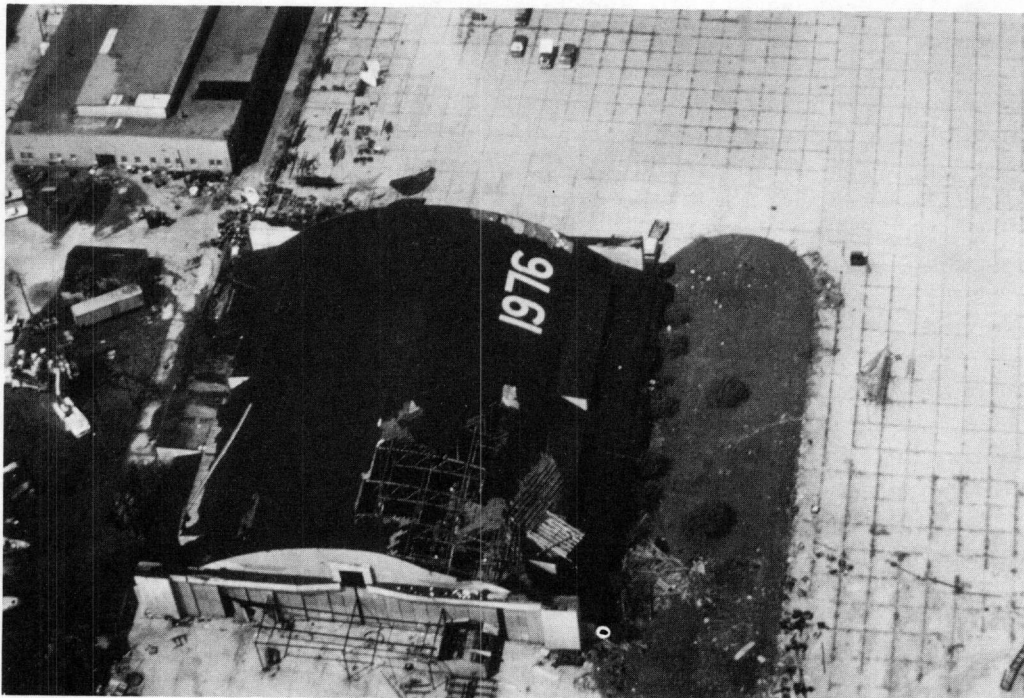
FIGURE 4.37 Wind damage to the roof of a hangar at Galveston Airport.

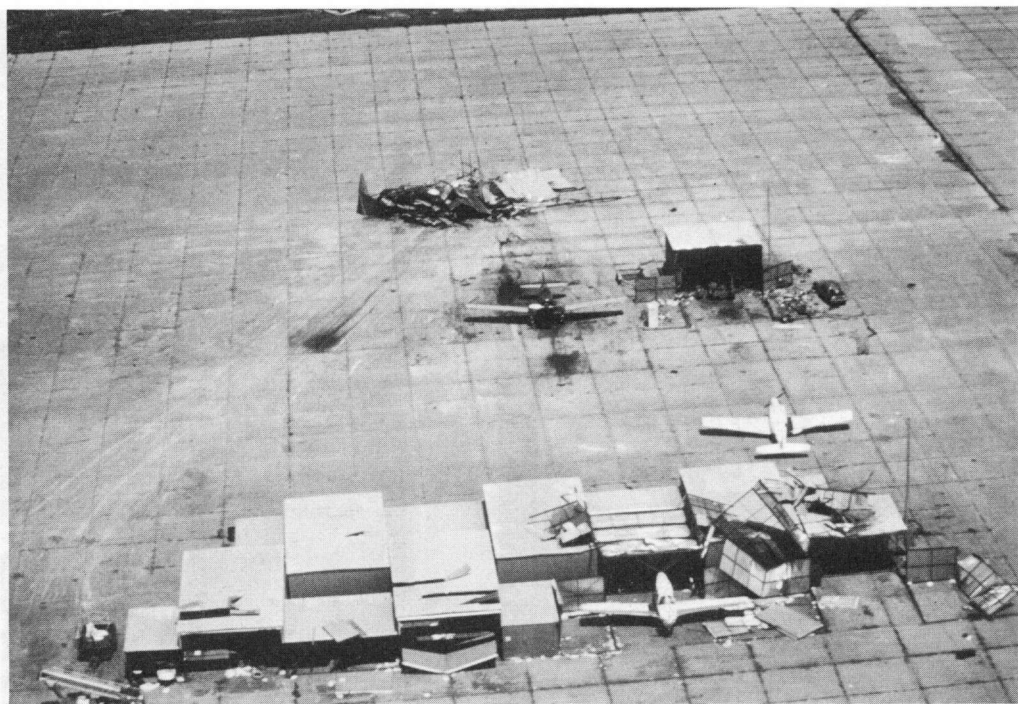
FIGURE 4.38 Damaged hangars and small aircraft at Galveston Airport.

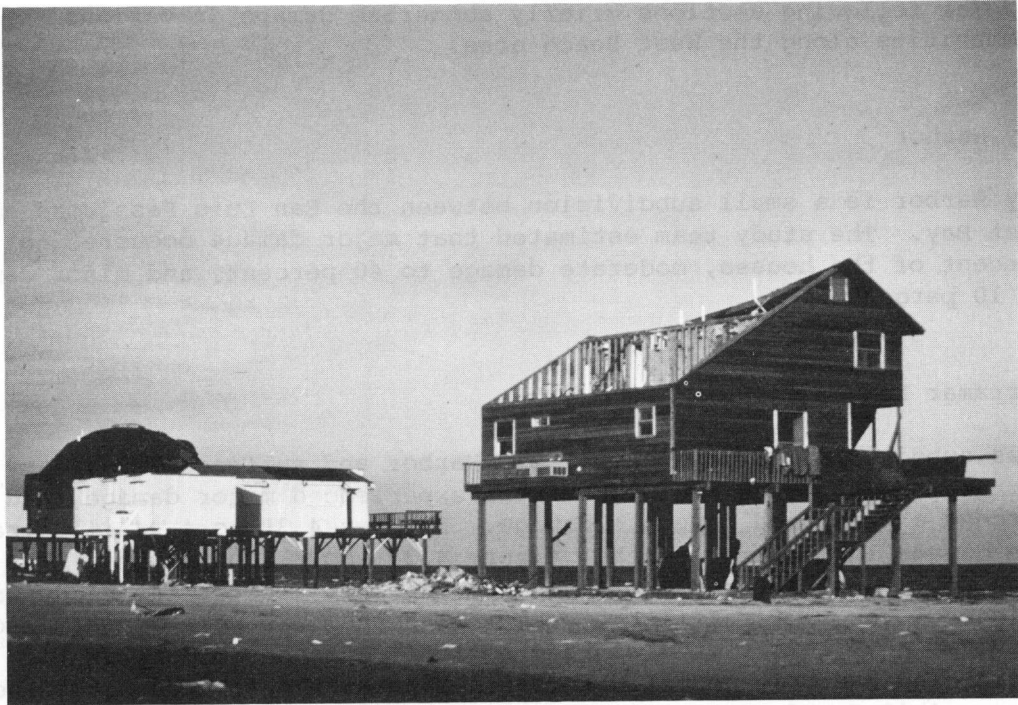
FIGURE 4.39 Example of a roof failure of a house in Terramar Beach.

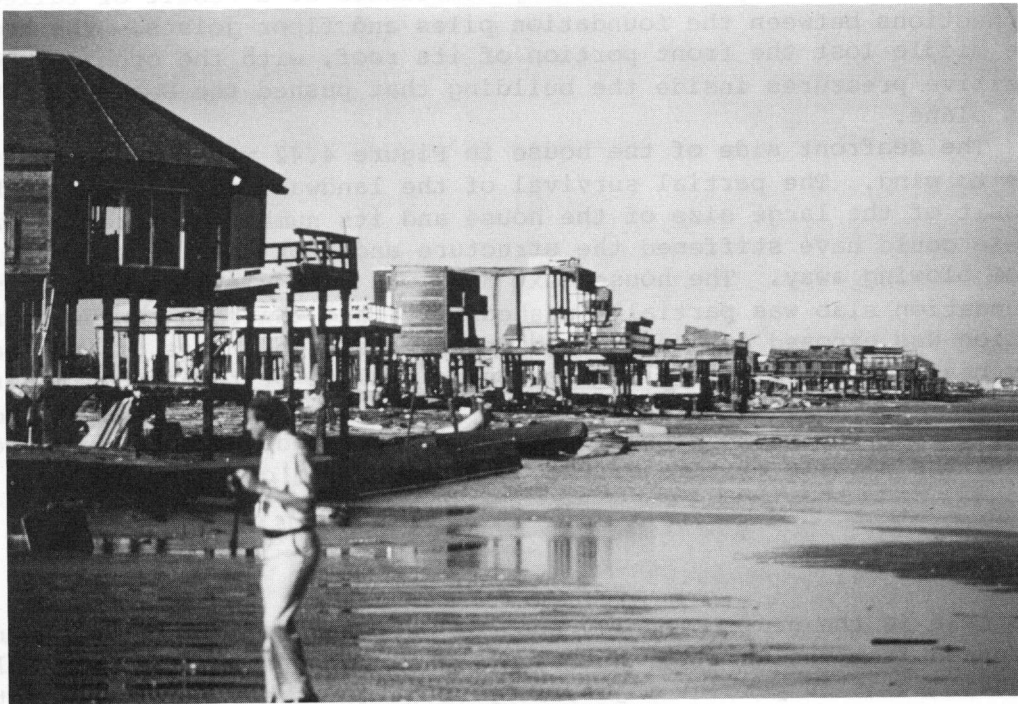
FIGURE 4.40 General view of damaged houses along Terramar Beach.

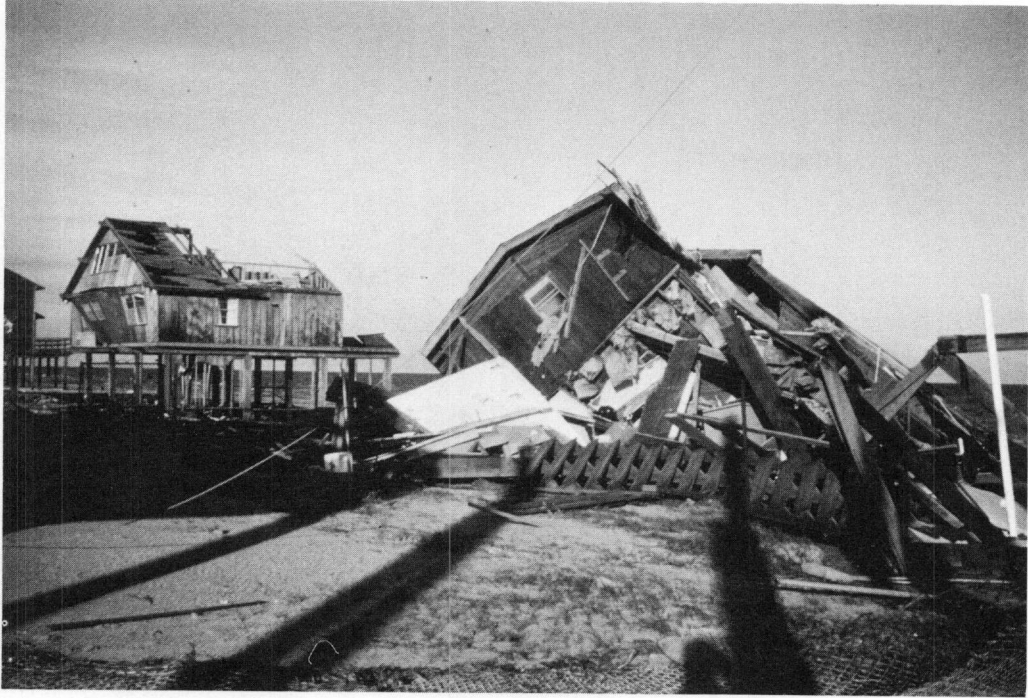
FIGURE 4.41 Example of overall collapse of a house and supporting structure.

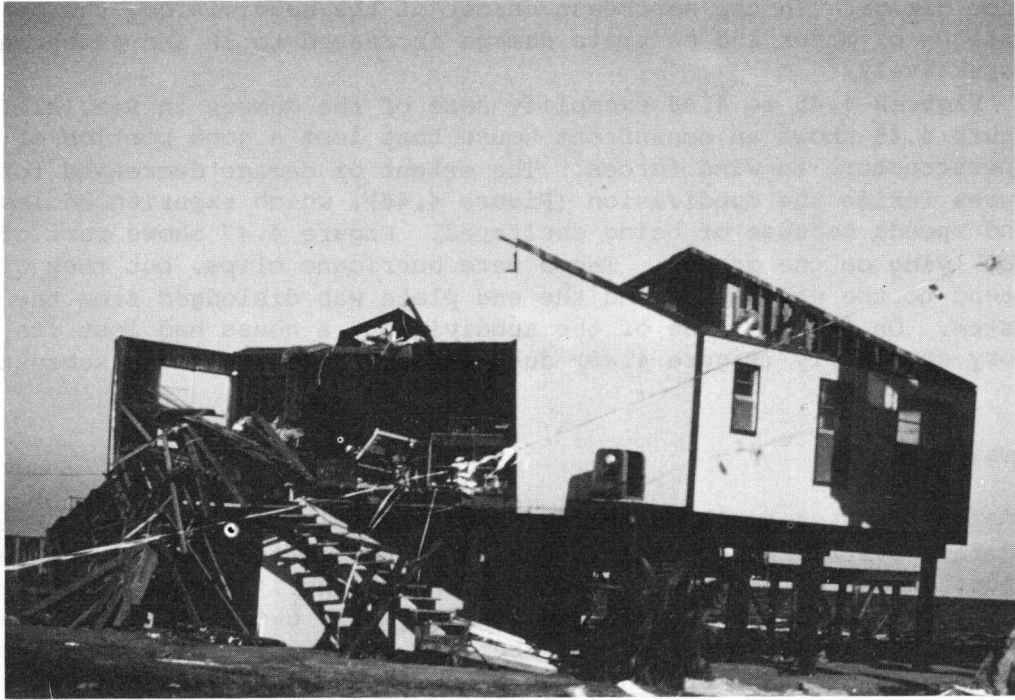
FIGURE 4.45 Damaged house fronting the Gulf in Sea Isle.
