**Hurricane Alicia
Galveston and Houston, Texas
August 17-18, 1983**

**Committee on Natural Disasters
Commission on Engineering and Technical Systems
National Research Council**

NATIONAL ACADEMY PRESS
Washington, D.C. 1984

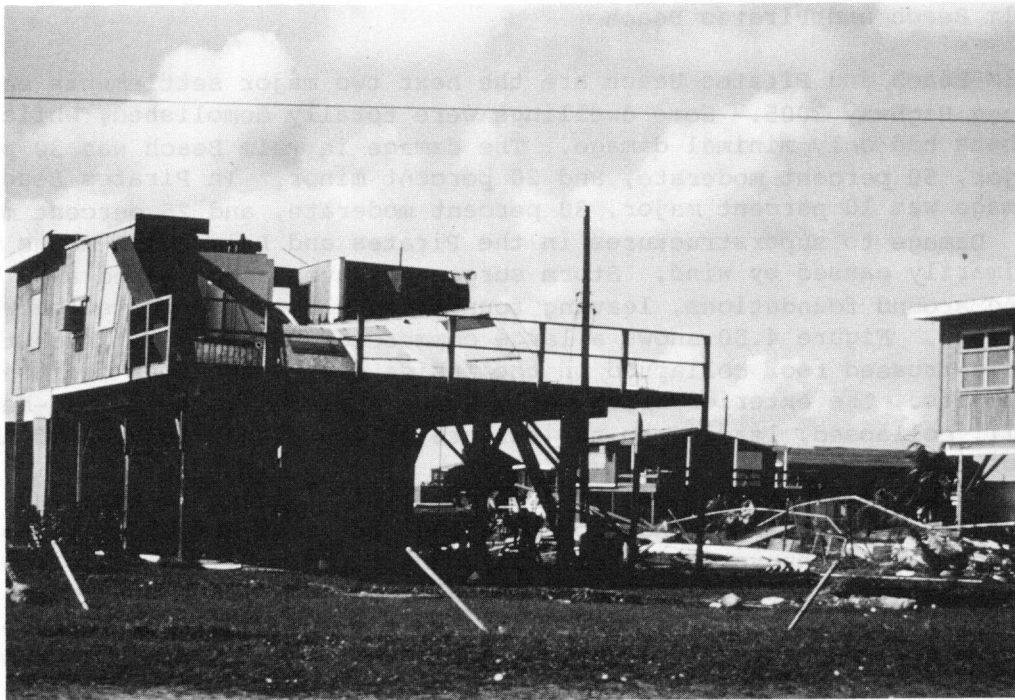
FIGURE 4.46 Damaged house in the second block from the coast in Sea Isle.

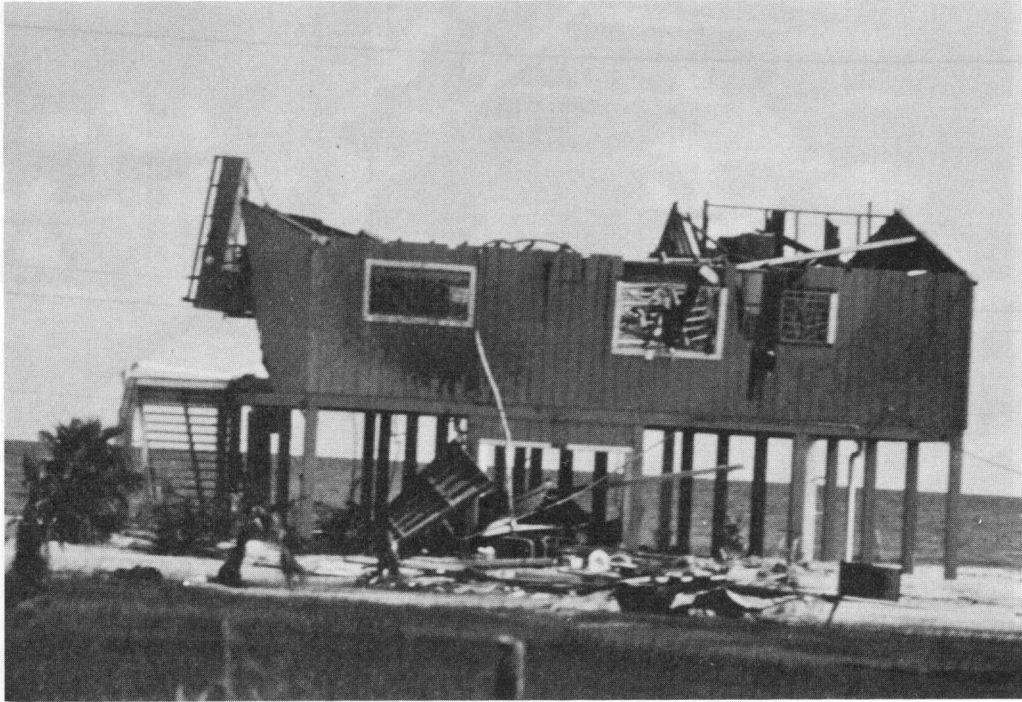
FIGURE 4.49 Damaged house in Jamaica Beach.

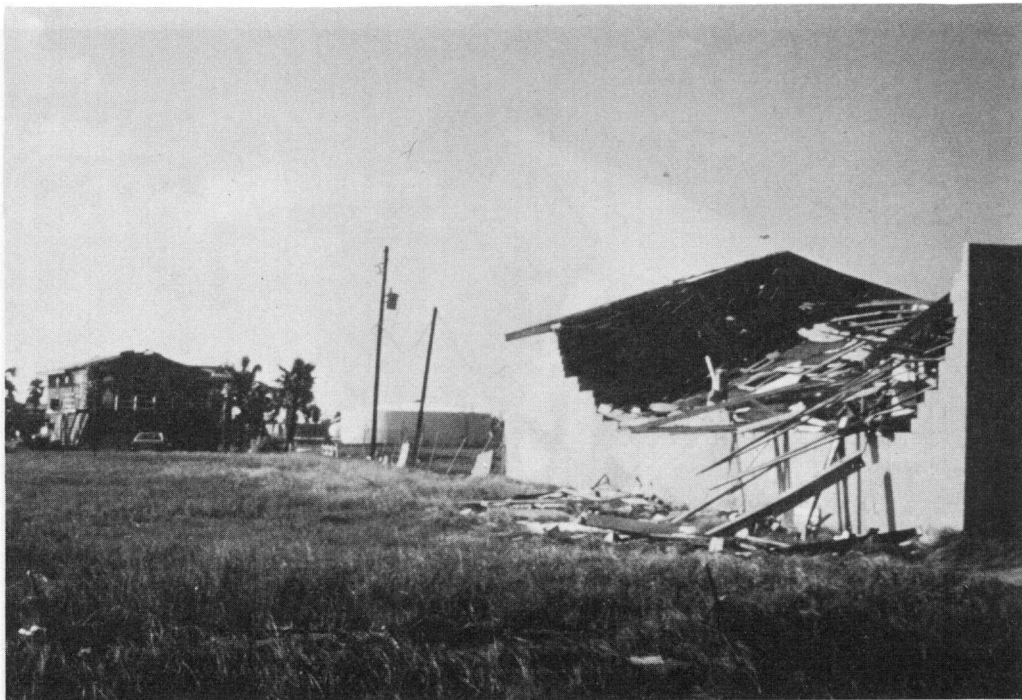
FIGURE 4.50 Damage to a large commercial warehouse building.

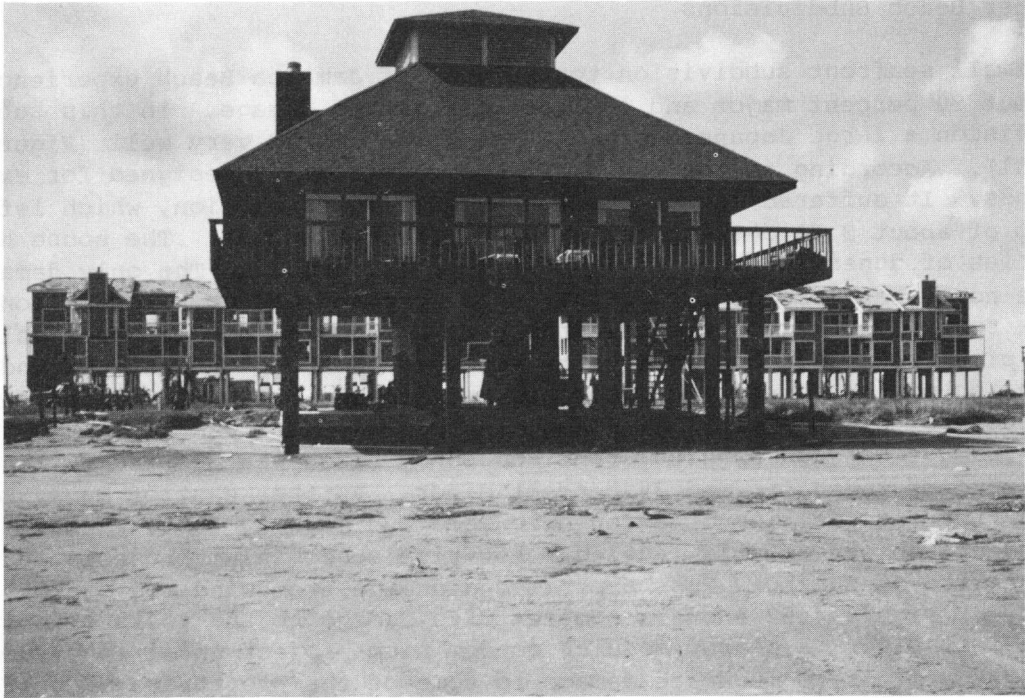
FIGURE 4.51 Example of a well-constructed house that performed very well except for erosion around the foundation.

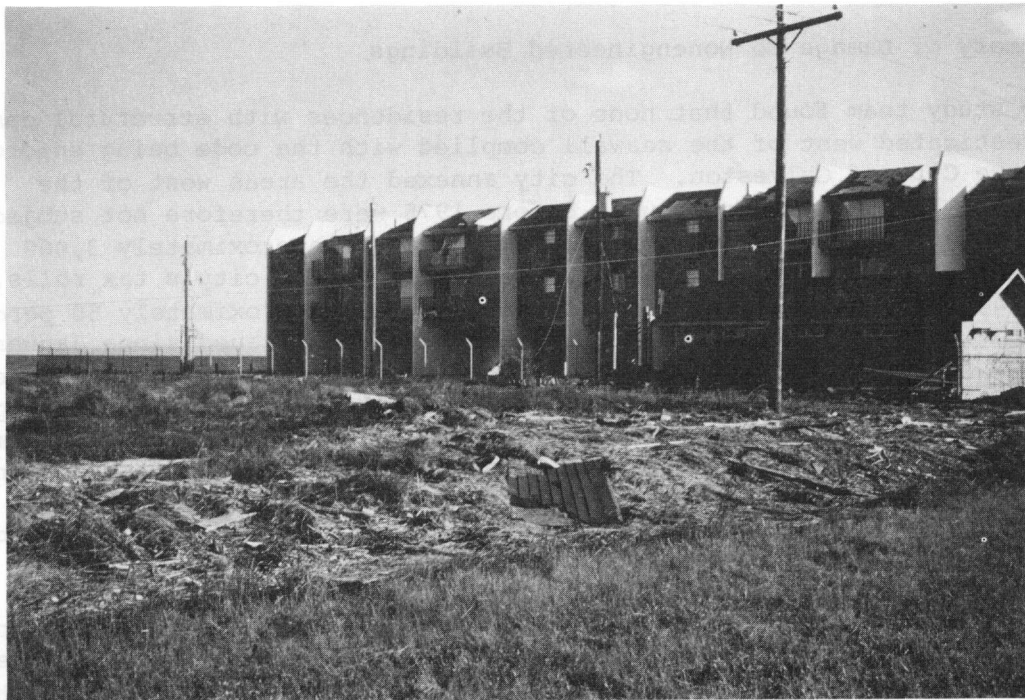
FIGURE 4.52 Damage to the roof and erosion around foundations of condominium units on the west side of San Luis Pass.

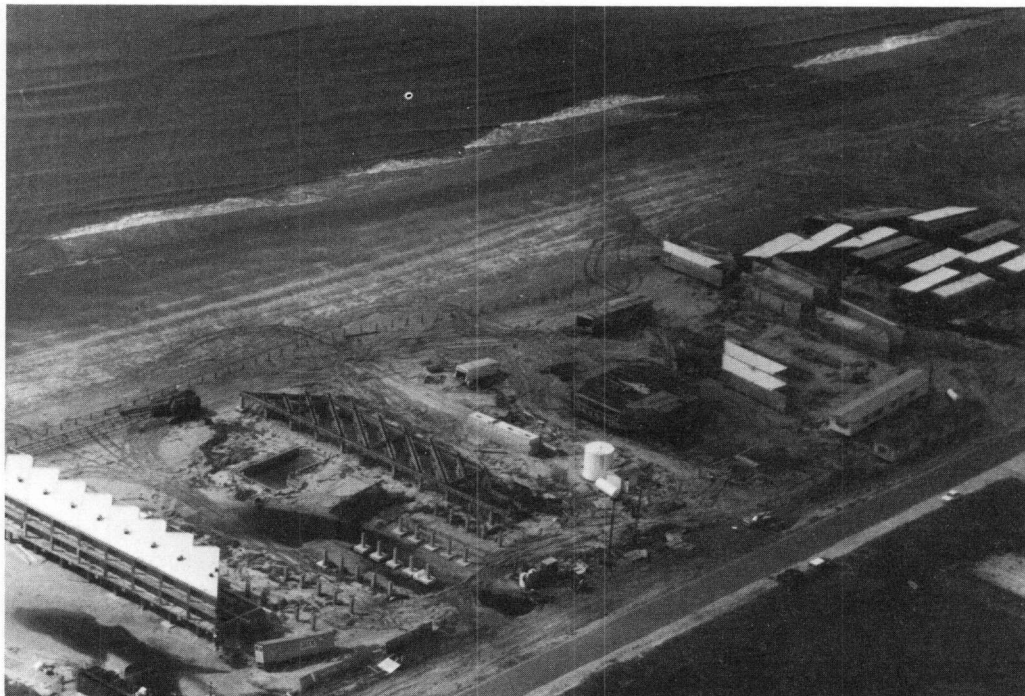
FIGURE 4.53 General view of a modular condominium project that experienced damage from wind and storm surge.

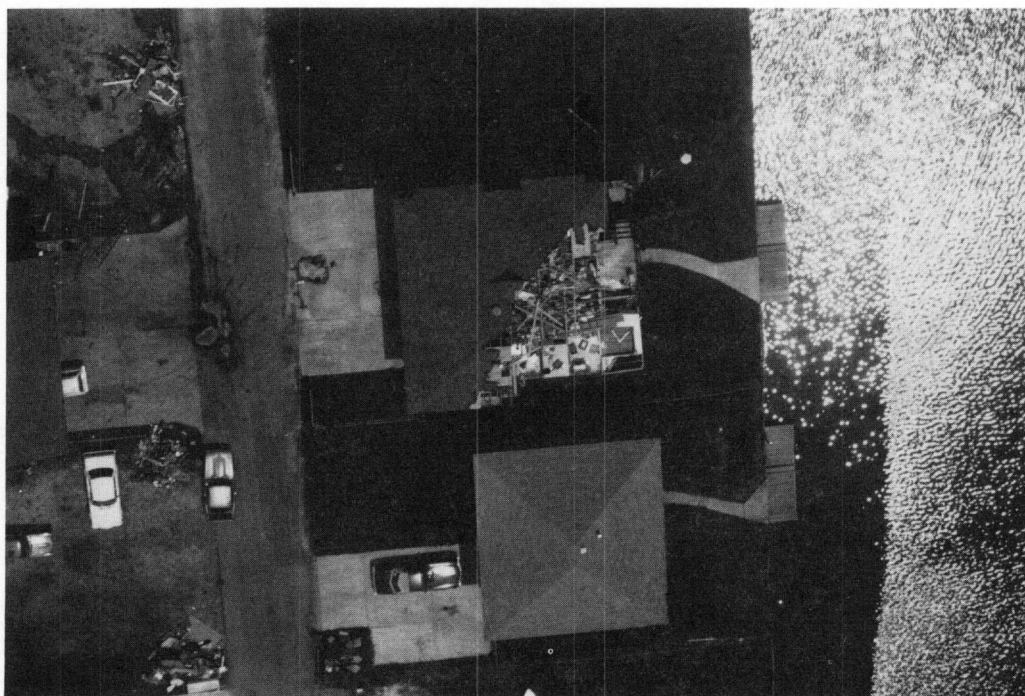
FIGURE 4.54 Aerial view of roof damage.

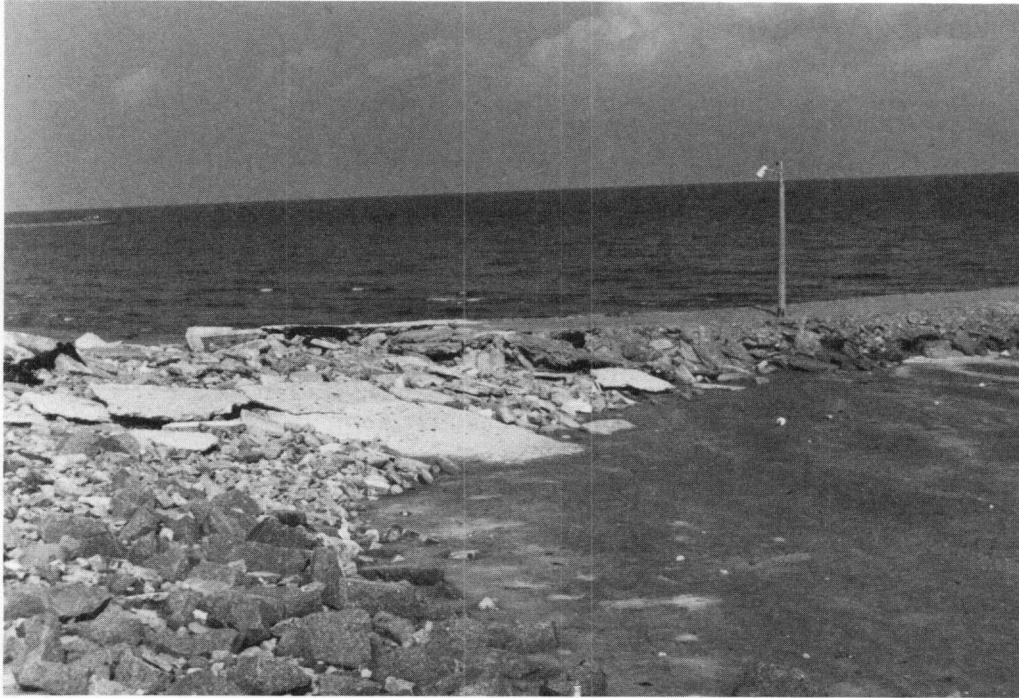
FIGURE 4.55 Damage to groin in front of the Galveston seawall.

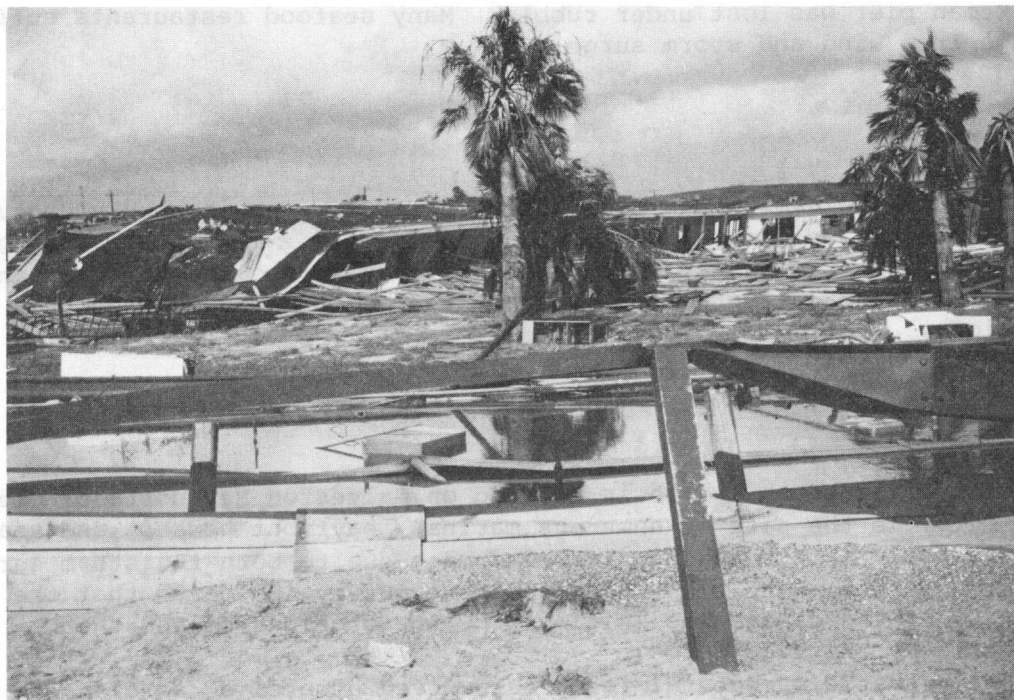
FIGURE 4.57 An elevated motel transported off its foundation by the storm surge.

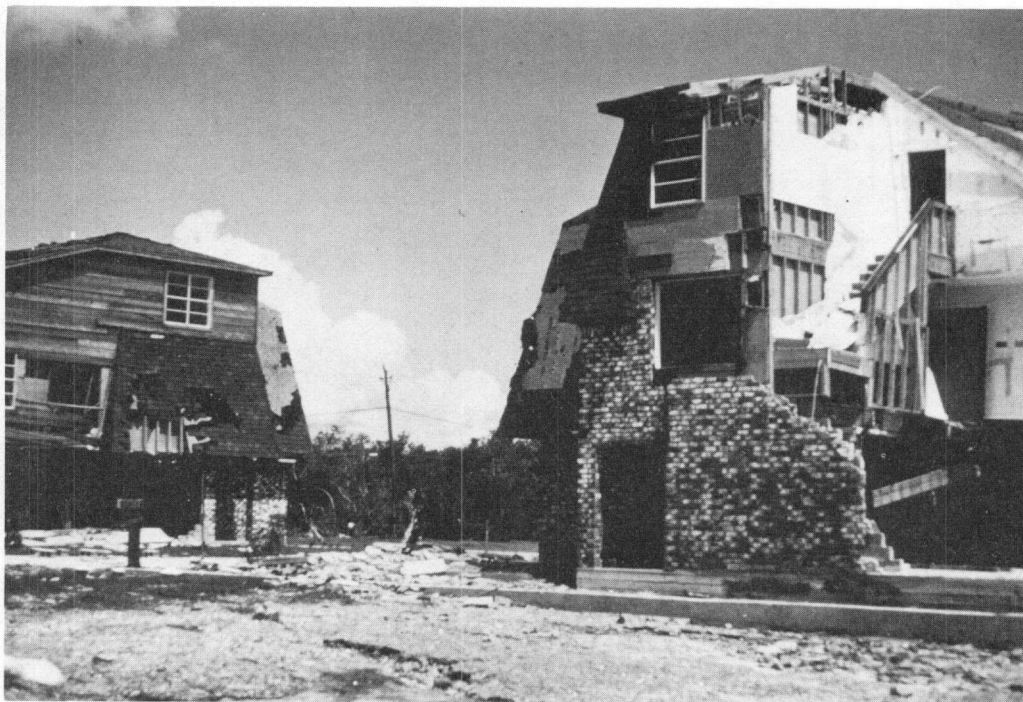
FIGURE 4.59 Failure of the roof and brick veneer wall of a condominium.

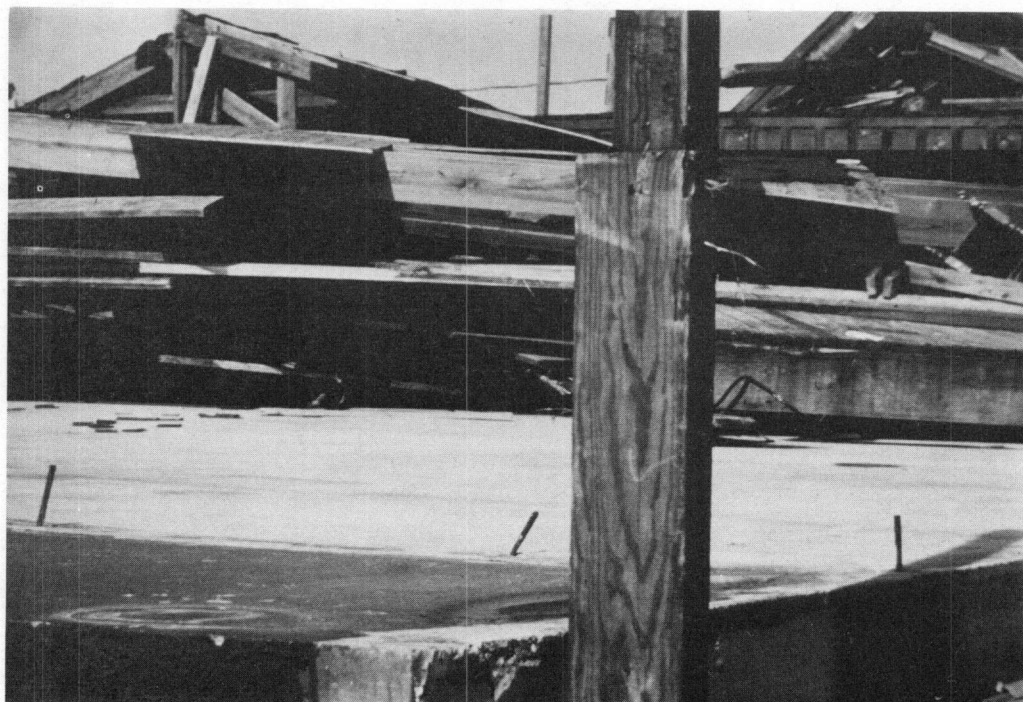
FIGURE 4.60 House washed away from its foundation slab by storm surge.

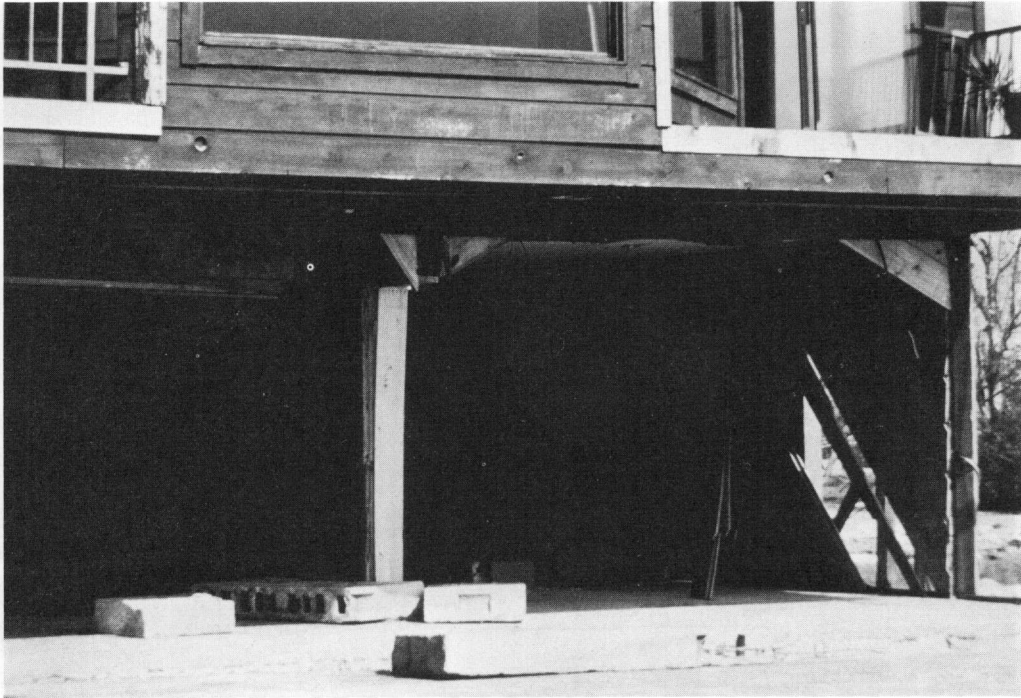
FIGURE 4.61 Damage to a grade-level enclosure.

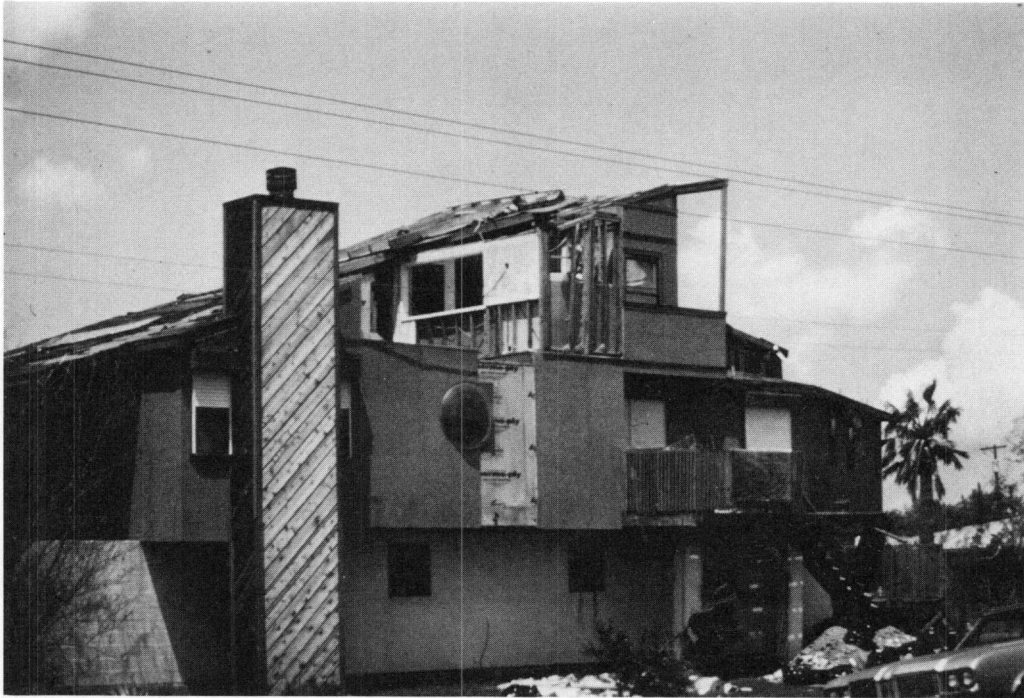
FIGURE 4.63 Roof damage to a condominium in Texas City.

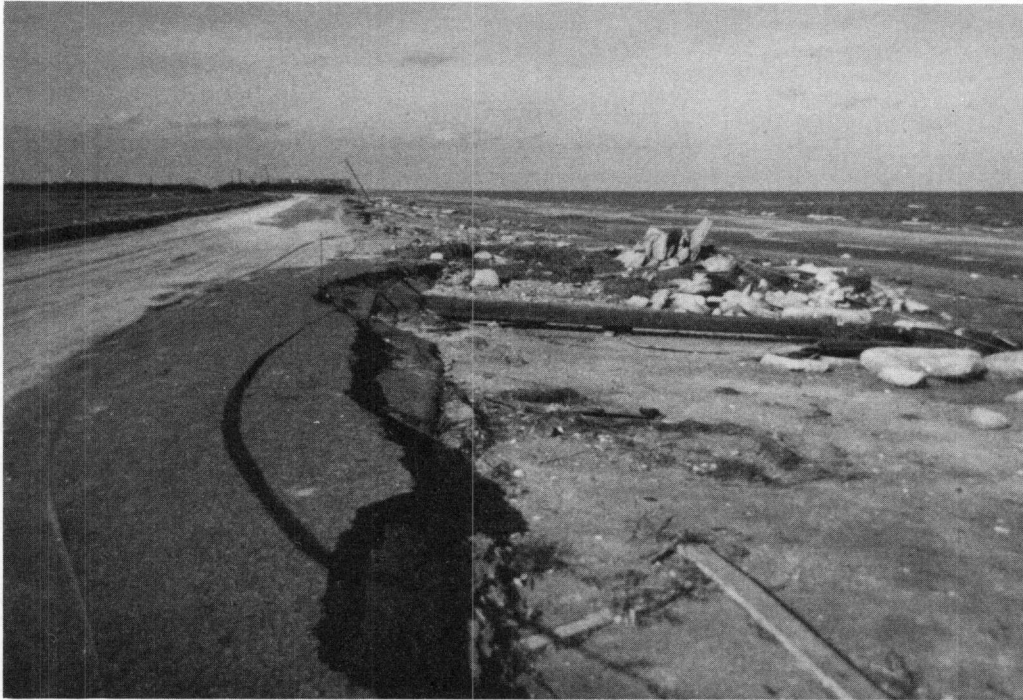
FIGURE 5.1 Typical washout of shoulder on San Luis Pass Road, Follets Island.

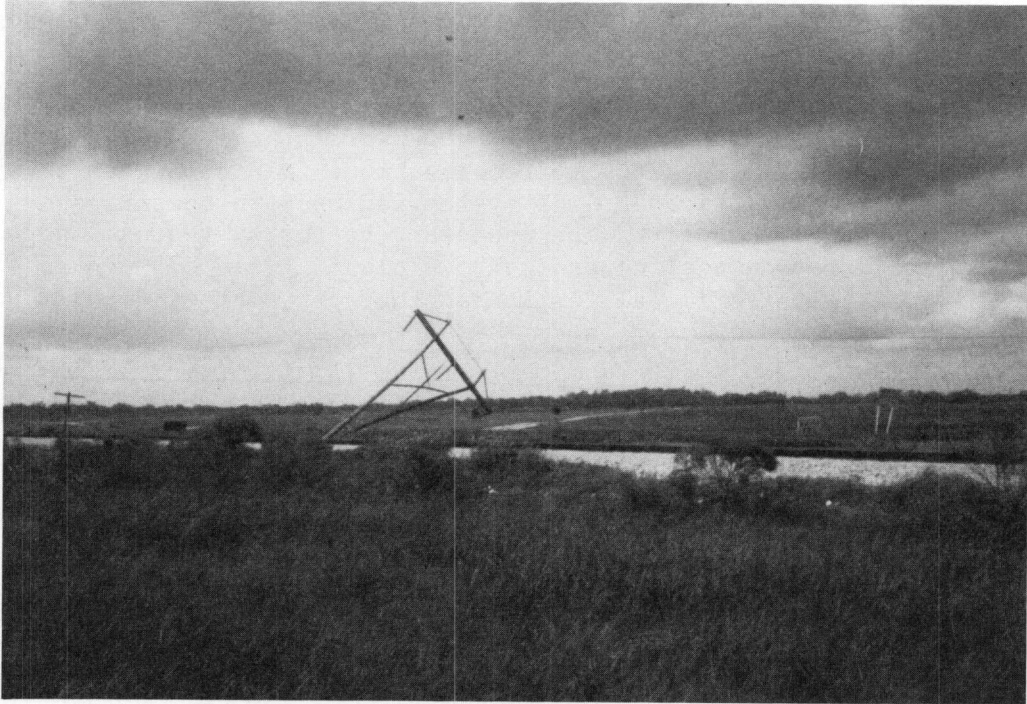
FIGURE 5.6 Failure of primary power pole near Highway 146 south of Bay City.

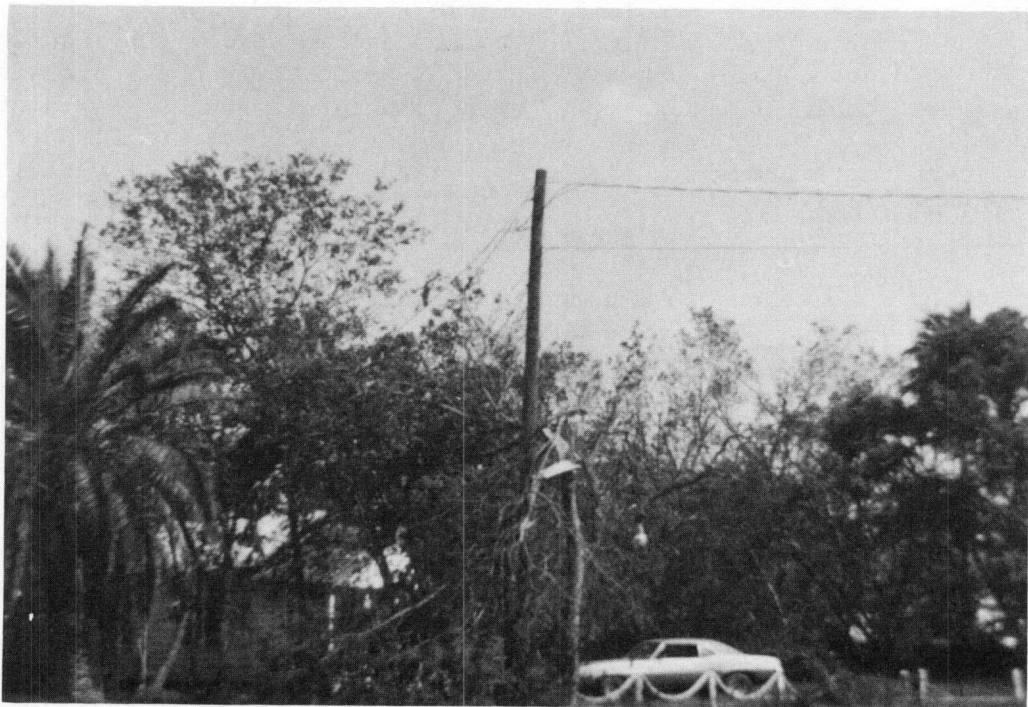
FIGURE 5.7 Typical failure of utility line caused by fallen trees in Seabrook.
