Every mil matters

One battalion's fight against error

By Lt. Col. Jim Collins and Capt. Joshua Herzog

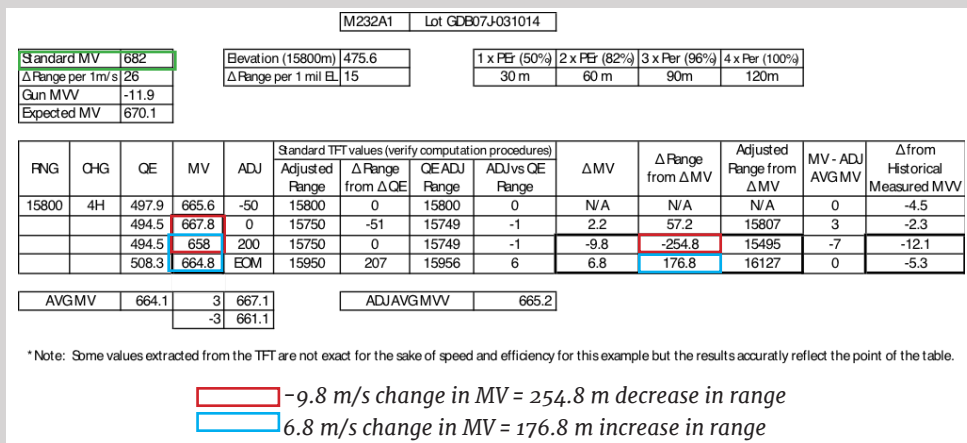
Figure 1. This figure shows the deviation in muzzle velocity. (Courtesy illustration)

We initiated troubleshooting associated with range errors. First, we compared the firing solution in the fire direction center as well as the command deflection/quadrant and actual deflection/quadrant in the Paladin Digital Fire Control System (PDFCS). We noticed an irregularity in the muzzle velocities on the PDFCS record of fire. The following chart outlines the data for one mission. The blue and red boxes highlight where the muzzle velocity increase or decrease directly affected the range. The standard muzzle velocity is highlighted in green for comparison.

The AFATDS was operating using the enhanced muzzle velocity (MV) mode, actively collecting and applying muzzle velocity data to the muzzle velocity variation (MVV) database. Therefore, range dispersion should have decreased with each mission fired. However, over 70 percent of the missions displayed erratic muzzle velocities that varied from 5–20 meters per second between rounds, resulting in errors in the range of 120–380 meters, increasingly outside of four probable errors in range.

After detailed analysis and an unshielded borescope, coppering of the tube, the thin film of copper deposited in the tube when high charges are fired and high velocities, was identified as a possible explanation. The previous approximately 1,000 rounds were fired exclusively with 4H and 5H. Initially, coppering was not considered due to the daily tube maintenance which includes cleaning the tube with the basic issue brush. The borescope proved the bore evacuators were clean and that there were no signs of cracks or fractures, but did present initial signs of residue. Approximately one month later, an Ammunition Information Notice was published warning of residue build-up in tubes after expending a high volume of M232A1, charge 5. The message stated routine tube maintenance cannot extract or dissolve this residue. Firing a low charge of M231 is the only method to burn or "clean" the residue. After the publication of this message, we obtained authorization to execute fire missions at a reduced range with M231. Since then, the muzzle velocity variations are now within +/- 4 m/s, leading us to conclude that the firing of the lower charge effectively burned away the residue deposited in the cannon by repeatedly firing M232A1.
