**US Army Corps
of Engineers**

Assessment of Structural Flood-Control Measures on Alluvial Fans

October 1993

PR-24

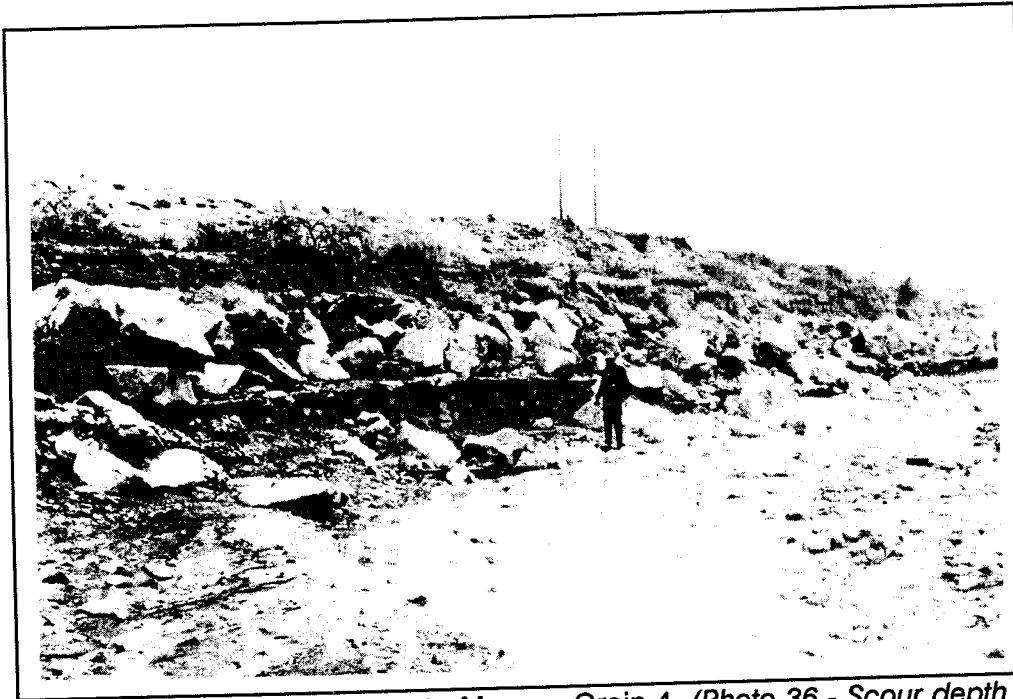
Investigation of effects of earlier floods revealed the ineffectiveness of the triangular-shaped toe protection on the grouted-stone revetment. This type of toe protection was used for the Lytle Creek levee and Muscoy Groin 4, as shown in Figure 2-1. Investigation of these two improvements after the 1969 floods, revealed the streamward displacement of the quarrystone toe protection that had originally been placed on the grouted-stone revetment. The scattering of the displaced quarrystone away from the revetment and the absence of the bulk of the quarrystone in the eroded

Figure 2-1 Scour Adjacent to Muscoy Groin 4 (Photo 36 - Scour depth of about three feet below the toe of grouted-stone facing.)

section at the toe indicated that this design is ineffective in providing additional protection against excessive scour along the toe.

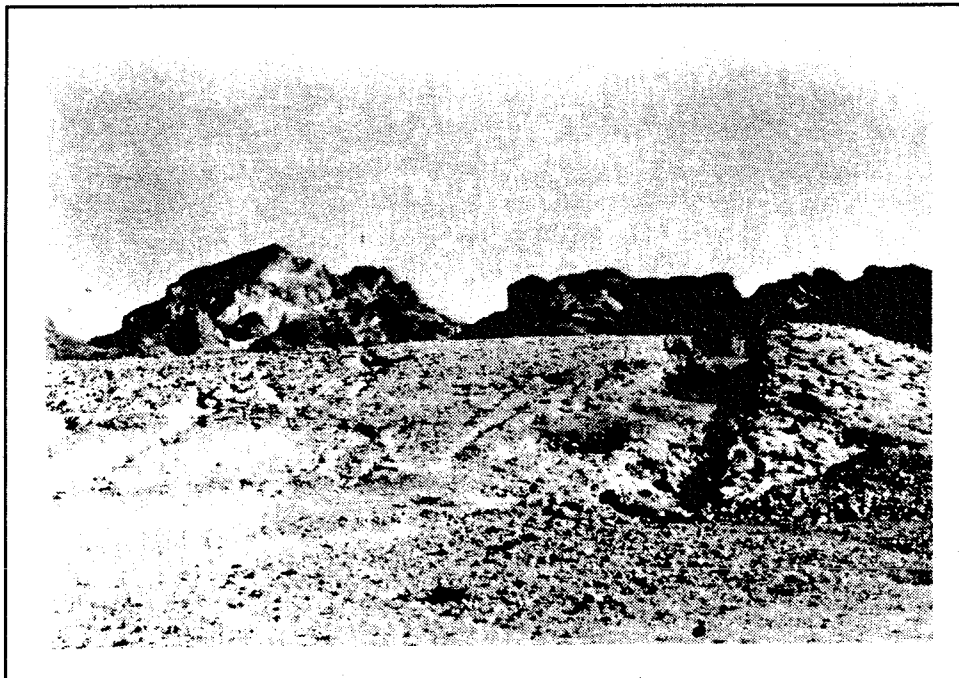
Figure 2-6 Severe Erosion on North Side from Overtopping (*Photo No. 9 - Station 80+12 Inlet #7*)

completely repaired and was in excellent condition when the site was visited on November 3, 1990.

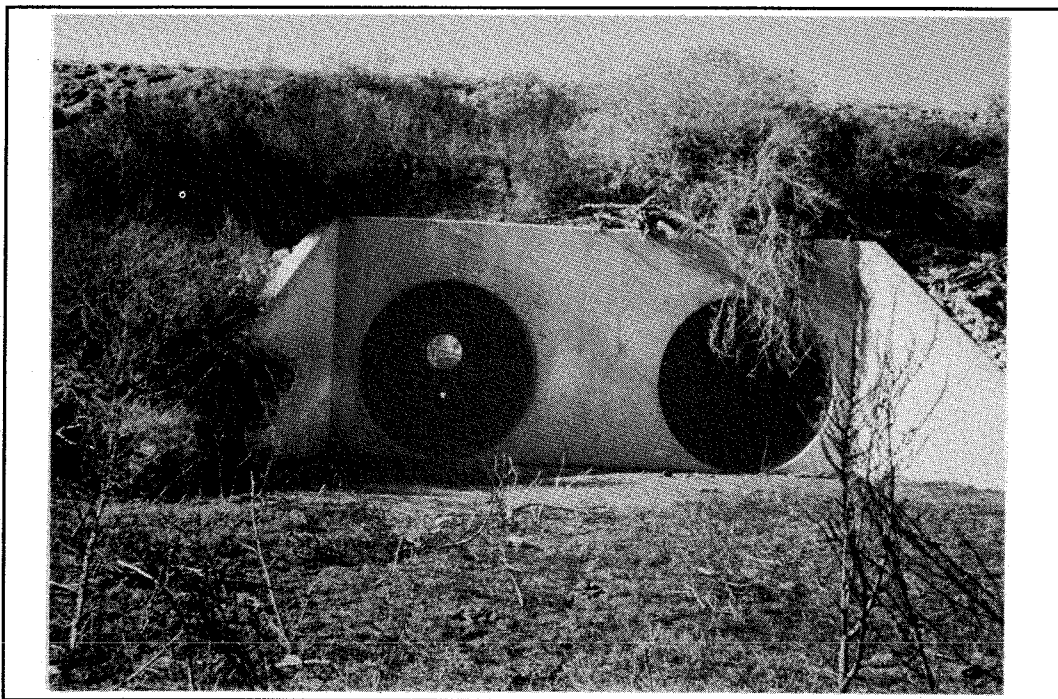
The Central Arizona Project (CAP) canals are protected, in some locations, by a flood-retention structure across fan outwash areas, just above and parallel to the canal. The outlet works are simple culverts (referred to as "overshoots") that carry the flood flow across the canal, preventing contamination of the canal water. Figure 3-6 shows the flood-retention structure and the inlet to a culvert crossing the CAP. The flow is then released into controlled or natural drainage systems below the canal. While the rural locations support using the natural drainage systems, more developed locations typically use a concrete-lined flood channel. The local experience indicated that flood-control performance has been favorable; however, there have been some problems with settlement. The settlement is probably the result of consolidation of fan

Figure 3-6 Flood Retention Structure and Inlet to Culvert Crossing Central Arizona Project, near Scottsdale, Arizona

material caused by flood inundation. Similar problems have occurred along the California Aqueduct in the Central Valley of California. Portions of the aqueduct right-of-way were flooded to consolidate the material prior to project construction.

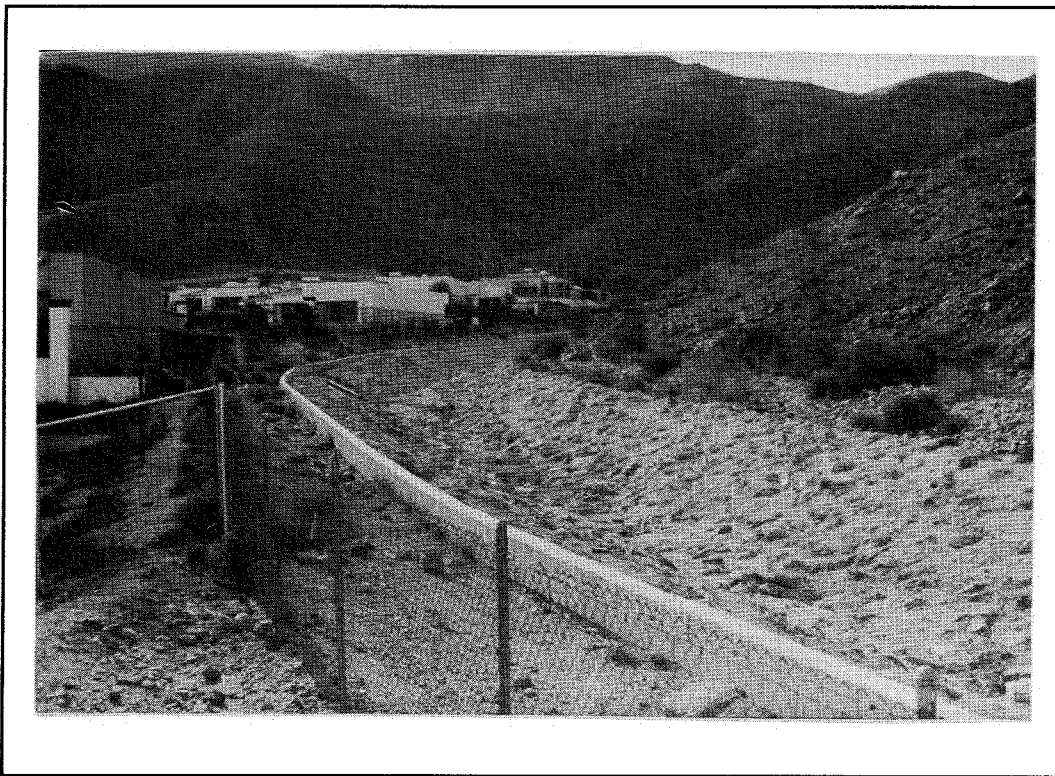
Figure 3-12 Low Concrete Wall on Outside Bend of Magnesia Canyon Channel, Rancho Mirage, California
