Contractor Weight Handling Mishap

Tipped Telehandler

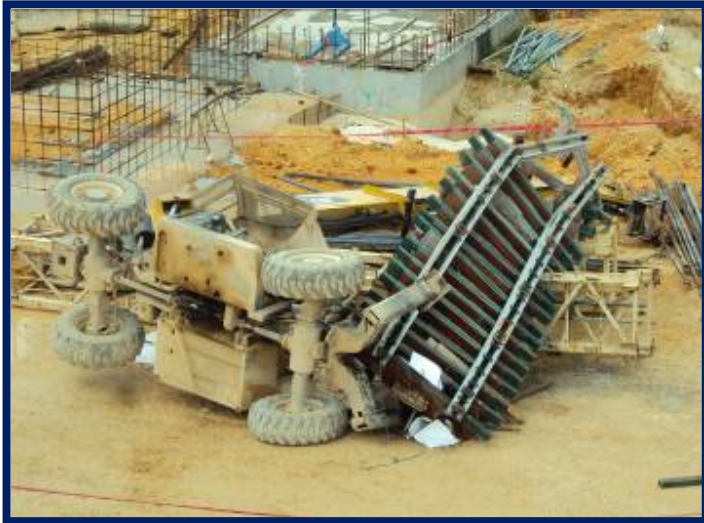
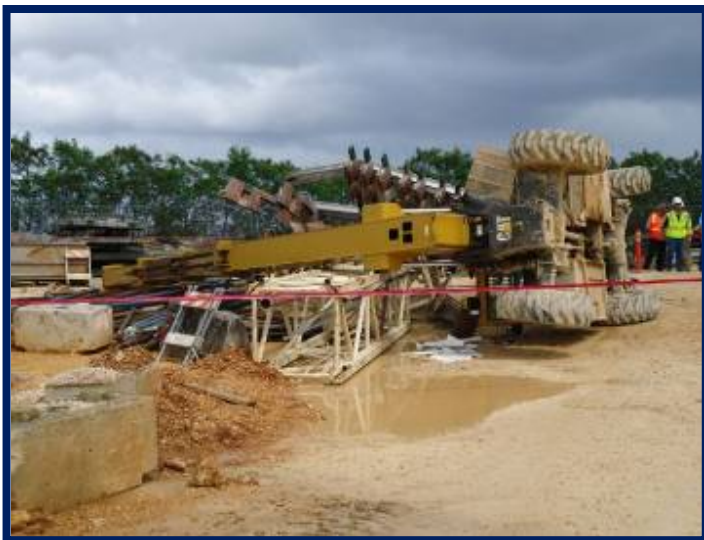
Activity: A Telehandler used in a crane like manner (approved arrangement) was transiting a sloped area with a large formwork panel (22' x 8') suspended vertically. The panel was rigged to a certified lift point on the end of the boom. The tall panel required the operator to extend the boom of the machine in order to clear the ground. According to the Original Equipment Manufacturer's (OEM) Manual, the boom must be fully retracted and raised no more than 45 degrees when traveling with a suspended load. The sloped ground and strong winds contributed to the instability of the telehandler causing it to turn onto its side. The boom landed on a sturdy piece of material preventing the cab from hitting the ground. The operator was wearing his seat belt which kept him in the cab. He was evaluated at the clinic and released back to work with no injuries.

- Operator unfamiliar with or unaware of the equipment operating limits
- OEM Manual instructions for hoisting and traveling were not utilized
- Improper rigging (vertical vs. horizontal orientation) of the load
- Significant environmental factors: sloped terrain, high winds

- Operators ***must*** pre-plan all work and walk equipment travel paths to identify and mitigate hazards before starting ***any*** work
- Operators ***must know*** equipment operational tolerances and restrictions in accordance with the OEM Manual
- Activity Hazard Analysis shall include environmental restrictions
