**U.S. Department of Transportation
Pipeline and Hazardous Materials Safety Administration (PHMSA)
Office of Pipeline Safety**

**Preliminary Factual Report
Plains Pipeline, LP, Failure on Line 901**

February 2016

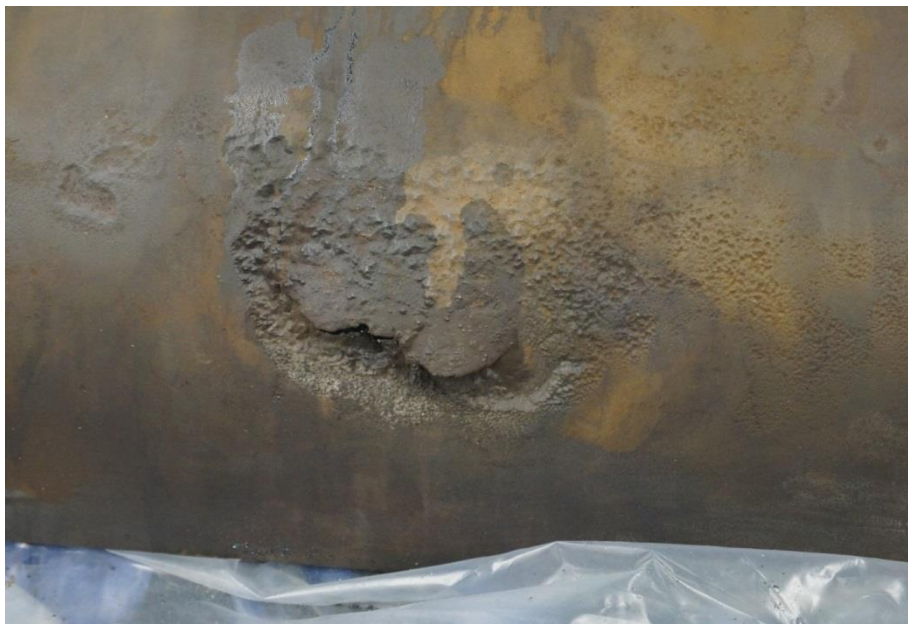
Pipe External Surface at the Line 901 Failure Site

“The results of the metallurgical analysis indicate that the leak occurred at an area of external corrosion that ultimately failed in ductile overload under the imposed operating pressure. The morphology of the external corrosion observed on the pipe section is consistent with corrosion under insulation facilitated by wet-dry cycling.”

The May 6, 2015 ILI survey data indicated corrosion at the failure site with an area of 5.38 inches by 5.45 inches, and a maximum depth of 47%. The DNV-GL metallurgical analysis physically measured corrosion at the failure site to have a maximum depth of 86%.³

11. Plains' existing corrosion control system is not preventing external corrosion of the pipe under insulation.
