## Track Record of In-Line Inspection as a Means of ERW Seam Integrity Assessment

J. F. Kiefner, K.M. Kolovich, C.J. Macrory-Dalton, D.C. Johnston,  
C.J. Maier, and J.A. Beavers  
November 15, 2012

**AS THE DELIVERABLE OF SUBTASK 1.3 ON  
U.S. DEPARTMENT OF TRANSPORTATION  
OTHER TRANSACTION AGREEMENT NO. DTPH56-11-T-000003**

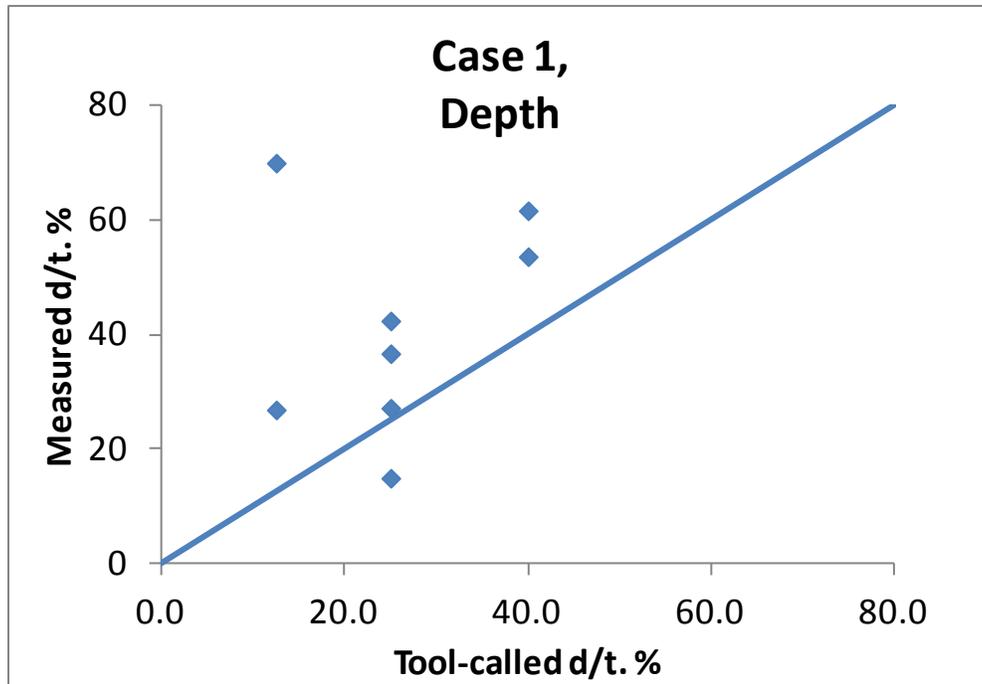
**Figure 1. Comparisons between Field-determined Anomaly Depth and ILI Anomaly Depth, Case 1**

It is also seen in Figure 1 that one value of measured depth (Anomaly No. 12) is way out of line with the ILI depth (d/t of 70% as field-measured versus d/t of 12.5% from ILI). Otherwise the field-measured and ILI depths seem to be aligned within some reasonable scatter band.

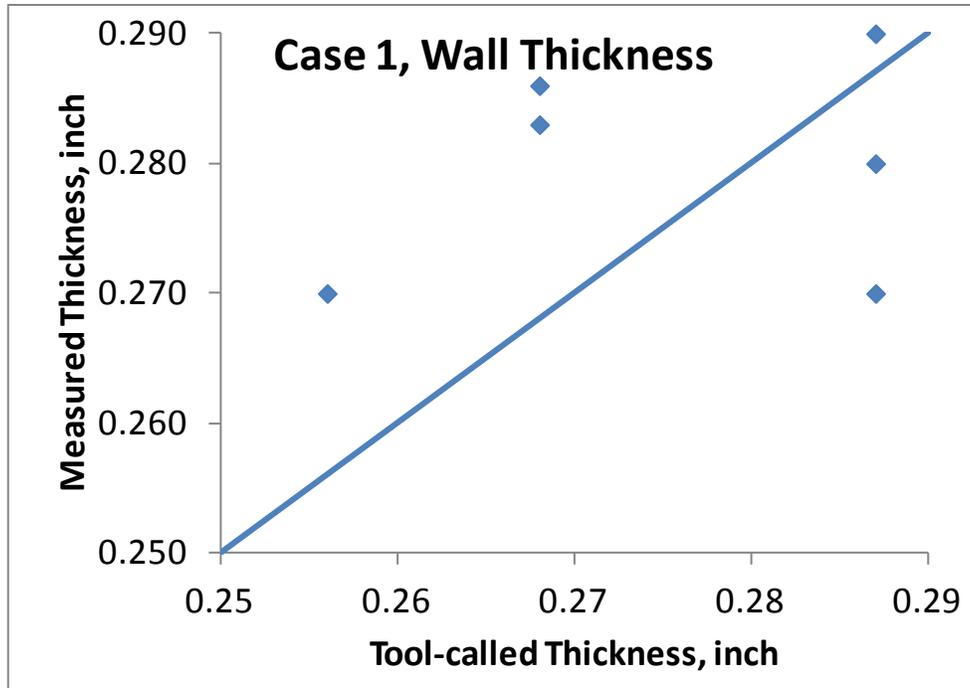
**Figure 3. Comparisons between Field-determined Wall Thickness and ILI Wall Thickness, Case 1**

Figure 3 illustrates the degree to which the wall thicknesses by ILI aligned with those measured in the field. When one considers the small range of thicknesses over which the comparisons are made, the relationship shown in Figure 3 reflects a reasonable comparison between ILI and field-measured wall thickness. Note that the ILI wall thickness at Anomaly No. 2. (0.268 inch) is out of line with the field-measured value of 0.375 inch. The scale of Figure 3 is too limited to allow this value to be plotted. This may be a case where the anomaly was in a short segment of heavier-wall pipe at a road crossing.

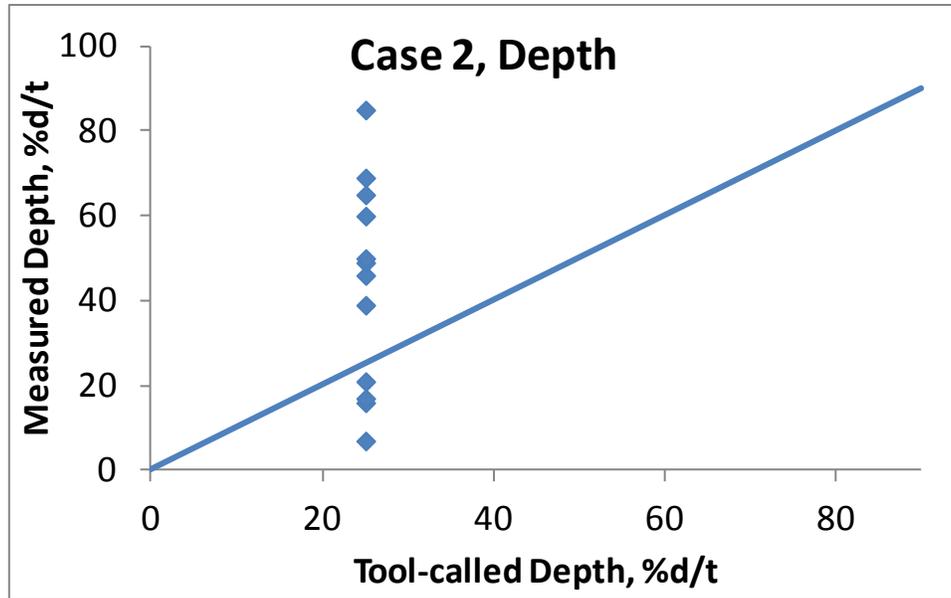
**Figure 5. Comparisons between Field-determined Anomaly Depth and ILI Anomaly Depth, Case 2**

It is also seen in Figure 5 that several values of field-measured depth are out of line with the tool-called depth. This may have to do with inaccuracies in the field depth measurements as will be discussed.

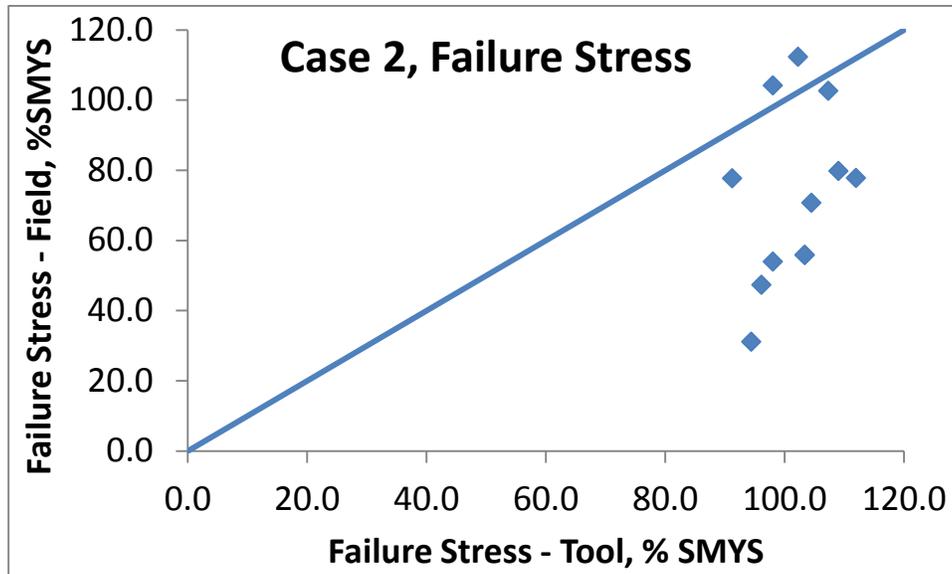
**Figure 7. Comparisons between Predicted Failure Stresses Based on Field-Measured Anomaly Dimensions and Those Based on ILI Dimensions, Case 2**

A comparison between failure stresses of the anomalies calculated on the basis of ILI dimensions and those calculated on the basis of field-measured dimensions is presented in Figure 7. Failure stress levels for these anomalies were calculated using the Modified Ln-Sec Equation Elliptical C-Equivalent model with a full-size-equivalent Charpy upper shelf energy of 20 ft-lb. As can be seen in Figure 7, the failure stress levels based on field-measured dimensions are well down into the operating stress range suggesting that they are likely not correct (i.e., no in-service failures have occurred and the actual operating stress of the pipeline is over 66% of SMYS near the pump stations).

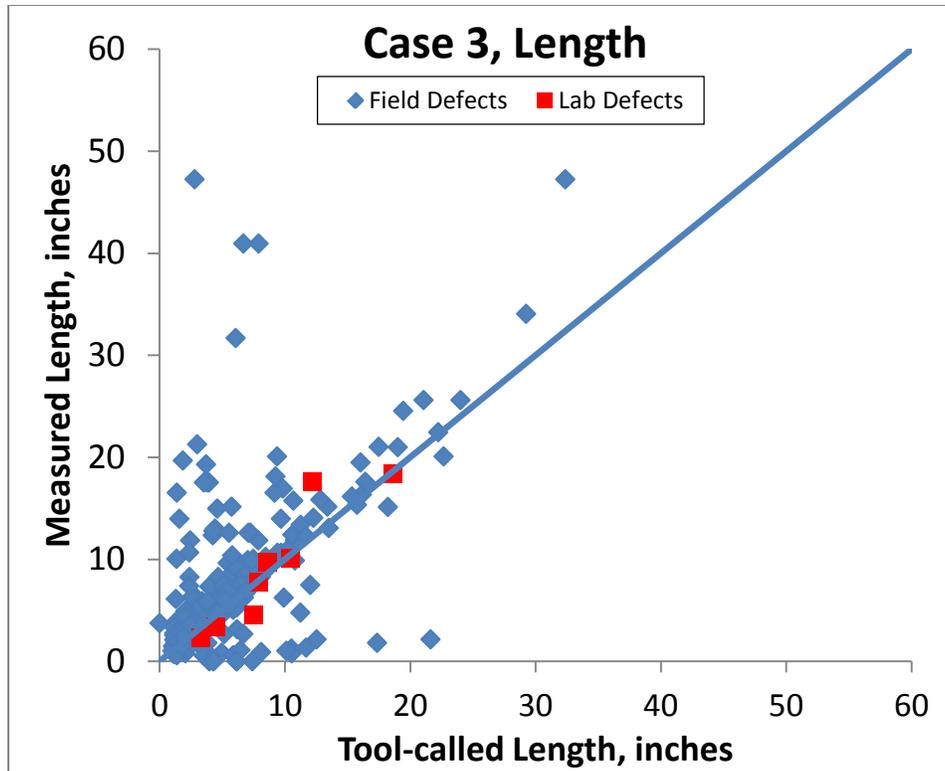
**Figure 9. Comparisons between Field-determined Anomaly Length and ILI Anomaly Length, Case 3**

For those anomalies (corresponding with hook cracks) sent to the lab for examination (red symbols in Figure 9), seven out of the eight anomalies had actual measured lengths within 3 mm of the tool-reported value and the eighth anomaly was within 5.5 mm. The ILI lengths agreed well with the lab-measured lengths.

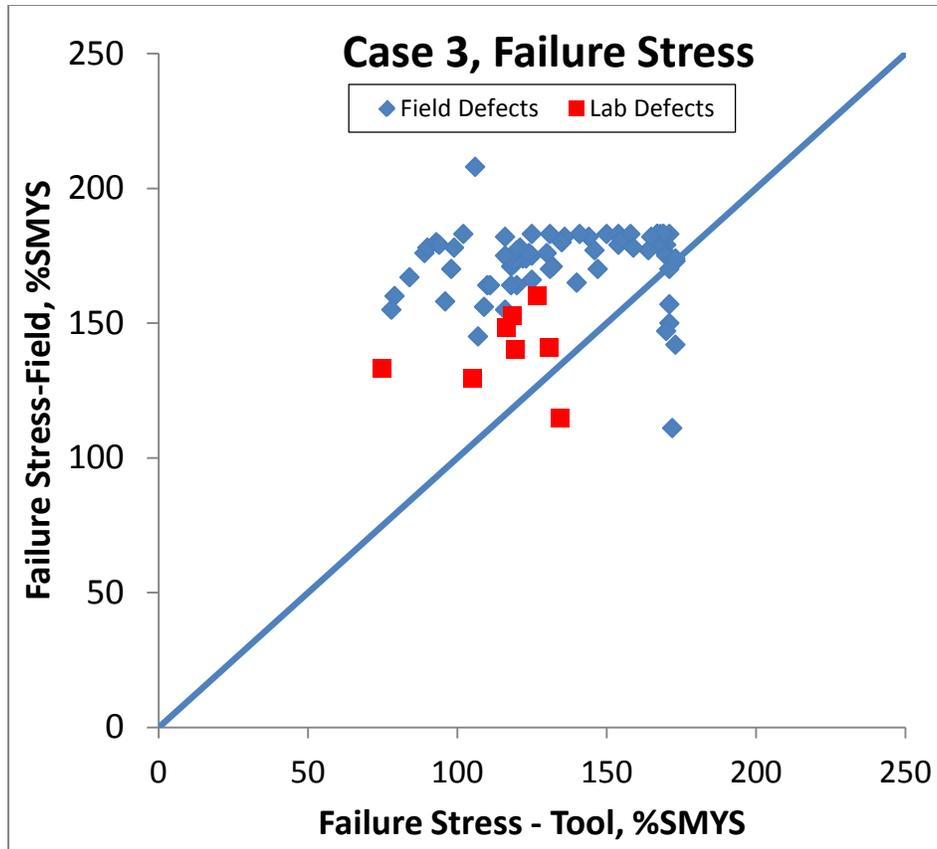
**Figure 11. Comparisons between Predicted Failure Stresses Based on Field-Measured Anomaly Dimensions and Those Based on ILI Dimensions, Case 3**

A comparison between failure stresses of the anomalies calculated on the basis of ILI dimensions and those calculated on the basis of field-measured dimensions is presented in Figure 11. Failure stress levels for these anomalies were calculated using the CorLAS™ fracture mechanics model with a full-size-equivalent Charpy upper shelf energy of 7 ft-lb (based on Charpy v-notch test results for the weld seam of this material. The notches were centered on the bondline). Figure 11 shows that the ILI-based failure stresses were all conservative (data above the 1:1 line) except for the smaller flaws, where the failure stresses were well above 100% of SMYS.

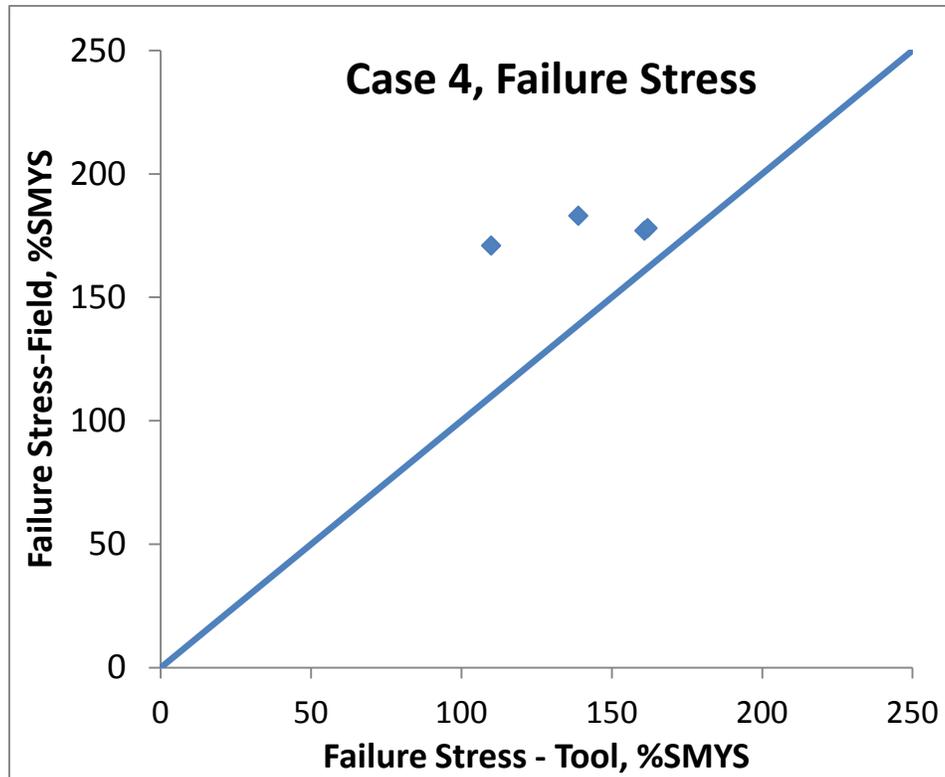
**Figure 15. Comparisons between Predicted Failure Stresses Based on Field-Measured Anomaly Dimensions and Those Based on ILI Dimensions, Case 4**

Figure 15 shows a comparison between failure stresses of the anomalies calculated on the basis of ILI dimensions and those calculated on the basis of field-measured dimensions. Failure stress levels for these anomalies were calculated using the CorLAS™ fracture mechanics model with a full-size-equivalent Charpy upper shelf energy of 7 ft-lb (based on Charpy v-notch test results for a similar material). As can be seen in Figure 15, the failure stress levels based on field-measured dimensions are above 150% SMYS. The plot shows a slight tendency for the ILI-based failure stress to be lower than the field and laboratory-based failure stress. This is the result of most anomalies being reported as being deeper than the field NDE indicated. These results indicate the predicted failure stresses based on ILI dimensions tended to be less than those predicted on the basis of dimensions determined by field NDE.

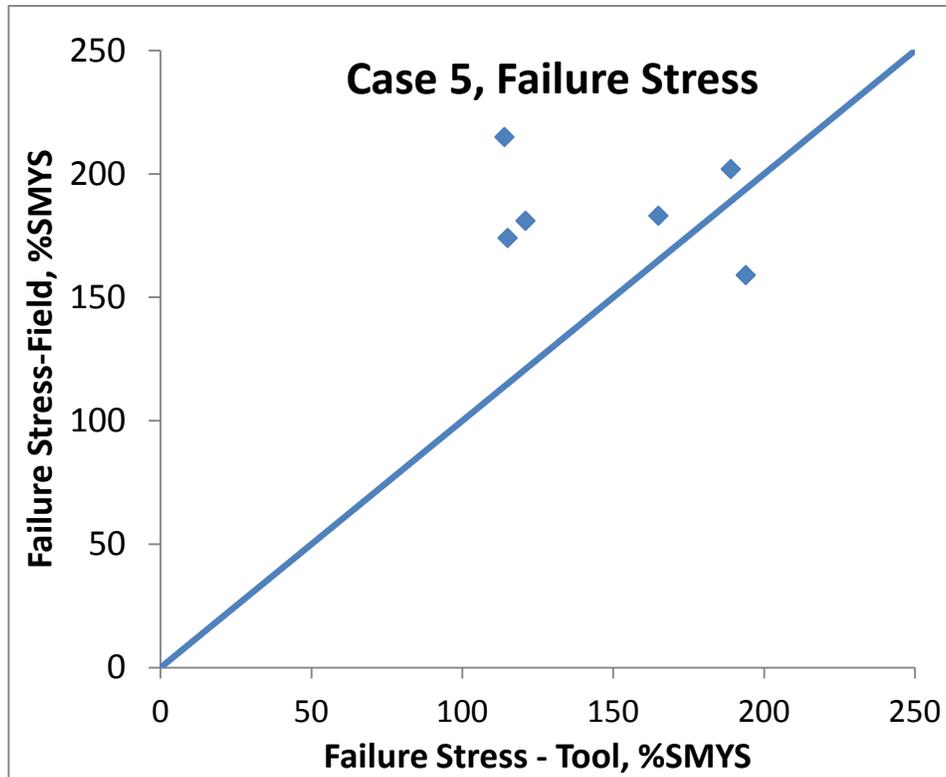
**Figure 19. Comparisons between Predicted Failure Stresses Based on Field-Measured Anomaly Dimensions and Those Based on ILI Dimensions, Case 5**

Figure 19 shows a comparison between failure stresses of the anomalies calculated on the basis of ILI dimensions and those calculated on the basis of field-measured dimensions. Failure stress levels for these anomalies were calculated using the CorLAS™ fracture mechanics model with a full-size-equivalent Charpy upper shelf energy of 7 ft-lb (based on Charpy v-notch test results for a similar material). As can be seen in Figure 19, the failure stress levels based on field-measured dimensions are above 150% SMYS. The plot shows a tendency for the ILI-based failure stress to be lower than the field-based failure stress. This is the result of most anomalies being reported as being deeper than indicated by the field NDE.

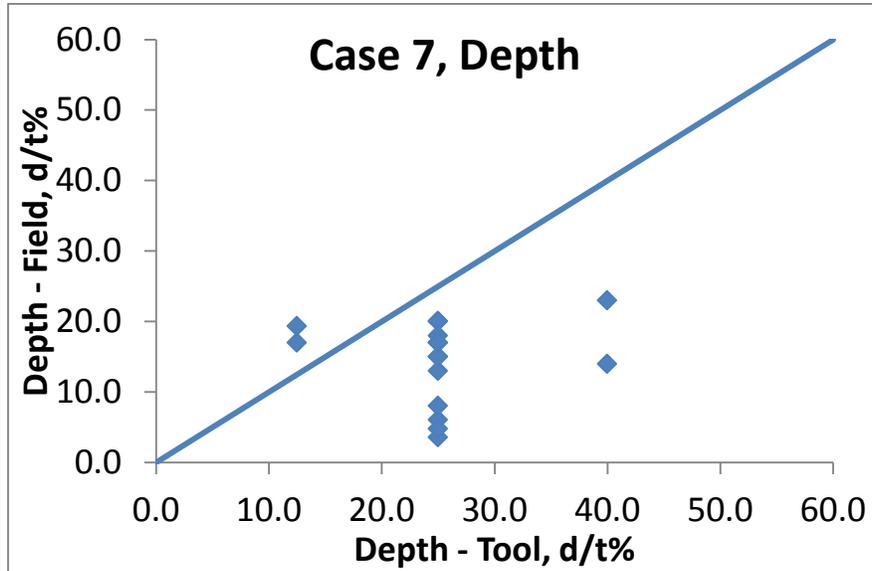
**Figure 24. Comparisons between Field-determined Anomaly Depth and ILI Anomaly Depth, Case 7**

It is seen in Figure 24 that the ILI dimensions are clustered at values of 12.5%, 25%, and 40%. That is because the depth-sizing capability of the tool was such that depth calls could only be categorized as being between 0% and 12.5% of the wall thickness, between 12.5% and 25% of the wall thickness, between 25% and 40% of the wall thickness, or greater than 40% of the wall thickness. In each case the investigating team member took the depth of the anomaly to be the highest value in the particular range. The depths of the laminations and that of the bottom dent were omitted from Figure 24 because they are not actually crack-like or weld defects. Except for two of the anomalies, the ILI depths were greater than those determined by non-destructive examination in the field. If the depths determined in the field non-destructive examinations can be believed to be accurate, the tool was over-estimating the depths of the anomalies in most cases.

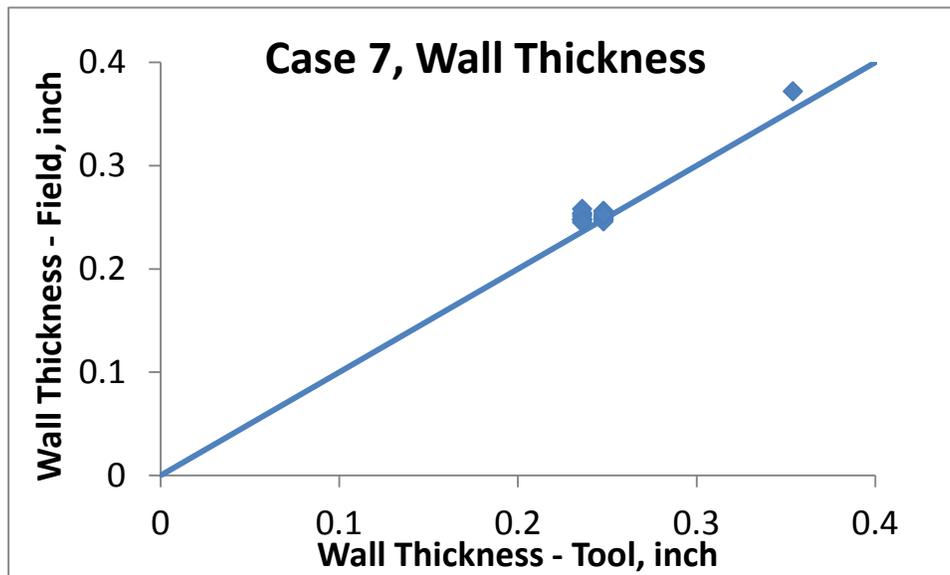
**Figure 26. Comparisons between Field-determined Wall Thickness and ILI Wall Thickness, Case 7**

Figure 26 illustrates the degree to which the wall thicknesses indicated by the ILI aligned with those measured in the field. The alignment is very good.

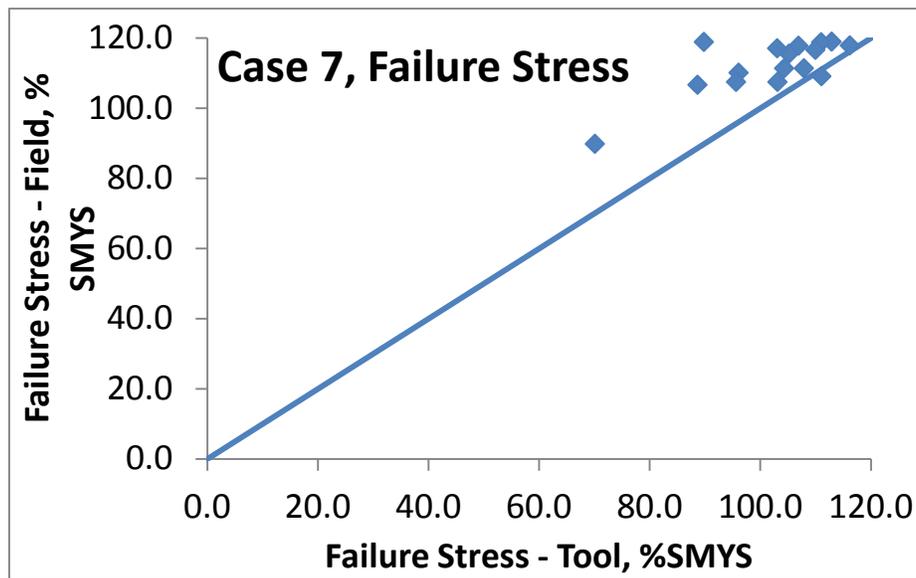
**Figure 27. Comparisons between Predicted Failure Stresses Based on Field-Measured Anomaly Dimensions and Those Based on ILI Dimensions, Case 7**

A comparison between failure stresses of the anomalies calculated on the basis of ILI dimensions and those calculated on the basis of field-measured dimensions is presented in Figure 27. Failure stress levels for these anomalies were calculated using the Modified Ln-Sec Equation Elliptical C-Equivalent model with a full-size-equivalent Charpy upper shelf energy of 20 ft-lb. In one case (Anomaly No. 14), the calculated failure stress based on the ILI dimensions was 70.1% of SMYS. In contrast, the calculated failure stress based on the field-measured dimensions was 89.8% of SMYS. The disparity is largely the result of the large difference between the ILI depth (40% of SMYS) and the field-measured depth (23% of SMYS).

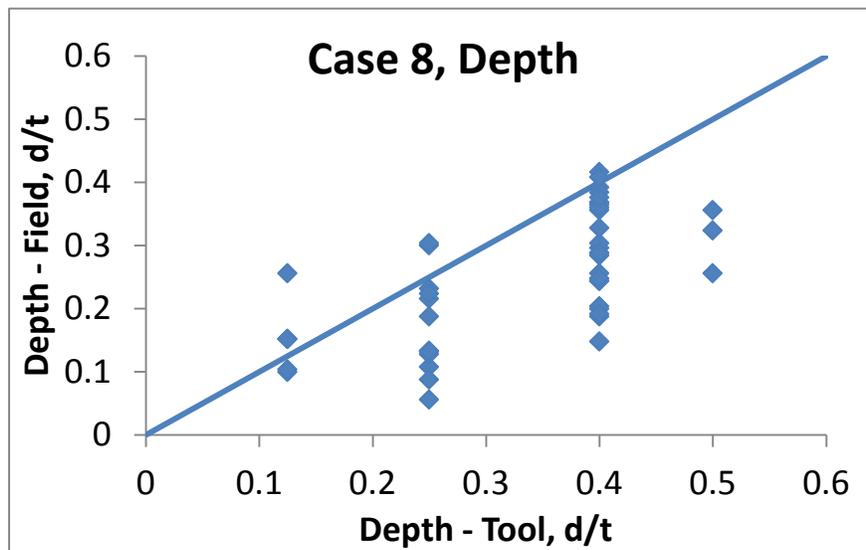
**Figure 28. Comparisons between Field-determined Anomaly Depth and ILI Anomaly Depth, Case 8**

It is seen in Figure 28 that the ILI dimensions are clustered at values of 12.5%, 25%, 40% and 50%. That is because the depth-sizing capability of the tool was such that depth calls could only be categorized as being between 0% and 12.5% of the wall thickness, between 12.5% and 25% of the wall thickness, between 25% and 40% of the wall thickness, or greater than 40% of the wall thickness. In each case the investigating team member took the depth of the anomaly to be the highest value in the particular range and values exceeding 40% to be 50%. Except for four of the anomalies, the ILI depths were greater than those determined by non-destructive examination in the field. If the depths determined in the field non-destructive examinations can be believed to be accurate, the tool was over-estimating the depths of the anomalies in most cases.
