Federal Highway Administration
Every Day Counts
Innovation Initiative

Safety Edge_{SM}
Demonstration Project
Seaford, Delaware

Field Report
January 30, 2011

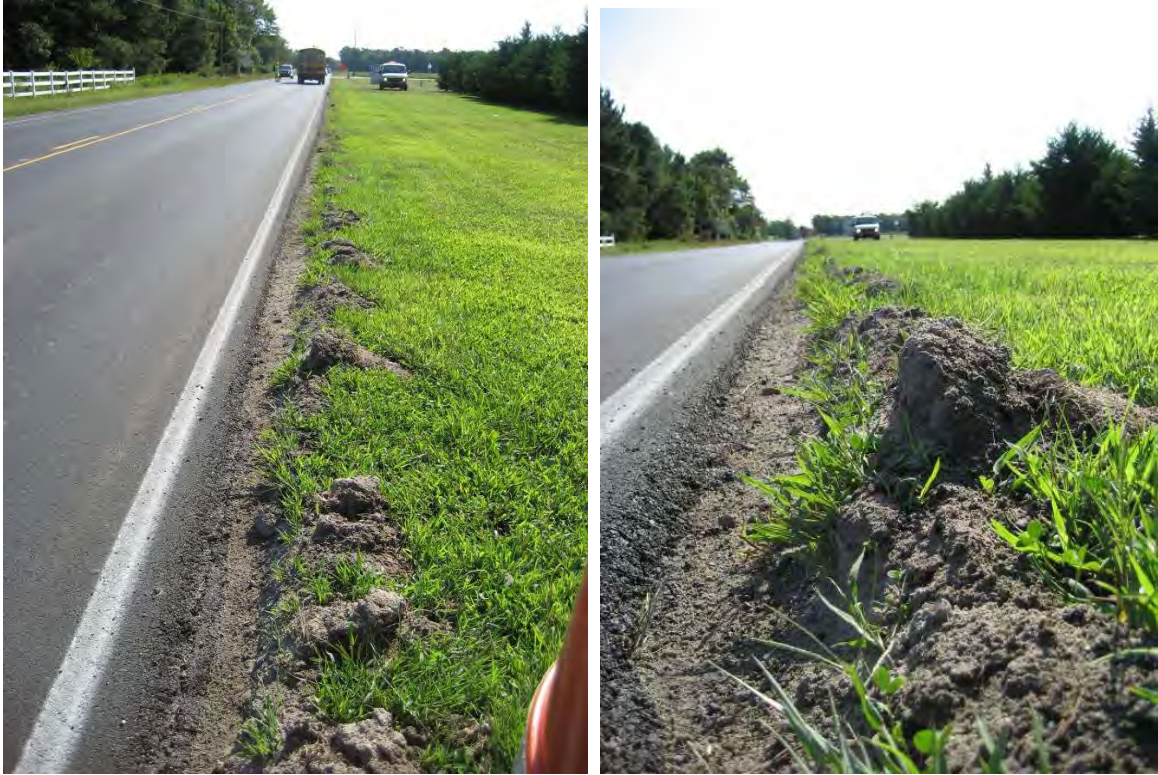
Figure 4. Edge of pavement graded in some areas to remove grass and debris.

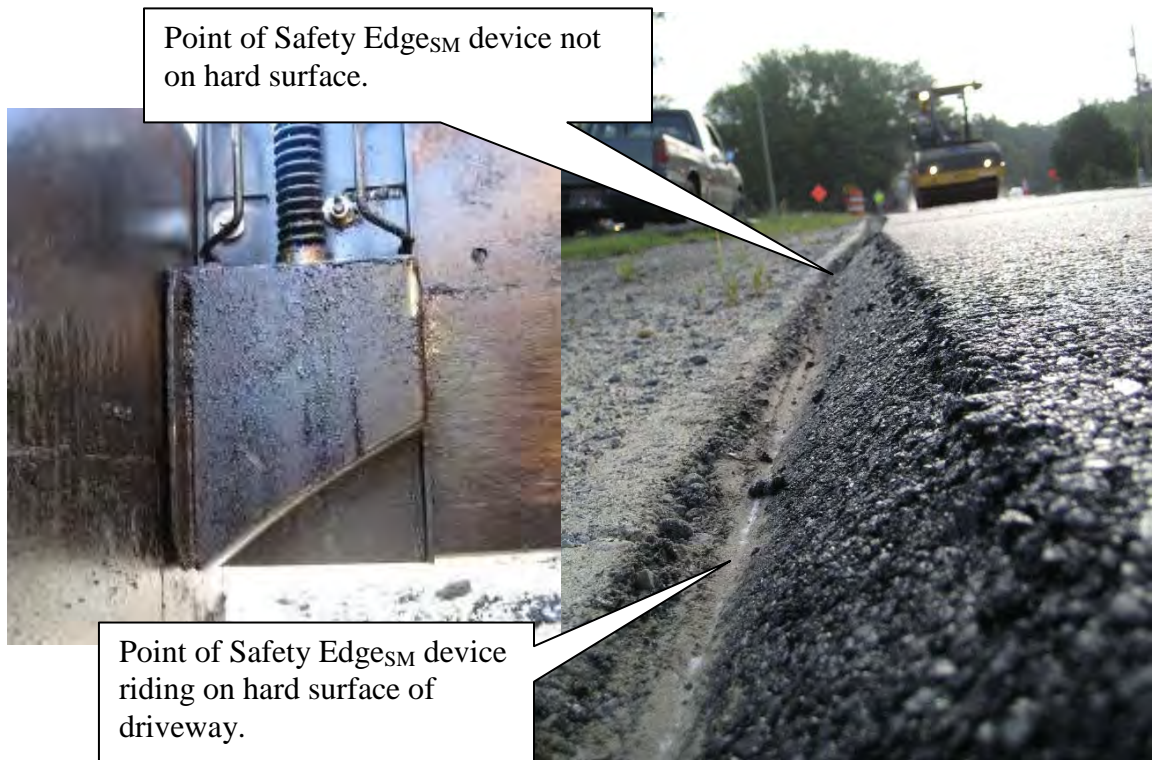
Both contractor and agency personnel stated the Safety Edge_{SM} device would raise the screed relative to the profile set by the longitudinal ski when paving across intersections or in areas with higher longitudinal profile with hard surfaces. In addition, both commented that it was difficult to get a good tie-in to existing driveways and other hard surfaces. Figure 18 shows the line caused by the tip of the Safety Edge_{SM} device along the edge of pavement over an intersection driveway.

Figure 18. Point of Safety Edge_{SM} scratching the surface of an intersecting driveway.

- After the evaluation, the Delaware DOT management stated that overlays greater than 1.25 inch will have the Safety Edge_{SM}.
- Paving across driveways and other features with hard surfaces causes the screed to rise resulting in a reduction of smoothness in localized areas.

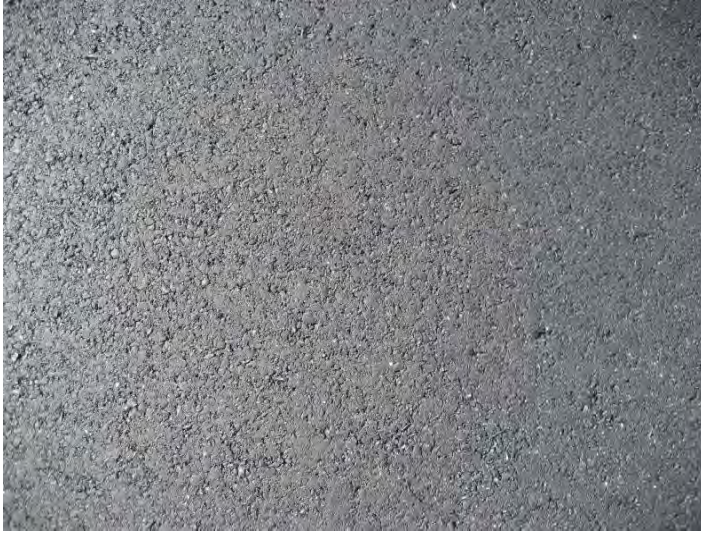
Example showing an area with a tight surface, fine texture of the mat; small surface voids.

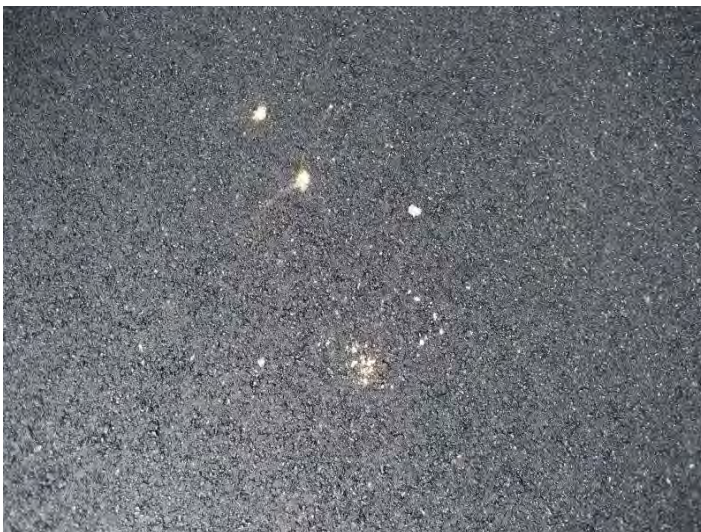
Example showing an area with localized crushed aggregate at the surface of the mat.

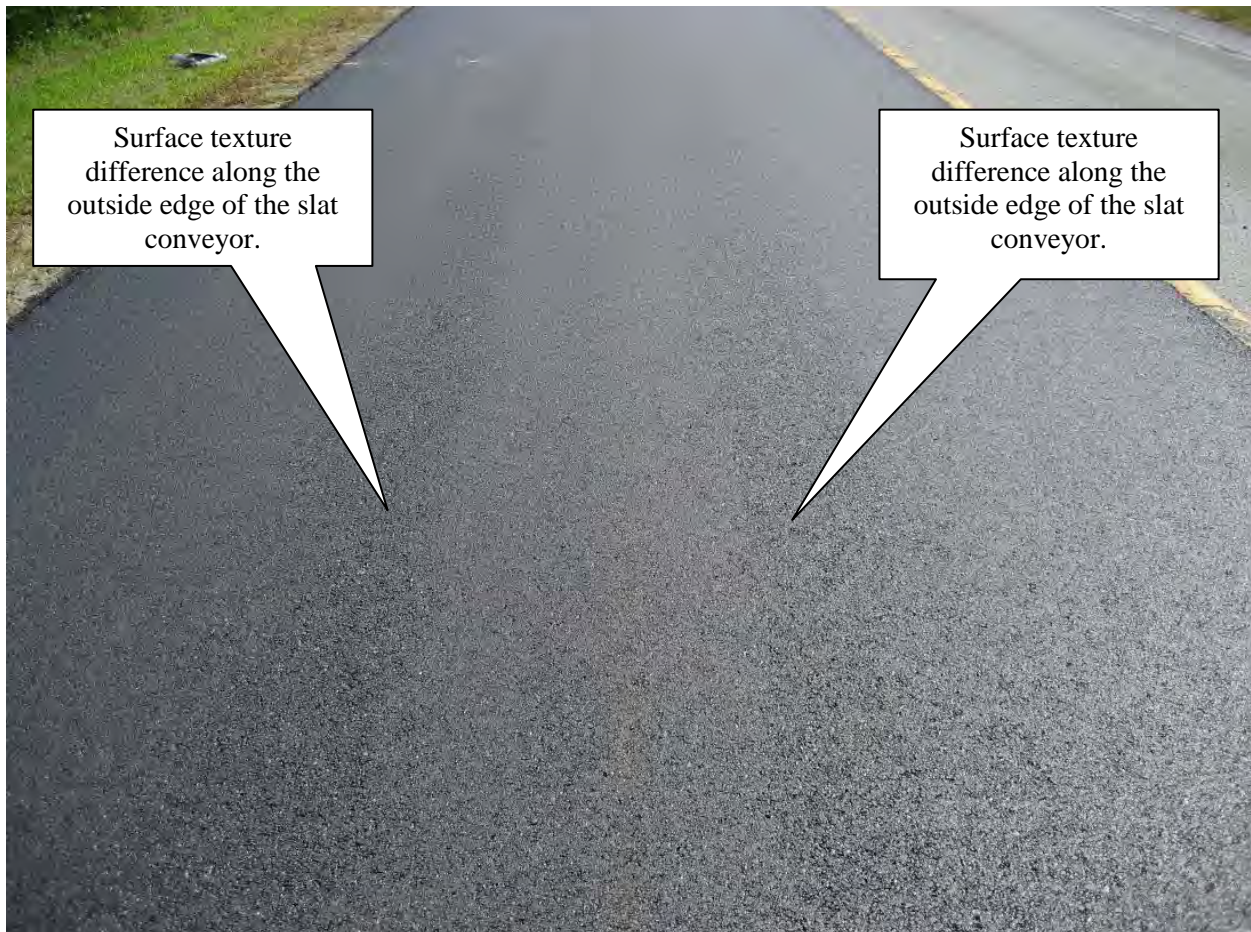
Longitudinal segregation or surface texture difference was observed along the edges of the slat conveyor (refer to Figure 23). Bulk mixture samples (for gradation testing), nuclear gauge

Figure 23. Longitudinal segregation or surface texture differences along the edge of both slat conveyors.

Thus, it was not confirmed whether these areas shown in Figure 23 were caused by segregation or surface texture difference near the surface. It was expected that these areas were a result of longitudinal segregation along the edges of the slat conveyor of the paver. Densities were taken with the nuclear density gauge for the non-Safety Edge_{SM} section near the area in question and some of these densities were found to be low (and high air voids).
