Main Reservoir Failures on General Electric Locomotives

Motive Power and Equipment Div.

May 18, 2005

MR Failures on GE Locomotives

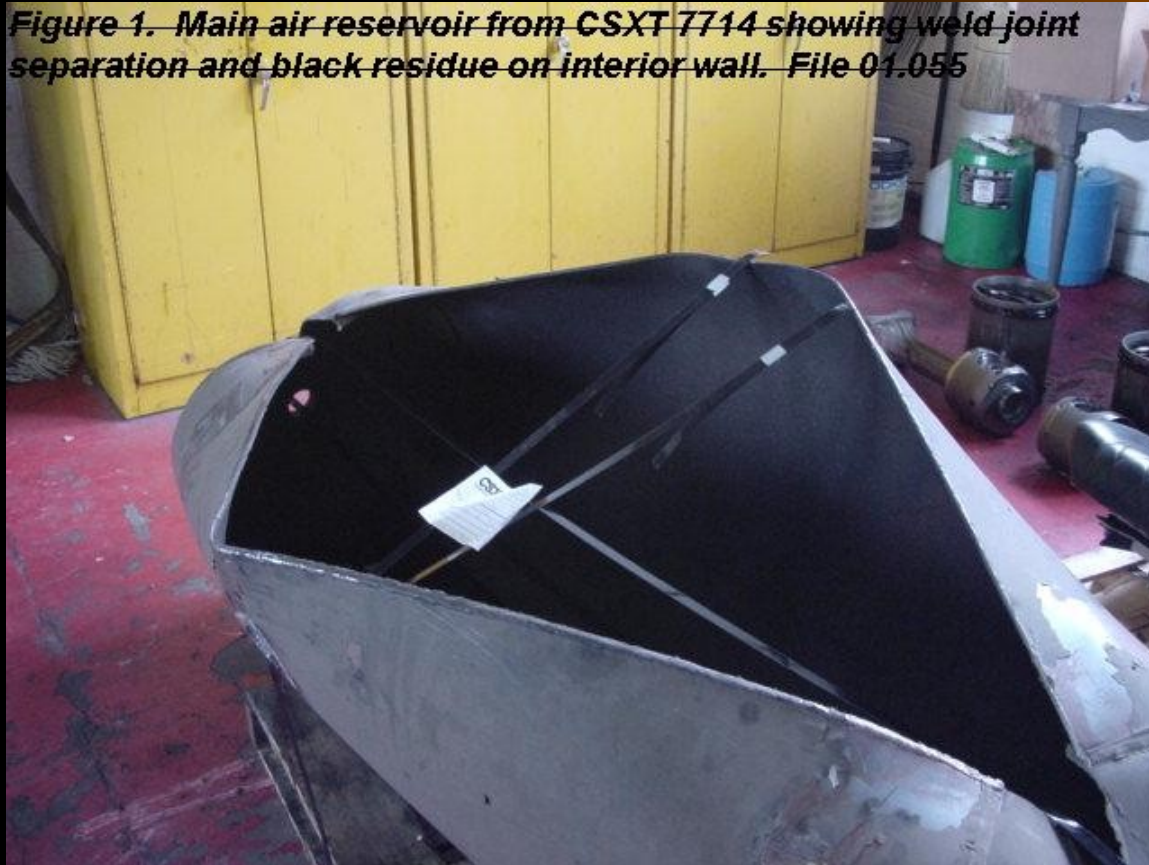
Figure 1. Main air reservoir from CSXT 7714 showing weld joint separation and black residue on interior wall. File 01.055

- BNSF inspected 468 reservoirs from the suspect group and found 65 which failed the gauge test.
- UP has expressed a desire to replace all R&R reservoirs in its fleet.
- CSXT did a laboratory analysis of a failed MR and found the proper base metal, but an inferior weld that lacked full penetration and fusion.

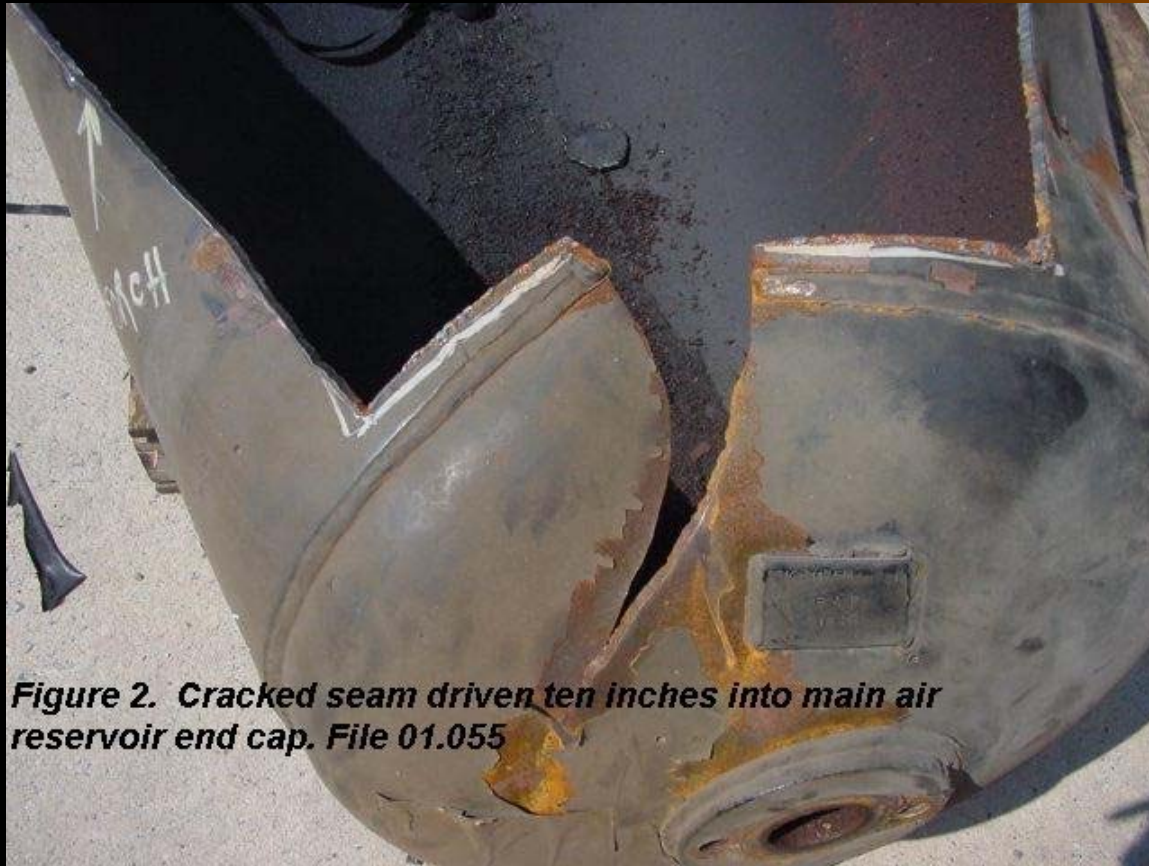
Figure 2. Cracked seam driven ten inches into main air reservoir end cap. File 01.055
