DOT US Department of Transportation  
PHMSA Pipelines and Hazardous Materials Safety Administration  
OPS Office of Pipeline Safety  
Western Region

**Principal Investigator** Peter J. Katchmar  
**Regional Accident Coordinator** Peter J. Katchmar  
**Region Director** Chris Hoidal  
**Date of Report** October 30, 2012  
**Subject** ExxonMobil Silvertip Pipeline Crude Oil Release into the Yellowstone River in Laurel, MT on 7/1/2011

## **Executive Summary**

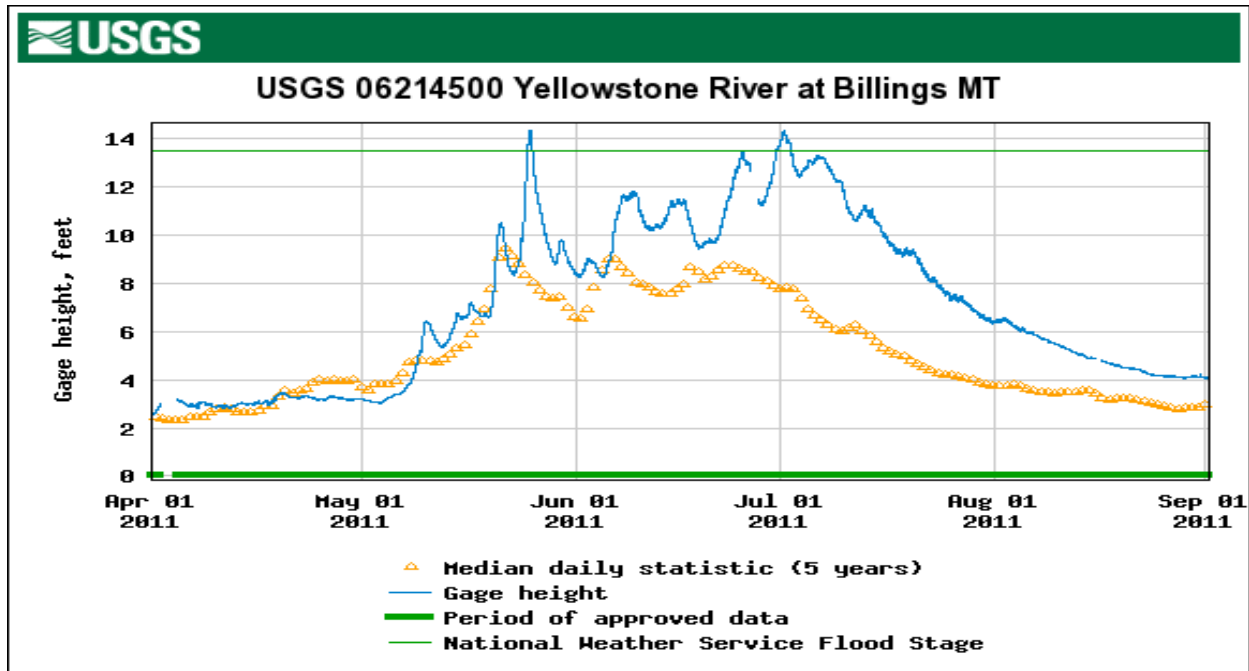
It appears that 2011 was the only year that the flood stage was exceeded at the gauge point. Of note is the fact that flood stage was exceeded 3 times in 36 days in 2011. In previous years the river would rise and then fall again in a relatively short time period and the water level did not rise above the twelve foot level. In 2011, the river rose and remained high for over a month. The prolonged high water level caused the river bottom downstream of the Highway 212 Bridge to scour and ultimately undermine the EMPCo pipeline.

Graph of gauge height April 1, 2011 through September 1, 2011.

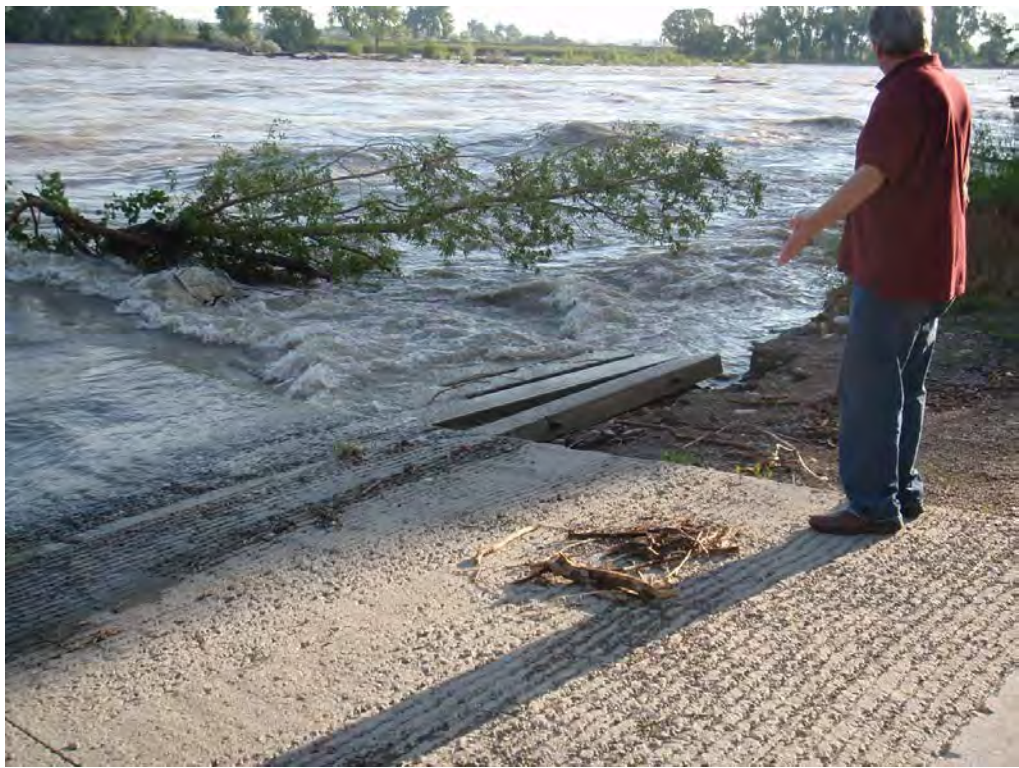
Looking NE from south bank of the Yellowstone River at the boat ramp just upstream of the EMCO crossing. Picture was taken Thursday, July 07, 2011, 9:24:08 AM 6 days after line rupture. The man is showing the location of the water on the south bank the day before. Notice the island is not visible. Also notice the debris pile in the river.

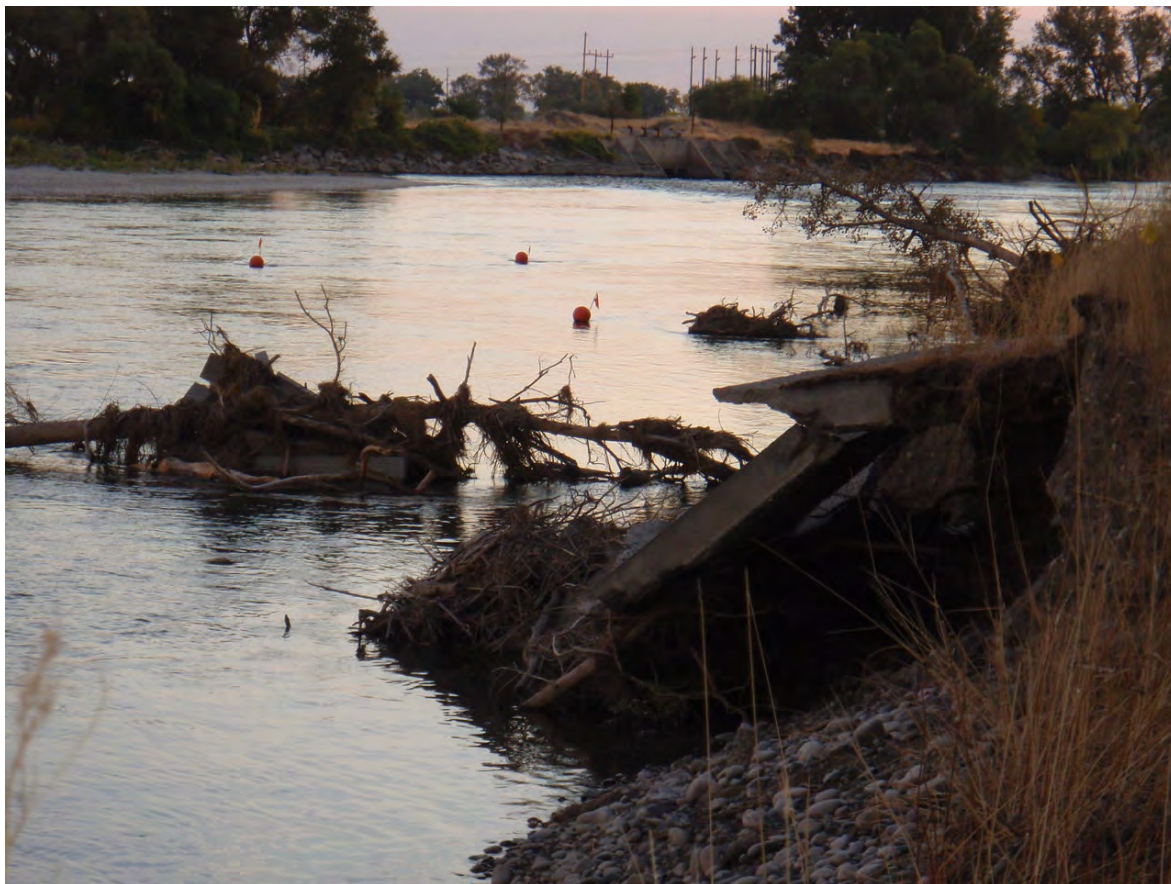
Looking NE from south bank of the Yellowstone River at the boat ramp just upstream of the EMCO crossing. Picture was taken Thursday, September 29, 2011, 2:52:11 PM after the river level dropped. One can see the same debris pile in the river as was in the last picture. The concrete seen in the foreground of this picture is the boat ramp in the previous picture. The buoy furthest to the right is marking the north end of the rupture from the south bank. The next buoy is marking the south end of the rupture from the north side of the main channel off of the island.

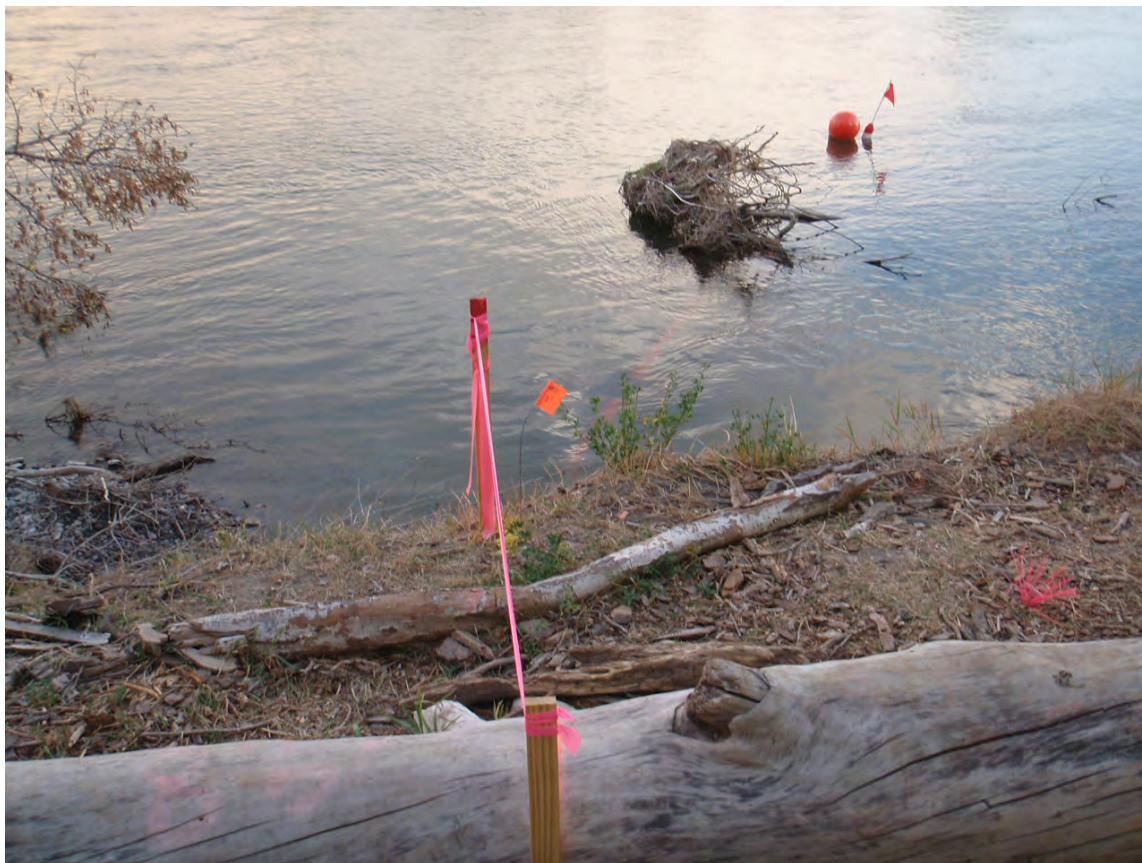
Picture taken from the south bank looking north on Thursday, September 29, 2011, 2:55:09 PM. One can see the pipe deflection downstream under the water. The buoy is marking the north end of the ruptured pipe from the south bank. The two lath tied together with pink ribbon are in line with the original pipeline right-of-way alignment from south to north. One can see a root ball that appears to be hung up on the pipeline. The red abrasive resistant fusion bonded epoxy (FBE) coating can be seen on the pipe. The pipe was originally concrete coated over the FBE coating.

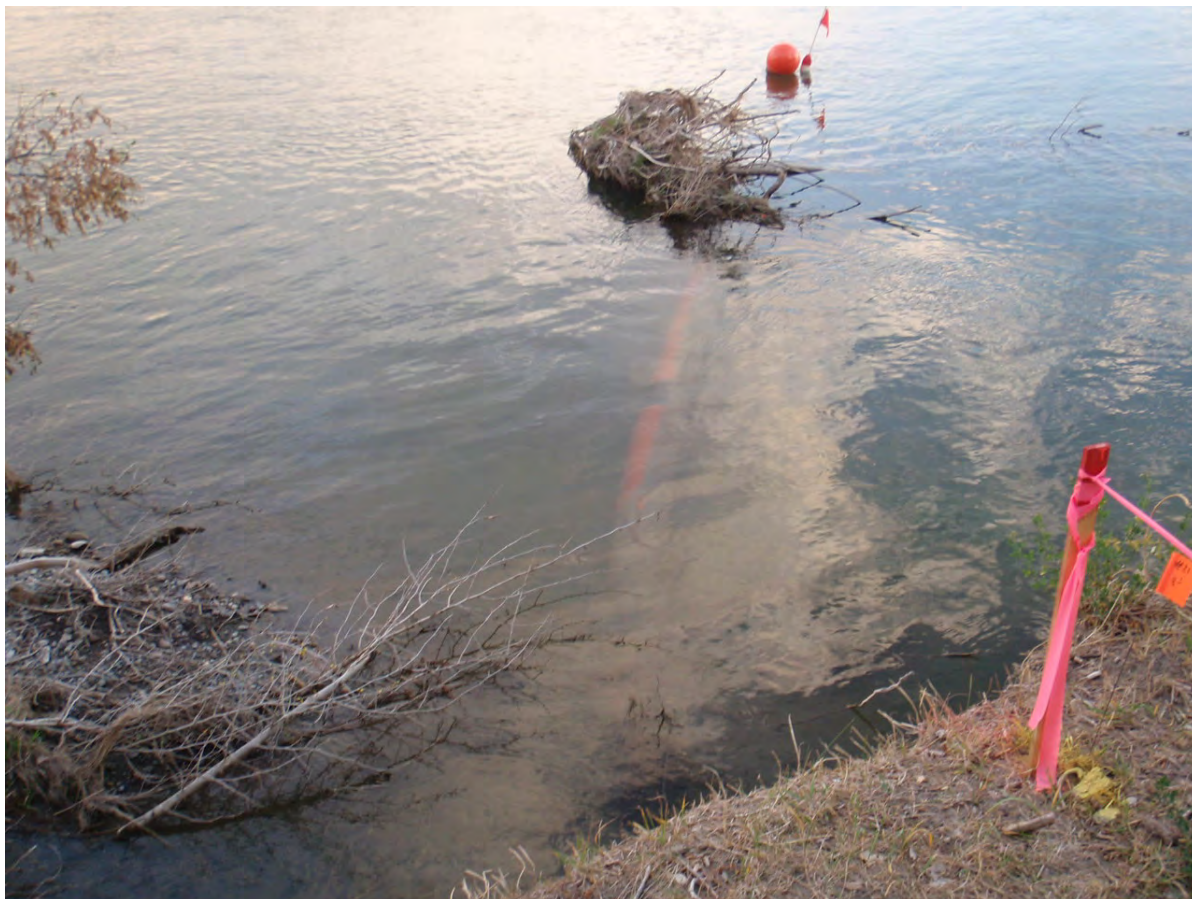
Picture taken on Thursday, September 29, 2011, 2:56:30 PM. Close up of the pipe from the south bank. Buoy is marking the north end of the rupture from the south bank pipe.

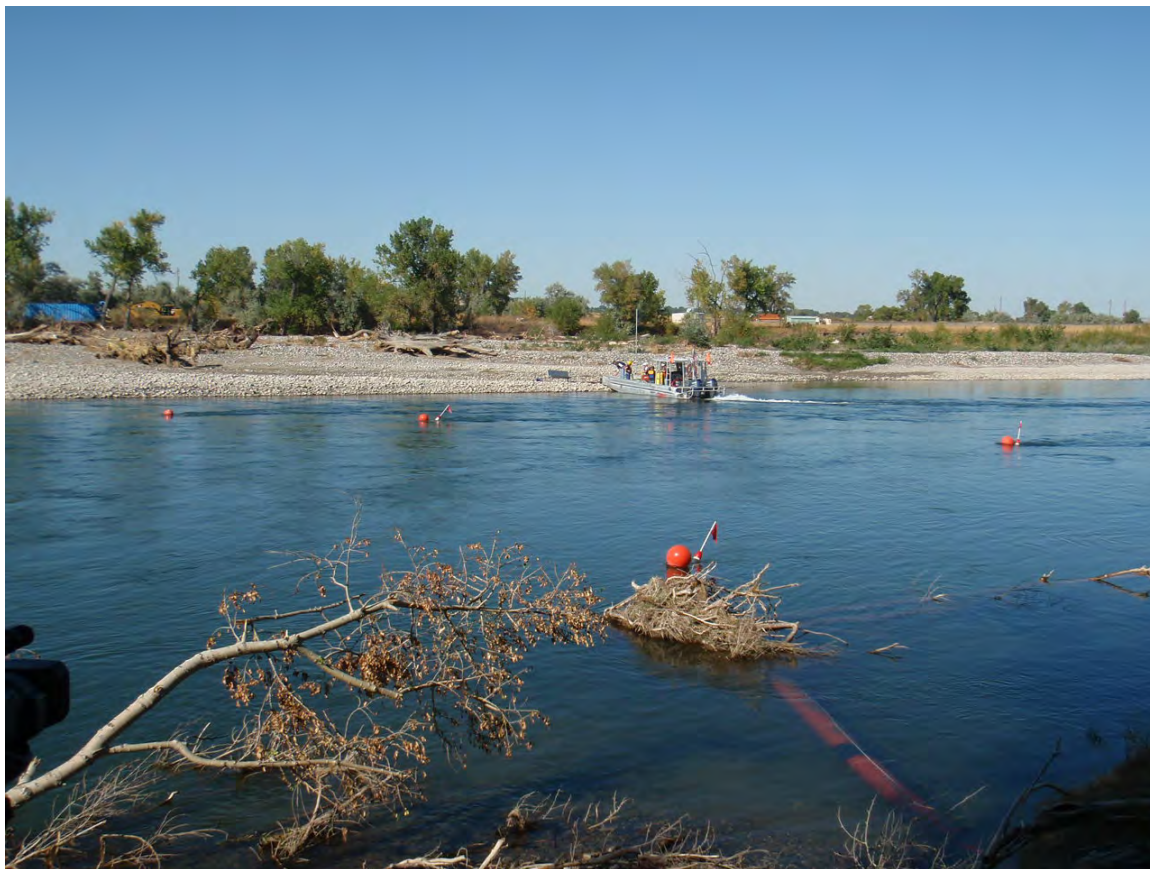
Looking NE from the south bank. Picture taken on Thursday, September 29, 2011, 2:59:16 PM. EMCO pipeline is visible under the water.

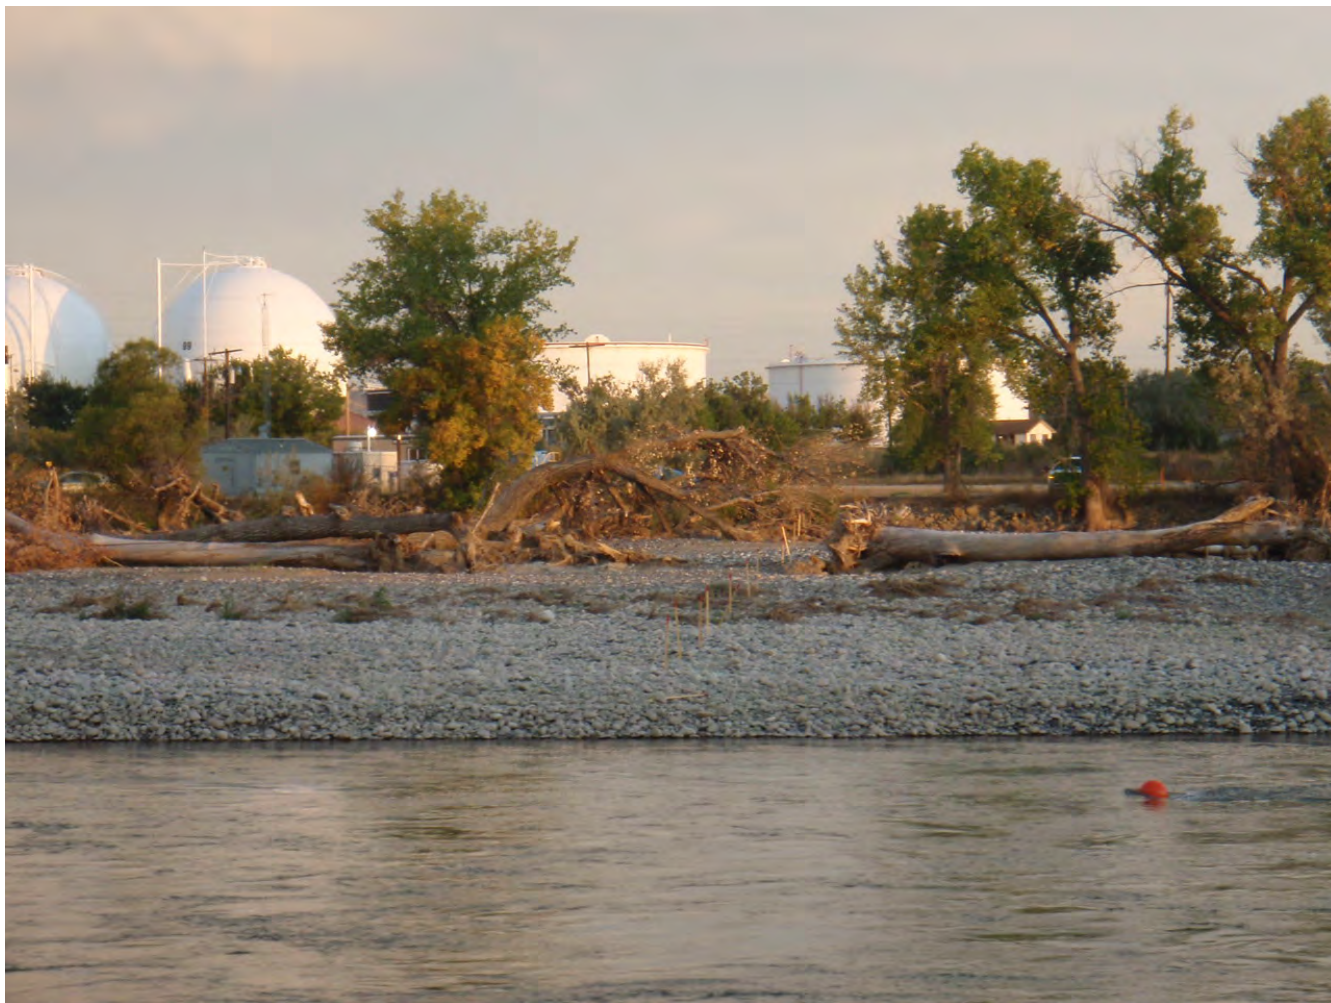
Looking north along original pipeline right-of-way alignment from the south bank taken Thursday, September 29, 2011, 2:55:19 PM. One can see the pipeline marked with lath and ribbon across the island and the first buoy to the south from the island that marks the pipe location being deflected downstream.

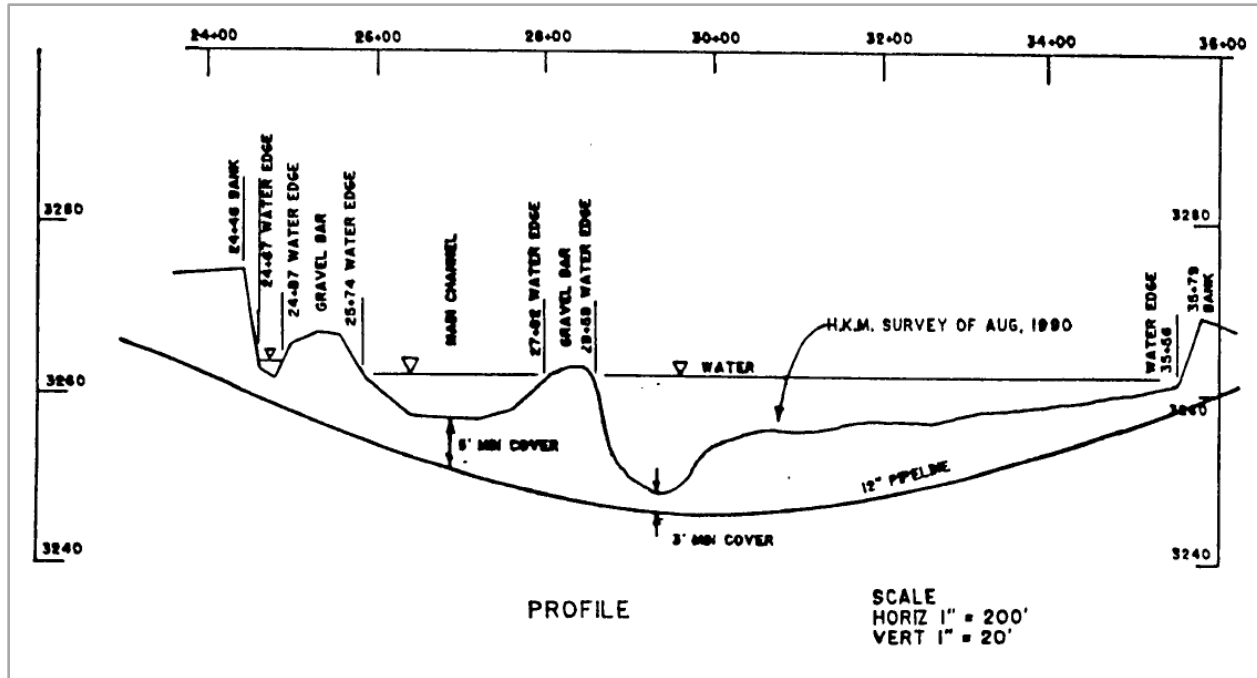
Figure 1. River Crossing Profile

The total length of pipe exposed by the flood was 207 ft. The failure occurred in the wider south channel, approximately 51 ft from the south bank.

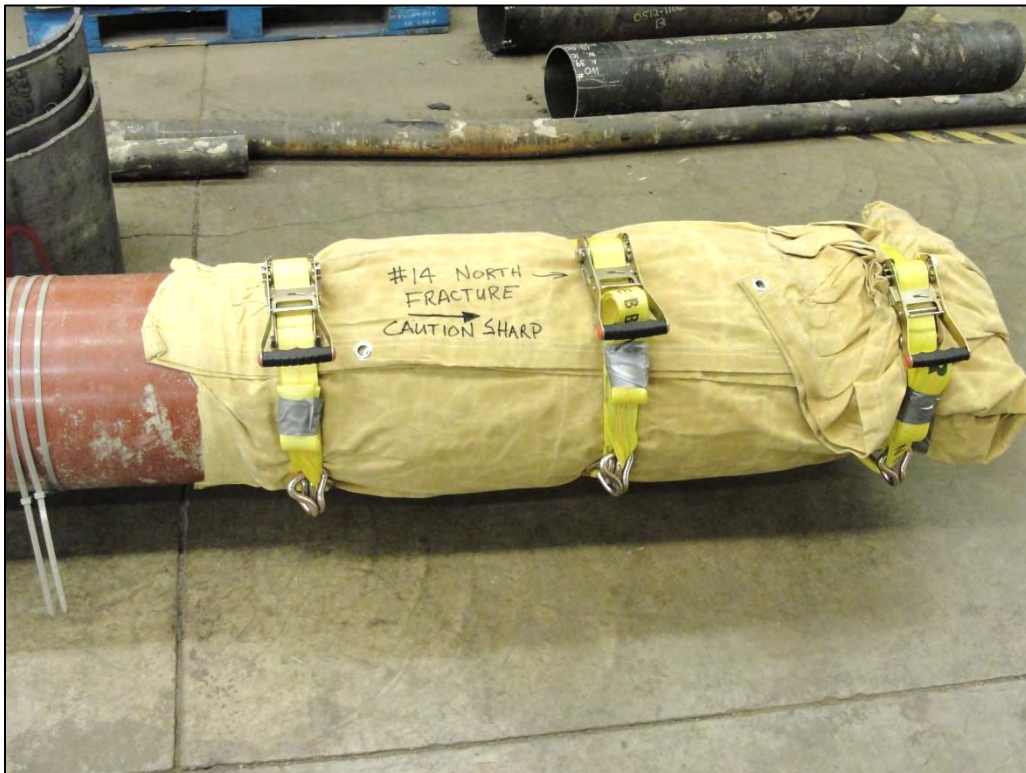
**Figure 3. Fractured end of Pipe 014 as received**

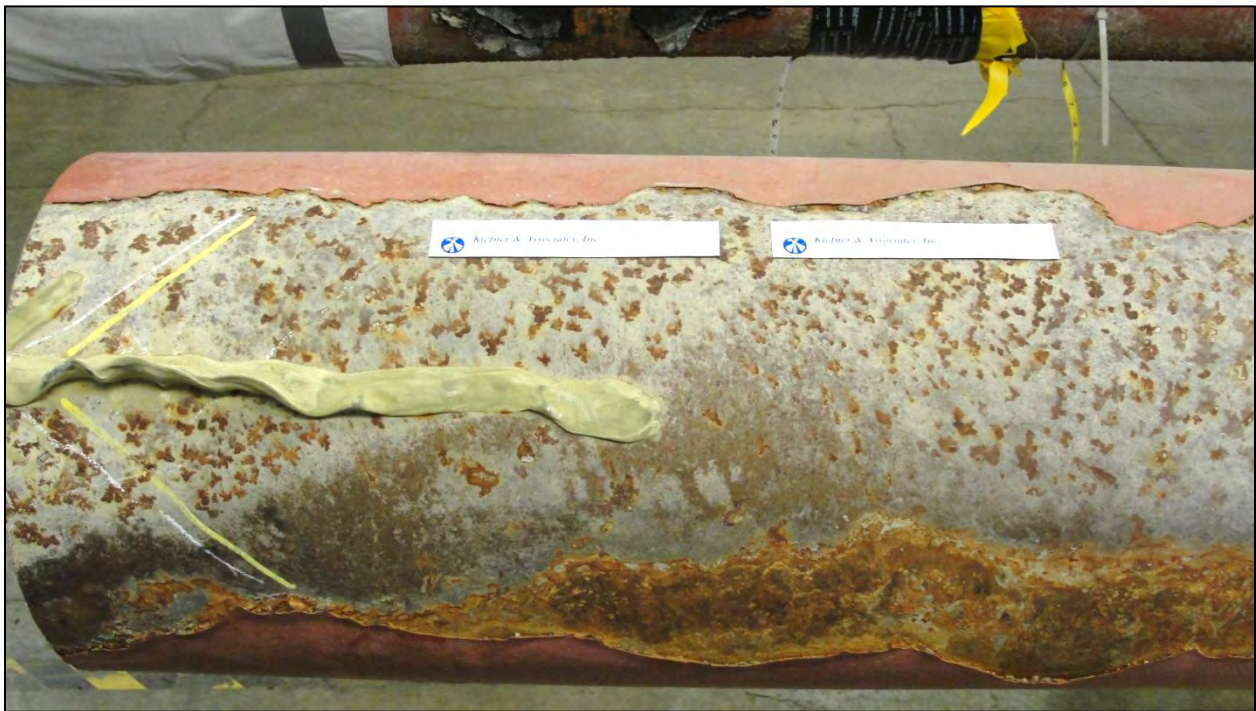
Both pipe samples were coated with red fusion-bonded epoxy (FBE) coating that had apparently been worn away to bare metal over large areas along the length of the pipe samples. For example, there were two bare areas on Pipe 024 that spanned the full length of the sample and measured 11 to 16 inches wide, separated by a strip of intact coating that measured 24 to 29 inches wide. Figure 4 shows a typical area of eroded coating on Pipe 024. Debris was impacted under the edges of the intact coating, as shown in Figure 5.

**Figure 4. Area of coating erosion on Pipe 024**

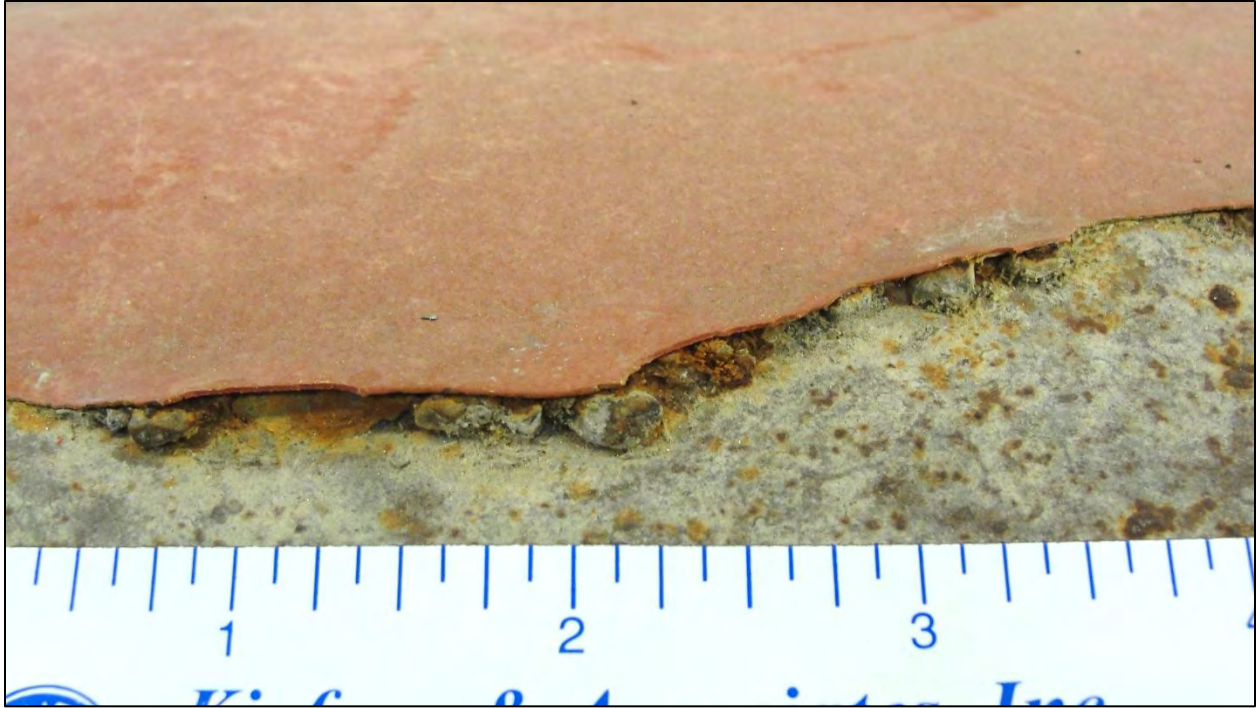
**Figure 5. Debris impacted under edge of intact coating**

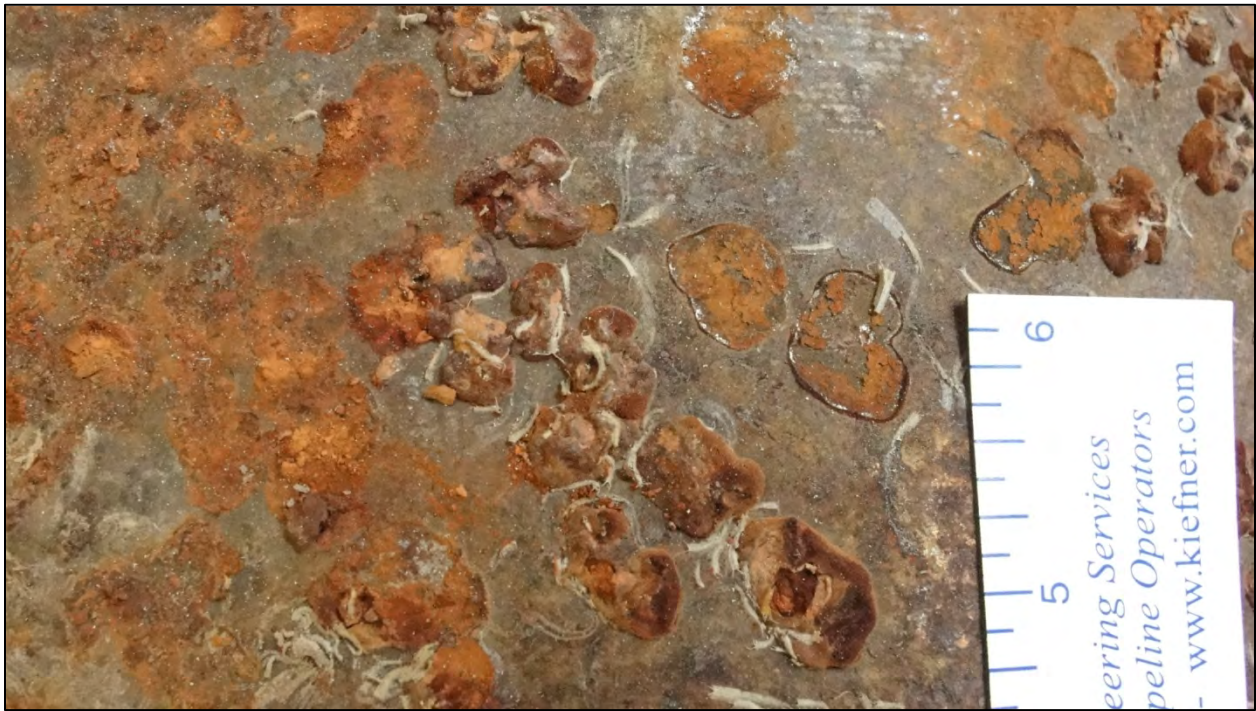
**Figure 9. Corrosion under biotic mass**

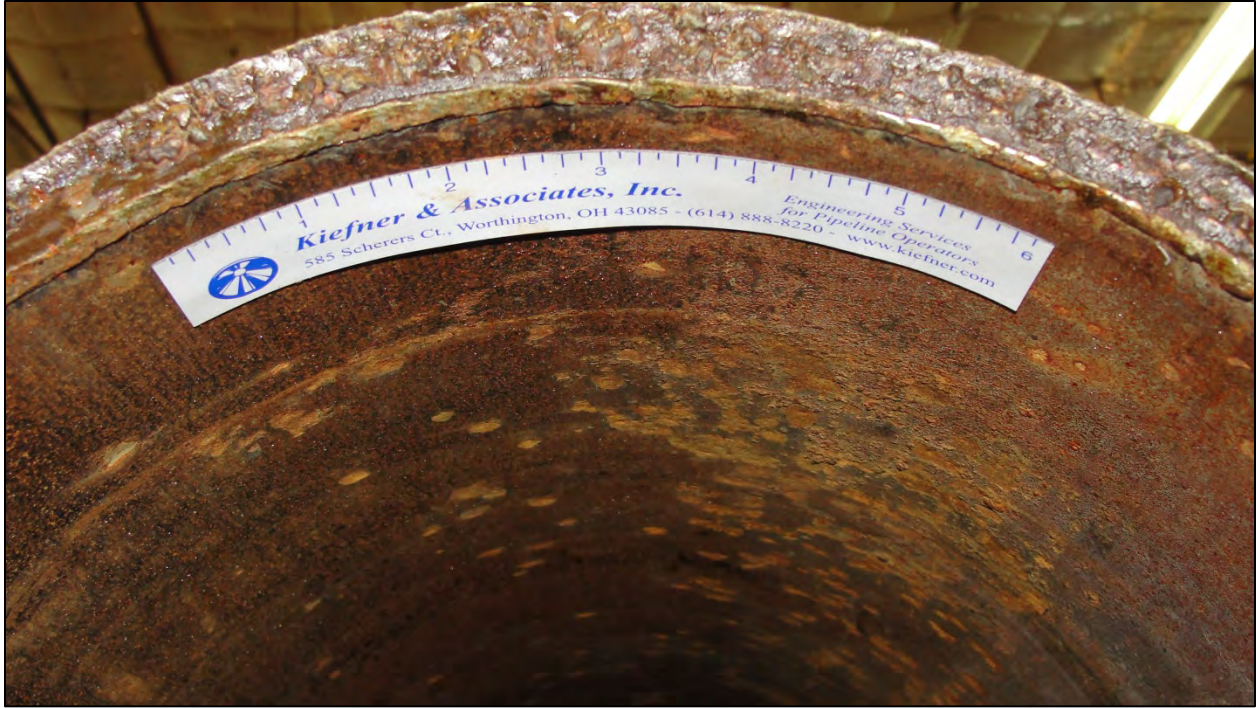
The protocol called for examining the interior surface of Pipe 014 and Pipe 024 near the fracture. The interior of the pipe was bare and was covered in a layer of orange-colored film, likely a surface rust from exposure to water and air, visible in Figure 10 as observed typically. The interior pipe surfaces exhibited light surface pitting, similar to the pitting observed on the exterior surface of the pipe where the coating had been removed. The metal loss was superficial in depth.

**Figure 11. Interior Surface Pitting**

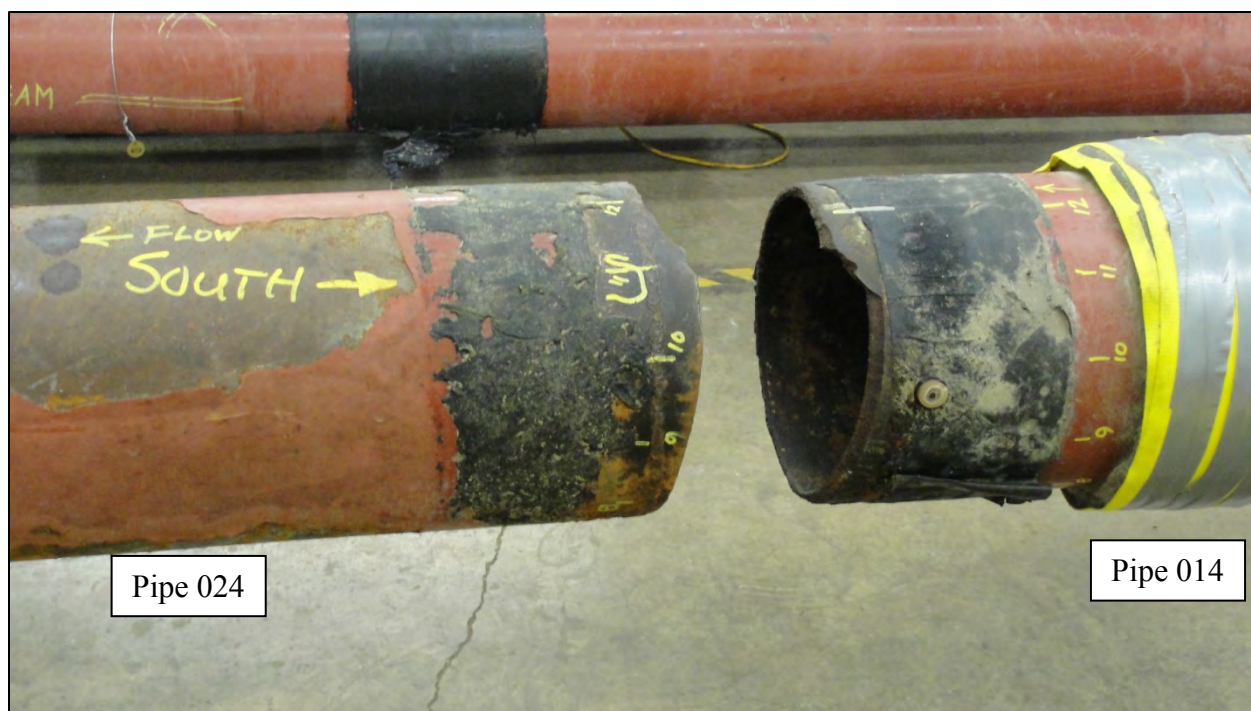
The failure occurred as a circumferential fracture in and adjacent to the girth weld joining Pipe 014 and Pipe 024. The fracture propagated in the girth weld for a distance of approximately 28 inches and in the adjacent pipe (Pipe 014) for a distance of approximately 12 inches. The fracture is shown in Figure 12 through Figure 14. The markings visible in the figures indicate the orientation of the pipe in service. The positioning in Figure 14 is approximately the same as in service.

**Figure 14. Fractured ends of the pipe aligned**

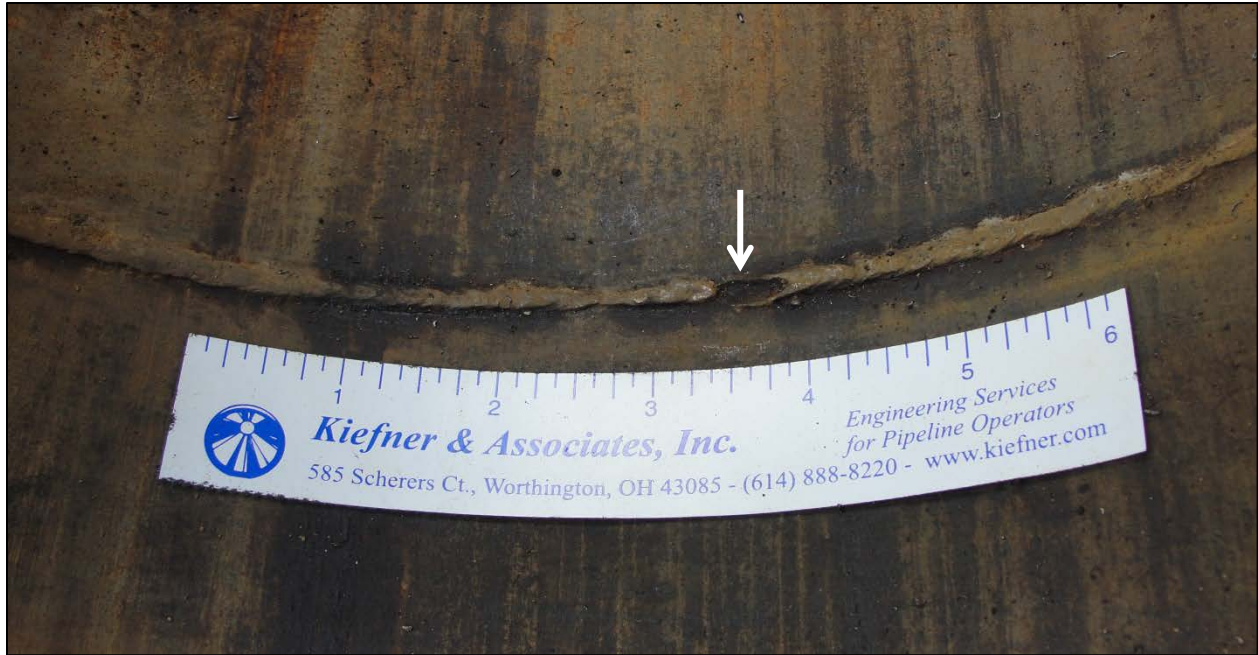
Figure 16 shows the burn-through feature in Weld 026. Figure 17 shows inadequate penetration in Weld 030. Minor interior beveling is shown in these views as well. Figure 18 exhibits the minor high-low across Weld 030, typical also of the failed weld.

**Figure 16. Burn-through Feature, Weld 026**

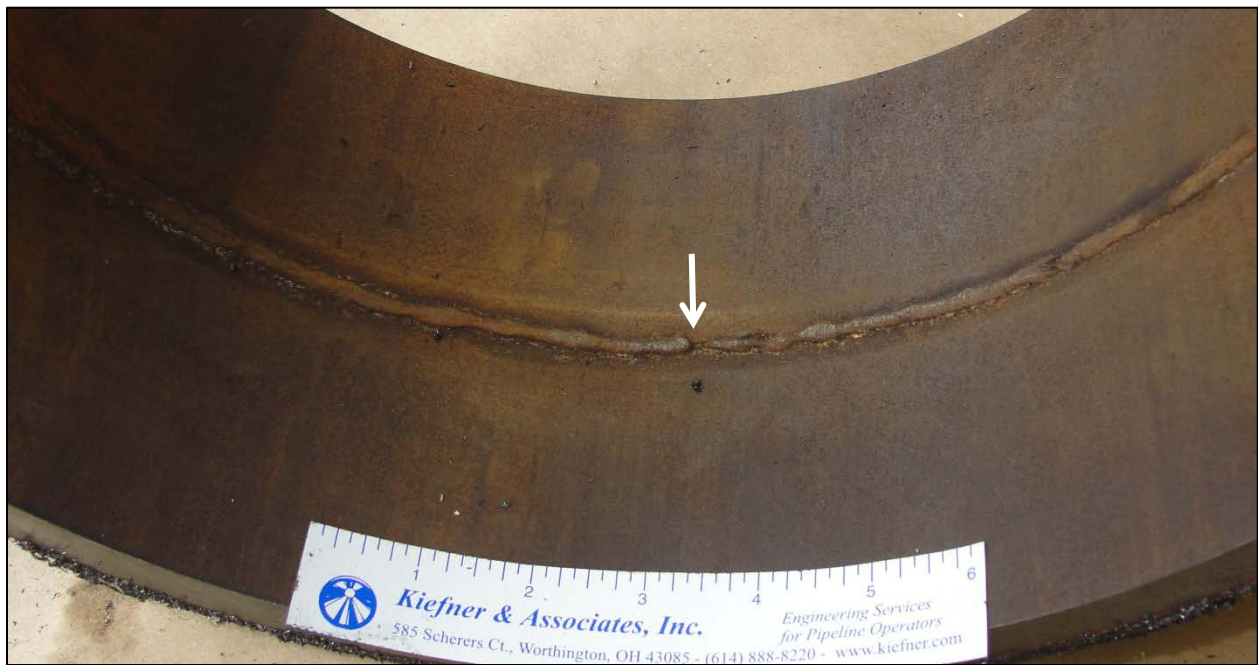
**Figure 17. Inadequate Penetration Feature, Weld 030**

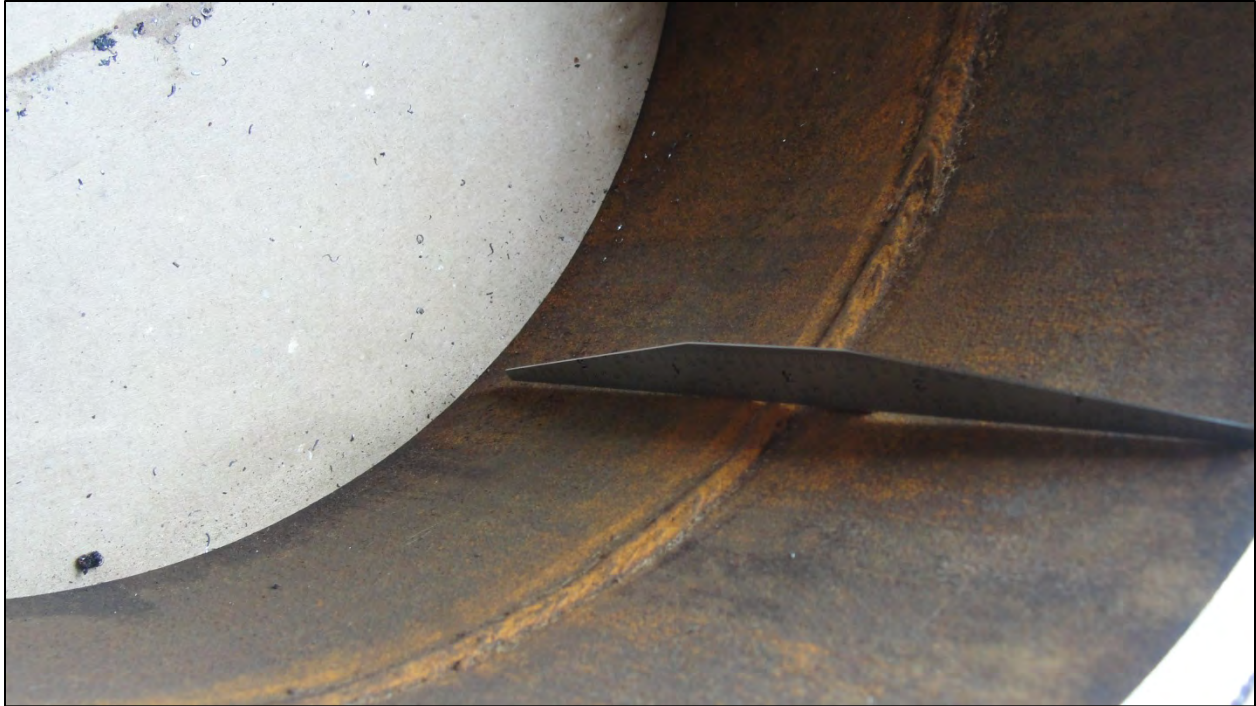
**Figure 18. Fit-up Across Weld 030**

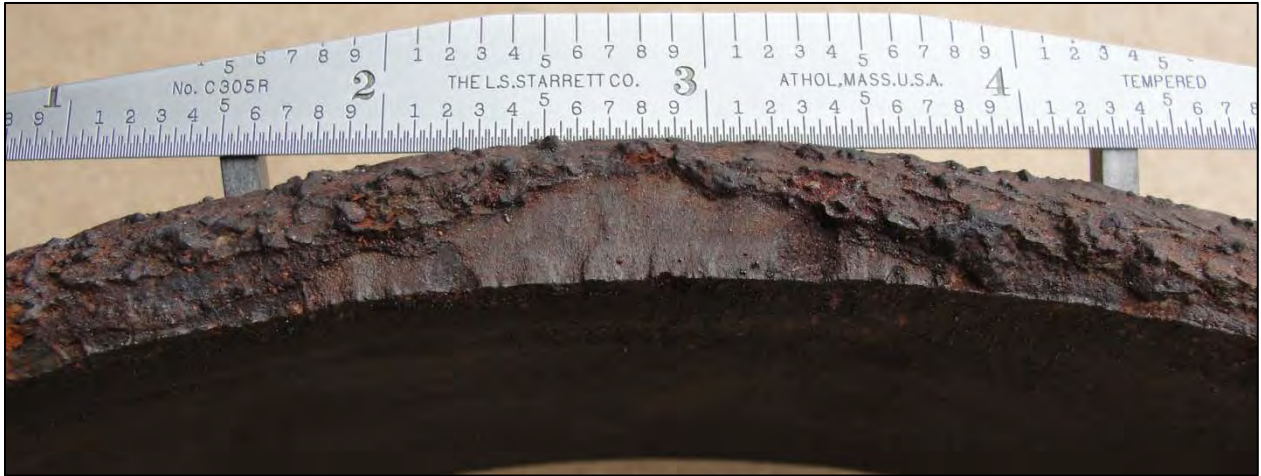
Two areas of relatively flat fracture were present on the fracture surfaces. The areas were not in equal condition, such that one feature was more visible on one side of the fracture, and the other feature was more visible on the opposite side. The larger of the two features, labeled feature “L”, is shown in Figure 20 and measured 10.5 inches long on the interior pipe surface. This feature was through-thickness near the mid-length. The smaller of the two features, labeled feature “S” is shown in Figure 21 and measured 3.1 inches long by approximately 70% of the wall thickness in depth.

**Figure 22. Fracture surface of Pipe 014 showing Feature “S”**

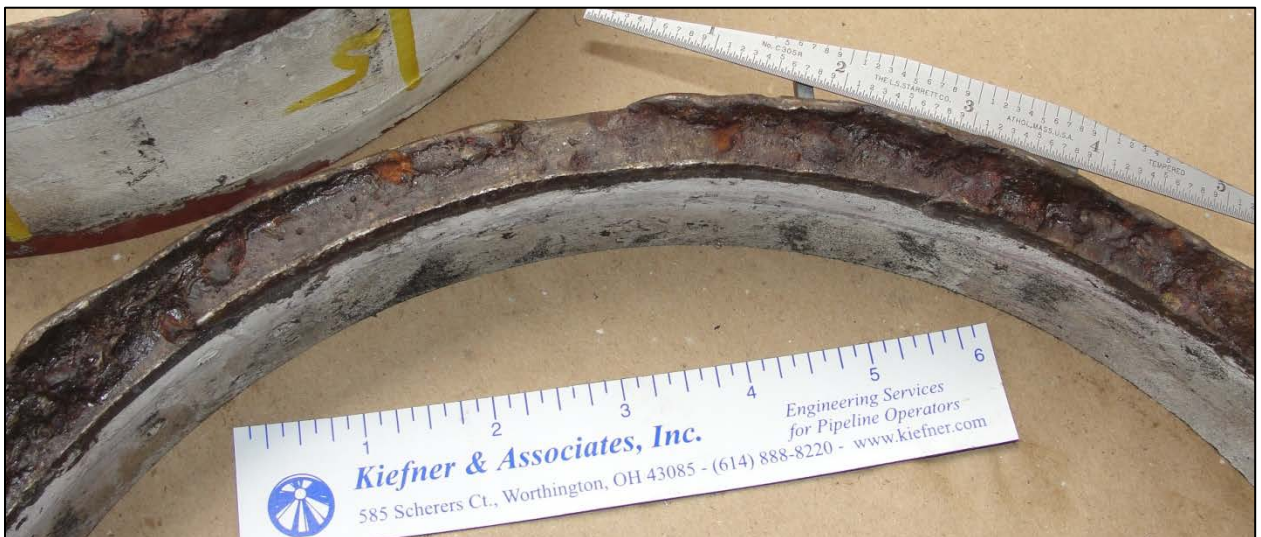
**Figure 23. Fracture surface of Pipe 024 showing Feature “L”**

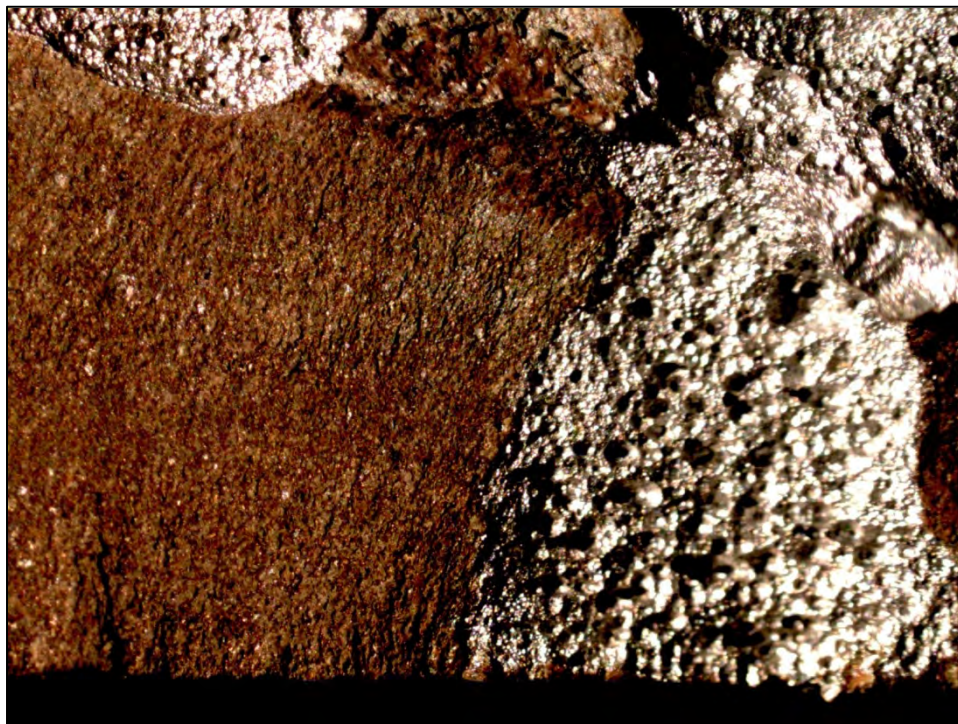
The samples were examined in an optical microscope after cleaning. The original fracture surface had a medium brown color. After cleaning, small light gray areas were visible. These light gray areas exhibited evidence of pitting when viewed on an optical microscope. A detail of pitting adjacent to the flat feature on specimen S1 is shown in Figure 28.

**Figure 28. Detail of Pitting Under Biotic Adherent**

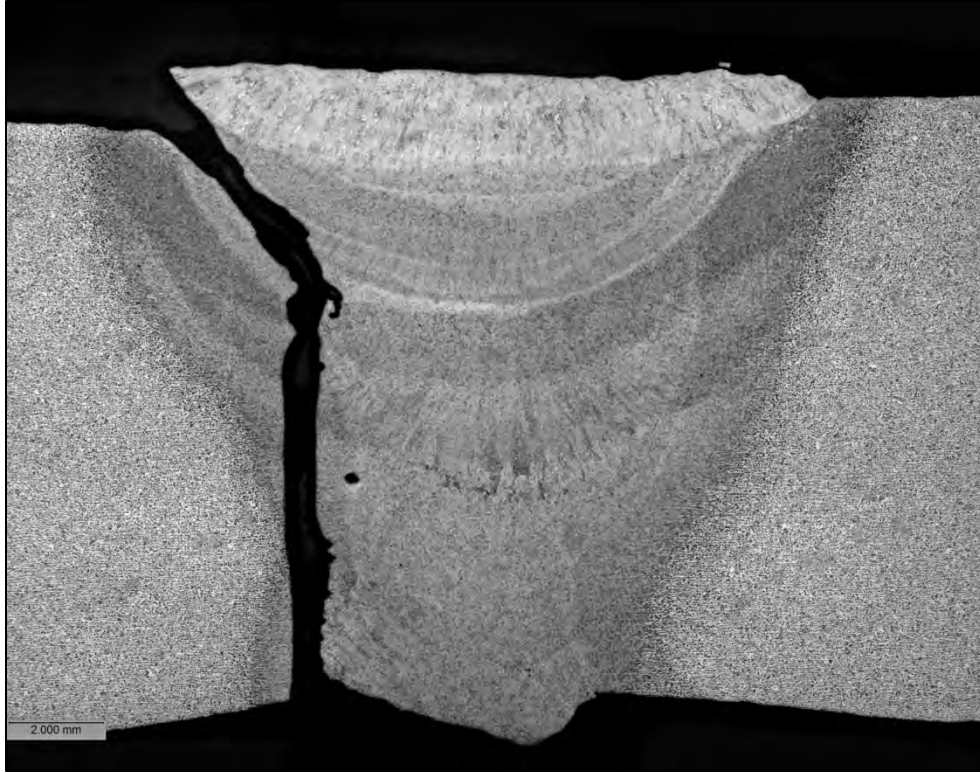
The metallographic section through Feature S is shown in Figure 50. The feature, a crack, is seen to initiate at the toe of the root pass and propagate into the weld metal. The crack is relatively flat and straight (radial) through about 75% of the pipe wall thickness, and exhibits ductile shear fracture in the remaining 25% of the wall thickness.

**Figure 50. Metallographic section through Feature S**

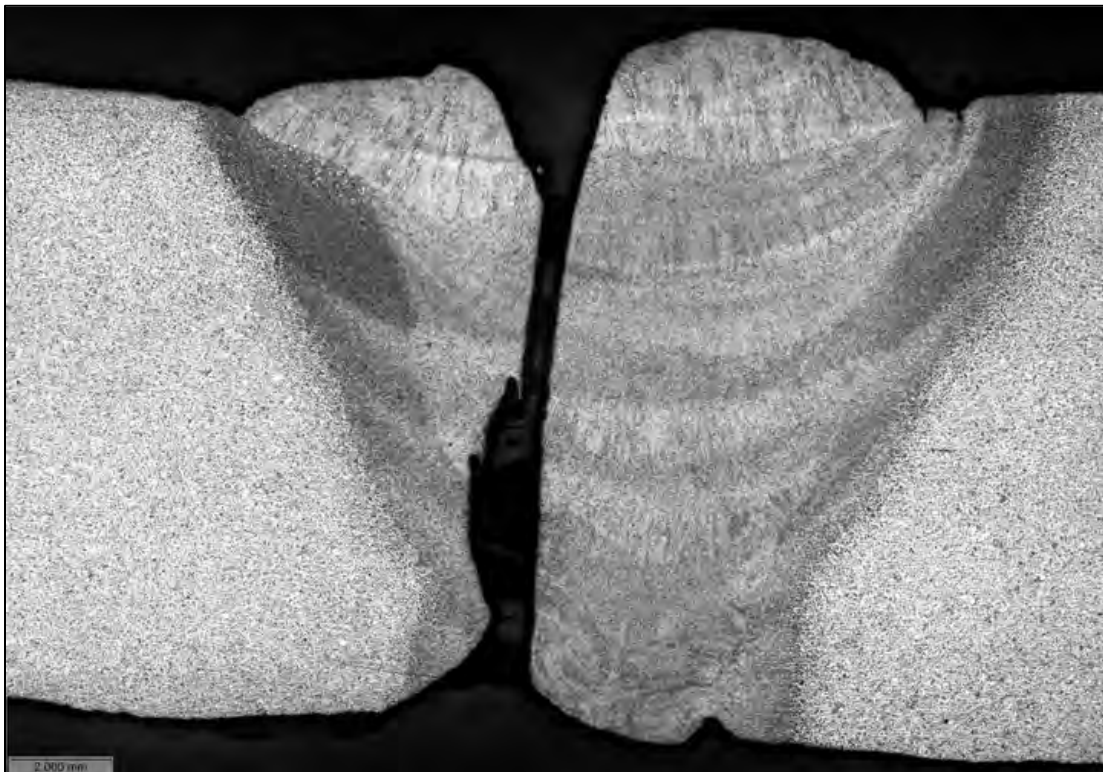
The second metallographic section through Feature L, shown in Figure 52, was taken where the feature propagated completely through the weld thickness. In this section, the crack is seen to propagate flat and straight through the weld metal. The metal on the left hand side of the figure shows evidence of damage near the surfaces and metal loss due to corrosion near mid-wall. However, the metal on the right hand side of the figure appears to be unaffected by such damage.

**Figure 52. Metallographic section through Feature L (at through thickness location)**

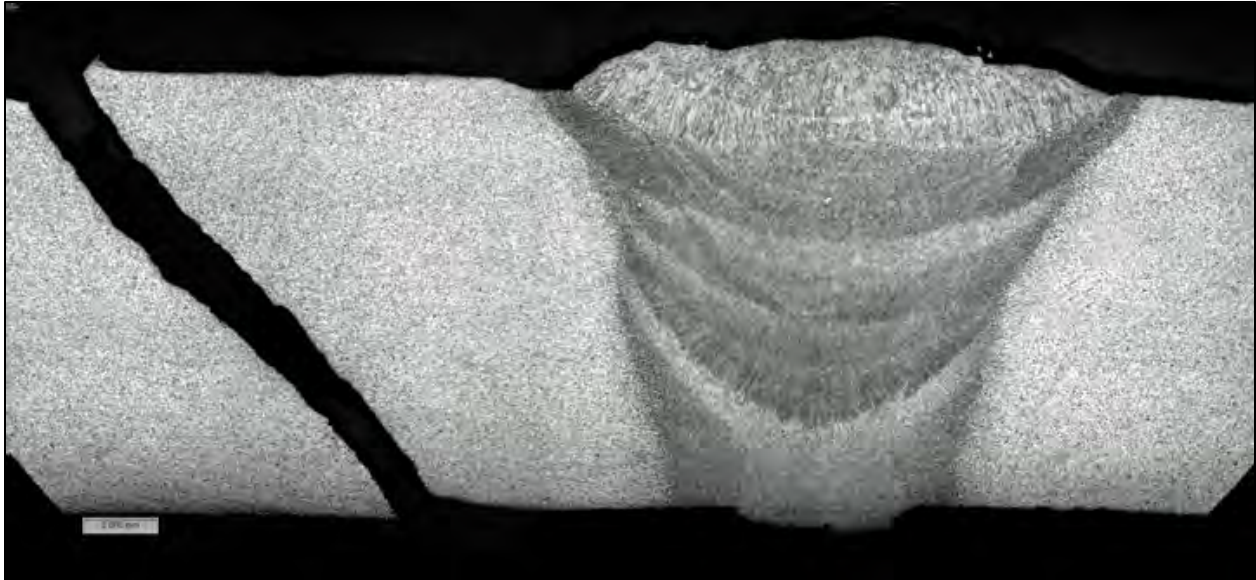
The metallographic section taken through the portion of the fracture that exhibited ductile shear in the pipe wall is shown in Figure 53. In this location, the weld is unaffected by the failure. No defects are present in the pipe wall thickness. The fracture in this location is oriented at approximately 45 degrees to the pipe surface, and the deformation at the surfaces, both internal and external, indicates a tearing (e.g., arrest) shear as opposed to a propagating shear mode.

**Figure 53. Metallographic section through shear area of fracture**

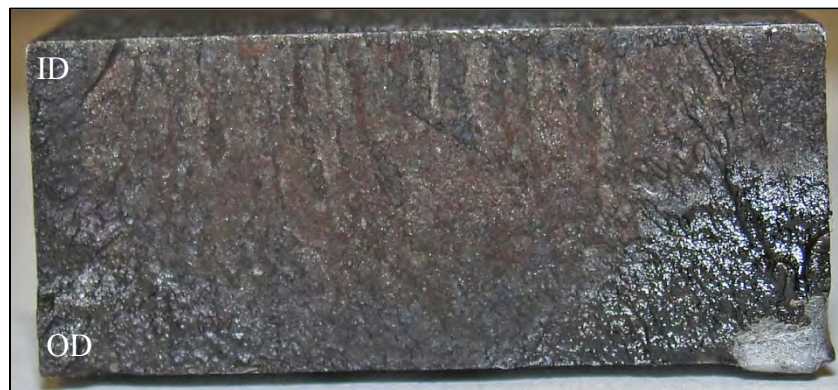
The surface of the crack in the CTOD specimen is shown in Figure 55. The crack surface is relatively smooth and flat and exhibited characteristics similar to features S and L in the failed girth weld. Weld 26 was exposed during the flooding event but remained intact during the failure.

**Figure 55. Crack surface of Weld 026 CTOD specimen**
