DOT US Department of Transportation  
PHMSA Pipelines and Hazardous Materials Safety Administration  
OPS Office of Pipeline Safety  
Western Region

**Principal Investigator** Peter J. Katchmar  
**Regional Accident Coordinator** Peter J. Katchmar  
**Region Director** Chris Hoidal  
**Date of Report** October 30, 2012  
**Subject** ExxonMobil Silvertip Pipeline Crude Oil Release into the Yellowstone River in Laurel, MT on 7/1/2011

## **Executive Summary**

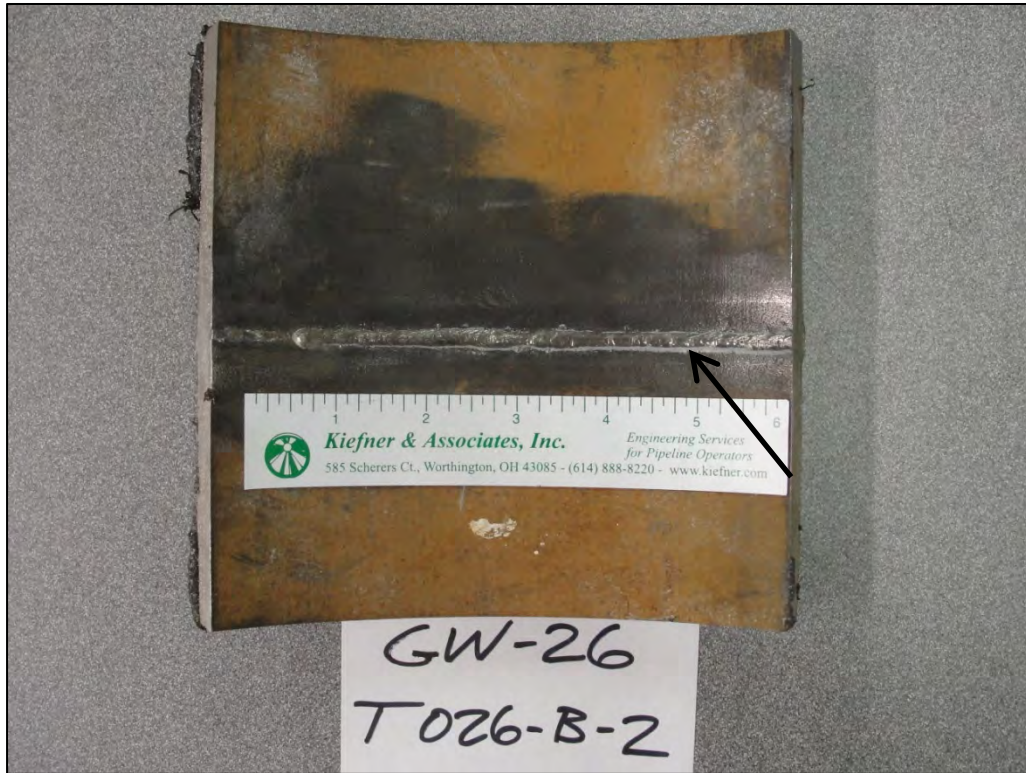
The remaining material coupon adjacent to the location where the CTOD specimen was taken was examined by MT. An indication was detected on the pipe interior that followed the toe of the root pass. The indication in the coupon is shown in Figure 59.

**Figure 59. Internal surface of Coupon T026-B-2 showing MT indication**

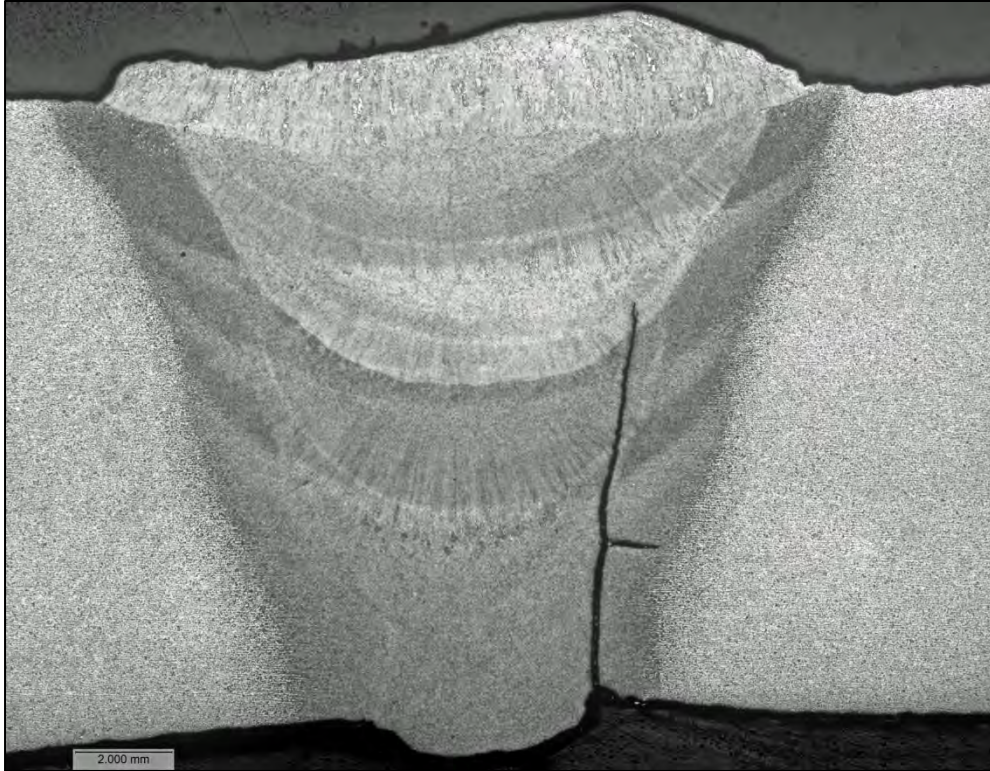
**Figure 61. Metallographic section through crack in Coupon T026-B-2**

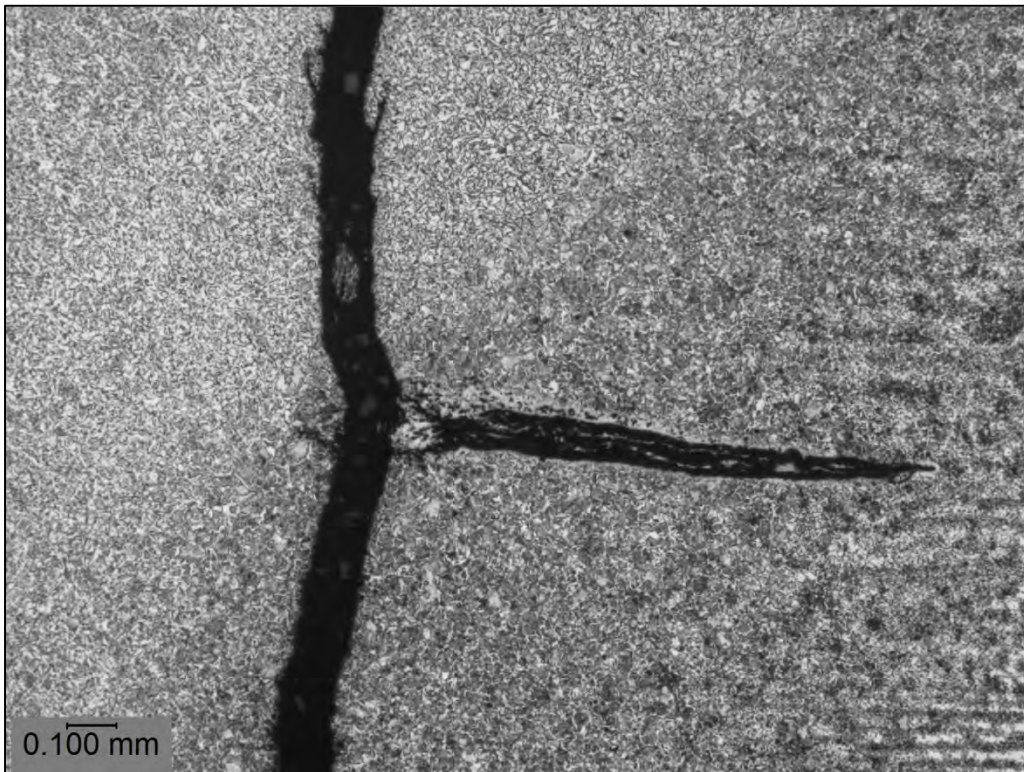
**Figure 62. Detail of flaw along crack path in Coupon T026-B-2**
