DOT US Department of Transportation
PHMSA Pipelines and Hazardous Materials Safety Administration
OPS Office of Pipeline Safety
Southwest Region

Date of Report 11/6/2012
Subject Failure Investigation Report - Magellan Pipeline Company,
Orion 20-inch Pipeline, 3012 Tank Line, East Houston
Terminal

**Failure Investigation Report – Magellan Pipeline Company – East Houston Terminal
December 1, 2011**

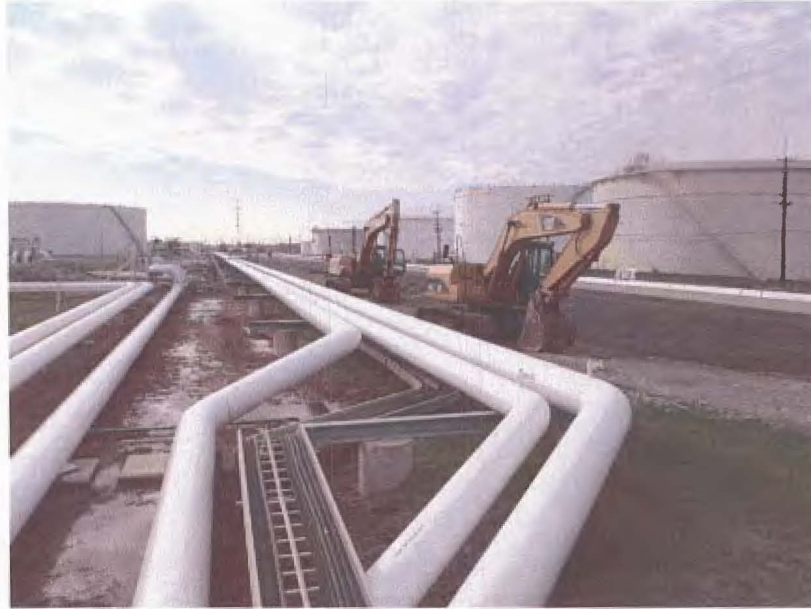
Picture 2 - 20-inch Tank 3012 Pipeline – looking towards Tank 3012

Tank 3012 and the 20-inch above grade pipe were constructed in 2008. It is comprised of 20-inch, 0.375 wall thickness, Grade X-35, carbon steel pipe. It was installed on pipe supports and is approximately 1000-feet long.

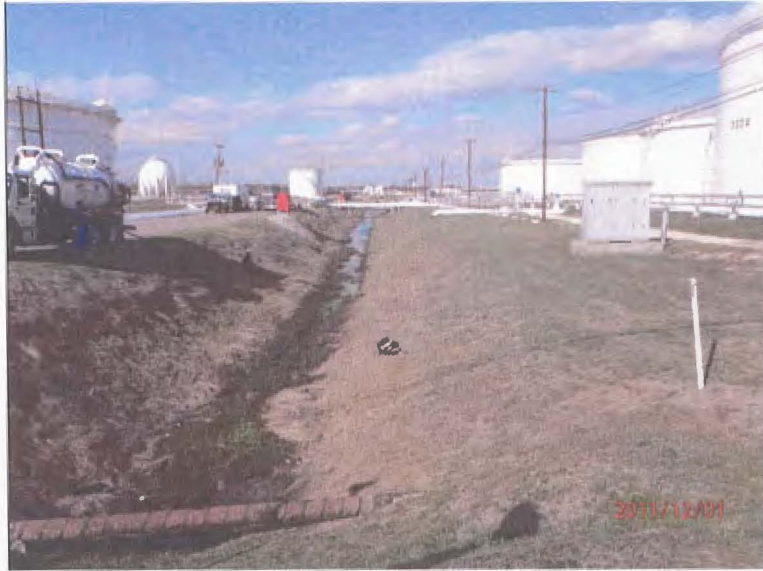
Picture 4 - Drainage ditch where the release product collected

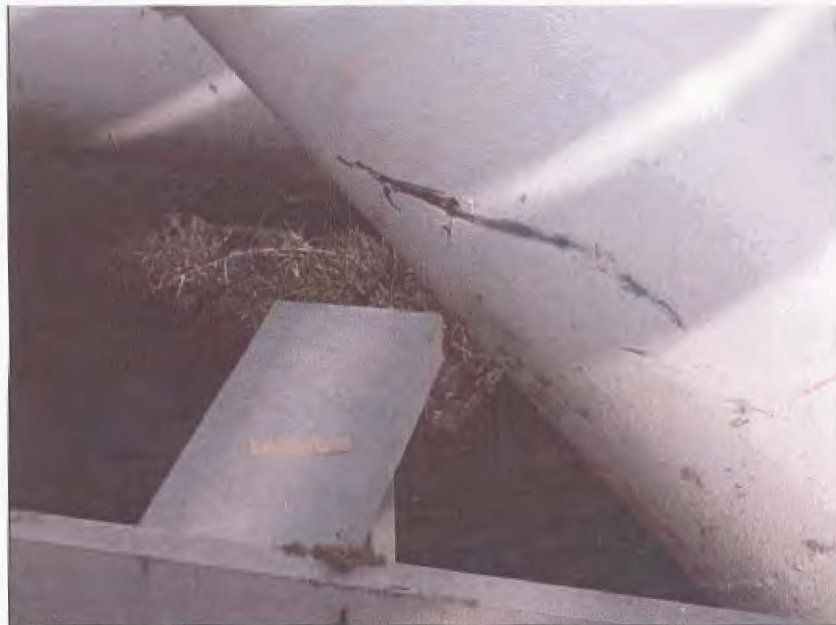
Picture 5 – Tank Line 3012 showing where it might have hit pipe support

The failure occurred when a 1-inch nipple located in the underside of the line 3012 failed when the pipe moved/shifted. It can be used to drain the line.

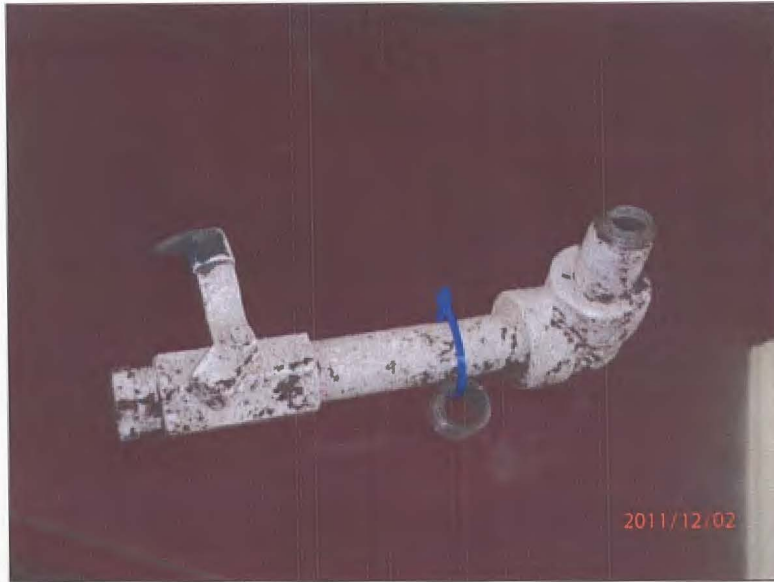
Picture 6 - Drain line that was damaged

The pipeline was inspected for any coating or pipe damage then pressure tested successfully using nitrogen. A leak test was performed per SIP 7.13-ADM-019 – Integrity Verification the leak test pressure did not exceed 100 psi. The test plan and the test were reviewed and witnessed by PHMSA representatives. No major repairs were necessary after the leak test or after the realignment had been completed. All girth welds that were moved during realignment were inspected using Non-Destructive Tests (NDT) methods prior to realignment of the line.

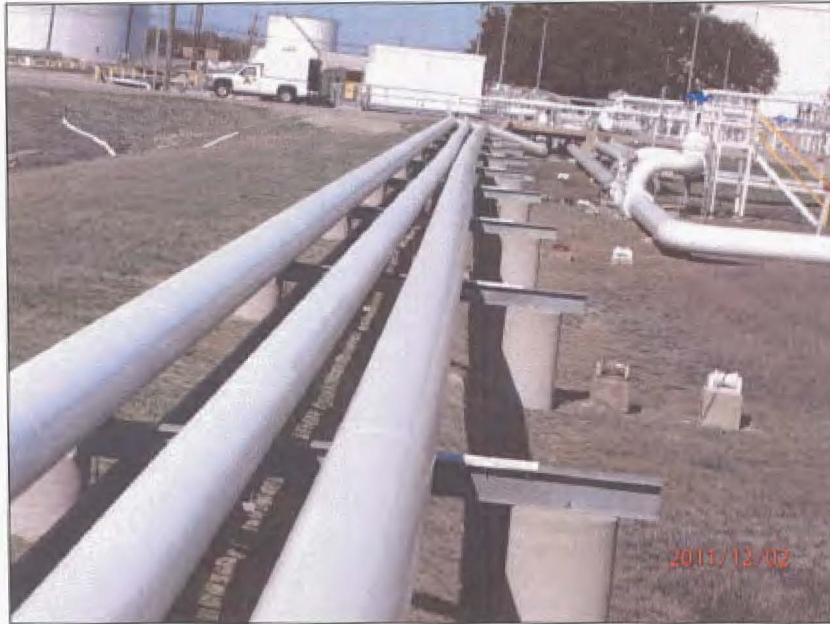
The vibration/shift caused the Tank 3012 pipe to move approximately 12-15 inches from left to right. The failure occurred when a 1-inch drip hit either a pipe support or the ground when the pipe moved/shifted.

The collapse of a vapor pocket caused a severe pressure transient on the 20-inch Tank 3012 pipeline. This was triggered by a dramatic drop in the pump suction pressure, which tripped the pump, which raised the pressure again. This caused the rapid formation and collapse of a vapor pocket and the pressure transient.

Picture 3 - Tank Line 3012 moved to the left – looking away from Tank 3012

- Management of Change to always have product flow through the dual, two meter configuration. This change in operation eliminates the potential for any upsets caused by opening/closing the second meter;
- Unit suction control programming has been implemented;
- Installed an additional pressure transmitter on the suction side of the yard booster; and
- Surge relief has been installed between the manifold and the pump suction.
