Pipeline Failure Investigation Report

Pipeline System: 22-inch Maumee Pipeline **Operator:** Mid-Valley Pipeline Company
Location: Cygnnet, Ohio **Date of Occurrence:** 2-18-2009
Medium Released: Crude Oil **Quantity:** 1250 bbls

On February 18, 2009, Mid Valley Pipeline's 22" Maumee Pipeline (Lima to Cygnnet) experienced a leak at a 12" diameter branch connection. The damaged pipeline, which was operating at the time, released 1250 barrels of crude oil into a farm field. Eventually, 782 of the 1250 barrels released were recovered. Some of the crude oil, approximately 200 barrels, did contaminate a local creek. There were no fatalities, or injuries. One person was evacuated for several hours. The release did occur in a high consequence area (drinking water).

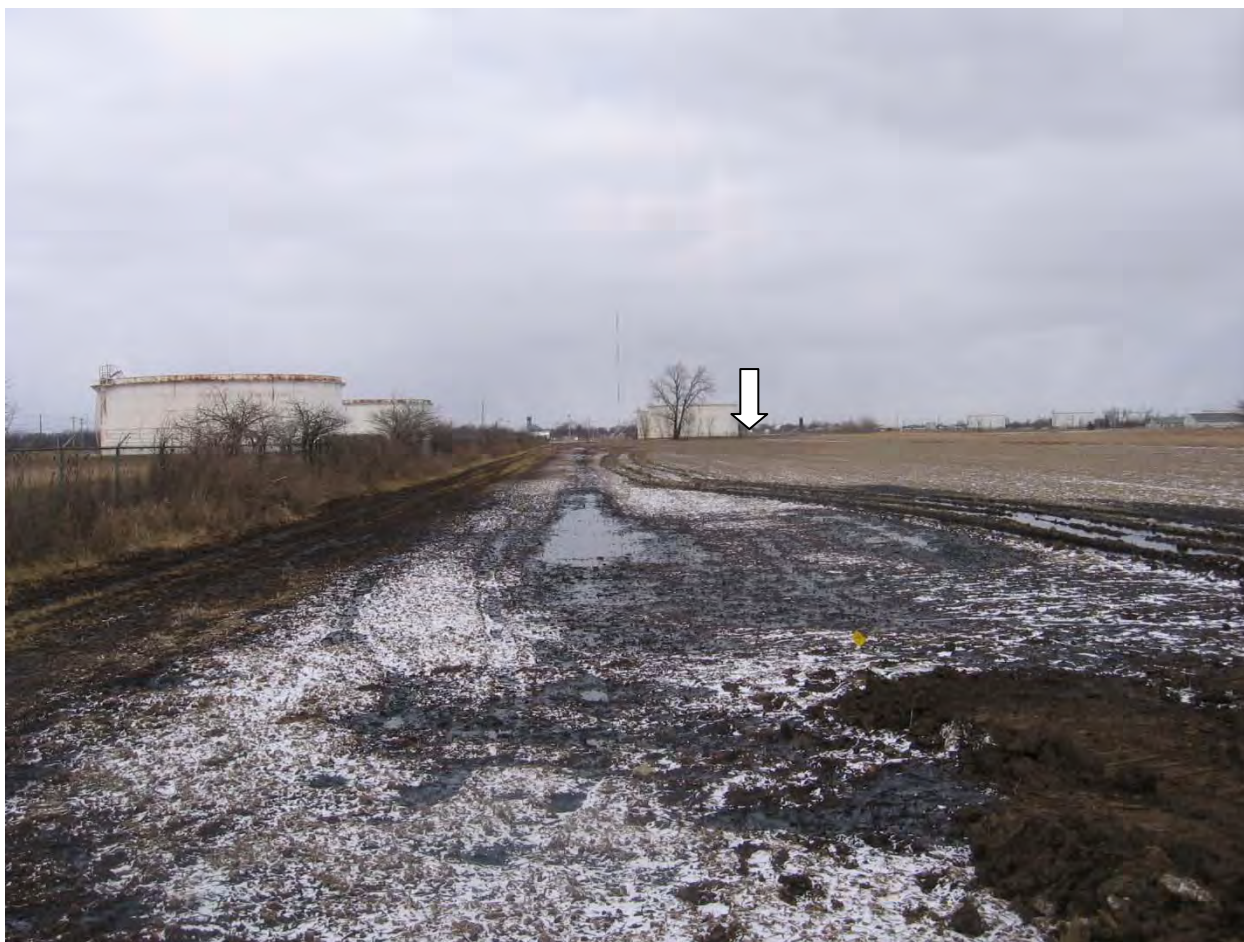
Photo 1 – View looking north from leak site. Tanks visible in the photo are no longer in service. The arrow points to Tank Farm Road.

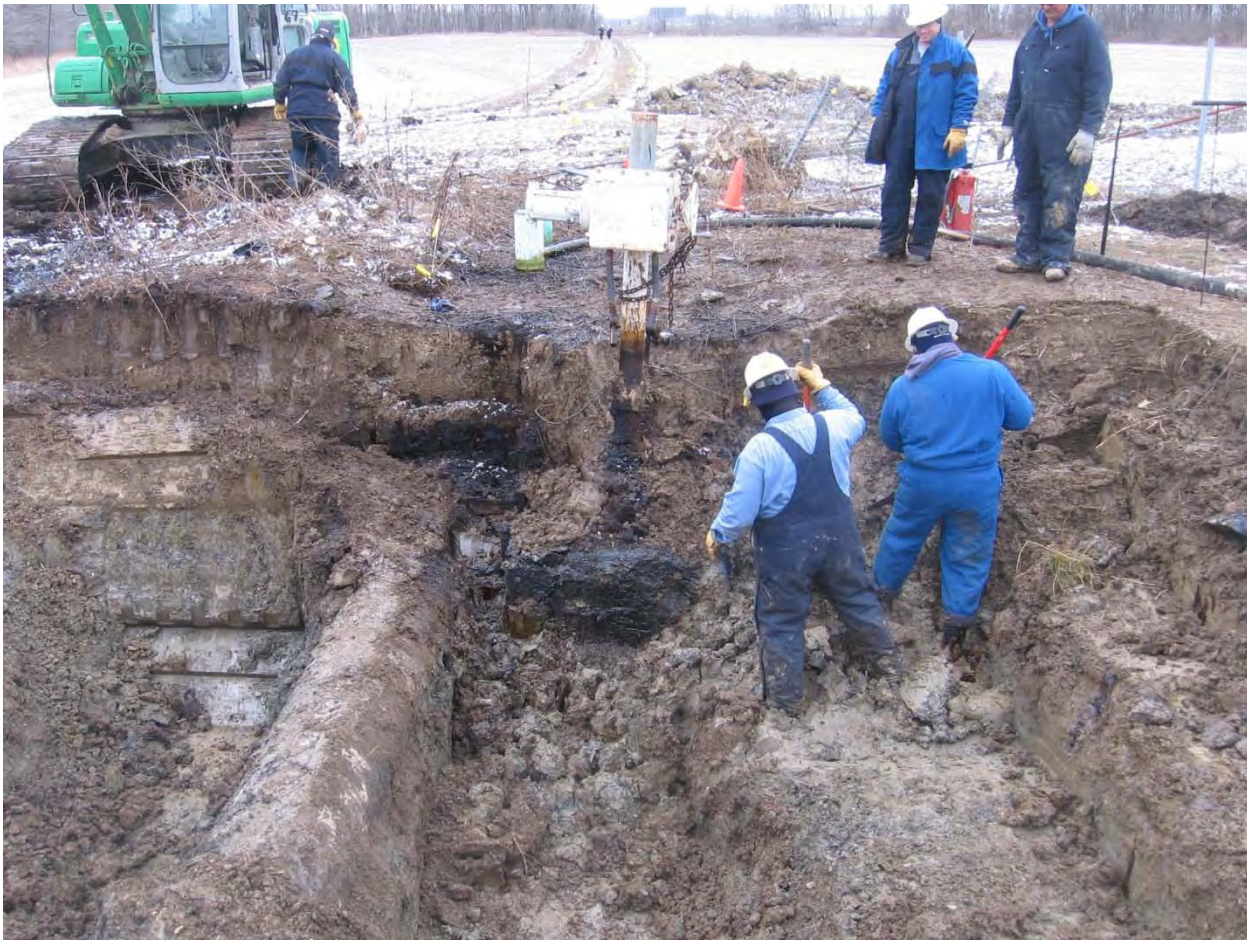
Photo 2 – View from leak site looking south. Visible is the branch connection and 12" valve.

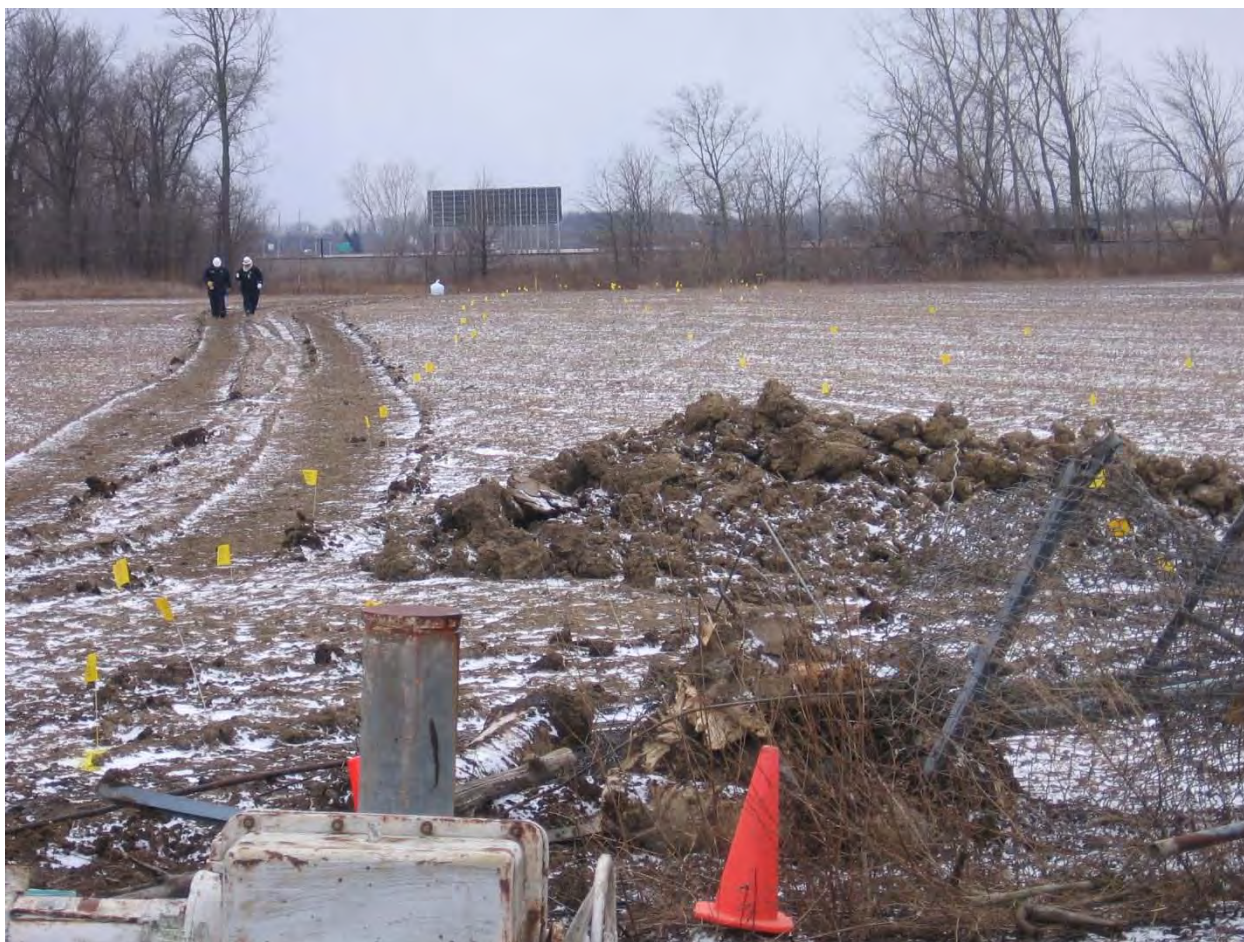
Photo 3 - The photo shows the view south of the branch connection. The tree line indicates Rocky Ford Creek. Field tile drain to the south into the Rocky Ford Creek and crude oil did reach the creek through the tile.

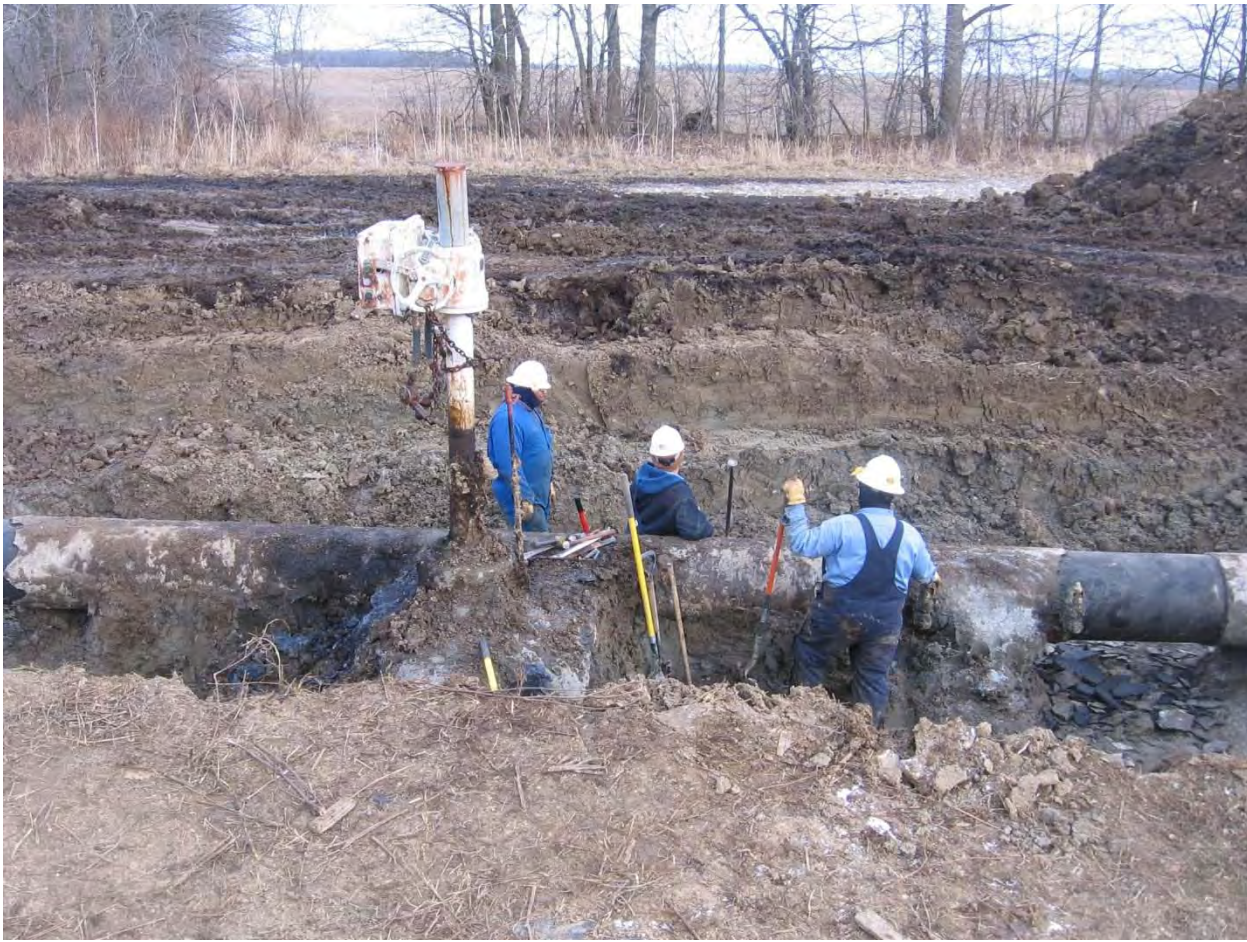
Photo 4 - The photo shows the valve actuator at the branch connection.

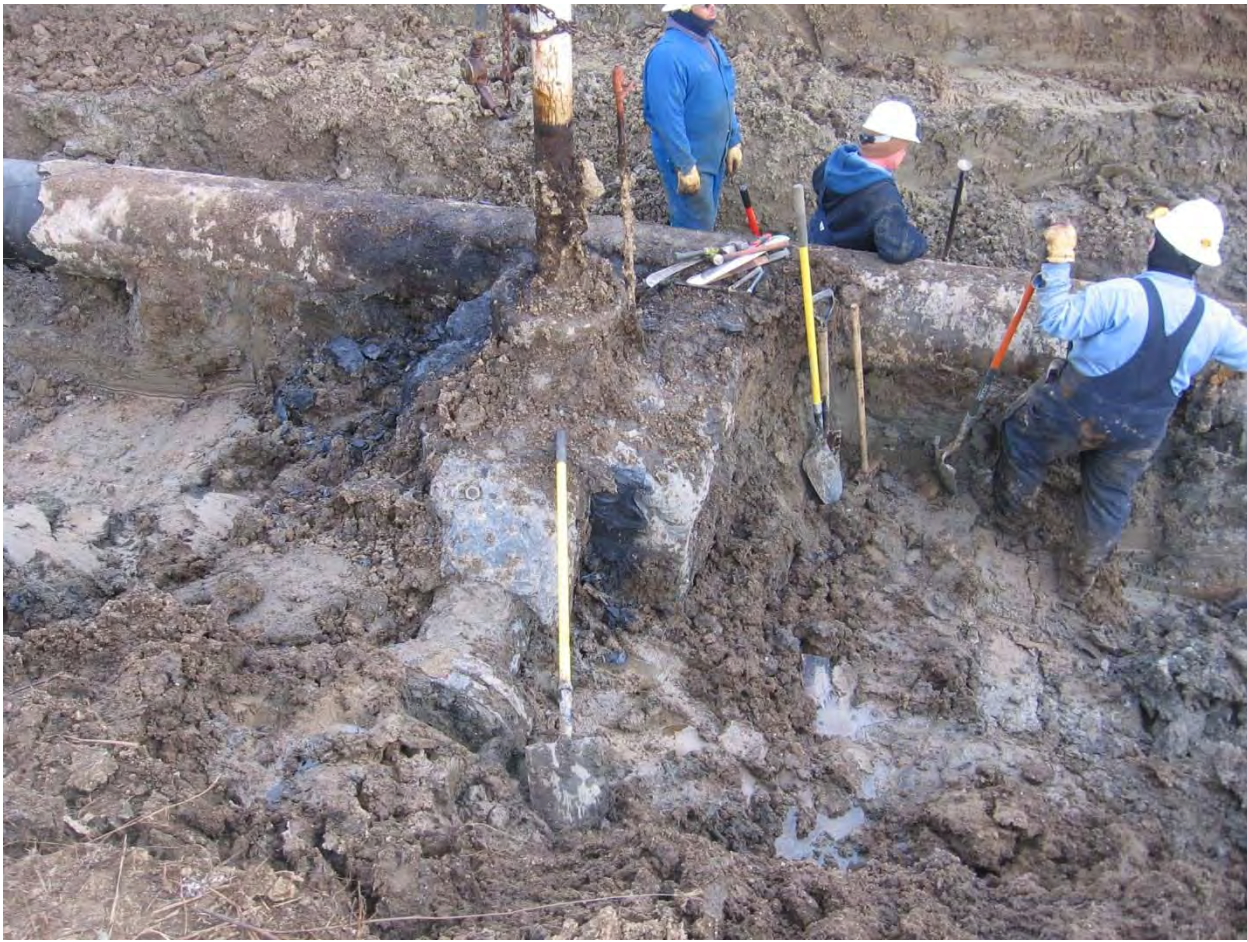
Photo 5 - The photo shows the valve and blinded flange.

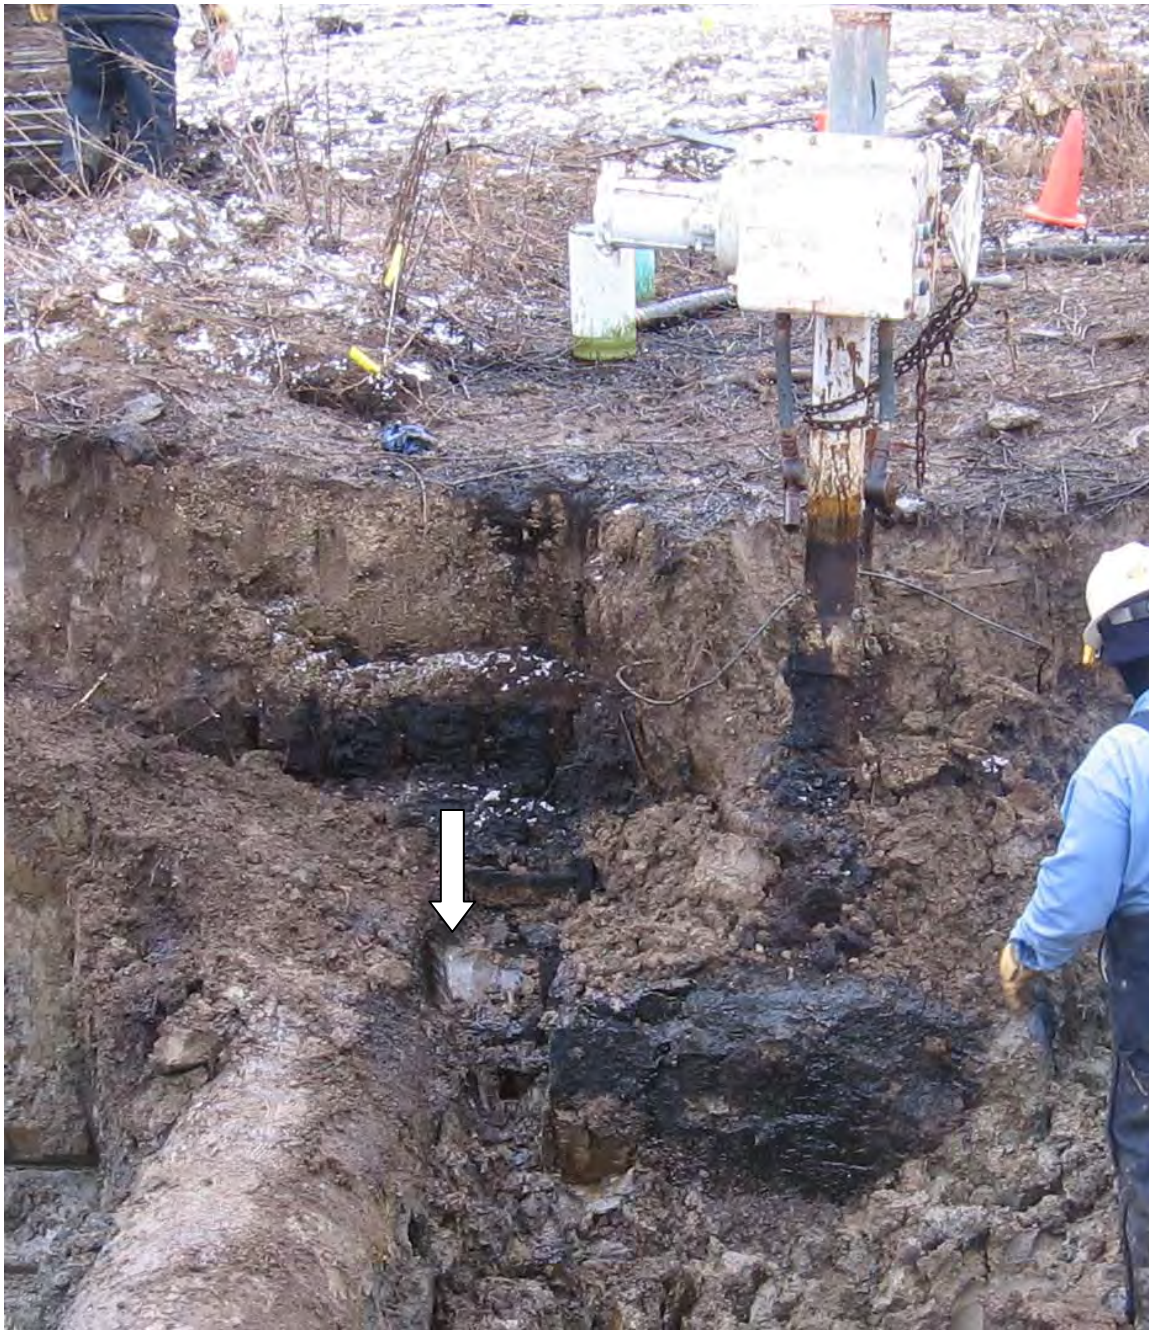
Photo 6 - The photo shows origin of the leak. The arrow points to the crack.

The failed branch connection along with approximately 80" length of mainline pipe containing it was cut out. The branch connection was transported to Kiefner and Associates for failure analysis (Appendix 5). The 80" long section of pipe was replaced with pretested pipe and the tie-in girth welds were radiographed. Mid Valley Pipeline initiated a cleanup of the crude oil near the branch connection. Unfortunately, crude oil found its way into the Rocky Ford Creek and Mid Valley Pipeline launched an extensive stream cleanup program under the direction of Ohio EPA and US EPA Region 5.

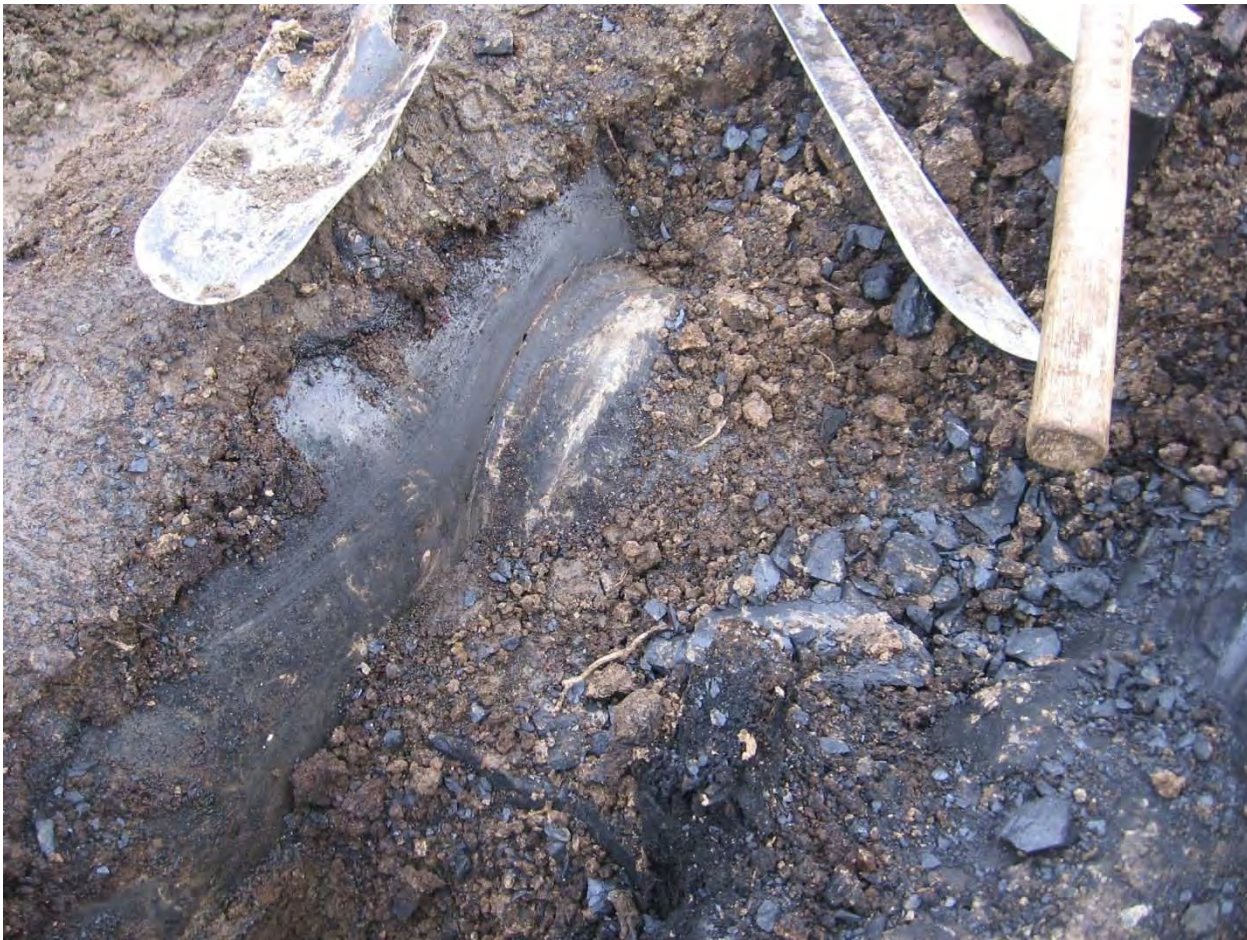
Photo 7 - The photo shows the weld between the mainline pipe and the branch connection.

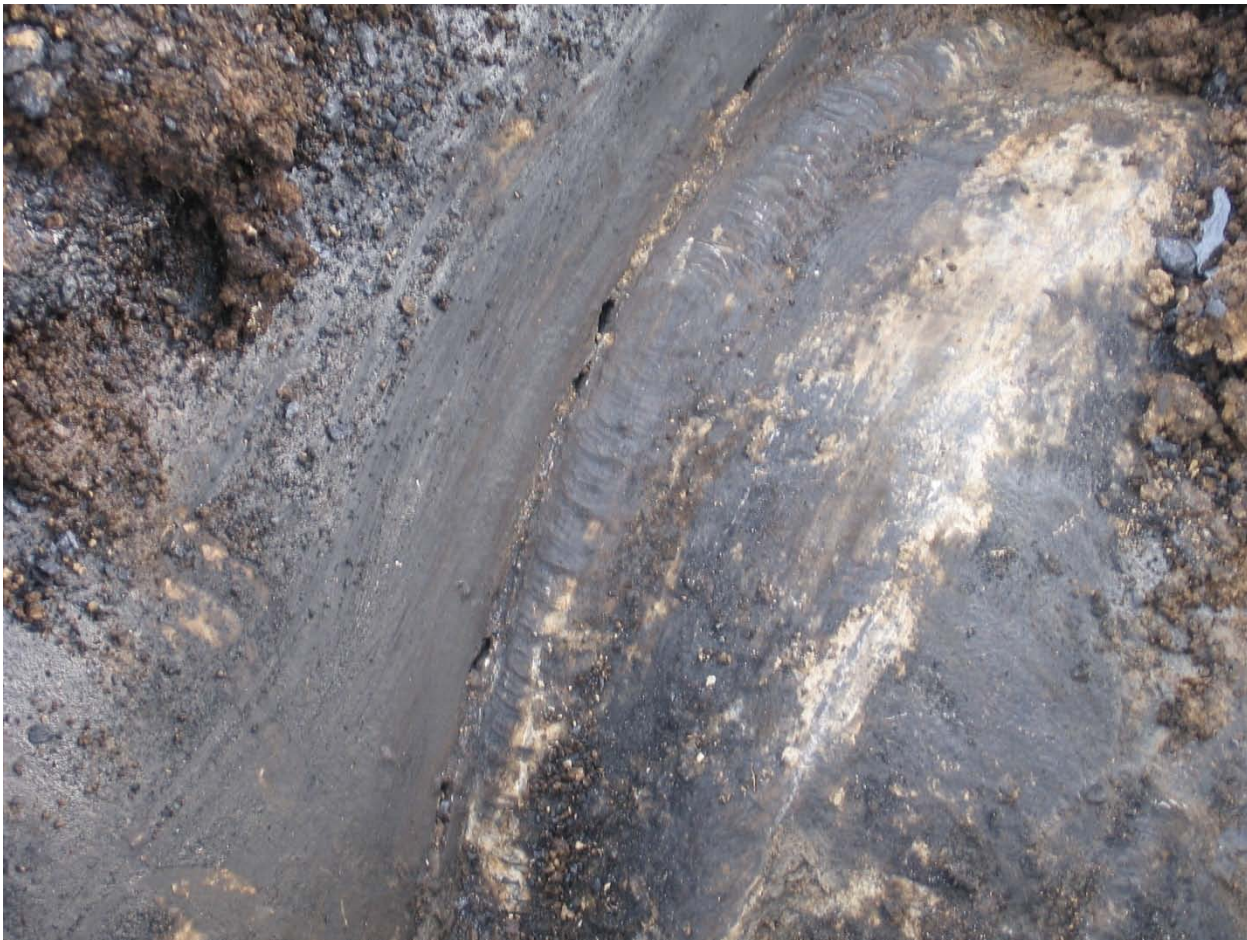
Photo 8 - The photo shows the crack. Note the crack does contain some dirt as the result of the excavation.

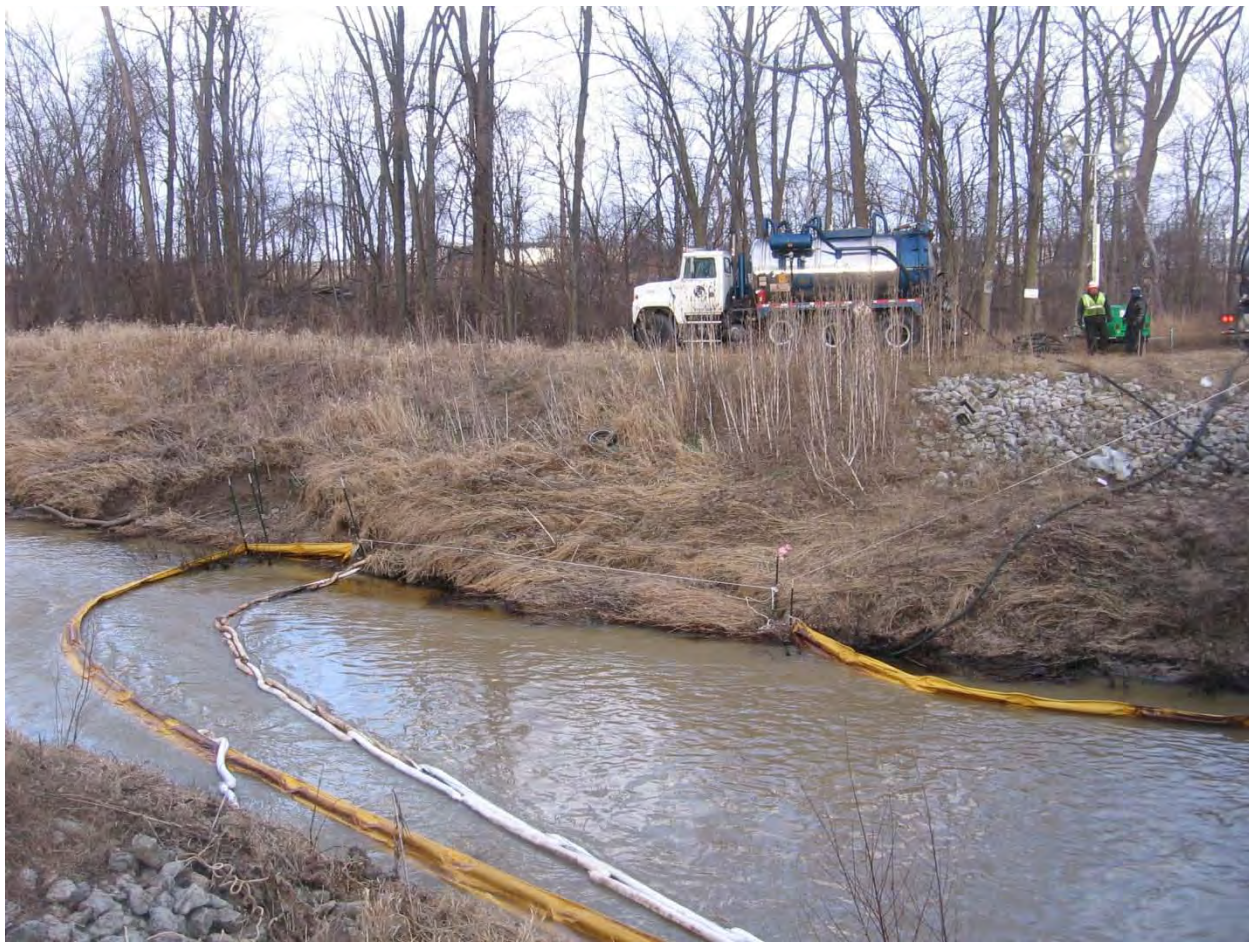
Photo 9 - The photo show booms in the Rocky Ford Creek just downstream of the Tank Farm Road.

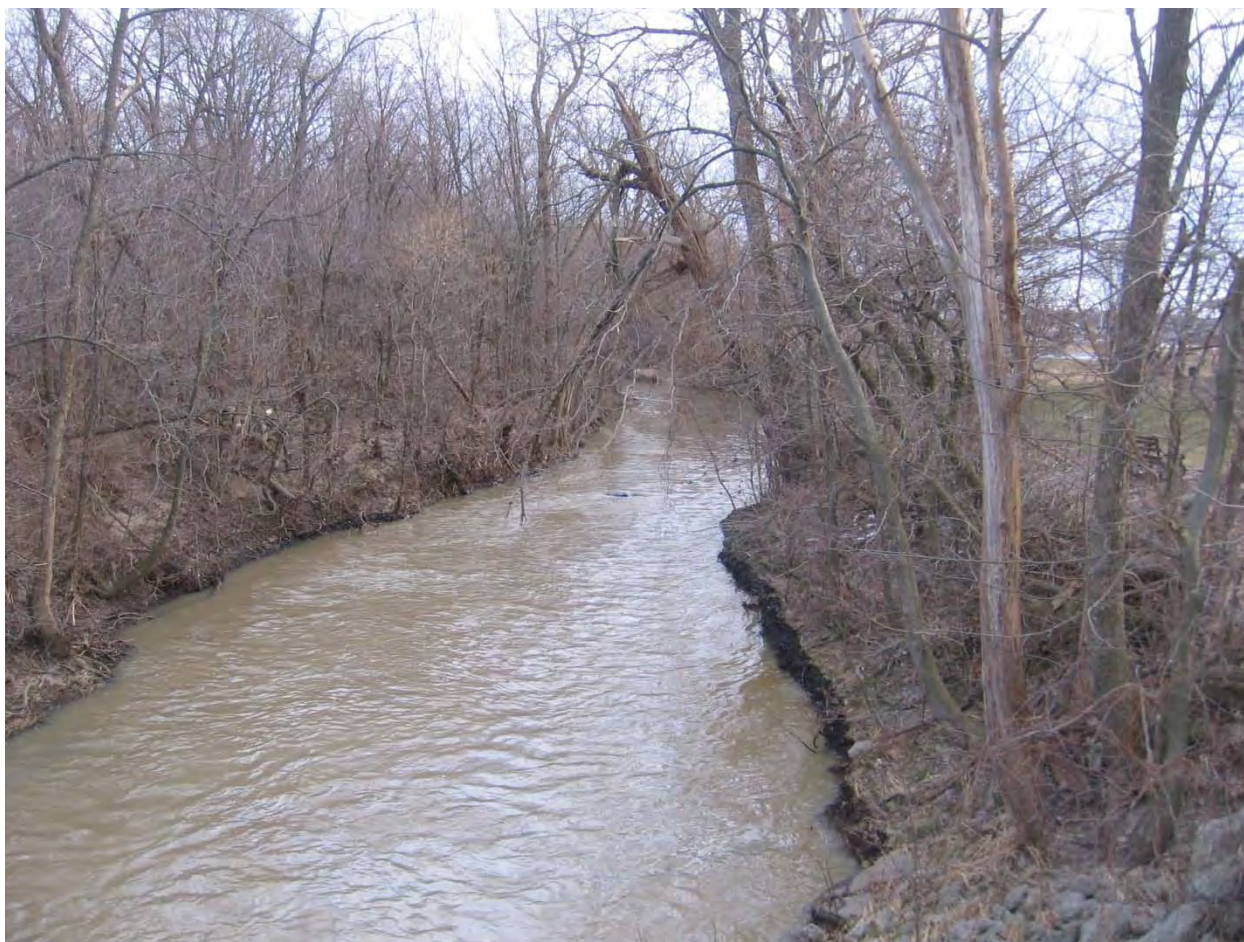
Photo 10 - The photo shows the crude oil contamination along the banks of the Rocky Ford Creek.
